Railway Investigation Report R11T0161

Employee fatality

VIA Rail Inc.
Train VIA 051
Mile 314.4 Kingston Subdivision
Durham Junction, Ontario
14 July 2011

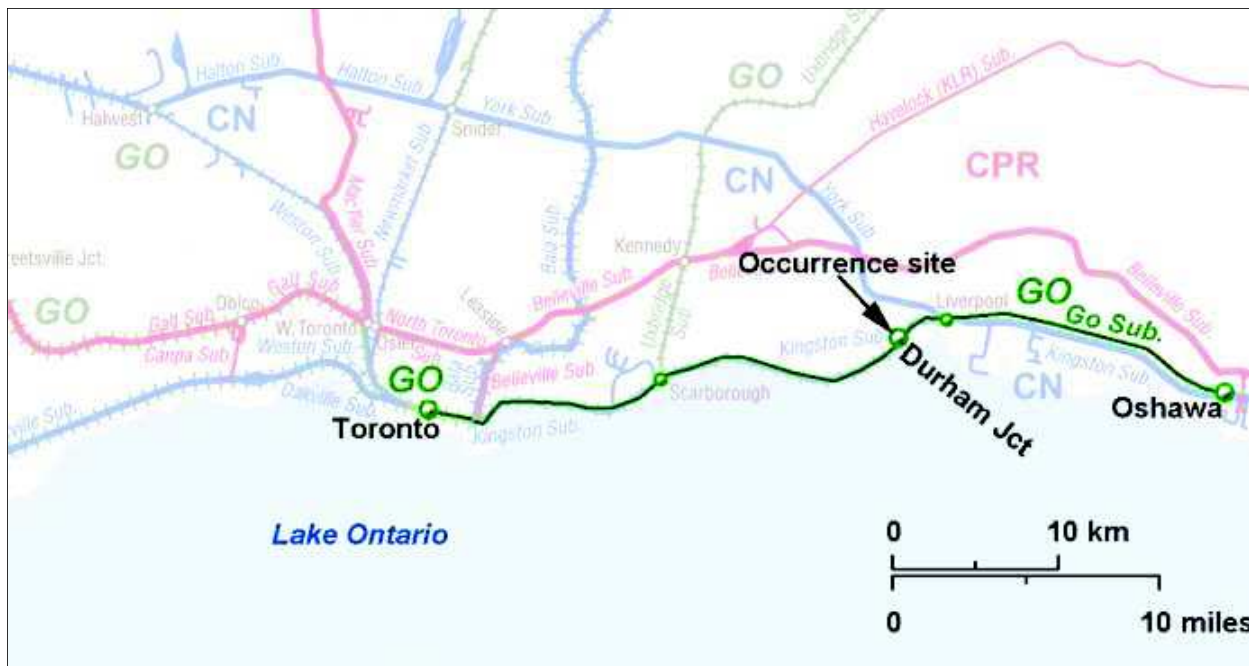
Figure 1. Occurrence site (Source: *Railway Association of Canada, Canadian Railway Atlas*) ¹

At approximately 1306, while travelling at 96 mph on the south track of the Kingston Subdivision near Durham Junction, VIA 51 rounded a 6000-foot long 1° left-hand curve. About 800 feet ahead (Mile 314.4), the crew noticed 2 CN Engineering Services (ES) employees, a senior track foreman and a trackman, working on the north track. At 1306:20, VIA 51's bell and horn were sounded approaching the work location. Just before arriving at the work location, the crew made an emergency train brake application. The trackman, who was facing north east, reacted to the approach of the train as it came into sight, approximately 6 seconds before it reached the work site. He moved north, cleared the track and shouted at his co-worker to clear the track. The senior track foreman attempted to exit over the south track, moving into the path of the oncoming train. The senior track foreman was struck by VIA 51 and was fatally injured. The train crew made an emergency radio call to advise the rail traffic controller (RTC) of the accident and to request emergency medical assistance. VIA 51 came to a stop approximately 3440 feet west of the accident location ([Figure 1](#)).
