Collision Between Two Massachusetts Bay
Transportation Authority Green Line Trains
Newton, Massachusetts
May 28, 2008

NTSB/RAR-09/02
PB2009-916302

Railroad Accident Report

Collision Between Two Massachusetts Bay Transportation
Authority Green Line Trains
Newton, Massachusetts
May 28, 2008

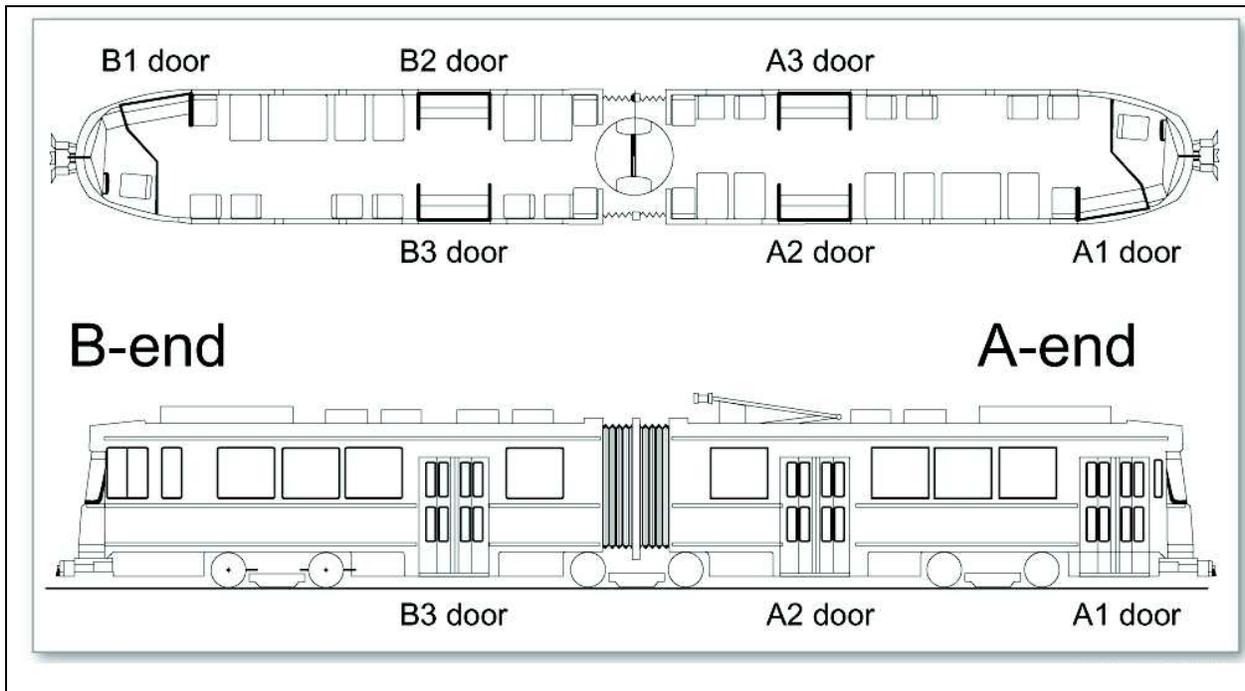
Train 3667 was operating A-end forward. (See figure 5.) In the A-end, the operator's cab and A1 door were crushed toward the rear and under the car body. This crushed area extended for a distance of 121 inches from the front of the cab. From the first row of passenger seats to the center doors, the ceiling was sloped downward, and it angled toward the right side of the front of the car. The floor in this area was buckled upward.

Train 3681 was operating B-end forward. In the A-end (the end that was struck—car 3703), the operator's cab and the A1 door were crushed toward the front of the car body. This crushed area extended from the front of the cab for a distance of 120 inches. The floor began to

buckle upward near the third row (from the rear of the car) of passenger seats. From this point to the rear of the car, the floor sloped downward.

Figure 5. Each train involved in accident consisted of two permanently coupled cars, as shown in drawing. Car 3667 was A-end and lead car of striking train; car 3681 was B-end and lead car of struck train.

The anticlimber⁹ of car 3703 was raised upward and toward the left side (in the direction of travel) of the car. The center of the anticlimber had been moved 13 inches to the left of its normal centerline. The anticlimber's highest point measured 39 1/8 inches above the top of the rail, and the centerline measured 38 7/8 inches above the top of the rail.
