**RAILWAY INVESTIGATION REPORT
R13W0260**

EMPLOYEE FATALITY

**CANADIAN NATIONAL RAILWAY
TRAIN L586 41-18
MILE 61.0, TISDALE SUBDIVISION
TISDALE, SASKATCHEWAN
18 NOVEMBER 2013**

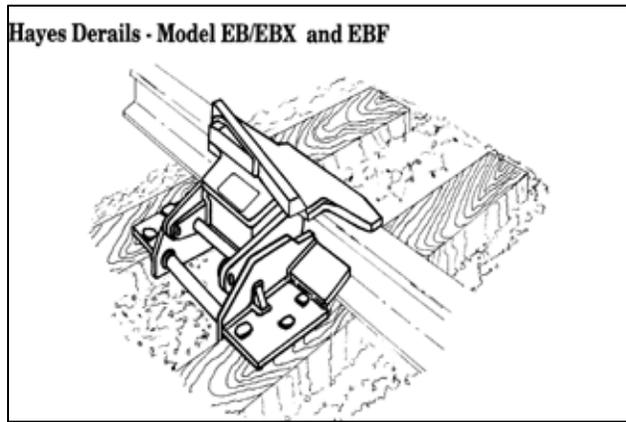
- Hinged derails are located between the rails (Figure 3). To operate them, particularly in situations that require the clearing of ice or snow, an employee usually works by standing between the rails and lifting the derail by hand in a semi-circular motion on and off the rail head.

Figure 3. A model EB hinged derail, mounted between the rails, in derailing position

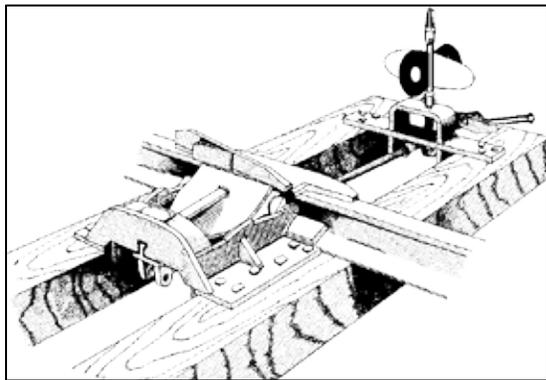
- Sliding derails are also located between the rails, but are operated from an operating lever and stand that is mounted outside of the rails (Figure 4). For this derail design, employees operate the derail while standing clear of the track.

Figure 4. A model HB sliding derail, with the operating stand mounted on 2 ties outside the rails, in the derailing position

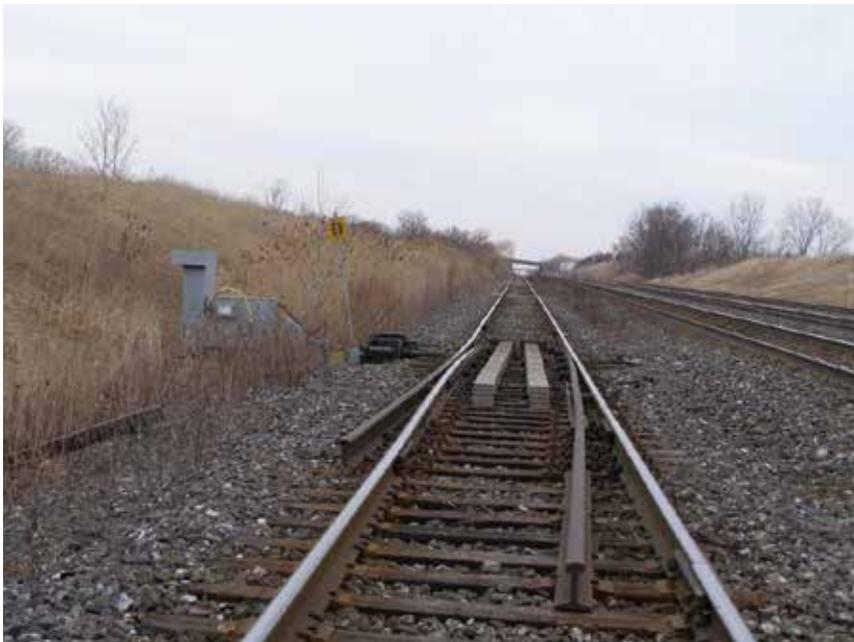
- A switch point derail (Photo 2), sometimes referred to as a split switch derail, is a track switch installed at the derail location. The switch point derail can be operated as a power derail or as a conventional hand-operated derail. In both cases, the switch is activated from outside the track just as a regular track switch would be. However, there is no track extending from the diverging route. When the switch point derail is in the derailing position, rail cars are diverted directly to the roadbed.

Photo 2. A switch point derail operated by a power switch
