Perspective Property Inspections
 A Steel Rhino Property Inspections Affiliate
 P.O. Box 3441, Littleton CO 80161
 720-221-3669
Providing the Peace of Mind You Deserve!

Client: Sample Client SClient@gmail.net (720) 555-1212	Property Address: 1005 E Sample St City, Colorado 80000	Date: <Today>
---------------------------------------------------------------------------------------------------------------	----------------------------------------------------------------------	-------------------------

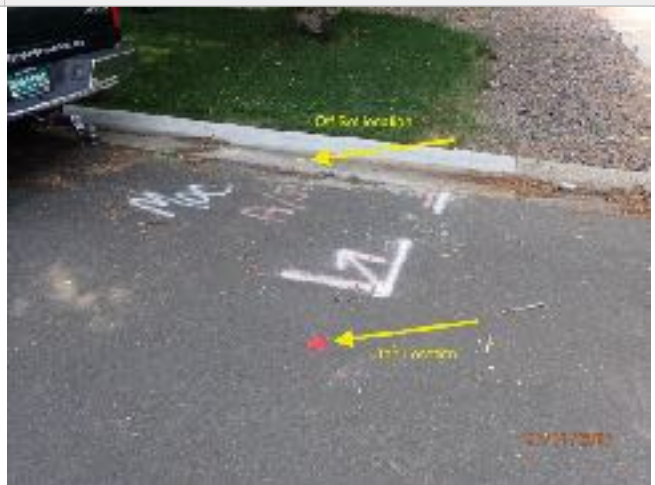
Approximate depth and location of sewer tap. Surface view

Recommend contacting a sewer line plumbing contractor to evaluate and repair the segment between the SDR/Concrete transition and the sewer tap. *Recommend re-scoping post repair and 1-2 years to monitor.
