Rock slopes and reservoirs - lessons learned

Dennis P. Moore

BC Hydro, Power Supply Engineering, Burnaby, B.C.

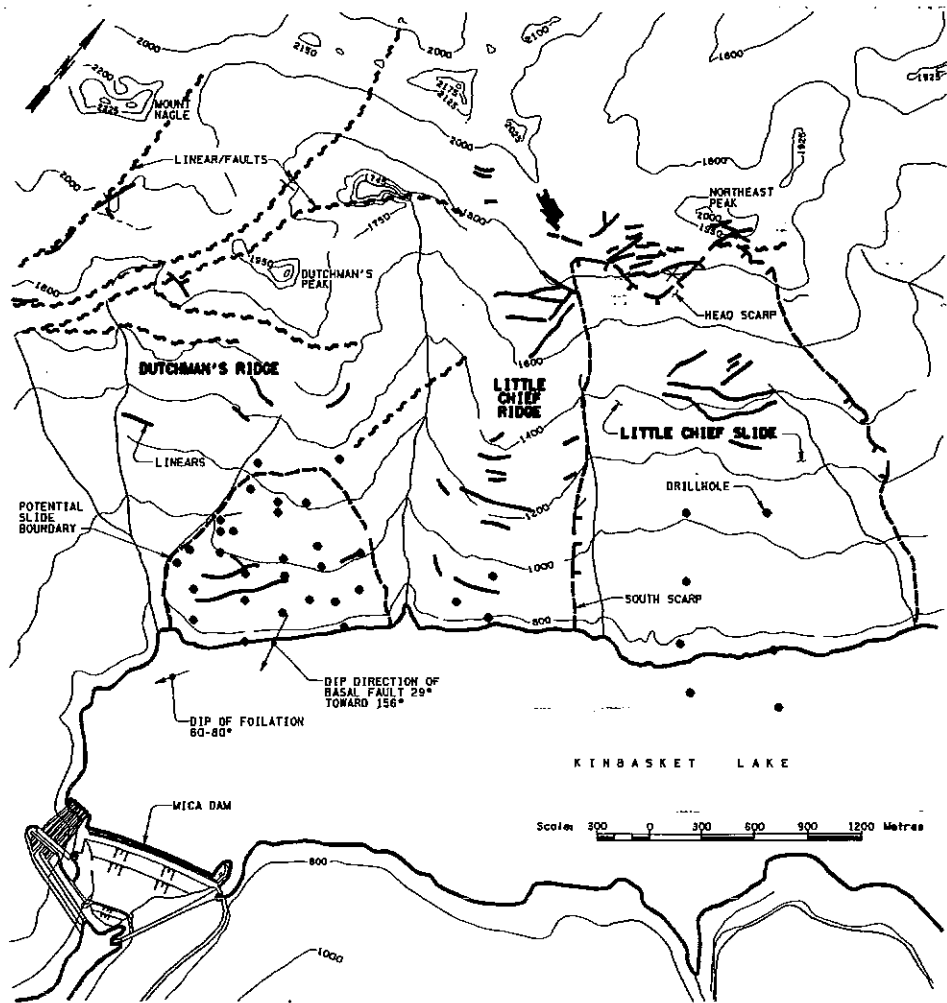
Fig. 2. Plan view of Little Chief Slide, Little Chief Ridge and Dutchman's Ridge and Mica Dam and reservoir. The "linears" are elongated troughs a few metres deep which generally follow the surface contours and the "linear/faults" are similar topographic features that are known to follow tectonic faults.

Long term monitoring also has proven to be valuable at Little Chief Slide. This slide (Fig. 2) was investigated in 1968-69: six holes were drilled and four of these were instrumented with inclinometers. Surface monument surveys were also instituted. The original investigators were concerned that the toe of the slide might rest on liquefiable sand or that strength might be lost for some other reason, resulting in a rapid acceleration of the slide mass. As part of the evaluation of the hazard this slide presented to the proposed Mica Dam, geological cross-sections were developed (Fig. 4). A choice was made based on one hole to select the upper of two possible slide bases because of its correlation with a seismic refraction boundary. These cross-sections indicated that the original dip of the slide surface was about 25° and the volume of the slide was about $375 \times 10^6 \text{ m}^3$. The geological investigations showed that rapid acceleration was unlikely. Nevertheless, knowing the uncertainties of subsurface interpretations, the original designers had the foresight to install one inclinometer to a much greater depth than the interpreted slide base.

This potential slide consists of $115 \times 10^6 \text{ m}^3$ of gneiss overlying a fault zone which dips 29° towards the reservoir (Fig. 2 and 3). The surface slope of the ridge is about 35° and it is only 1.5 km upstream from the dam so the impact of a rapid slide from this slope could be severe. The designers recommended a short adit to provide further information and some drainage, but this was not agreed to by BC Hydro's Advisory Board at the time. Instead, the crest of the dam was widened to provide increased erosion resistance and a monitoring program for the slope was instituted. Should movement be detected, the stability of the slope was to be re-examined.
