Evaluation of Predicted and Actual Water Quality Conditions at the Marlin Mine, Guatemala

**Prepared by
E-Tech International**

August 2010

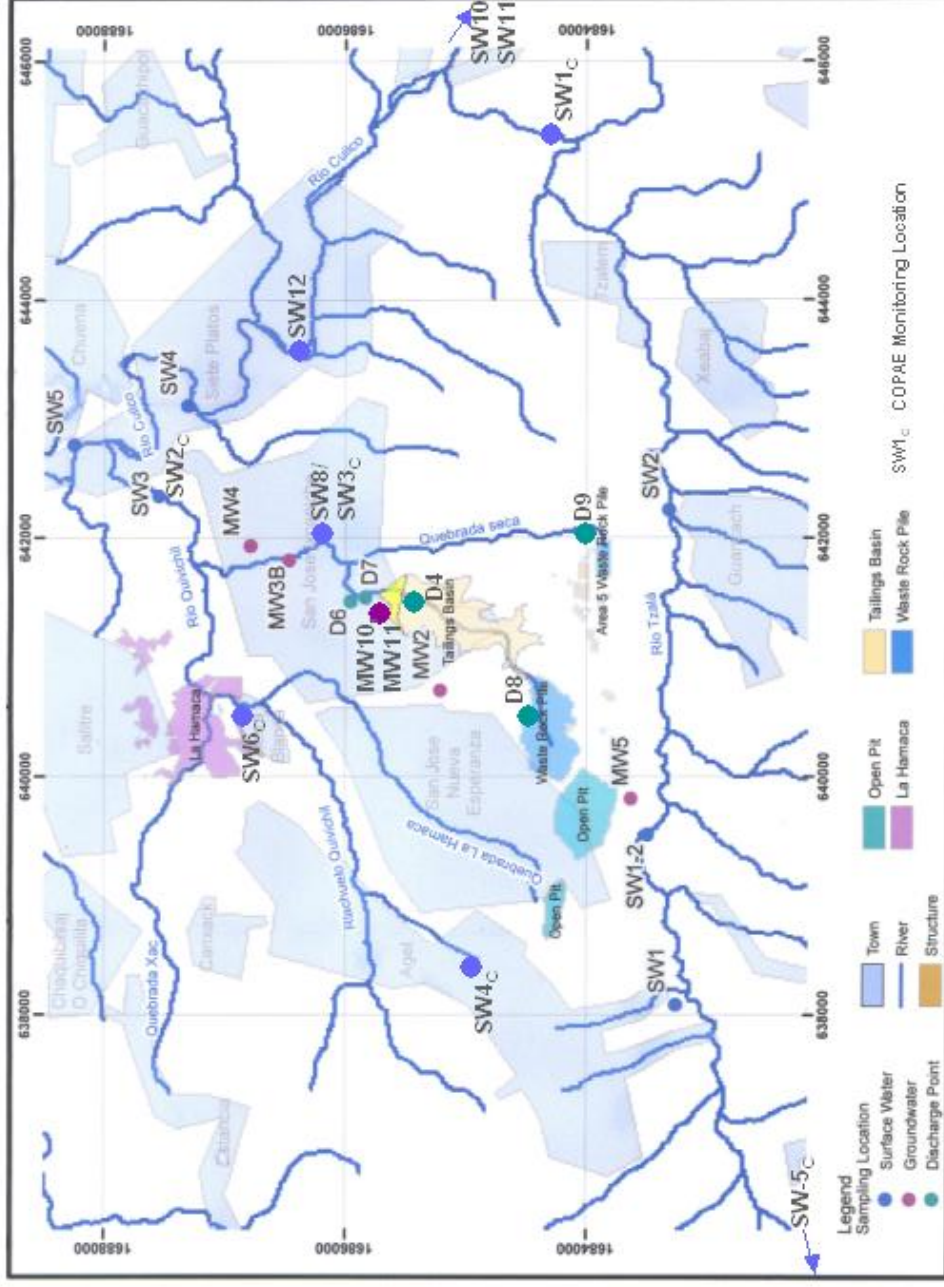
Figure 2. Location of major mine facilities and environmental monitoring locations.

Waste rock seepage from the small waste rock pile in Quebrada Seca (see Figure 2) was sampled in 2007 (2007 AMR, Appendix C). The pH was somewhat depressed (6.53), but no other parameters or constituents had elevated concentrations or appeared to be contaminants of concern for waste rock, based on the one sampling in 2007.

A tributary of Riachuelo Quivichil that drains the mine (Quebrada Seca, and its tributary below the tailings dam) was sampled by Goldcorp (SW8) and COPAE (SW3_c) (same location, see Figure 2). This location is downstream of both the waste rock dump and the tailings impoundment (see Figure 2); no sampling sites that would be unaffected by mining activities exist on the tailings impoundment tributary upstream of Quebrada Seca or on Quebrada Seca upstream of the tailings impoundment tributary (because the mine wastes are located at the very upstream end of the drainages) that would allow monitoring of possible separate effects from the two mining-related sources.

Goldcorp and COPAE sampled surface water station SW8/SW3_C, a non-perennial location in Quebrada Seca located downstream of the tailings dam and large waste rock pile (see Figure 2). Goldcorp's data showed occasional detections of total and WAD cyanide in October 2005 (0.40 mg/l), but concentrations were below detection (at 0.002 and 0.02 mg/l) in September and November of that year. No samples were collected during the dry season in 2006 (January through April), and cyanide was detected again in
