The Potential for Imminent Endangerment to Human Life and the Environment from the Mirador Open Pit Copper Mine in Southeastern Ecuador

Submitted to the InterAmerican Commission on Human Rights

E-Tech International

28 August 2022

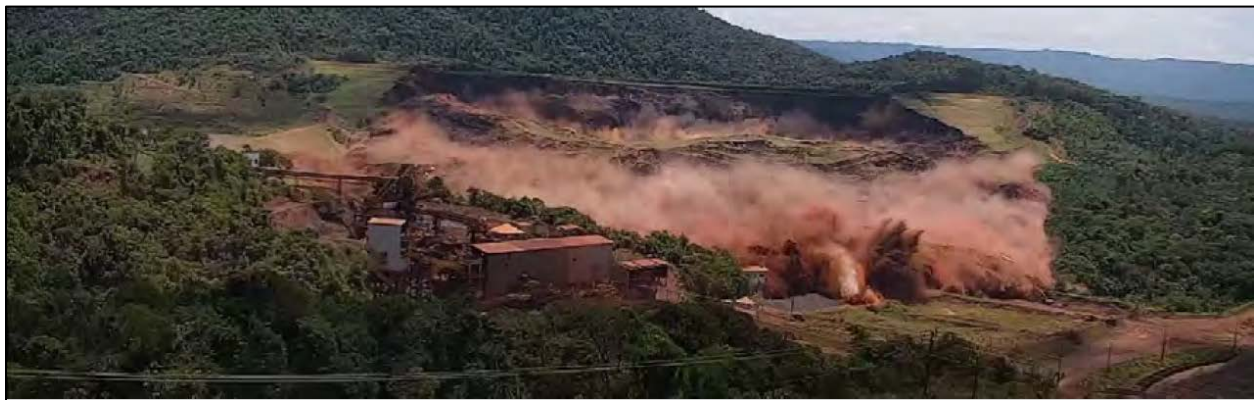
The failure of the tailings dam at the Córrego do Feijão Mine, Brumadinho, Brazil, on January 25, 2019 (Figure 4), took place during midday when employees were actively working at the mine (Robertson et al., 2019). The dam failed almost instantaneously. There were no warnings from the instruments monitoring the dam, even though the dam was well instrumented. There were no visual signs that dam was about to fail. However, it was known that the drain system for the dam was not working properly, and the employees working on the dam were attempting to assess and fix these problems. According to Robertson et al. (2019), the immediate cause of the

Figure 4. Tailings dam failure at Brumadinho, Brazil, 18 seconds after the initiation of the failure

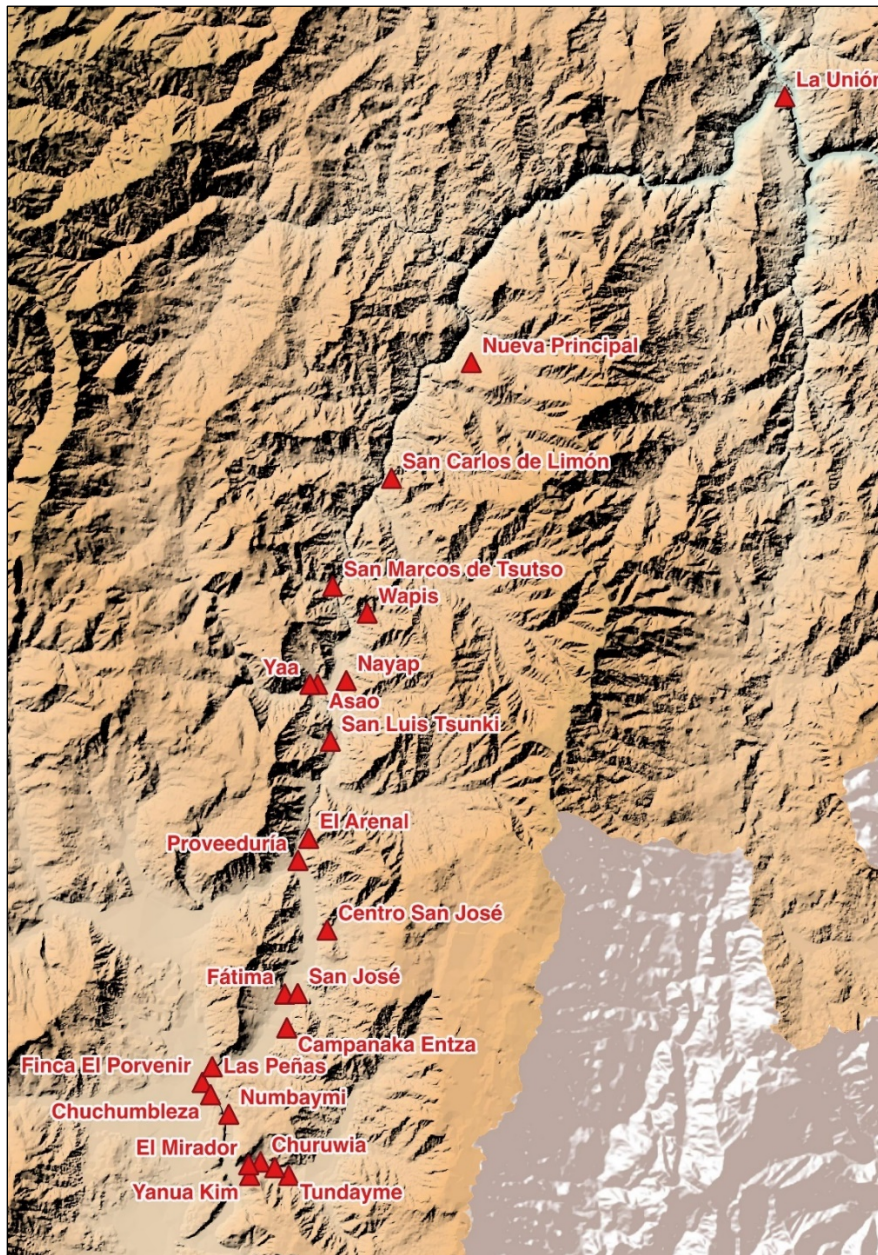
In other words, the impact of Mirador implies a large multi-ethnic territory (indigenous Shuar and peasant farmers), located both in the province of Zamora Chinchipe and in the adjoining province of Morona Santiago, in what constitutes the Cordillera del Cóndor. The downstream communities at risk of a tailings dam break include those shown in Figure 8 and the communities along the Zamora River to the confluence with the Santiago River, as shown in Figure 9.

Figure 9. Location of communities affected by a potential tailings dam failure at the Mirador Mine
Source: Cliff Jones, Open Street Map; base map from the Instituto Geografico Militar

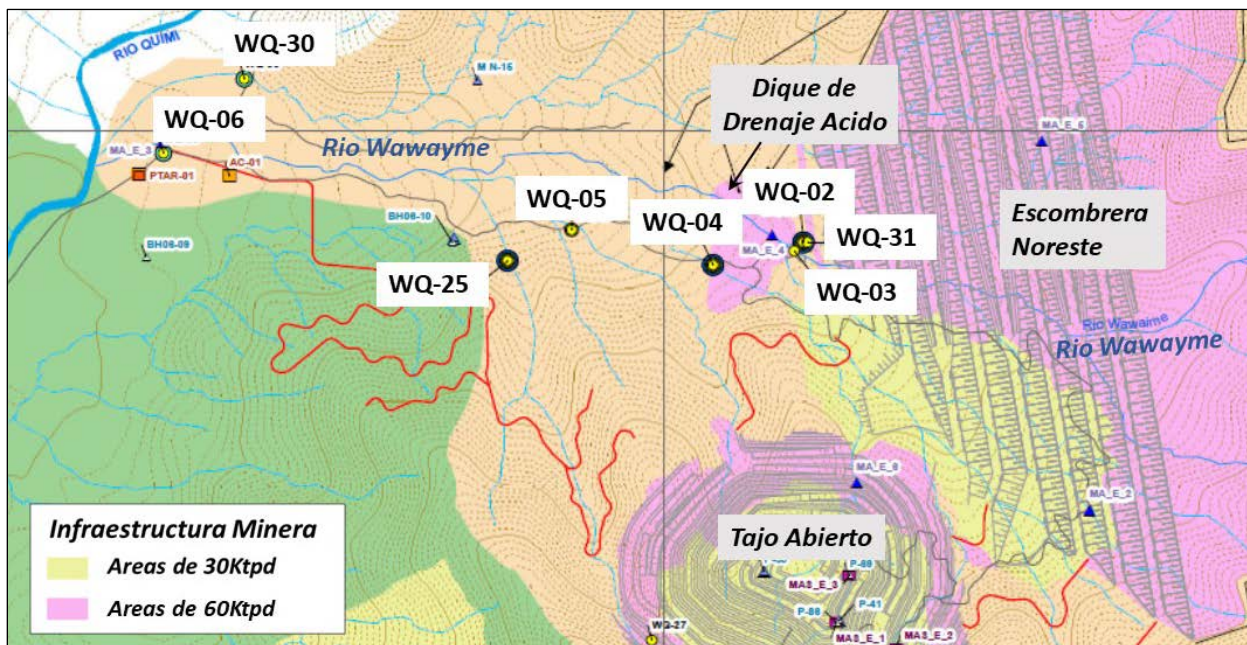
Rio Wawayme drains the large waste rock pile known as Escombrera Noreste, and surface water monitoring locations close to the piles and just upstream of where it flows into the Rio Quimo have water quality standard exceedences of many metals, including copper, iron, aluminum, lead, manganese, and zinc and low pH values (< pH 6). The locations with the highest metal concentrations and lowest pH values are WQ-04, WQ-05, and WQ-34, which are located in tributaries to Rio Wawayme that drain Escombrera Noreste and the open pit (Table 1 and Figure 10³). Metal concentrations near the mouth of Rio Wawayme (WQ-06) were generally lower and pH values were somewhat higher, based on limited additional data obtained as part of the information requests. The elevated metal concentrations and low pH values compared to pre-mining conditions are a strong indication that surface water is adversely impacted by mining and that the contaminants derive from leaching of waste rock in Escombrera Noreste. The lower concentrations farther away from the waste rock pile indicate that the source is the pile, and dilution occurs downstream; however, concentrations are still elevated at the mouth. The results also show that environmental control measures to capture mine-influenced water from the waste pile are not effective.

Figure 10. Surface water sampling locations on Rio Wawayme and waste rock and open pit facilities

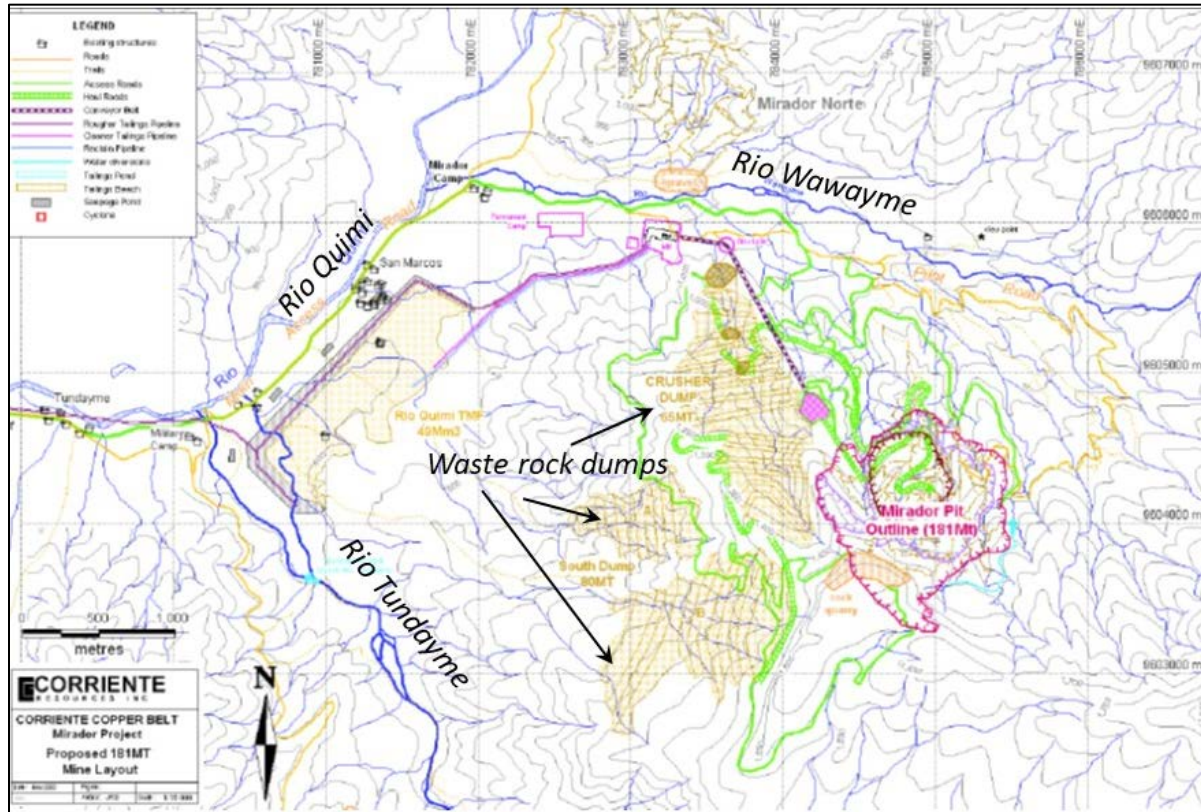
The Contraloria (2020) report also shows elevated concentrations of metals and low pH values in Rio Tundayme and Rio Quimi compared to baseline values (IIGE, 2018) and Ecuadorian water quality criteria. The upper Rio Tundayme receives water from tributaries draining the open pit area, and the lower Rio Tundayme contains the Quimi TDF. The 2008 Feasibility Study (Corriente Resources, Inc., 2008) shows that large waste rock dumps were planned for the west side of the open pit that would drain to the Rio Tundayme watershed, as shown in Figure 11.

Figure 11. Mine layout for the 30,000 ton/day operation showing waste rock dumps in the Tundayme and Wawayme watersheds

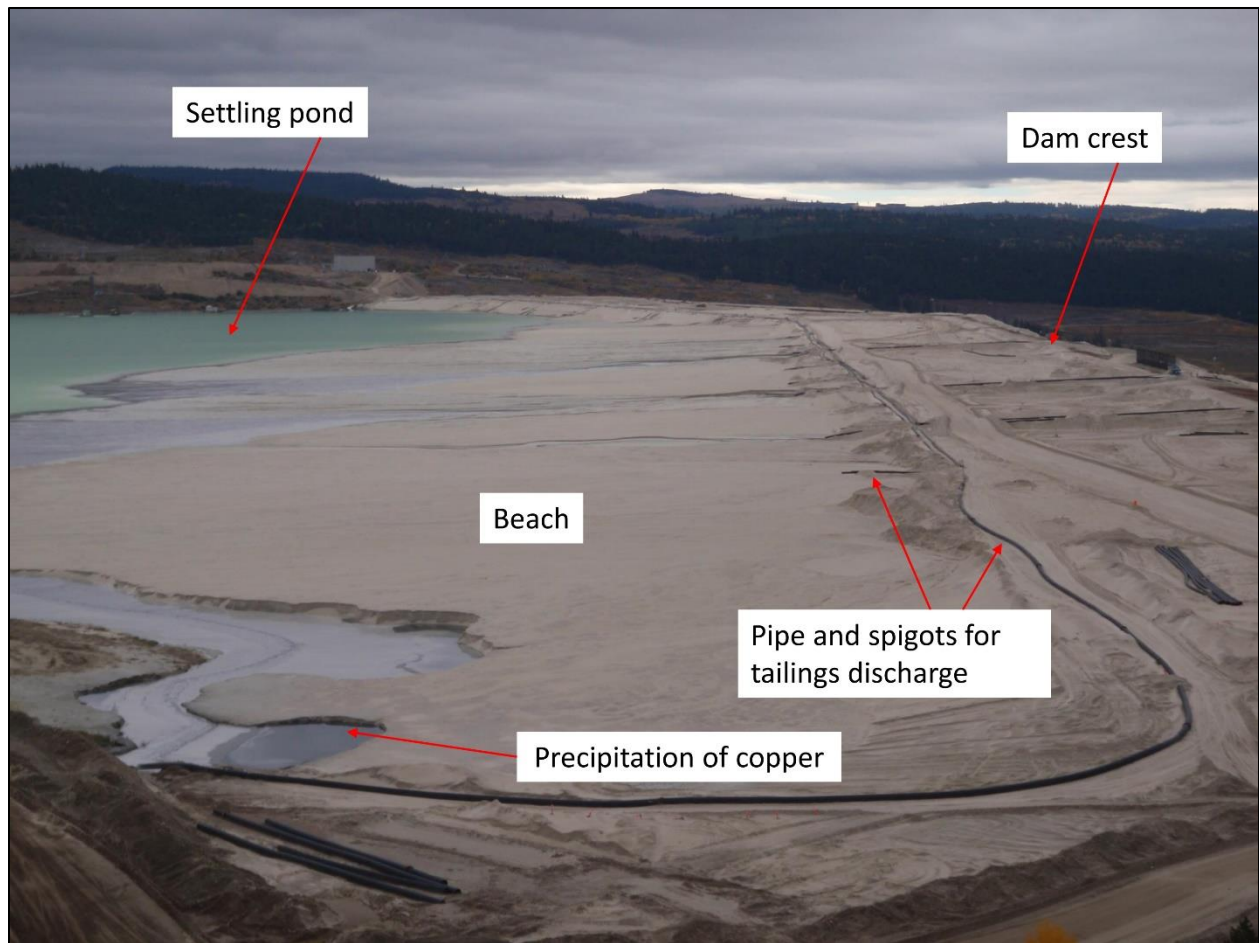
Figure 4. At the tailings storage facility of the Highland Valley Copper mine in British Columbia, wet tailings are discharged in the upstream direction from a pipe and spigots along the crest of the dam. The larger particles (sands) are deposited near the dam to form a beach. The smaller particles (slimes) are transported farther from the dam to form a settling pond. The precipitation of copper in the tailings pond indicates the incomplete extraction of copper from the ore. The narrow beach (especially on the opposite side, where the beach is almost non-existent) makes the dam susceptible to failure by overtopping. Photo taken by the author on September 27, 2018.

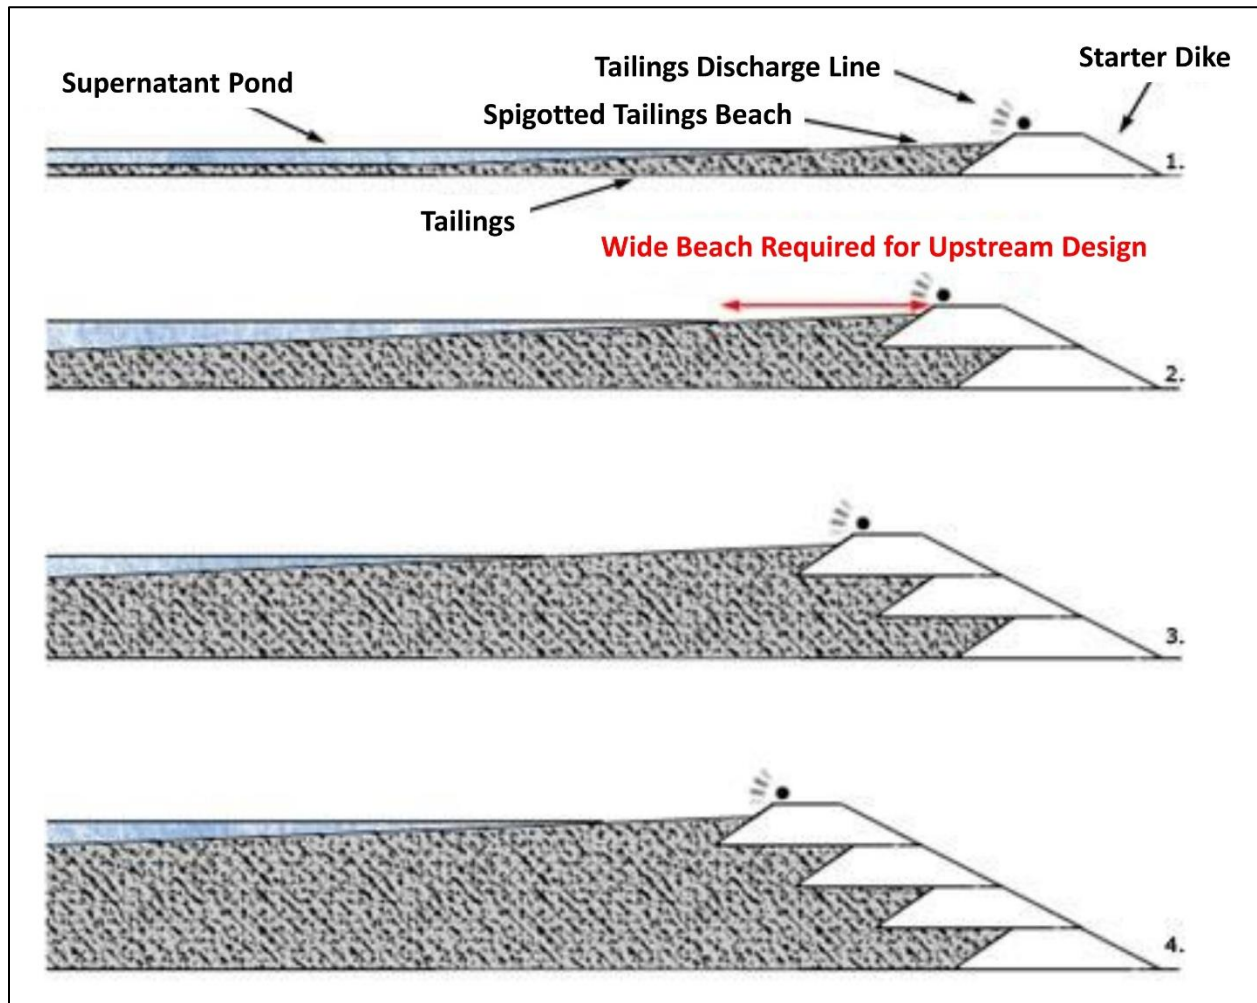
Figure 5a. In the upstream construction method, successive dikes are built in the upstream direction as the level of stored tailings increases. The dikes can be constructed out of mining waste rock, natural soil or the coarser fraction of tailings (with appropriate compaction). The advantage of the method is its low cost since very little material is required for the construction of the dam. The disadvantage is that the dam is susceptible to failure by seismic liquefaction since the wet uncompacted tailings are underneath the dam. For this reason, the upstream construction method is illegal in some countries with seismic activity, such as Chile. Dams built by this method are also likely to fail by overtopping when the beach is too narrow due to insufficient sand in the discharged tailings or excessive water in the settling pond. Figure modified from TailPro Consulting (2018).

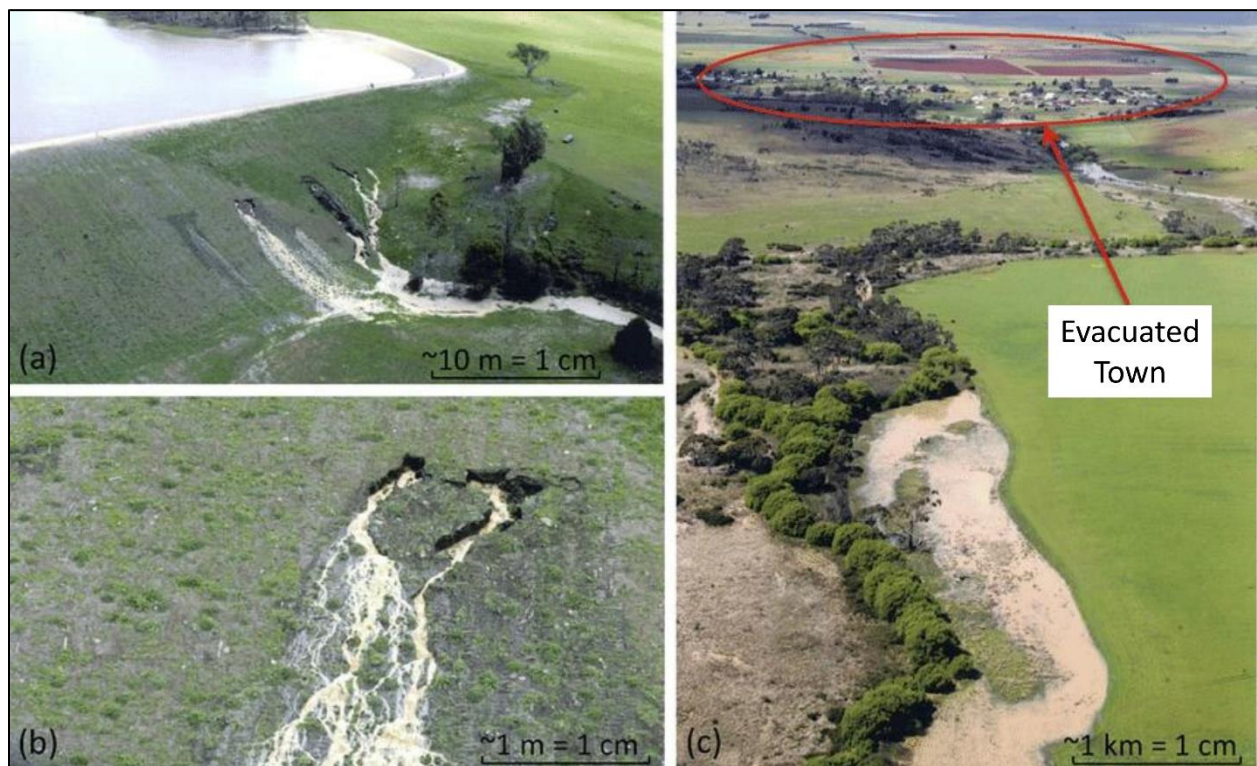
Figure 7. Internal erosion (also called piping) caused the failure of an earthen dam in Tunbridge, Australia, in 2005. During internal erosion, seepage washes solid particles out of the dam so that the dam loses its structural integrity. Internal erosion can be considered a type of liquefaction because the water supports the load of the dam. Internal erosion is promoted by an excessively steep embankment and the resulting high hydraulic gradient, forcing water to flow through the dam. Photo modified from Fisher et al. (2017).

The last common cause of failure of tailings dams is internal erosion, which occurs when the seepage of water through the dam washes the tailings or other construction material out of the dam (see Fig. 7). Internal erosion can create an open pipe in the dam (so that internal erosion is also called piping), which causes the dam to lose structural integrity. Internal erosion can be considered a type of liquefaction because the water supports the load of the dam. Internal erosion is promoted by an excessively steep embankment and resulting high hydraulic gradient, forcing the water to flow through the dam (note the excessively steep embankment in Fig. 7). (The hydraulic gradient is the drop in the water table across the dam divided by the length of the dam.)

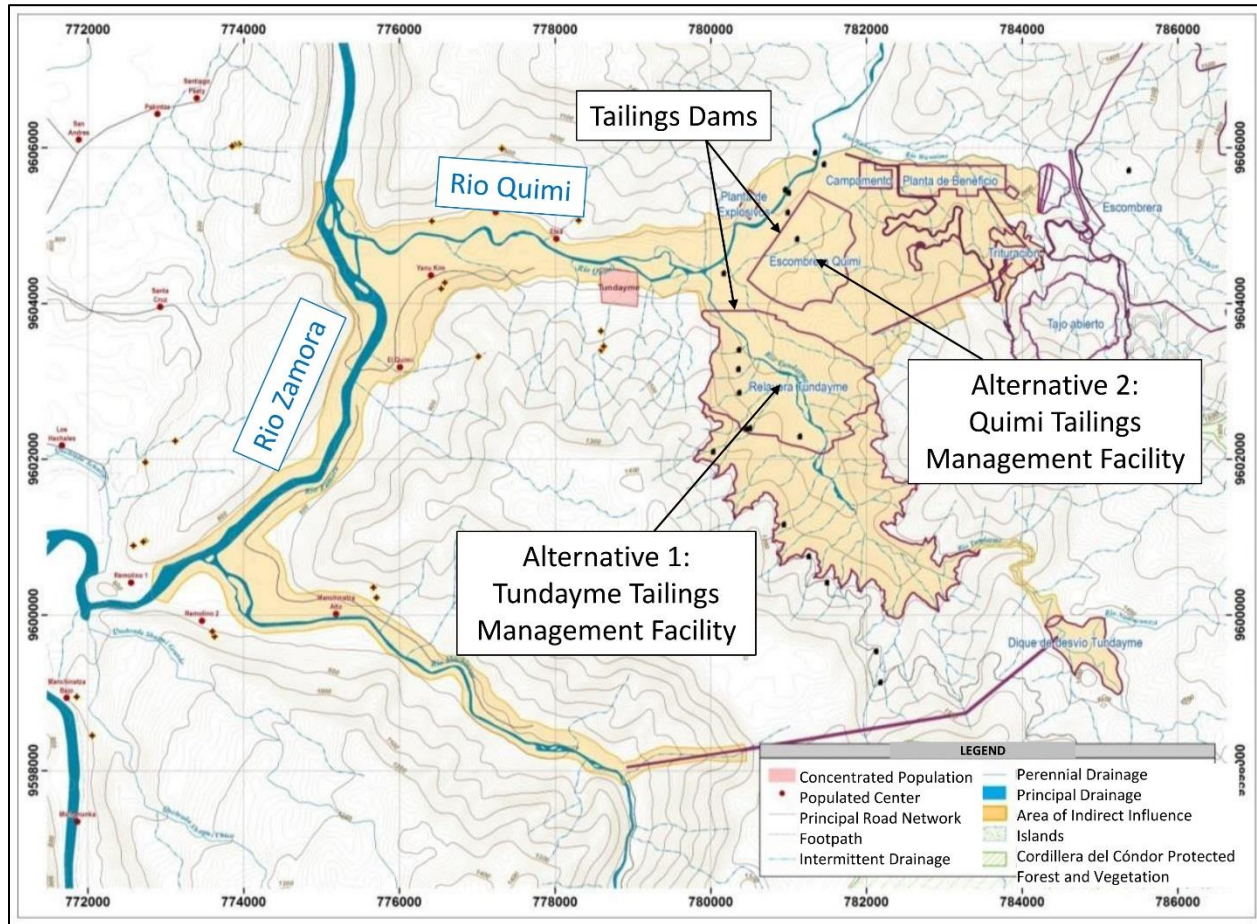
Figure 11. The second Environmental Impact Study (Cardno, 2014a) proposed two alternatives for increasing the production of copper ore from 30,000 to 60,000 metric tons per day. Alternative 1 was to replace the Quimi tailings management facility with the Tundayme tailings management facility, for which the dam would be 260 meters high, the tallest tailings dam ever built. Alternative 2 was to keep the Quimi tailings management facility, but increase its capacity by dewatering the tailings. Alternative 1 was preferred due to its lower cost, although it would have a greater environmental impact (Cardno, 2014a). Both alternatives are currently under construction, which is inconsistent with the Environmental Impact Study (Cardno, 2014a). Figure modified from Cardno (2014a).

The Tundayme dam had a planned height of 260 meters, which would be the tallest tailings dam in the world. (The current tallest tailings dam is the Quillayes dam at the Los Pelambres mine in Chile (Campaña et al., 2015)). The height of the Quimi dam remained unchanged at 63 meters. The outer embankment slopes were 1:1.5H and 1V:2H for the Tundayme dam and the Quimi dam, respectively. Although the construction methods were never explicitly stated, the discussion of the impermeable layers for both dams made it clear that the upstream construction method was not intended, as discussed above. For example, with respect to the Tundayme dam, Cardno (2014a) wrote “*En el talud aguas arriba del dique inicial se colocarán instalaciones impermeables (una capa impermeable y una capa de filtro). La capa impermeable consiste en geotextil de 2 mm + esteritas de bentonita (4800 g/m²)*” [On the
