Tree Inventory Report

Central Erin Property Management

2228 Marine Drive
Oakville, ON
L6L 1C1

August 11, 2022

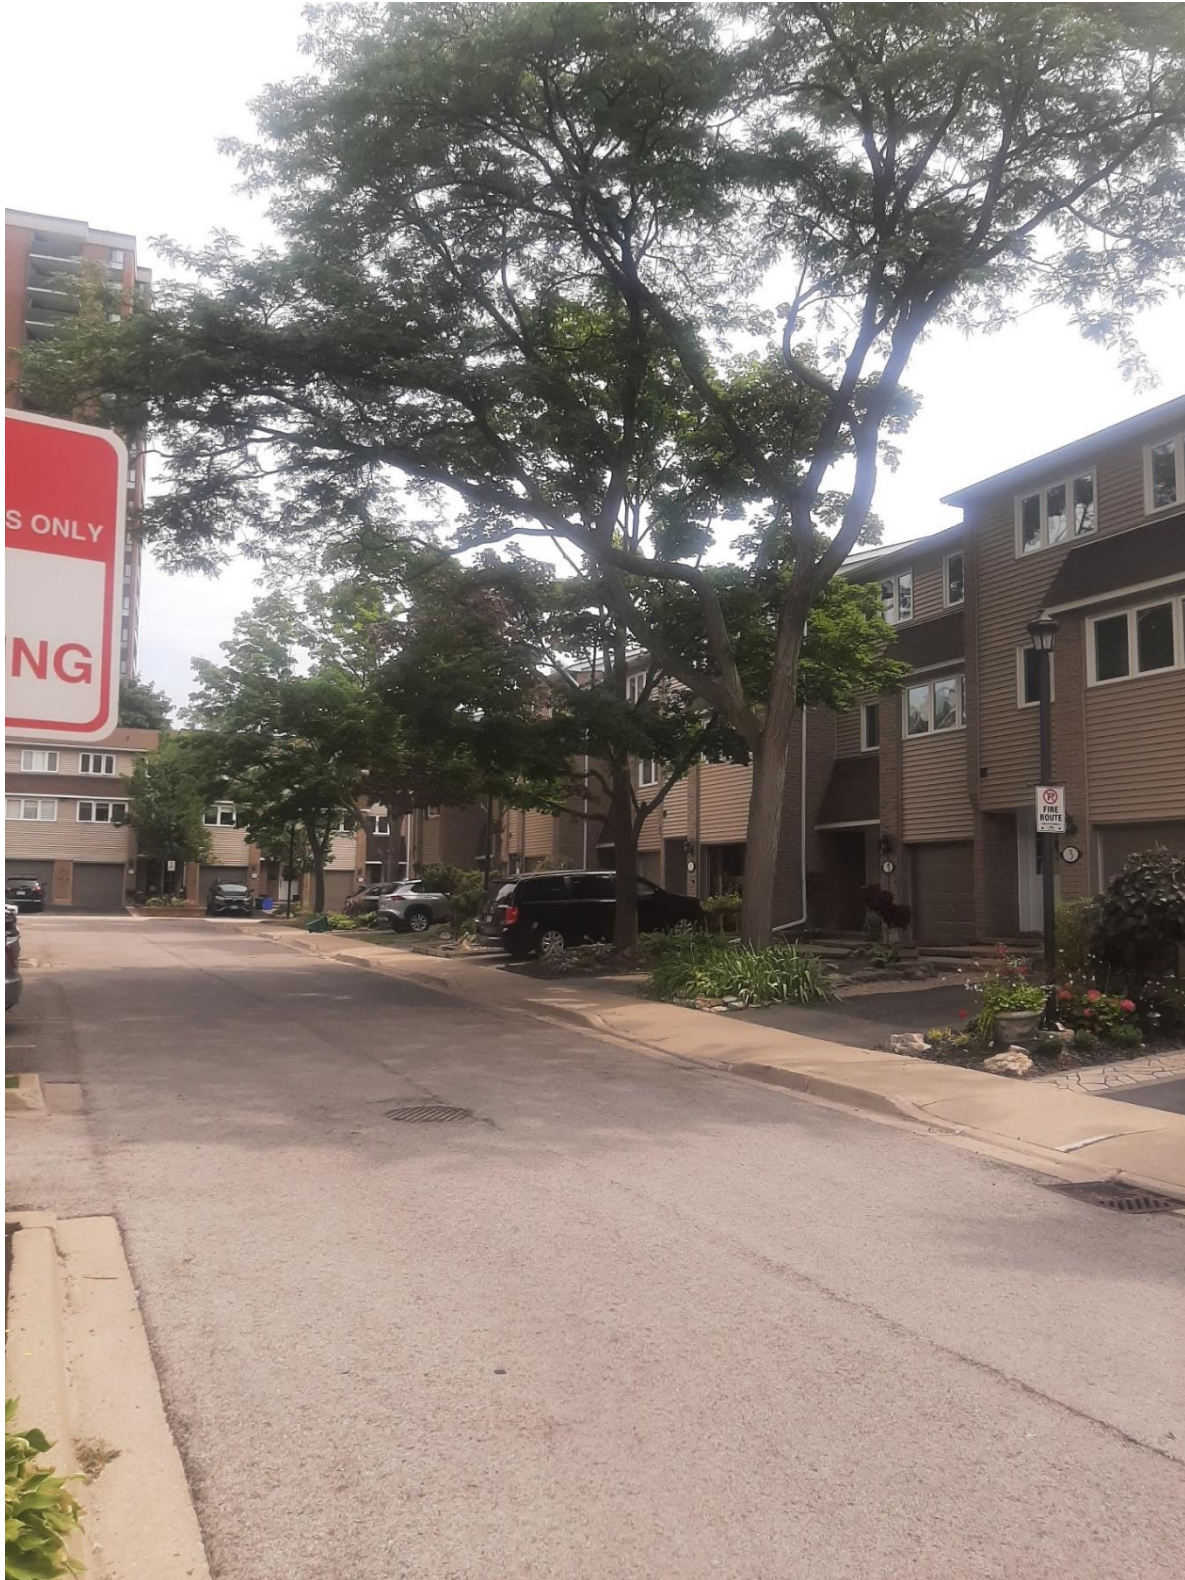
Trees #414-417

416	Norway maple	<i>Acer platanoides</i>	30	Good	Good	Good	70	5	9	14	small dead wood <5cm	Crown clean within 3 years	Low
417	Norway maple	<i>Acer platanoides</i>	32	Good	Good	Good	85	5	9	15	basal wound,good healing	None	Low
418	White fir	<i>Abies concolor</i>	9	Good	Good	Good	100	0	2	3	None	None	Low
419	Norway maple	<i>Acer platanoides</i>	39	Good	Fair	Good	85	0	8	16	Large frost Crack, cabled	Check cabling	Medium
420	Norway maple	<i>Acer platanoides</i>	42	Good	Good	Good	80	10	10	16	Steam hanger in canopy	crown clear	High
421	White fir	<i>Abies concolor</i>	16	Good	Good	Good	100	0	3	4	None	None	Low
422	Dawn redwood	<i>Metasequoia glyptostroboides</i>	14	Good	Good	Good	80	0	4	6	None	None	Low

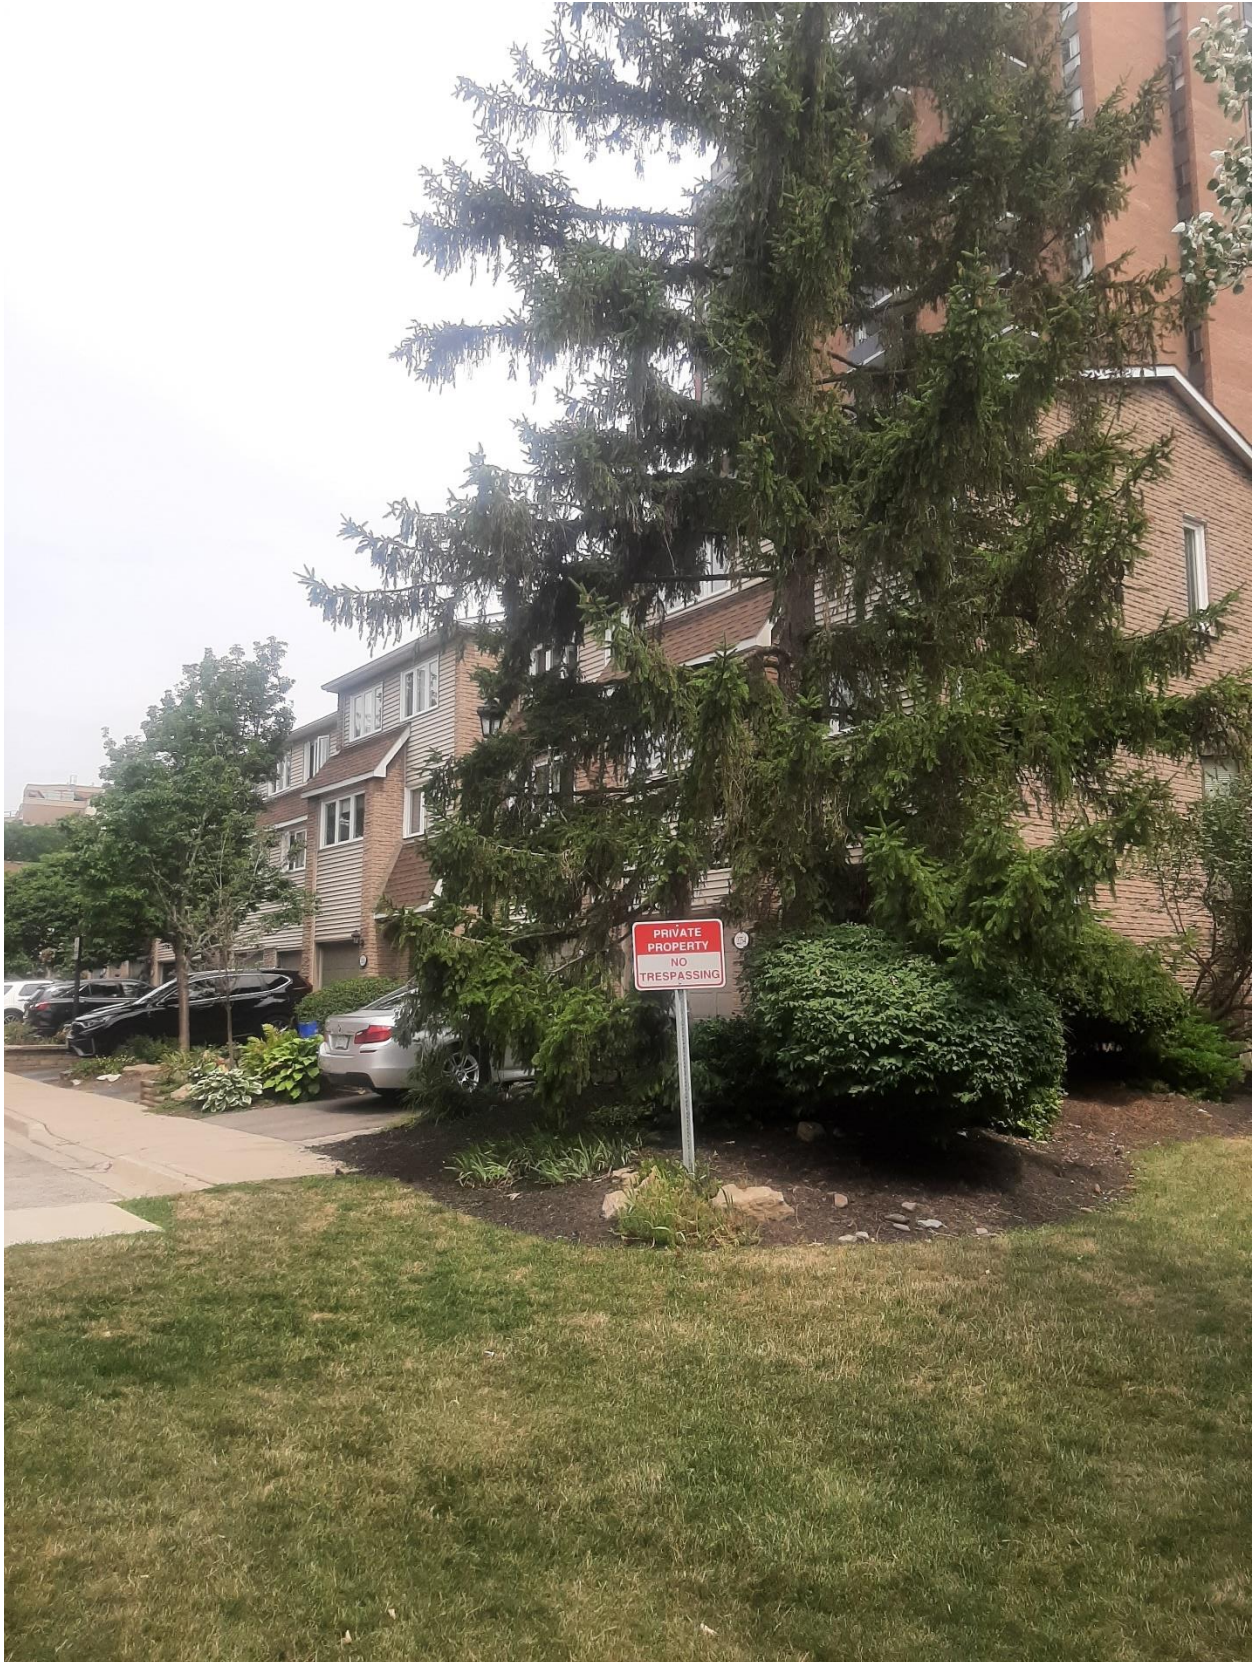
Trees #443-447

Tree Map Number	Species	Botanical	DBH (cm) @ 1.4 m	Health	Structure	Overall Condition	Live Crown Ratio (%)	Deadwood (%)	Crown Width (m)	Tree Height (m)	Notes	Recommended Maintenance	Priority (High/Medium/Low)
446	Norway maple	<i>Acer platanoides</i>	39	Good	Good	Good	60	0	9	12	None	None	Low
447	Honey locust	<i>Gleditsia triacanthos</i>	45	Good	Good	Good	60	0	10	16	None	None	Low
448	Austrian pine	<i>Pinus nigra</i>	43	Good	Fair	Fair	70	0	9	13	leaning, unblanced crown	Monitor	Low
449	Norway maple	<i>Acer platanoides</i>	58	Good	Good	Good	60	0	12	16	cabled	Check cabling	Low
450	Honey locust	<i>Gleditsia triacanthos</i>	46	Good	Good	Good	50	5	12	17	small dead wood <5cm	Crown clean within 3 years	Low
451	Blue spruce	<i>Picea pungens</i>	27	Good	Good	Good	85	0	5	10	None	None	Low
452	White spruce	<i>Picea glauca</i>	13	Good	Good	Good	100	0	5	7	None	None	Low
453	White cedar	<i>Thuja occidentalis</i>	13	Good	Good	Good	90	0	3	4	Multistems (13,9, 8)	None	Low

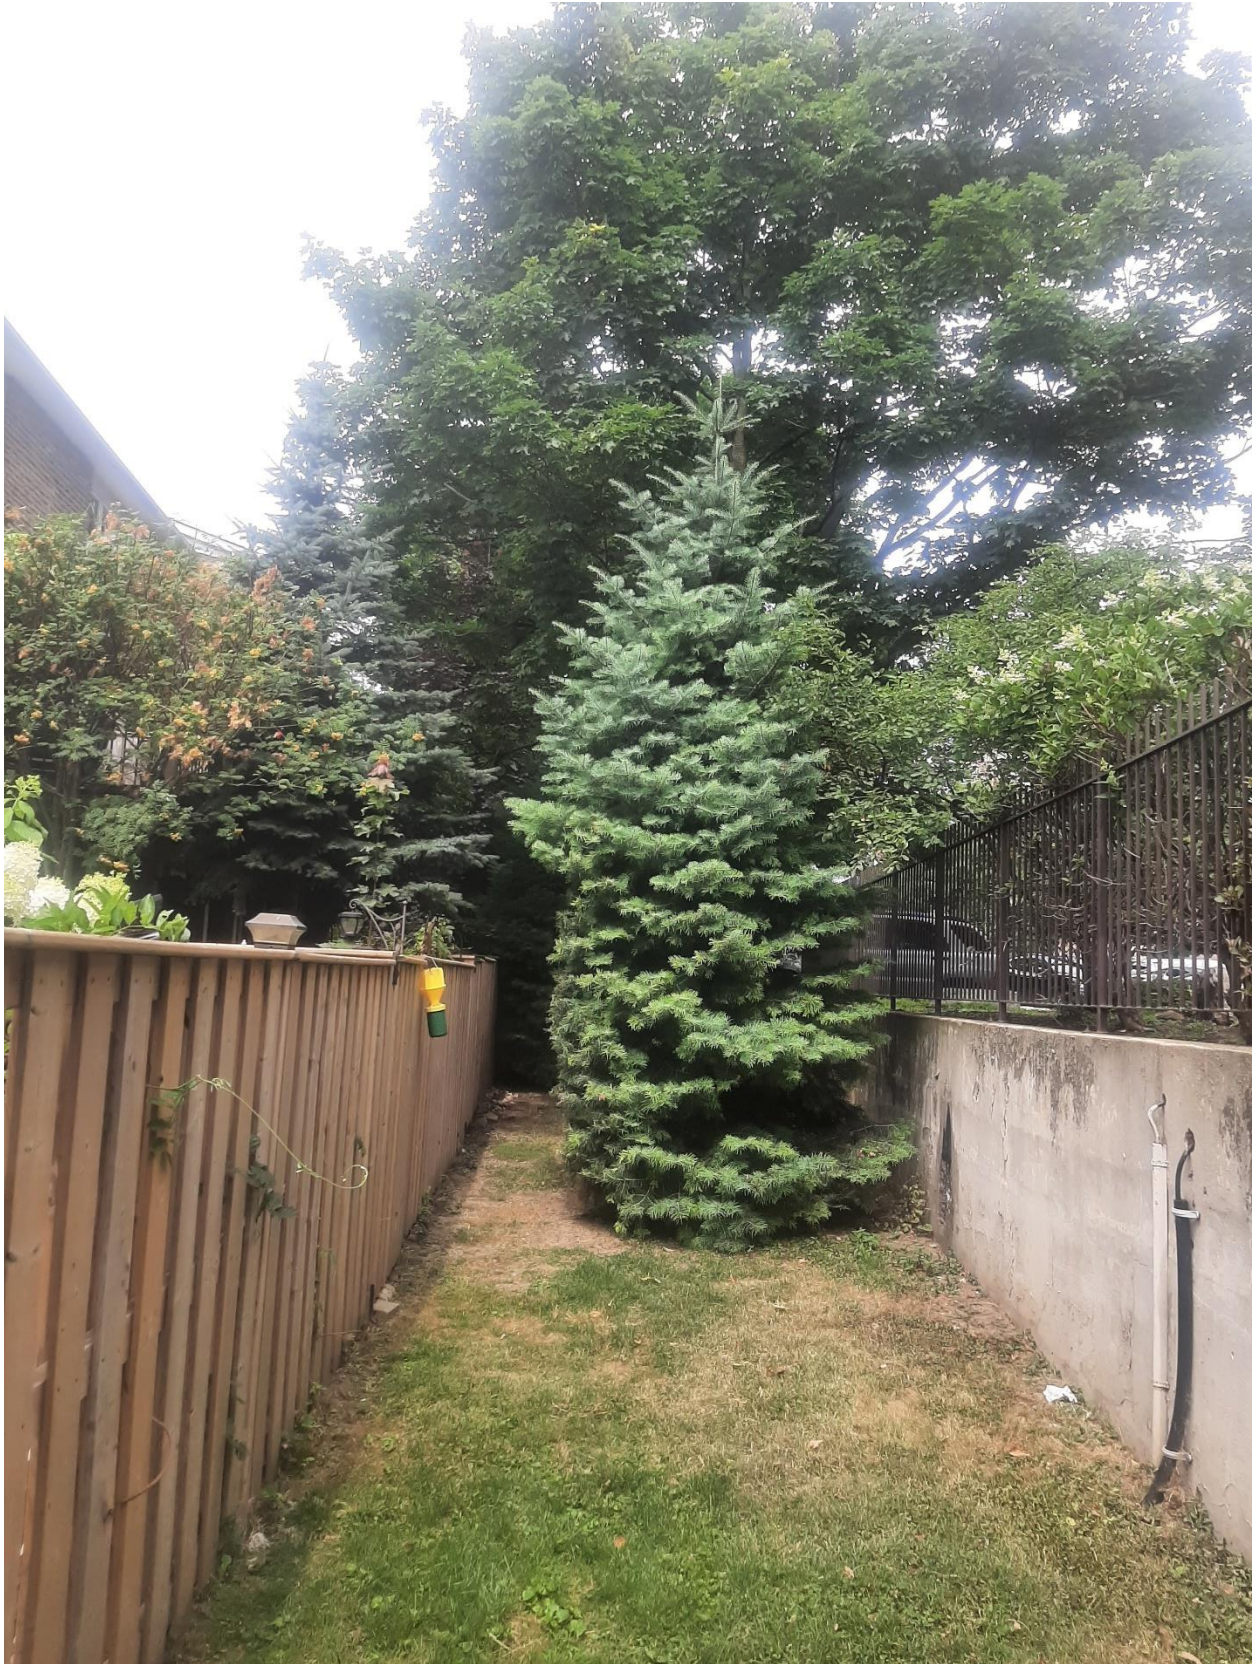
Tree #423

Tree Map Number	Species	Botanical	DBH (cm) @ 1.4 m	Health	Structure	Overall Condition	Live Crown Ratio (%)	Deadwood (%)	Crown Width (m)	Tree Height (m)	Notes	Recommended Maintenance	Priority (High/Medium/Low)
423	Dawn redwood	<i>Metasequoia glyptostroboides</i>	18	Good	Good	Good	85	0	4	5	None	None	Low
424	White fir	<i>Abies concolor</i>	11	Good	Good	Good	100	0	2	5	None	None	Low
425	White fir	<i>Abies concolor</i>	11	Good	Good	Good	100	0	3	5	None	None	Low
426	Norway maple	<i>Acer platanoides</i>	35	Good	Good	Good	80	0	10	16	In barck yard by fence	None	Low
427	Norway maple	<i>Acer platanoides</i>	57	Good	Fair	Good	85	0	11	17	Included bark	Prune included leader within 3 years	Low
428	White poplar	<i>Populus alba</i>	46	Good	Good	Good	70	10	8	10	Dead limb over parking lot	Crown clean within 1 year	Medium
429	Norway maple	<i>Acer platanoides</i>	30	Good	Fair	Fair	80	5	10	10	Suppressed, trunk cavity	None	Low
