Safety Culture and Safe Sealing- Anacortes Refinery Explosion

**Engineering Symposium in Rochester
Hyatt Regency Downtown, Rochester, NY
April 18, 2017**

**Jim Drago, P.E.
Principal Applications Engineer
Garlock Sealing Technologies,
Palmyra, NY**

Naphtha Hydro-treater (NHT) Heat Exchanger - E-6600E

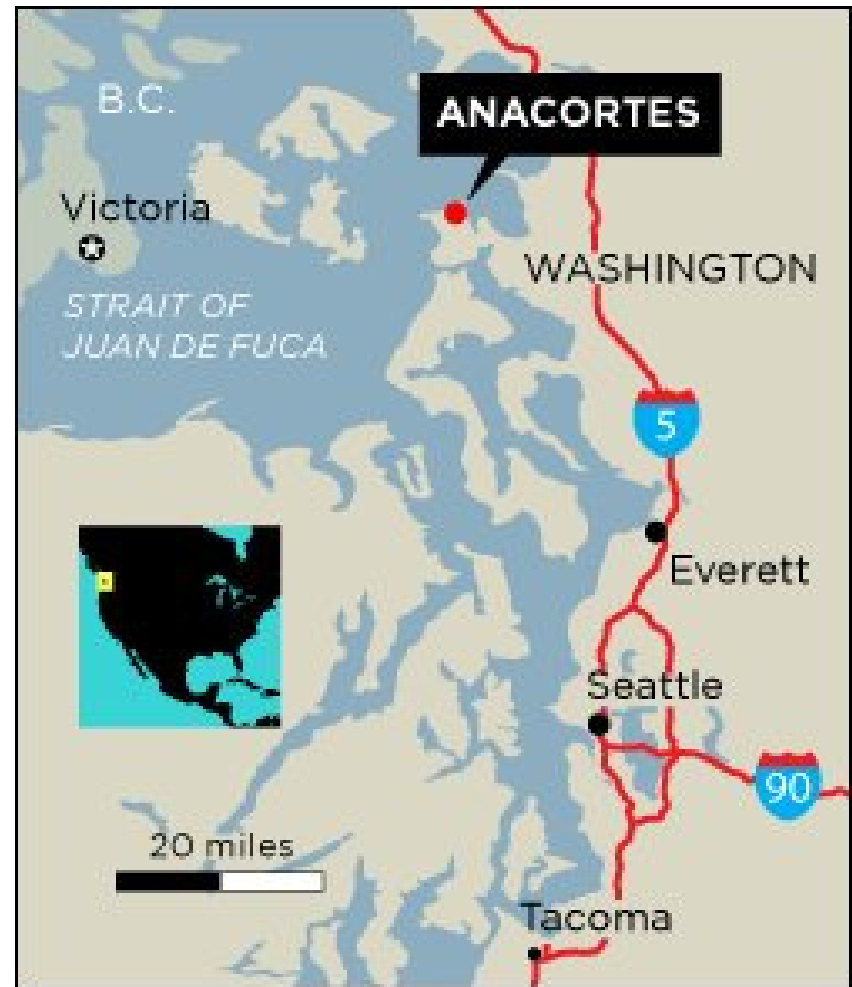
Fire at heat exchanger bank

- Fatally injured seven Tesoro employees
 - One shift supervisor and six operators
- All assisting with start-up in the immediate vicinity of the heat exchanger
- Why were they there?
- How does this relate to flange leakage?

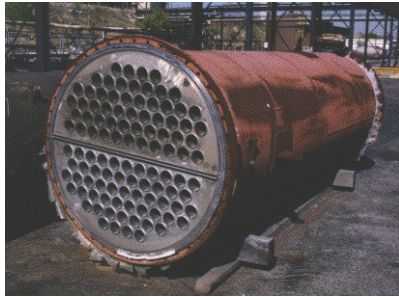
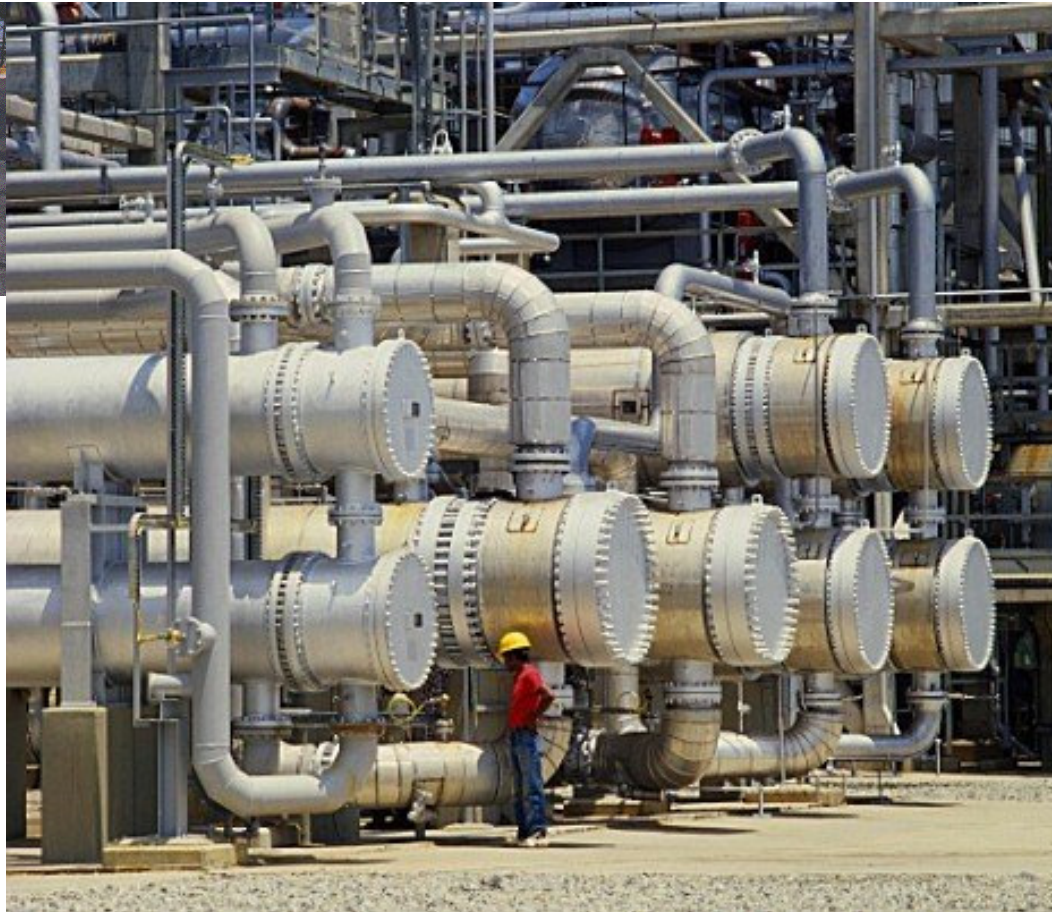
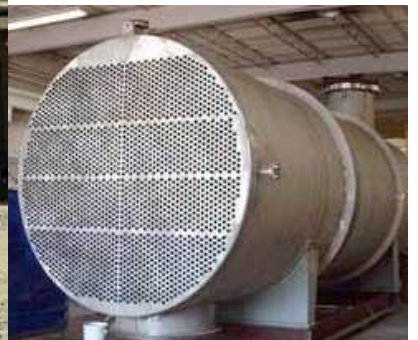
Heat Exchanger

Why can't a gasket be reused? Shell & Tube Heat Exchangers Flange Joint Dynamics

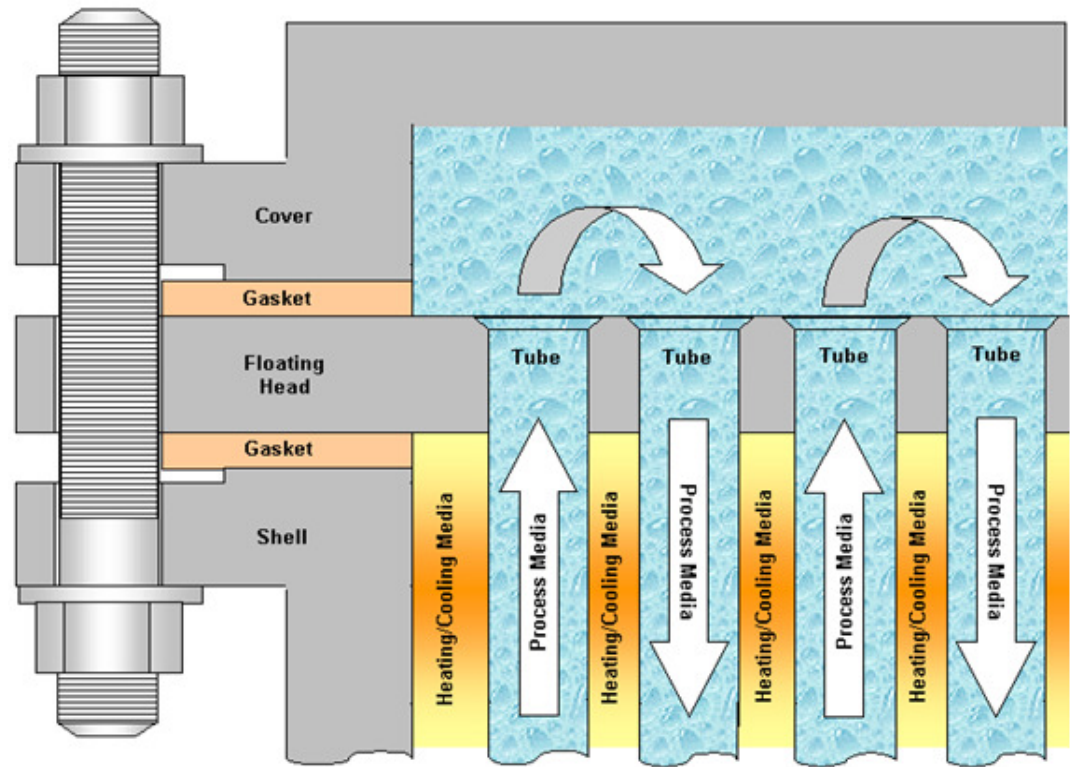
- When process equipment goes from ambient to elevated temperature
 - Flange joint components are subject to thermal growth and movement.
 - Head flanges, tube-sheets, bolts and gasket grow at different rates
 - This upsets the flange-gasket interface
 - Change in stress on the gasket
 - Can cause leaks
- Thermal growth
 - Bolts, flanges, tube-sheets and gasket are different masses and materials so grow at different rates
 - Bolts, flanges and tube-sheet grow axially and radially
 - Axial growth can cause compressive stresses on the gasket beyond those applied at assembly
 - Radial growth causes the flange surfaces to shear across the gasket upsetting the gasket-flange interface promoting leak paths
