Stephen J. Wedlock
MARINE SURVEYOR
Surveying the Bay area since 1998

Survey Report #Sample
© 2014 - All rights reserved

Vessel name:

Purpose of survey: Condition and valuation for purchase and insurance underwriting.

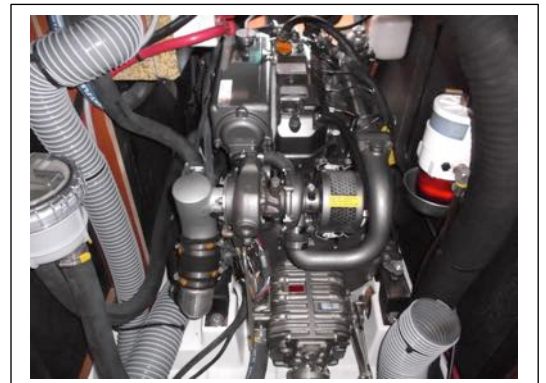
Type: Turbo diesel
Make/Model: YANMAR / 4JH4-TE
Serial #: 110990
Cylinders/HP: 4 / 66 continuous
Year: Believed original
Hours: 161 by meter
Engine beds and mounts: Good condition
Cooling system: Fresh water cooled (note)

-A small amount of engine coolant was found in the bilge and the engine coolant reservoir was empty. Coolant system should be monitored to determine source of leak.
