**AGENDA FOR THE SPECIAL MEETING  
DUNSMUIR CITY COUNCIL  
COUNCIL CHAMBERS  
5902 DUNSMUIR AVE, DUNSMUIR, CA  
SEPTEMBER 22, 2016  
CLOSED SESSION: NONE  
REGULAR SESSION: 3:00 PM**

Phase 1 Bridge Feasibility Study  
Butterfly Bridge

**PHASE 1 BRIDGE EVALUATION  
FEASIBILITY STUDY**

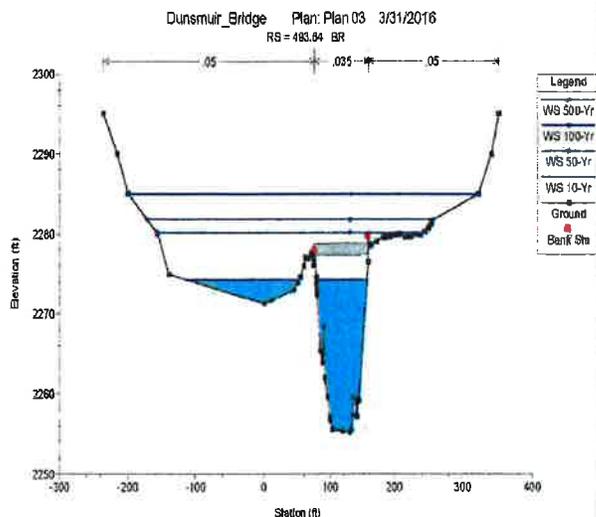
Despite this floodplain geometry, the west abutment (Abutment 1) has been the subject of concern for the existing bridge much more so than the east abutment. According to City sources, more severe scour has been recently observed on the west abutment, and concerns about the scour on Abutment 1 have been noted since 1981.

Scour countermeasures are recommended at both abutments. The degree of these measures is dependent on which structural retrofit solution is selected. During the next design phase, with additional geotechnical information provided as the basis for the design, a more detailed scour analysis will be performed. In addition, scour countermeasures will be designed in accordance with HEC-23, Bridge Scour and Stream Instability Countermeasures. Such countermeasures are needed for local scour only (at the bridge abutments), and are not anticipated for contraction scour across the width of the channel.

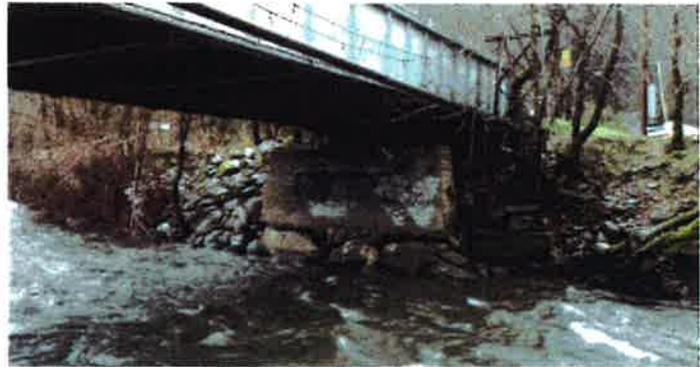
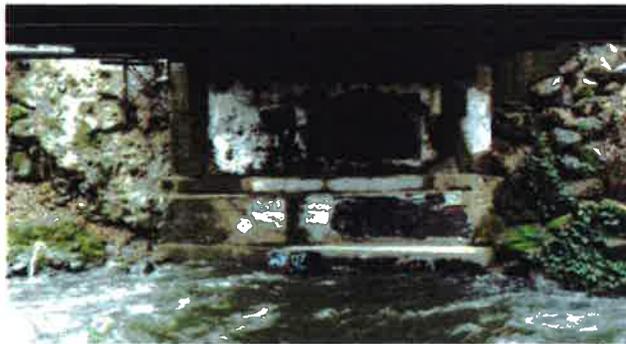
Channel bank protection is present at the bridge and upstream and downstream on both banks. Left bank channel protection consists of 2 to 4 ton rip rap upstream from the bridge. The rip rap extends from the channel bank toe to within 3 ft of the top of Abutment-2 wall. The rip rap is placed loose on the slope and three point contact was not observed in some of the rip rap locations. Riprap does not extend downstream on the left bank. The riprap slope is generally two horizontal to one vertical (2H:1V) or flatter.

The right bank is protected by similar 2 to 4 ton rip rap. Grouted riprap is present near the toe of the channel bank upstream from the bridge but grouting is not consistently applied. Downstream on the right bank, grouted riprap is present. The grout appears only applied to the surface of the riprap to an approximate depth of 1-ft measured perpendicular to the slope. Areas approximately 10-ft wide and from the bank toe up to approximately 4- to 5-ft from top of bank are eroded, exposing the ungrouted riprap below the grouted riprap slope face.

The downstream grouted riprap toe location is inconsistent and in places protrudes into the channel approximately 5- to 8-ft. These protrusions occur immediately downstream from the west abutment spread footing and causes back eddies, upstream flow and vortices at the western abutment face. Riprap slopes are generally at 1.5H:1V and locally steeper on the right bank. *Note: removal of this downstream protruding slope may have upstream benefits at the abutment, but it may also have been placed to protect the downstream utility crossing foundation, the triangular structure immediately downstream of the bridge shown in the picture below. With no as-builts and no plans for the placement of this riprap, the intended purpose is not known. More site analysis is required before this material can be modified. If the utility crossing is not dependent on this protruding protection, it will be removed.*

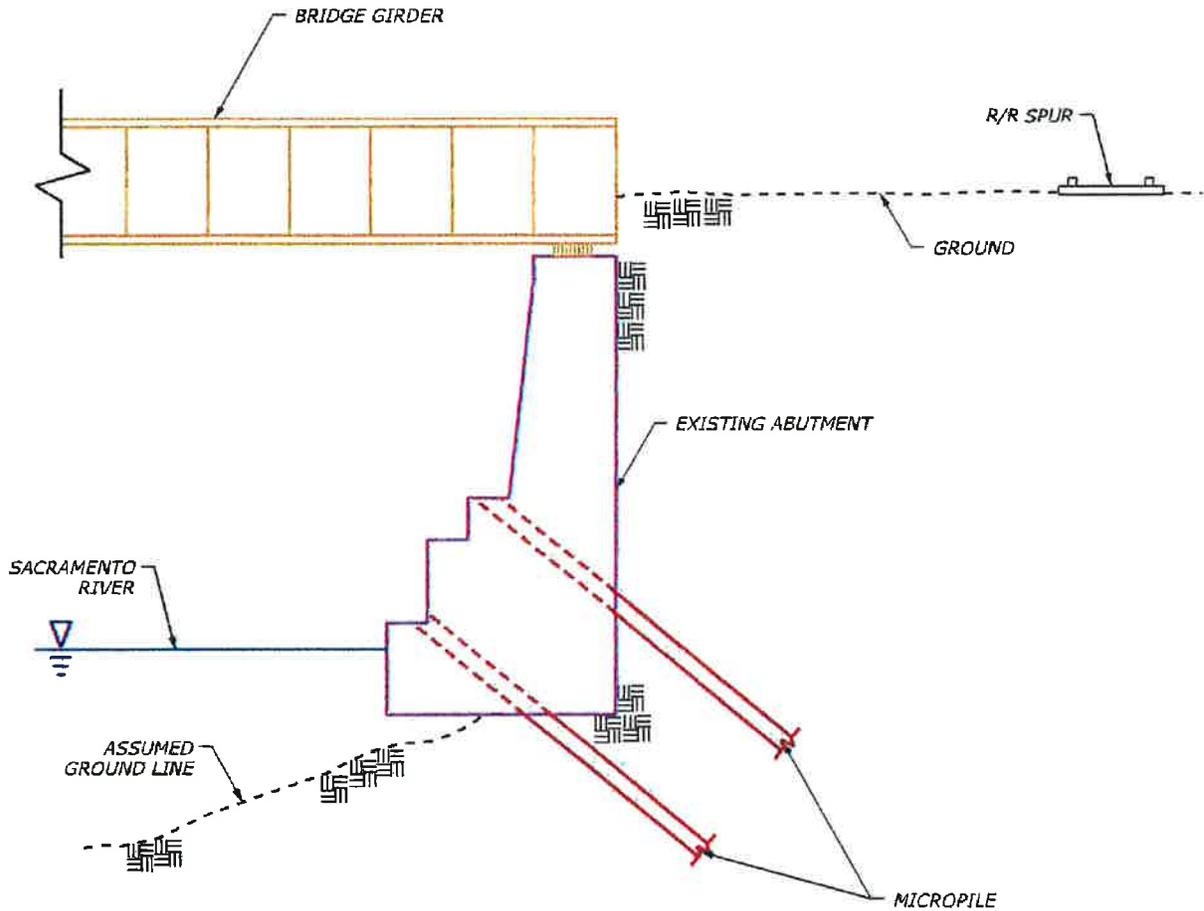
As shown conceptually above, some of the micropiles could be installed at an angle (battered) to facilitate construction access and fine-tune system performance. Small micropile rigs are available that may fit under the existing bridge so that coring through bridge deck (proposed in the previous solution), will not be necessary.

The costs for this system are likely to be less than the solution shown on the previous page, however, it is all dependant on what the site geotech investigation, and the bridge foundation structural elements cored, or non-destructively tested. For budgeting purposes, with the information known, both are statistically about the same price.

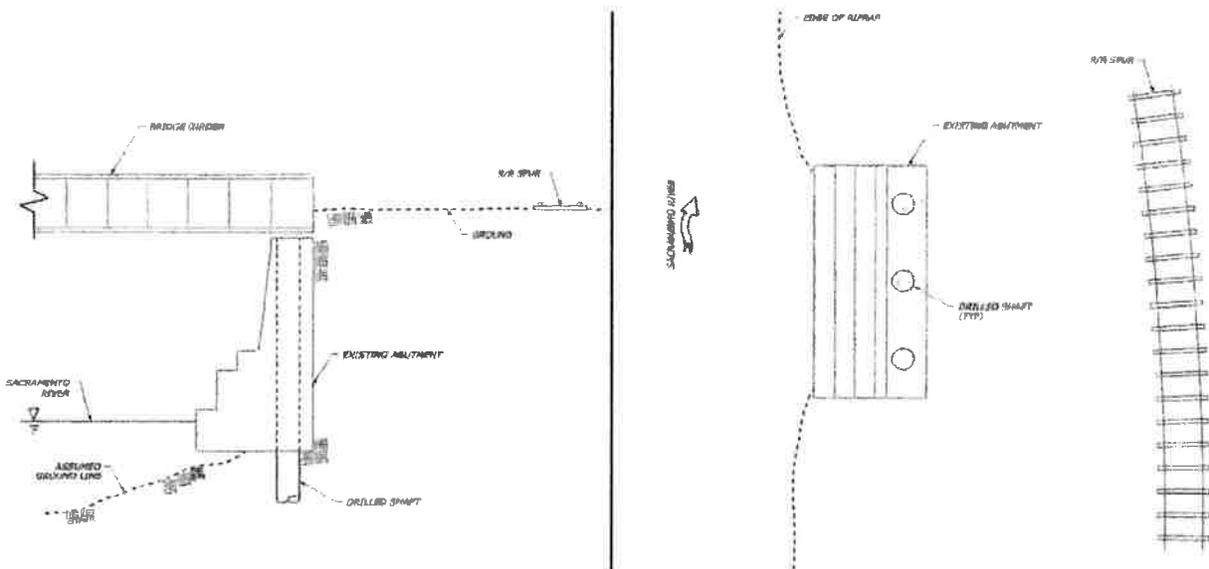
**Option 5: Adjacent Deep Foundation**

This solution addresses the scour problem by adding deep foundation elements to the existing abutment. These deep foundation elements support the abutment even if material below it is lost during future flood events. Unlike the underpinning solutions, this alternate installs deep foundation members on each side of the abutment. These deep foundation members are then connected to the sides of the abutment, allowing the necessary load transfer to occur. Challenges with this system include wet construction methods for the drilled shafts and suitable work zones beside each abutment. The illustration below shows connection of the drilled shafts at a relatively high location on the abutment. It is possible the connection point could be lowered to optimize behavior and construction. Such an element would be investigated in final design.

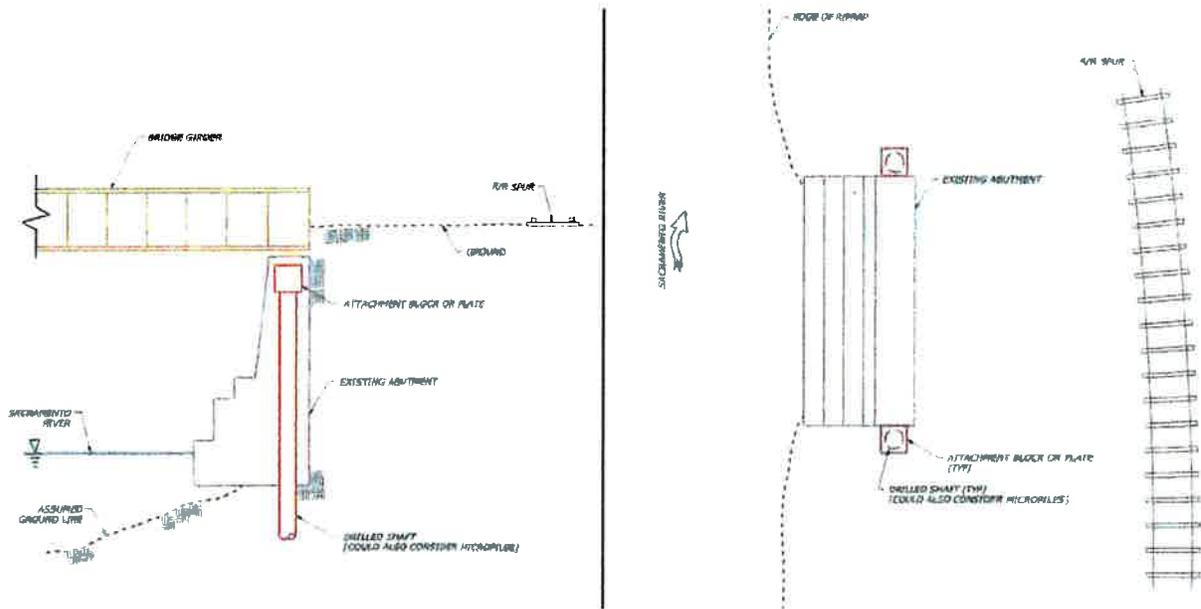
**Option 6: Straddle Bent**

This solution addresses the scour problem by constructing a new support with deep foundations at the end of the bridge. The bent itself consists of a reinforced concrete pier cap and columns. The columns are supported by drilled shafts. Modifications to the superstructure are required to move the support points from the existing abutment to the new bent location. Challenges with this system include wet construction methods for the drilled shafts and the construction of substantial members beneath the existing bridge. Also, the straddle bent does nothing to support the existing west abutment. While it would prevent bridge collapse, it does not prevent abutment collapse and loss of the approach roadway.

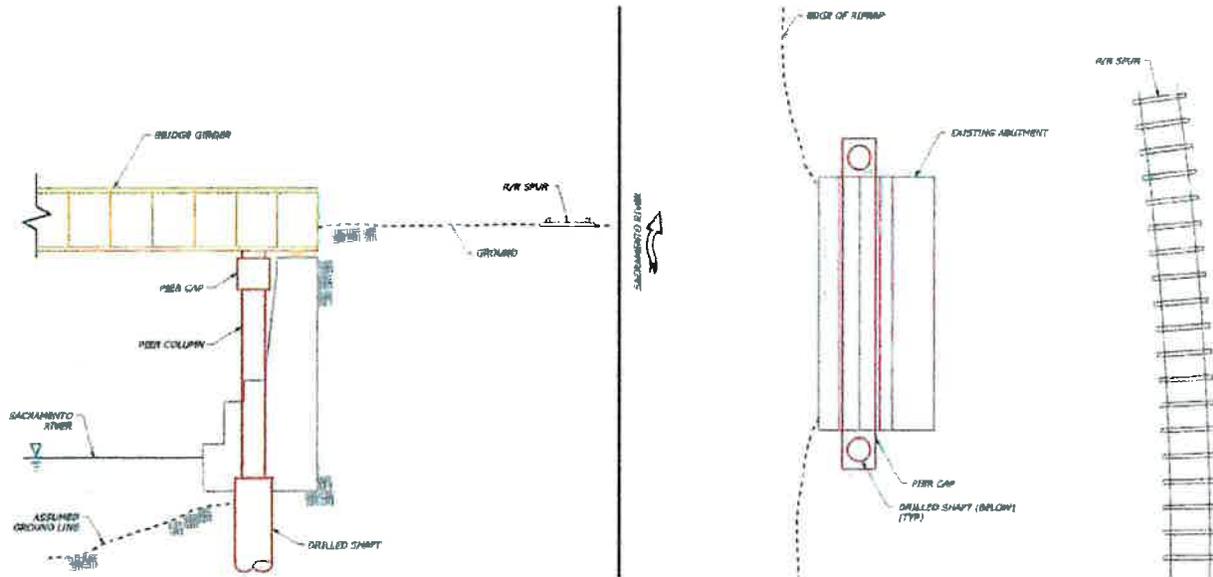
**Option 7: Abutment Replacement**

This retrofit would replace the existing abutments with new abutments. New abutments would most likely be supported on deep foundation elements. To accomplish this work, the superstructure will require either complete removal or temporary support. Complete removal can be accomplished as explained above. Support in place would require falsework and shoring.

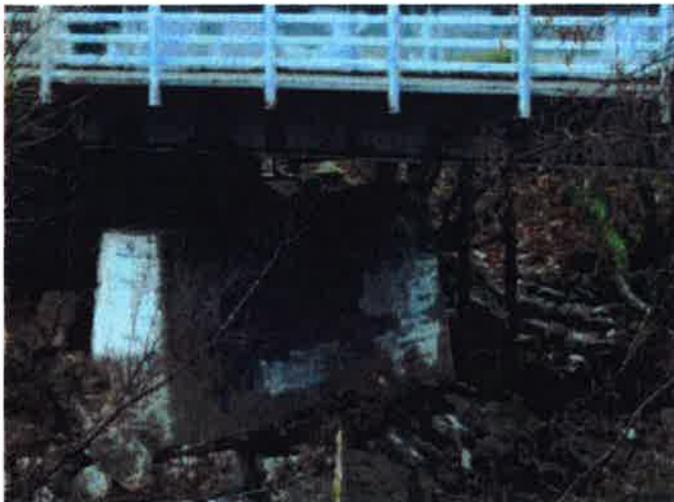
In the picture to the right, the shows the tower support structure for this waterline to the right (downstream) of the old bridge pier.

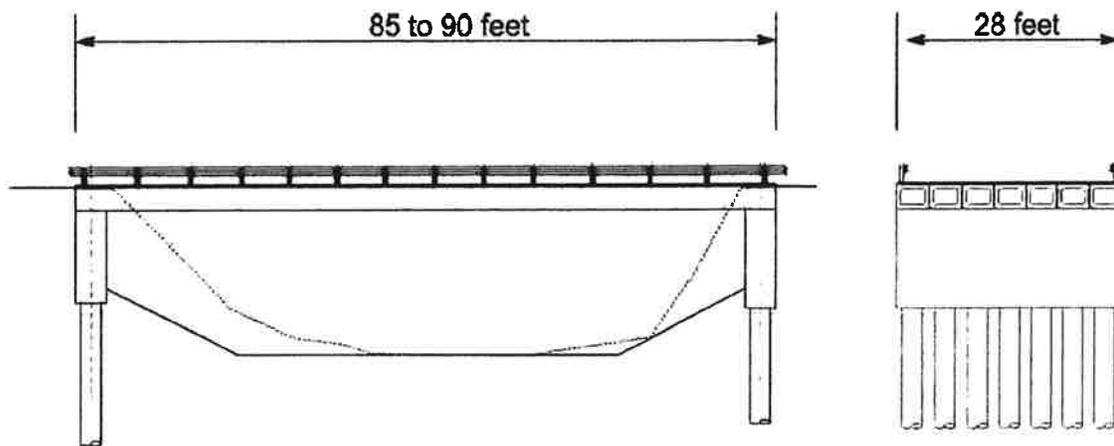
**New Vertical Abutments:** The existing gravity abutments were stepped while blending with the banks of the River channel. The bridge design should maximize the available opening under the bridge as to allow the largest possible River cross section possible. The grade of the bridge is fixed by the adjacent railroad profile, and therefore will remain with the same roadway profile.

**No Scour Countermeasures:** Making the abutments vertical to the bottom of the River channel, being founded on bedrock with drilled shafts supporting the abutments, the bridges can be designed without any scour countermeasures, again, opening up the cross section under the bridge to maximize the bridge opening.
