Christ Church Cathedral

Materials, Conditions, & Preservation Recommendations

Preservation Technology (PRST6720)
Master of Preservation Studies
Tulane School of Architecture
Spring 2015

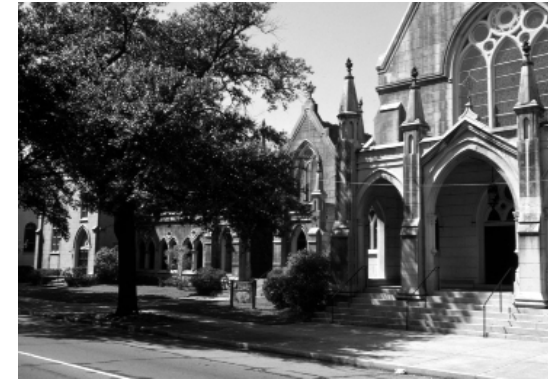
The masonry would have most likely retained the water it absorbed from ground, rain, and humidity.¹⁴ In a photograph dating from 1972 a great amount of staining can be seen on the walls of the cathedral and chapel; it is possible that this staining is from biological growth that would have accumulated while the vines were still on the building. A photograph exists of the building where there were still vines attached to the church, most likely in the 1950s when the renovations

Figure 2.4: View of St. Charles Avenue elevation showing staining on the facade, 1972. Tulane School of Architecture, New Orleans Virtual Archive.

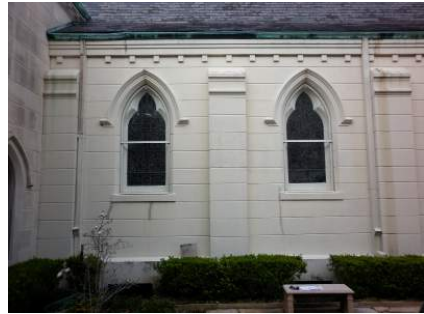
in hairline cracks. Eventually with the growth of this organic material, the cracks enlarge. This organic growth can be seen in archival photographs from the 1910s to the 1950s. This damage is also visible on the pinnacles of the elevation and there are a number of cracks in the base of this section of the elevation. It is currently apparent that there still is a moderate amount of organic growth that is attributing to the damage of this façade. The pilaster directly to the left of the archway seems to have evidence of iron oxide on its face, otherwise known as rust. This is especially interesting as this appears to be the only location in which this evidence is

Figure 2.6: Picture of the Seventh Street Elevation of the Chapel Showing Cracks Under the Windows. Photo by Matthew Cerick. 2015

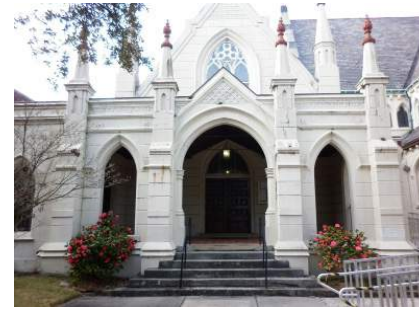
could be attributed to the crack in the gutter above allowing water intrusion. This elevation also has a considerable amount of water damage to the pilasters on the façade, which is being caused by ineffective downspouts and gutters. The St. Charles Avenue elevation of the chapel shows a number of cracks that have formed throughout the years. This can be attributed to years of organic growth on the building, where vegetation can root

Figure 2.7: Picture of the St. Charles Avenue Elevation of the Chapel Showing Cracks. Photo by Matthew Cerick. 2015

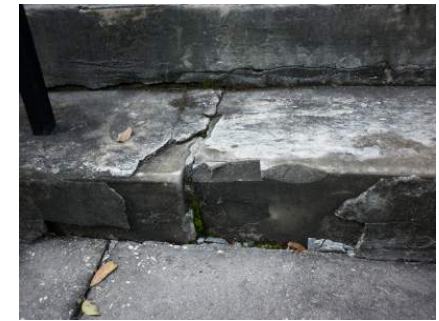
visible. The cast stone concrete steps leading up to the chapel entry show evidence of delamination. This could be attributed to water intrusion and the effects of freezing and thawing. It is possible the steps here were having settlement issues and to bring the riser heights to a uniform level they could have put a topping layer of concrete to these bottom risers, which could account for the way the steps are chipping.

Figure 2.8: Picture of the St. Charles Avenue Elevation Chapel Steps Showing Cracks. Photo by Matthew Cerick. 2015

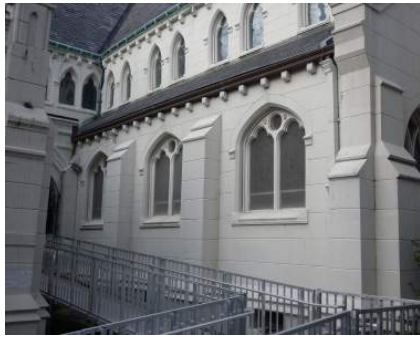
Figure 2.10 Picture of the Seventh Street Elevation Cathedral Showing Water Damage on the Recessed St. Charles Avenue Portion of the Facade Cornice. Photo by Matthew Cerick. 2015

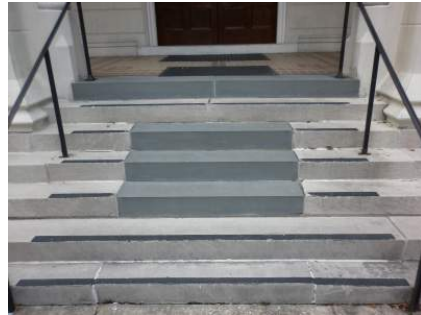
Figure 2.11: Picture of the St. Charles Avenue Elevation Cathedral Steps. Photo by Matthew Cerick. 2015

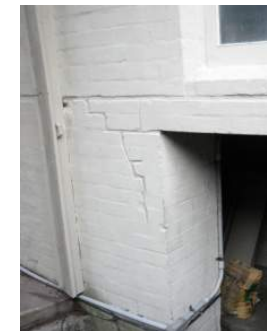
Figure 2.18: Detail Picture of the Crawl Space Entry on the Carondelet Street Elevation Near the Crawl Space. Photo by Matthew Cerick. 2015

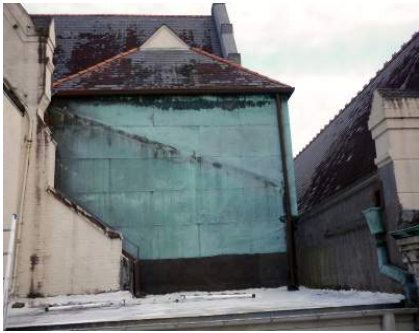
Figure 2.19 Picture of the Carondelet Street Elevation Cathedral Showing Water Damage on the Facade and Showing the Copper Plating. Photo by Matthew Cerick. 2015

the gable above the ambulatory have staining due to water damage and a small amount of organic growth. It is worth noting that the Carondelet Street elevation is painted brick and lacks the stucco finish the other facades have. To the right of the ambulatory closest to the Seventh Street side, there is water damage to the bricks and the side wall is covered in copper plating that has shown its age with a well-worn patina.

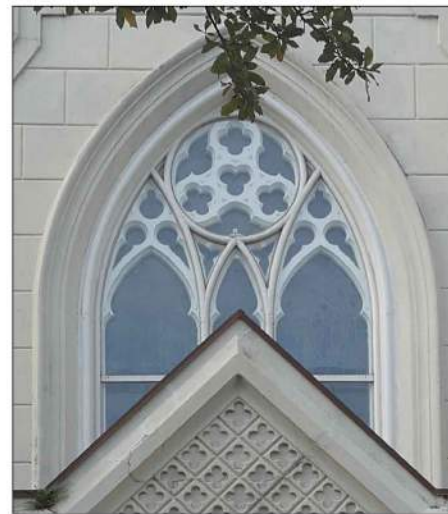
WINDOW: S2.1

TYPE O:
PROTECTIVE GLAZING: FRONT OF FRAME, SEMI
TRACERY MIMICKING, SINGLE VENTED

REQUIRES MULTIPLE VENTS FOR AIR CIRCULATION

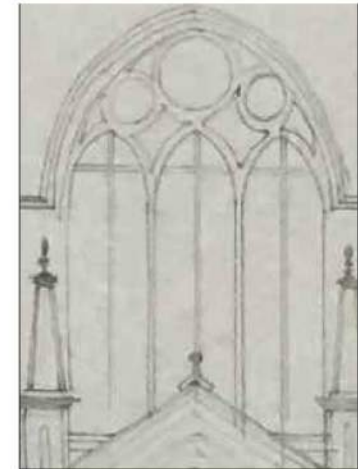
WINDOW: S2.13

TYPE P:
PROTECTIVE GLAZING: WITHIN TRACERY
SINGLE VENTED
REQUIRES MULTIPLE VENTS FOR CIRCULATION

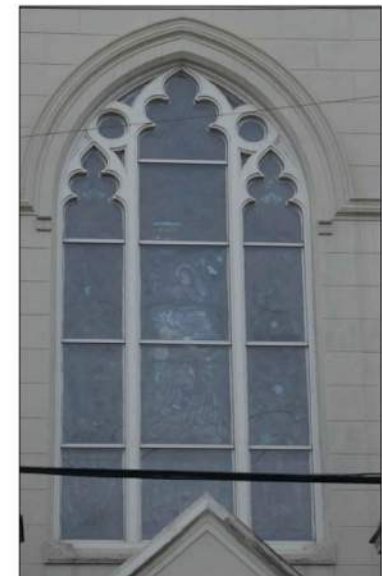
WINDOW: E2.16

TYPE Q:
PROTECTIVE GLAZING: FRONT OF FRAME
NOT VENTED
REMOVE AND REPLACE WITH VENTED PROTECTIVE
GLAZING

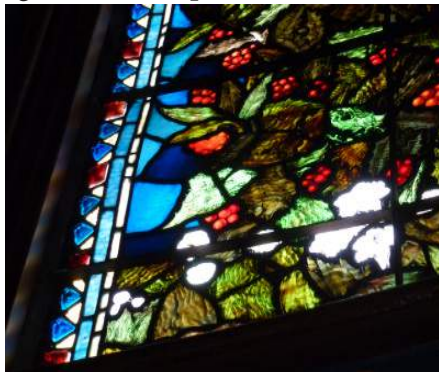
The altar windows all show signs of failing structural stability. The window on the far left side has twelve main sections created by the interior support beams. The section on the lower left is a wavy. The adjacent window has waving in the top left and bottom right; the third window has a rather homogeneous horizontal waving pattern; the fourth window's damage is mostly concentrated on the right transept of the cross. Because of the highly ornate and busy quality of the design, it may be difficult to discern the damage in the following images (Figures 2 – 8). The fifth window has a diagonal wavy pattern; the sixth altar window shows the most severe waving near the thickest central support beam; and the last window shows damage near the top and at both bottom corners.

Figure 3.7: Moving from left to right, altar window 1 of 7

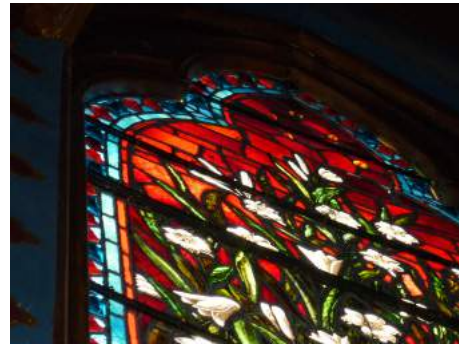
Figure 3.8: Altar window 2 of 7

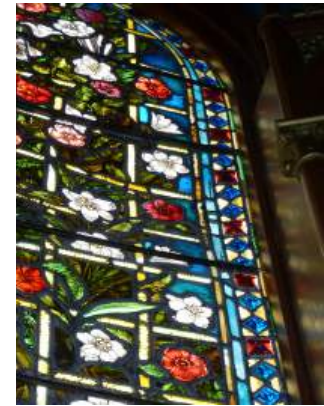
Figure 3.9: Altar window 3 of 7

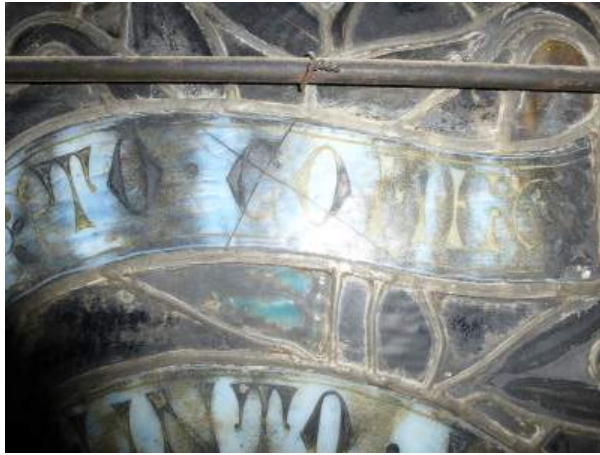
The choir clerestory window has a concave planar deformation in the circles of the window's Venetian design. There is also cracked glass under the lily near the support beam (see Figure 9).

Figure 3.14: Cracks in window

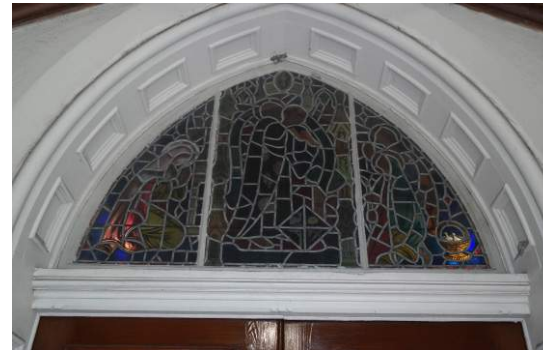
Christ Church Cathedral has numerous examples of failed protective glazing units. The majority of glazing systems are either not vented (see Fig: 3) at all or have only a top vent which does not allow for air circulation (see Fig: 4). This has resulted in hazing to the point of opacity (see Fig: 5) and sealant failure (see Fig: 6)

Figure 3.17: Non-vented window/transom at Cathedral main entrance.

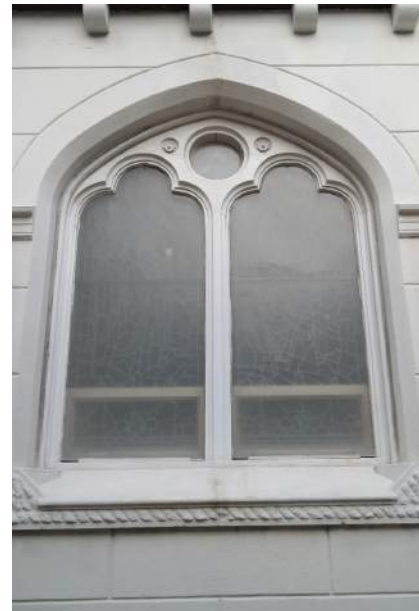
Figure 3.19: Non-vented opaque/failed protective glazing example on West Cathedral wall. All photos on this page credited to Samantha Williams

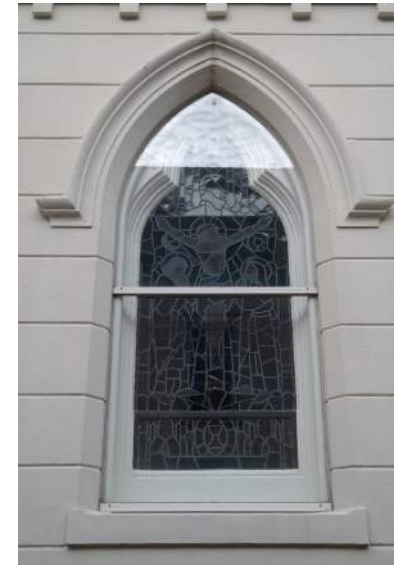
Figure 3.18: Single vented window on West Chapel Exterior Wall

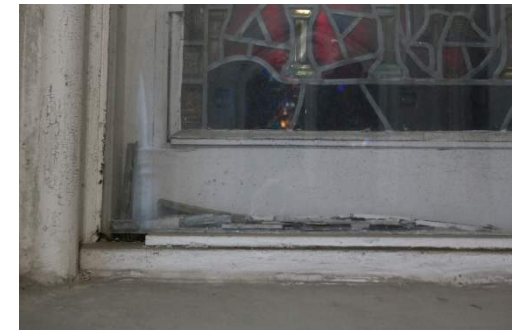
Figure 3.20: Sealant failure and debris visible behind glazing system. Window on East Chapel Wall, by Cathedral western entrance.

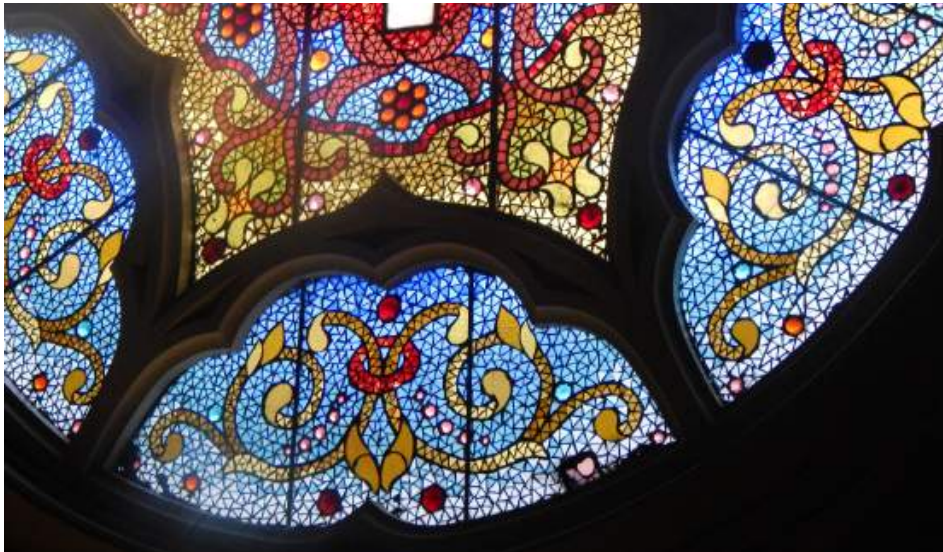
Figure 3.28. Detail photo of the rose window that is now located in the choral practice room above the Harris Memorial Chapel. Prior to renovations that added the choral practice space, this window was situated above the altar in the Chapel. Photo taken 01/15/2015, by Elizabeth Shultz.

Given the current relative stability of the Rose Window in the Harris Memorial Chapel, this program of securing the window in-situ between two panes of “museum quality anti-reflective glass”¹² would be an excellent preservation solution for the Christ Church Congregation.

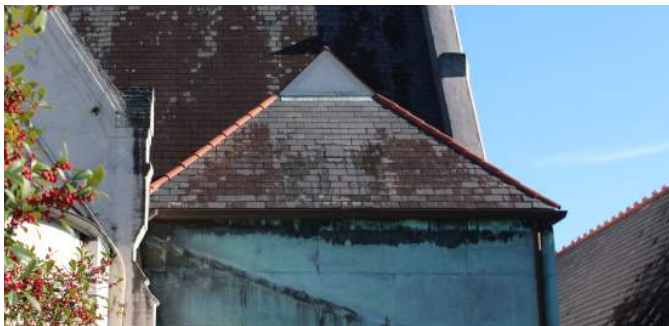
Figure 4.12: Organ roof. Photo by Cody Ellis, 2015.

The hipped roof of the building that contains the organ has a vent opening that faces towards the courtyard, which in the past was used to remove hot air from the building. Today this opening has been sealed over, and thus compromises the building ability to shed moisture (Figure 4.12). Two smaller vent opening can be seen on the apse roof, and appear to be functional. Based on visual observation and narratives of Dimitri Roby the skylight at the top of the apse does not appear to be operable (Figure 4.23). Because the passive ventilation measure were either reduced, which is the case in the cathedral room, or covered, which is

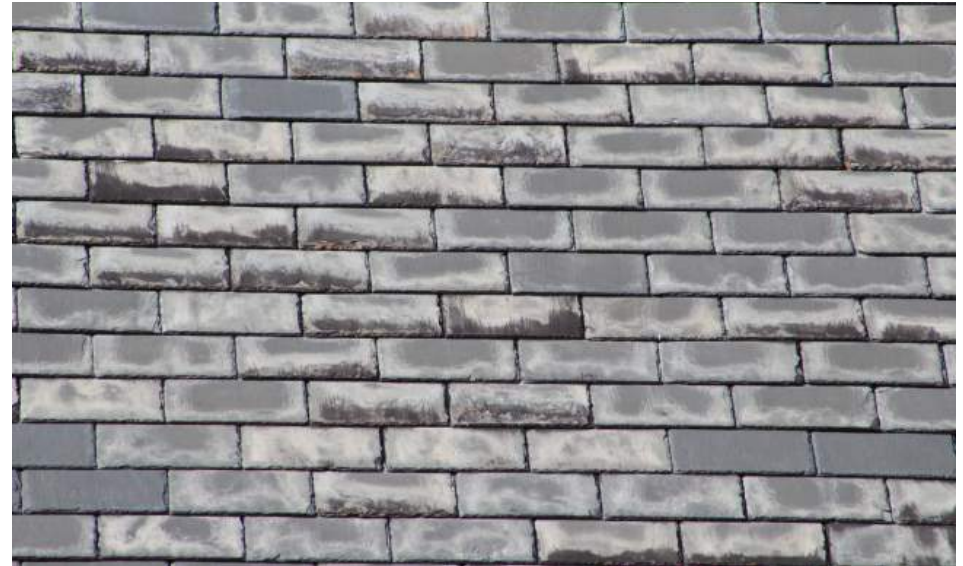
Figure 4.14: Slate shingles on cathedral roof. Photo by Cody Ellis, 2015.

Based on information gathered through firsthand conversations with Dimitri Roby and visual comparison to known examples, the original shingles of cathedral, chapel, side hall, and apse roofs are likely Pennsylvania blue slate (Figure 4.14). These shingles were fixed to a wood sheathing without any sort of impermeable vapor barrier in between. These shingles were crafted of quality slate and fastened in a manner that allowed moisture that is trapped within the roof space to slowly dissipate upwards (Figure 4.15). As the sketch demonstrates, a combination of flashing and slate shingles protect from precipitation, but the lack of an impermeable substrate allows moist air from below to escape because of construction tolerances that allow for air movement.

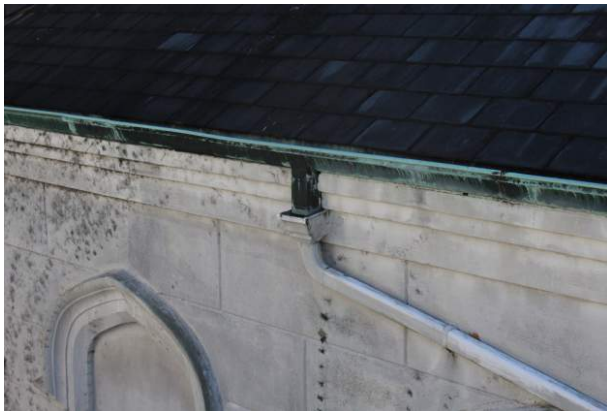
Figure 4.19: Damaged gutters. Photo by Cody Ellis, 2015.

The gutters and downspouts around the roof edges are one of the major issues associated with the roof structures. The proximity of vegetation and lack of general maintenance have allowed the gutters to become clogged and develop leaks (Figure 4.19). These leaks result in precipitation being deposited against the building and much closer to the foundation than the original rainwater diversion system called for (see drainage system section for more information).

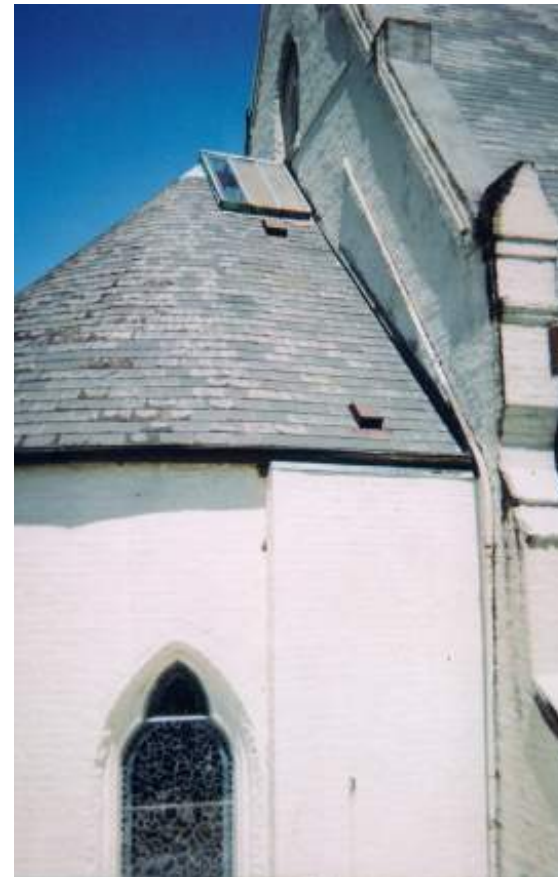
Figure 4.23: Apsé roof.
Photo by Cody Ellis, 2015.

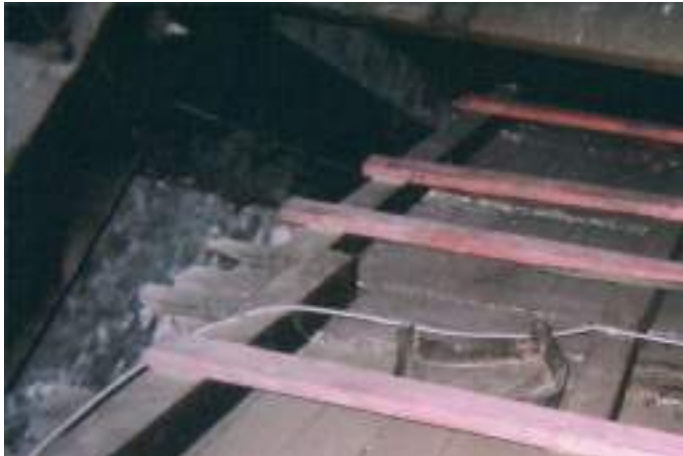
Figure 4.33: Current water damage in vault
Photo courtesy of Dimitri Roby, 2014.

the substrate. Areas above detected moisture damage in the vault should be inspected and replaced as needed. (Figure 4.33) The goal of these repairs should be to minimize water damage to maintain the integrity of the structure. Proper technique should be used when replacing slate tiles. Friction fit copper pieces or alternate hooks should be used to cover the nail hole in the new tile. These will prevent water from penetrating the new hole.³¹ The application of roofing mastic or sealants should be avoided as they deteriorate over time allowing water to enter. Examples of sealants can already be seen across the cathedral roof. (Figure 4.34)

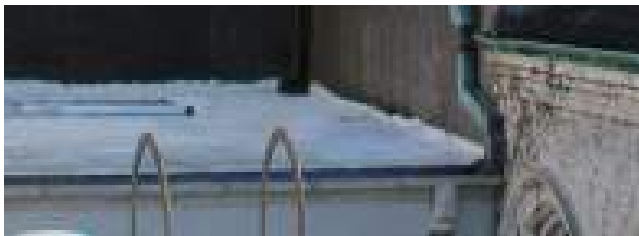
roofs.³³ It is also important to check all the flashing. Heavily tarred areas can mask small cracks around the flashing that will allow water penetration. (Figure 4.36) Removal of excess tar and proper replacement of any damaged flashing will guarantee the quality of these important seals.

Figure 4.36: Built up tar edge around flat roof
Photo courtesy of Cody Ellis, 2015

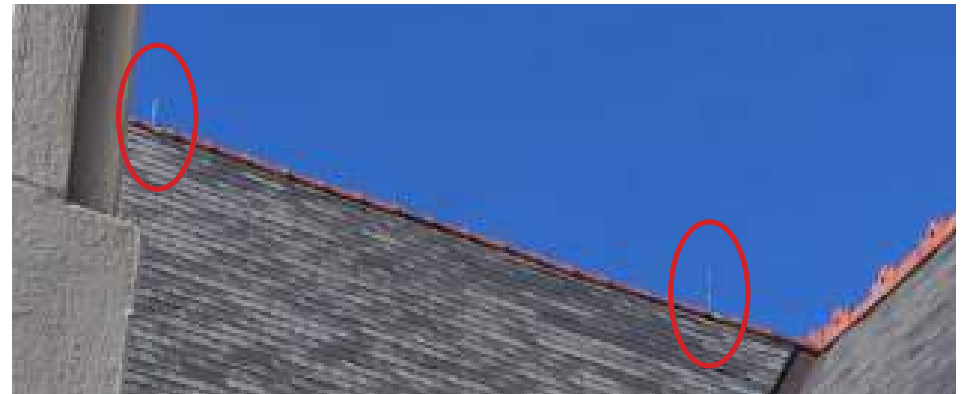
Figure 4.42: Existing lighting rods on the cathedral roof
Photo courtesy of Cody Ellis, 2015

It is important to remember that the roof does contain several lighting rods. While they are not a necessity, it is extremely important that they remain grounded. Contractors need to be made aware that the lines are still live and must be maintained or completely removed.

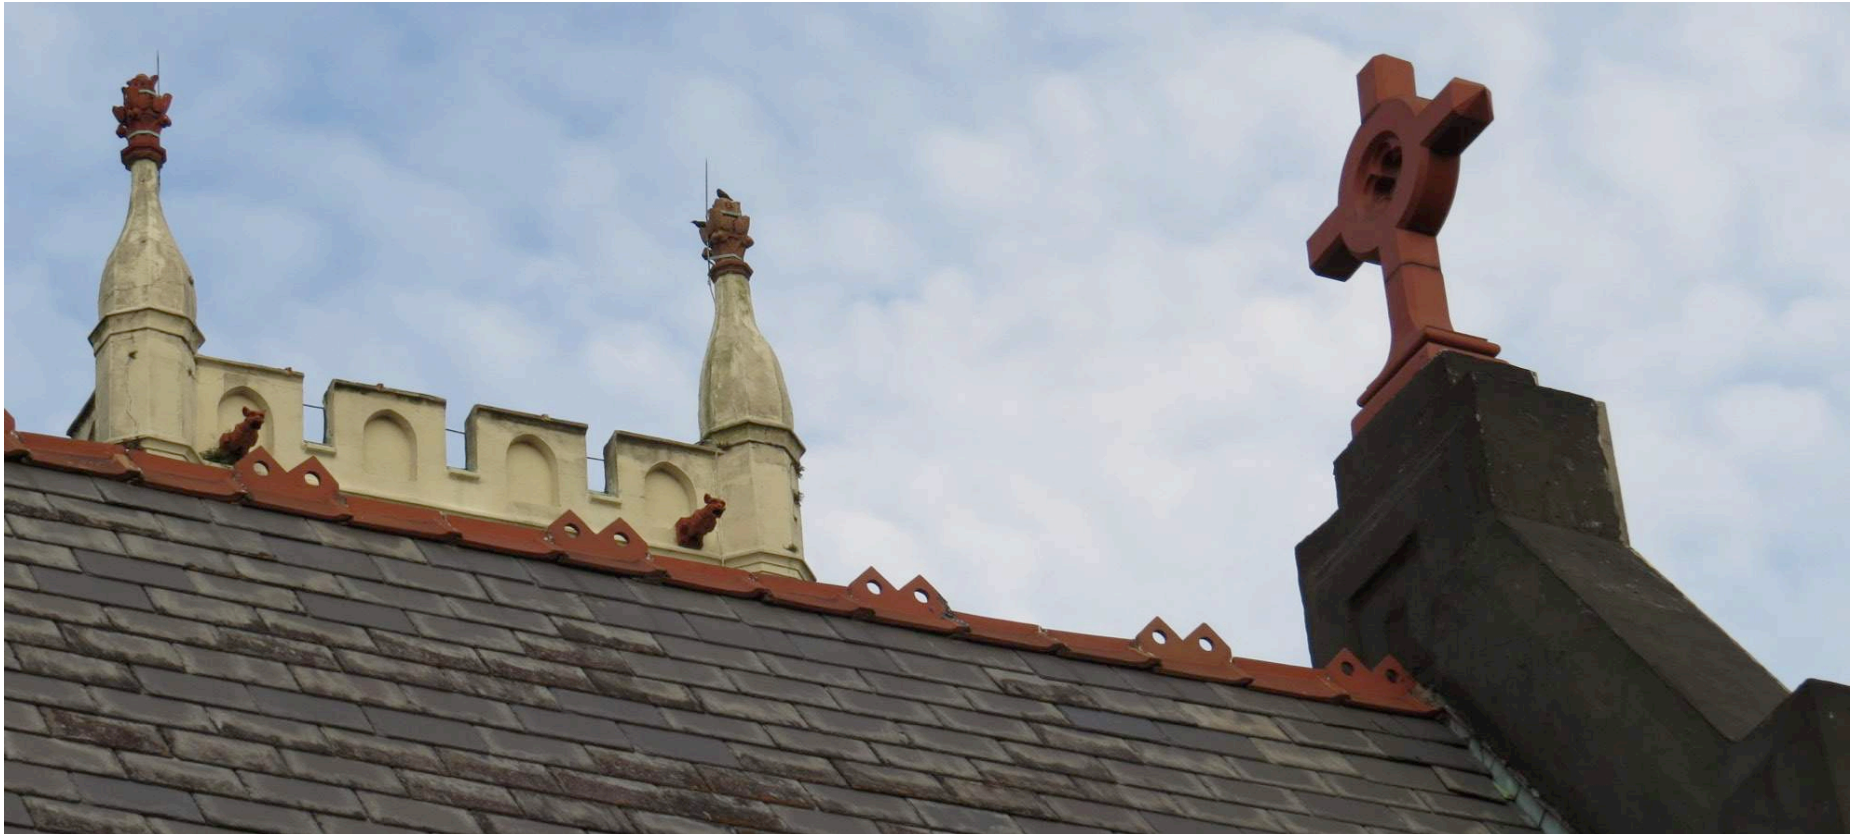
Figure 5.1: Terracotta cresting, finials, and decorations on Christ Church Cathedral. Photo by Laura Stokley, 2015.

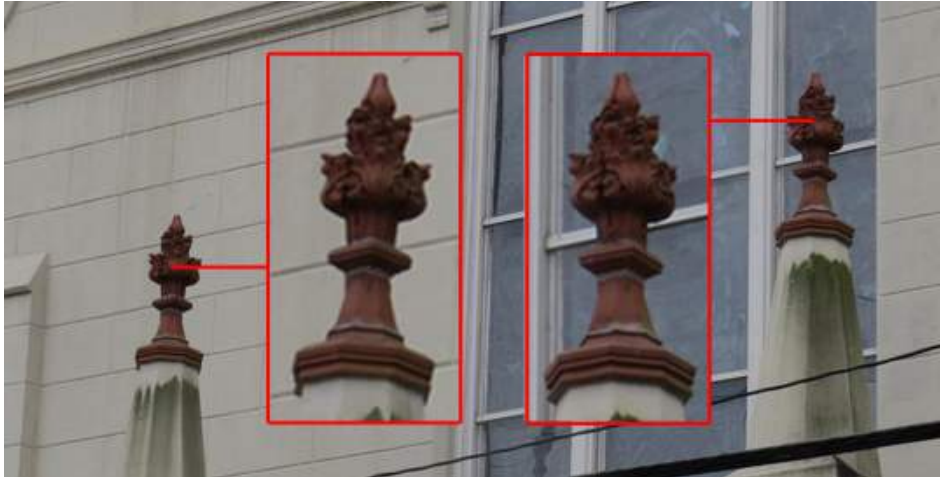
Figure 5.7 : Cathedral side entrance finials. Photo by Laura Stokley, 2015

The cathedral has finials adorning its front and side entrances as well. These have a Romanesque style byzantine leaf motif culminating in a bud at the top (Fig.5.7-5.10). The chapel has similarly designed finials adorning its front entrance as well, but they are clearly not made from the same mould (Fig.5.11-5.13). The chapel's finials have the same motif, but are rounder where the cathedral's are more boxy. The chapel's finials are also taller and more slender. The chapel finials are in good shape and

seem firmly secured, however one of the finials on the chapel is visibly crooked (Fig5.13). All of the entrance finials have a visible layer of dirt and grime, but none have any apparent cracks or chips. They all seem fully intact and unblemished.

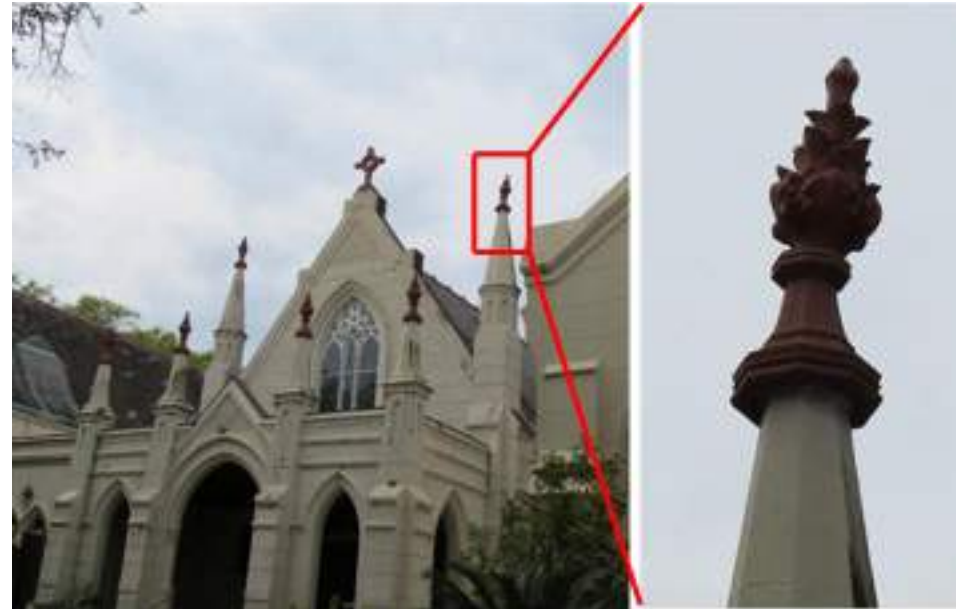
Figure 5.13 : Crooked chapel finial. Photo by Laura Stokley, 2015

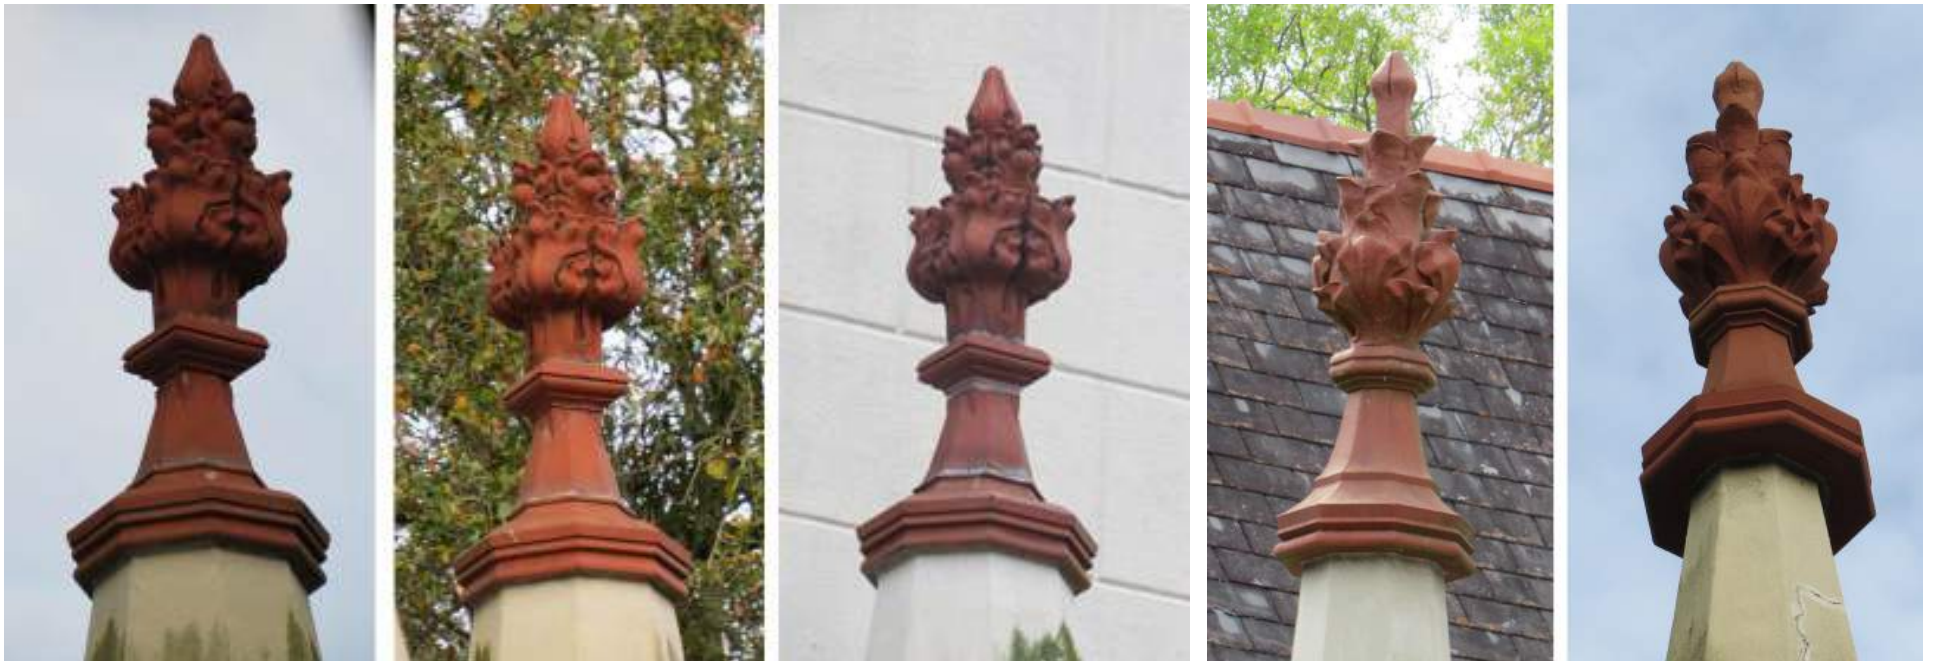
Figure 5.8-5.12 : The three on the left are from the cathedral. The two on the right are from the chapel. Note the slight differences in shape. Photos by Laura Stokley, 2015

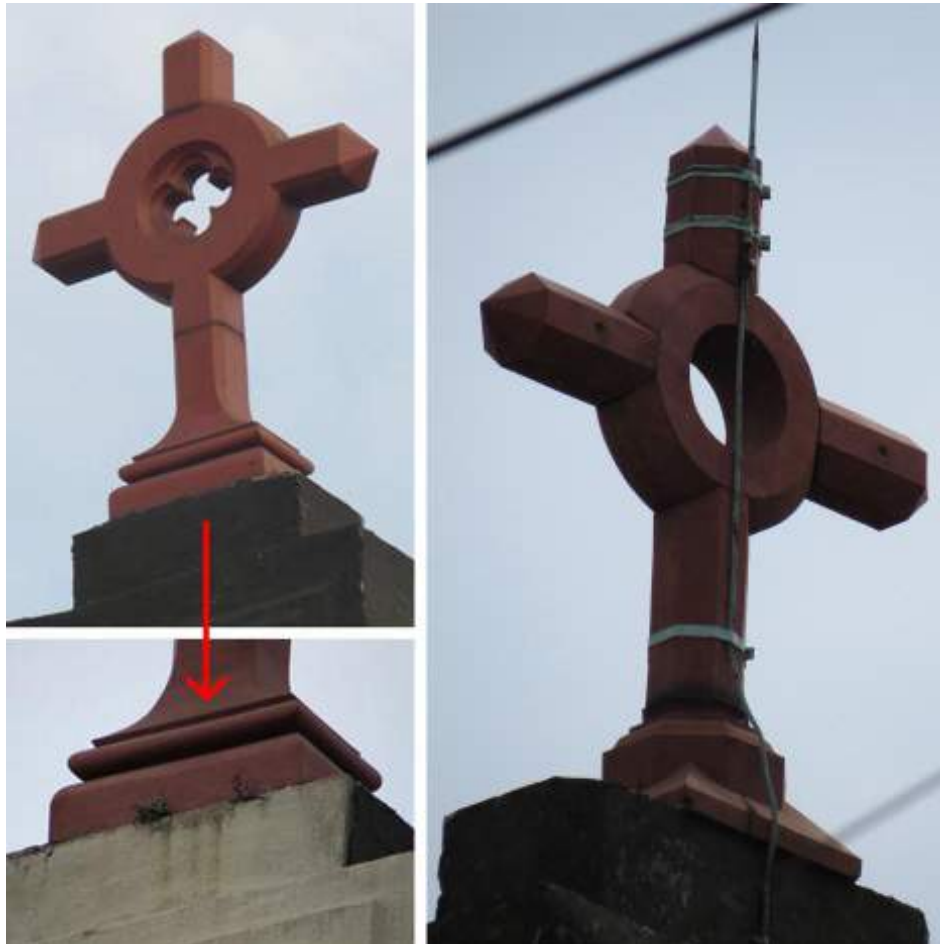
The cross on top of the cathedral has a lightning rod attached to it presumably because it is one of the highest points on the building. This cross also has some slight cracking at its base and dark discoloration on the shaft just above the base (Fig5.16). The cross on the chapel is in great shape except it has some plants growing from its base (Fig5.14-5.15).

Figure 5.14-5.16 : left, chapel cross; right, cathedral cross. Photo by Laura Stokley, 2015

- All plants should be gently removed from the terracotta decorations, particularly from the gargoyles and crosses. It is best to remove vegetation after it has been killed so that the roots will more easily let go of the building fabric. Herbicides should never be sprayed directly on building surfaces, but rather applied directly onto the leaves of the plant.
- The crooked finial on the chapel should be inspected up close to check its stability and evaluate the potential for straightening it. This is an aesthetic measure and should only be attempted if one is sure that it will not damage the terracotta piece.
- All terracotta pieces should be gently cleaned. Many chemical solutions are available to do this cleaning, but only the gentlest of methods

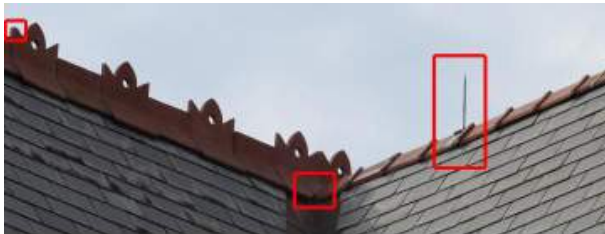
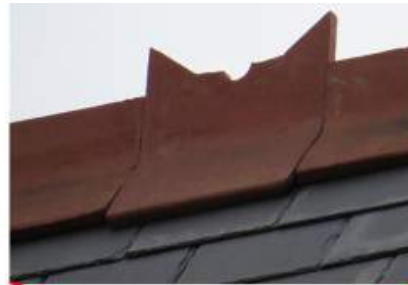
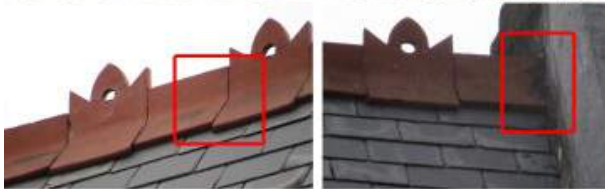
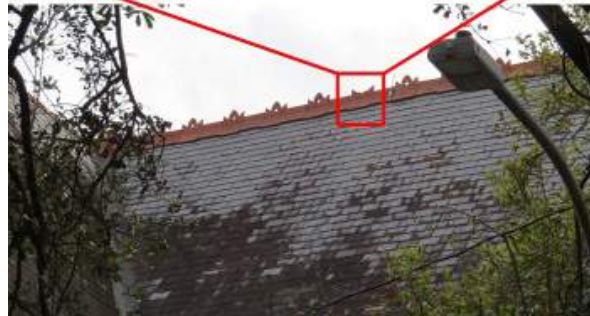
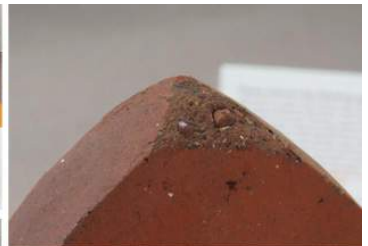
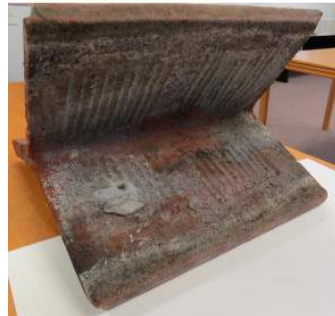
matching those on the chapel (Fig5.22). The drawings even note that the tiles should match those of the existing chapel. And once again, a different, less ornate tile was used. One of the ridge tiles on the cathedral is significantly damaged, and a few others are chipped and cracking, but most are intact (Fig5.27). The rest of the ridge tiles on the building appear to be in good shape. The cathedrals tiles are also strung together with a fine wire not visible from the street. This is likely part of the lightening protection system, but may serve the subsidiary function of physical anchoring as well.

Figure 5.23-5.33 : Cathedral tiles with lightning rods, mortars, connections, and wires; Broken tile also noted; images on the far right are of a fallen ridge tile currently in the Southeastern Architectural Archives, Special Collections Division, Tulane University Libraries. Photos by Laura Stokley, 2015.

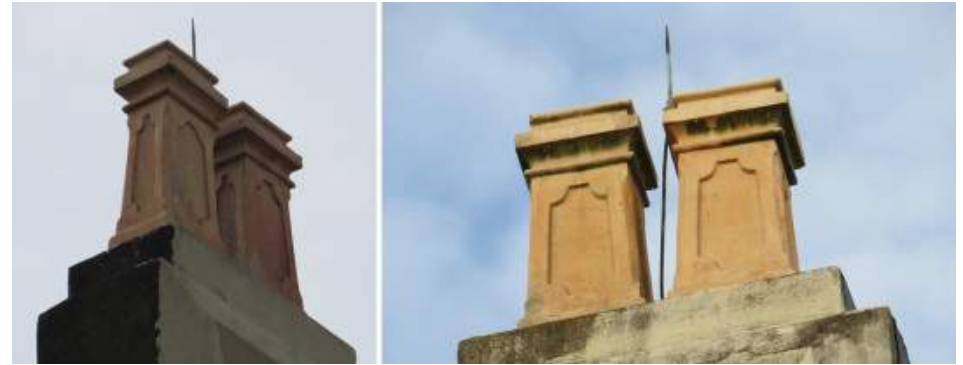
The chimney pots also have a moderate amount of dirt and grime build up as well as some biogrowth (Fig5.37 - 5.38).

Figure 5.37-5.38 : Clay chimney tops on the cathedral. Photos by Laura Stokley, 2015

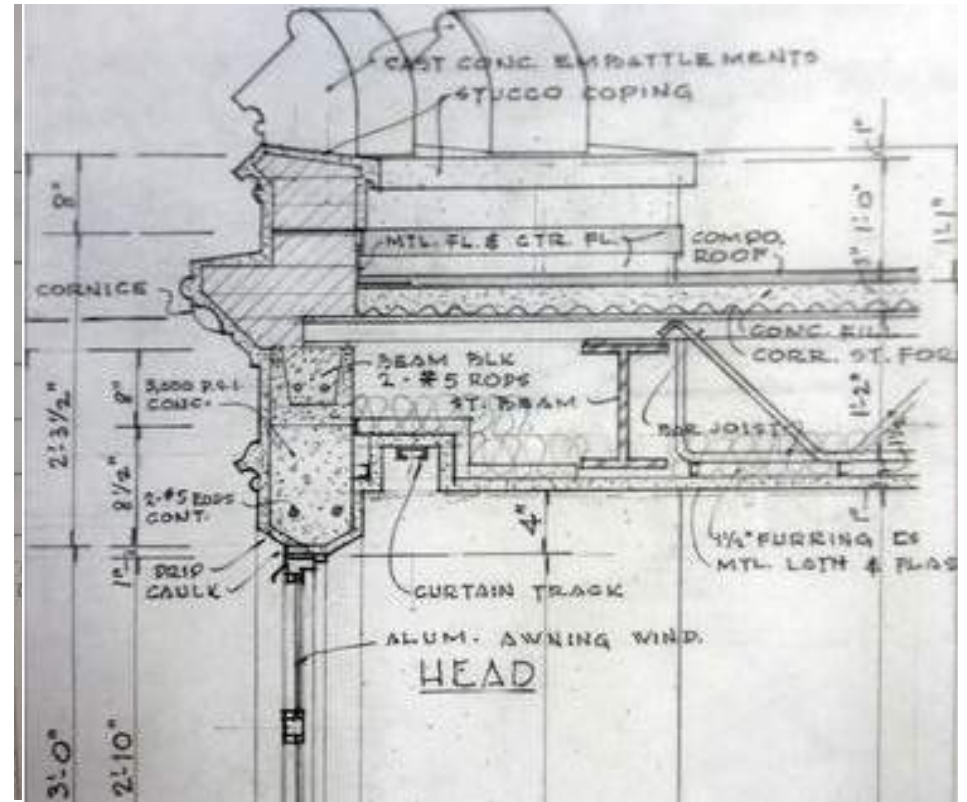
Figure # 6.2: Freret & Wolf's drawings depict a gutter system for the New Parish House in 1959. Freret and Wolf Office Records, Collection 40, Folder 151, Southeastern Architectural Archive, Special Collections Division, Tulane University Libraries. Photo by Laura Blokker, 2015

to be replaced when damaged by hurricanes or rust. While we do not have the original plans for the cathedral, we do have plans for a mid-century addition by Freret and Wolf that include only minimal details about the gutters and downspouts to be installed, as seen in the image above. We can also infer from the plans that some alterations to the existing drainage system were required.

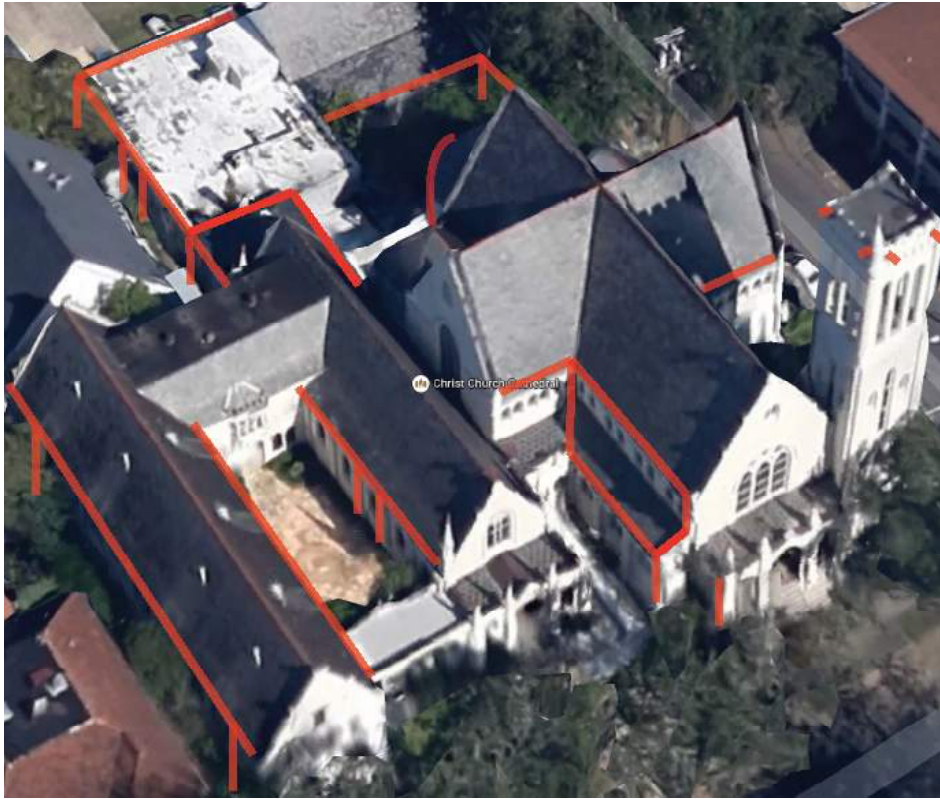
Figure # 6.4: On this aerial view of the church, gutters and downspouts are mapped in red. Photo by Google Earth, Edits by Nathan Lott, 2015

spouts on the Carondelet Street-side of the cathedral now discharge into an elevated, hardscaped courtyard and must drain toward Sixth Street via a network of subterranean pipes. One particularly worrisome outdoor area, the walled Mechanical Yard, sits below the level of the courtyard and is insufficiently linked to the subterranean system.

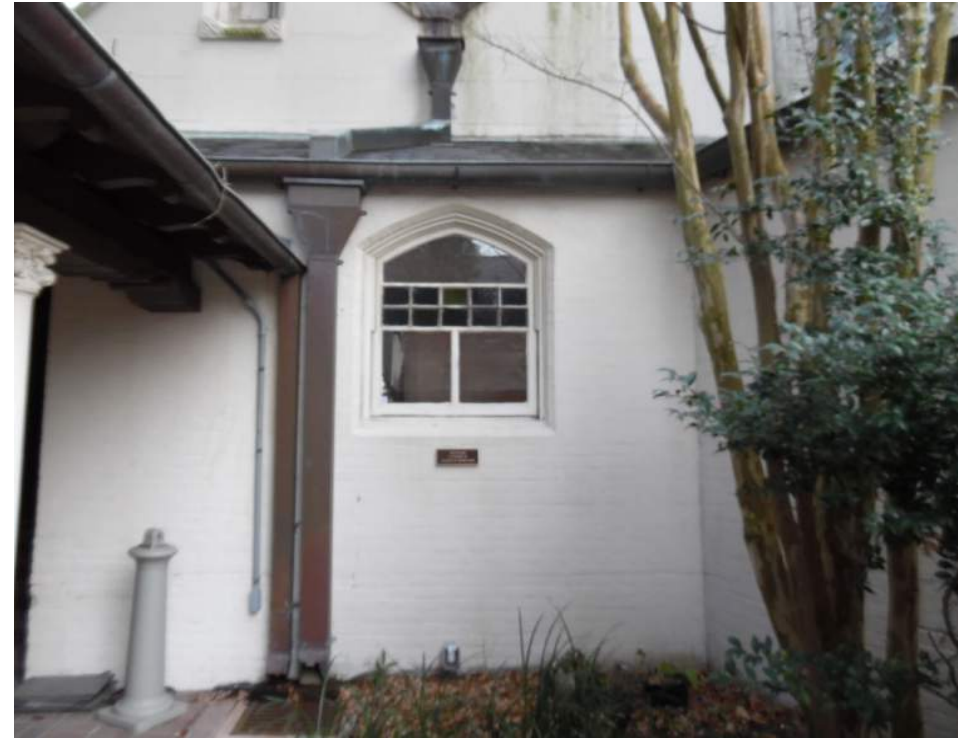
Figure # 6.8: Leader heads are positioned at and fitted to the tops of downspouts, allowing water to enter from different angles and minimizing overflow. This image from the Bishop's Garden shows leader heads attached to downspouts along two tiers of roof. Photo by Trudy Andrzejewski, 2015

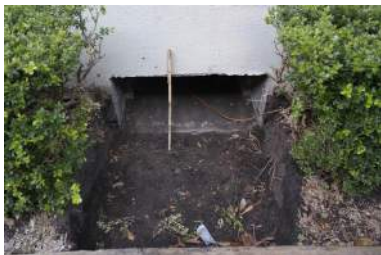
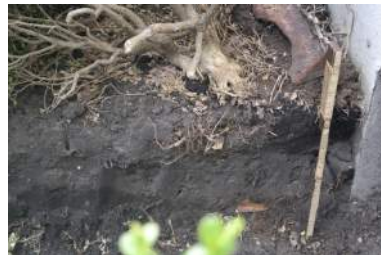
Figures 7.14 & 7.15: Exposed vents covered by a foot of soil during grade changes over time, photo by Amanda Keith, 2015

over the years due to the grade change in this space (Fig.7.14 & 7.15).¹³ A profile of the soil in the beds

against this wall reveals that plant roots from the Japanese box growing in this area are touching the wall. Plantings this close to the foundation of a building can cause issues by drawing moisture to the foundation and

holding it there.

E. A more extreme intervention to mitigate this situation would be to lower the grade in the Cloister Garden. This is something the Cathedral may want to consider as a long term plan as it would require removal of the paving stones, the slab of cement under the paving stones, seen in the Wold and Freret designs from 1959, current plantings, and a good deal of soil. Hopefully, by lowering grade, it would bring the soil level back down to below the “damp course” of slate installed in the original masonry walls, allowing this slate to do its job of preventing moisture from wicking up into the masonry.²² This plan would ultimately result in a sunken courtyard, but may be a successful strategy for solving issues of drainage in this garden. Because it is open air, installation of a rain garden in the center of the space may be an innovative plan to draw moisture away from the walls of both the chapel and the administration building while maintaining a peaceful garden atmosphere for quiet contemplation and prayer.

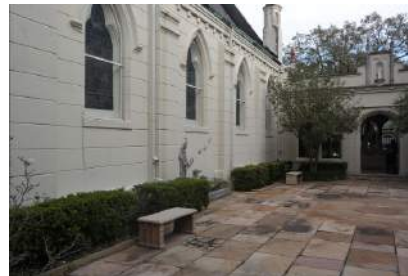
cifically in the Cloister Garden, where grade was raised to a degree in which it covered the original ventilation system, allowing excess moisture to collect in the walls. In the Bishop's Garden, the raised grade is mostly an issue in the bed of plantings that rests against the exterior wall of the ambulatory, where it is also causing problems of excess moisture in the masonry wall.

Figure 7.13: The Cloister Garden, view towards St Charles Ave, photo by Amanda Keith 2015

The current Cloister Garden (Fig. 7.13) is a courtyard space that sits where the former Middle Garden was located between the chapel and the administration building. It is enclosed on its other two sides by a covered open-air walkway on the front façade and a totally enclosed walkway in the rear that connects the administration building with the chapel. The Cloister Garden features a raised grade patio paved with large flagstones. Japanese boxwood flanks the outer perimeter of this garden space. There are also lily turf (*liriope muscari*) plants in areas of the landscaping that jut out into the larger rectangular space. A small dogwood tree is planted in the corner as well as camellia bushes. In the center of the garden placed on the wall of the chapel is a bas-relief fountain designed for the church in 1962 by Angela Gregory.¹²(Fig. 7.16) The fountain does not currently work, but the church would like to have it repaired and for it to remain in the garden. Recently, during investigations by Dimitri Roby, some soil test units were excavated along the chapel wall and the ventilation openings were once again exposed after being covered

C. Replacement of the plant beds in the Cloister Garden and the Bishop’s Garden with container plants would help to solve the issue of plants being too close to the foundation. This would help to alleviate issues with moisture and the threat of insect invasion through root systems planted near foundations. Removal of trees that are too close to the building will prevent the threat of future disturbance to the masonry from growth of roots underground. A smaller scale tree known for moisture absorption,

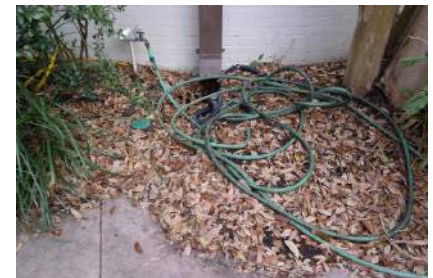
Figure 7.18: Drain clogged with plant matter in bed against ambulatory, Bishop's Garden, photo by Amanda Keith, 2015

of the building. The space is paved with concrete pavers. There is a bed of three crepe myrtle trees, banana shrub, lily turf, and cast iron plant (*aspidistra elatior*) planted against the ambulatory wall. This bed has two large drains, which empty the downspouts coming off the roof in this area that are partially clogged with plant matter.(Fig. 18) According to Dimitri Roby, these drains were totally covered by soil and plant matter when he began his conditions assessment of the church and grounds.¹⁴ There

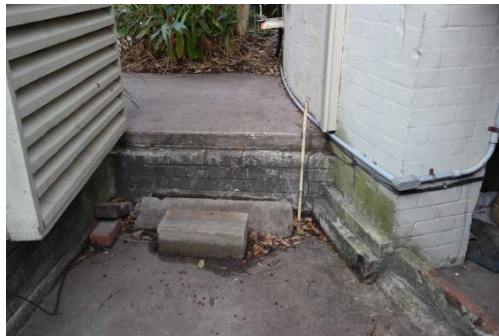
Figure 7.20: Grade change from Mechanical Yard to Bishop's Garden of 18 inches, photo by Amanda Keith, 2015

The grade change in the Bishop’s Garden is less of a problem for the historic building fabric because that area does not touch any part of the original building. However, the plant bed next to the wall of the ambulatory is contributing to excess moisture and deterioration of masonry in that part of the building. The combination of having 18 inches of damp soil that does not drain properly and large tree roots planted against the brick wall is wreaking havoc on the ambulatory and is obvious from the condition of the plaster on the interior of that section of the church.

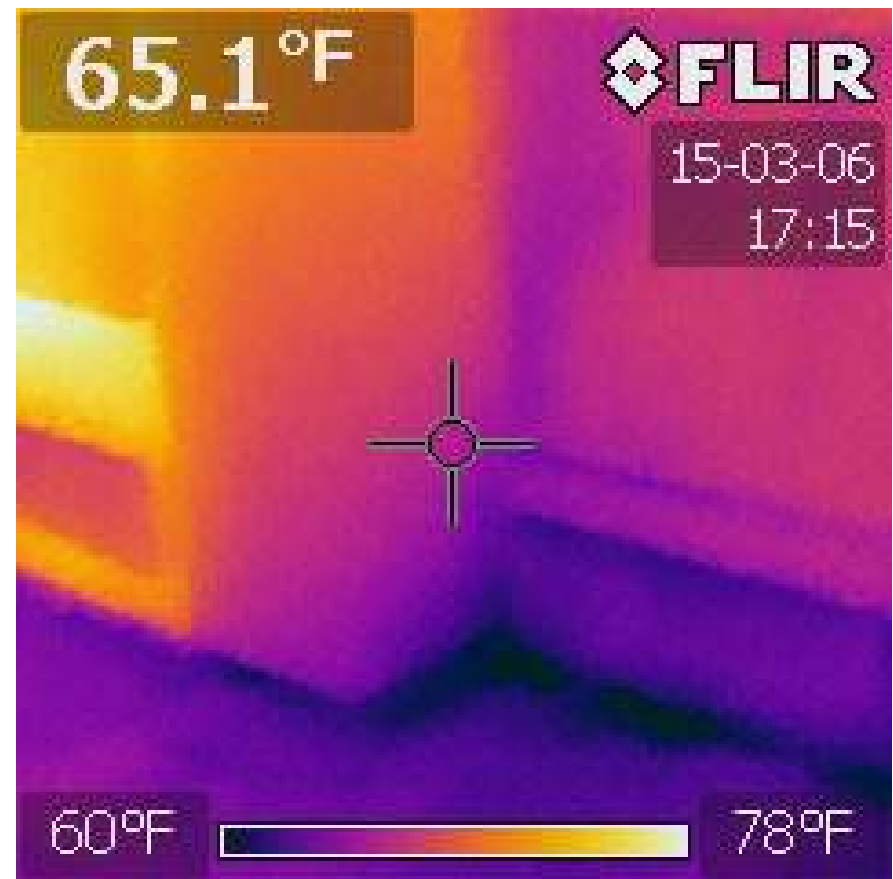
from the cooler season to the warmer season. (Figure 8.4) The rigidity of these summer and winter settings poses an obvious problem as they are not adjustable and therefore are not responsive to daily conditions. This is specifically an area of concern in New Orleans, where seasonal changes in temperature are not as pronounced as other areas in the country and it is not uncommon to have warm, sunny days in January or February, thus warming the interior of Christ Church when it is already being warmed according to the winter fan-coil setting. On the other hand, during the summer setting, the building has a thermocline effect, where the space

is cooled by the fan-coil units on the ground but the stack effect leads to warm air being trapped by the ceiling. Historically, this warm air was permitted to escape through now inoperable ventilators in the ceiling and walls (discussed in more depth later). The result of this accumulation of trapped warm air is tangible, where the warm air condenses on the walls at the thermocline during the summer and leads to moisture-related issues, posing a threat to the historic fabric. Thus, goals for the building entail promoting more stable interior temperatures year round and allowing for increased air circulation and ventilation.

Figure 8.4: Infrared image of air compressor unit when turned to heating. Photo by author, March 2015.

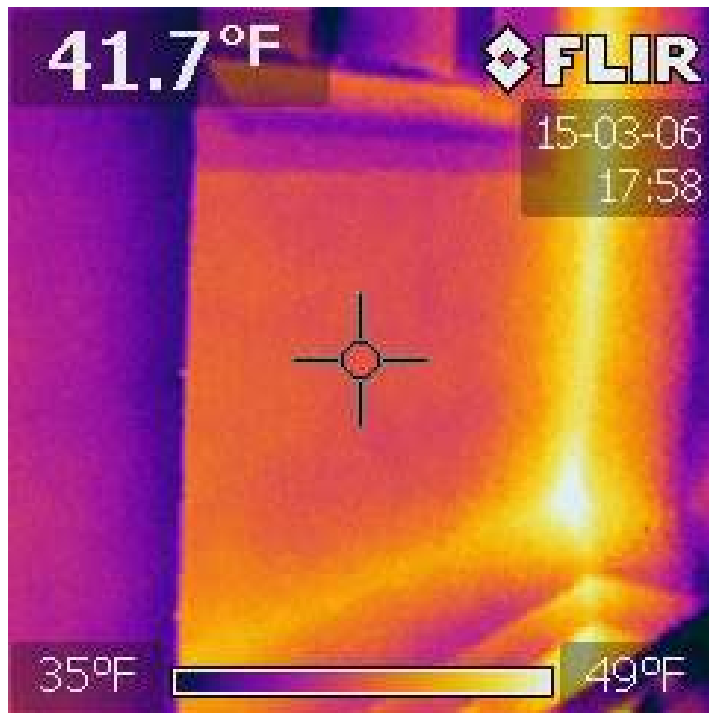
within the wall assemblies that provide ventilation within the actual walls of the church. The article could, however, simply be referencing the lower wall vents that brought fresh air and breezes into the building interior. Although infrared pictures taken of the walls of the church do not entirely validate either claim, they most support the idea of lower wall vents (Figure 8.15).

Figure 8.15: Infrared photos taken of the exterior walls did not show evidence of any “ventilators” referenced by the Times Picayune article. Colder areas along the bottom of the walls, however, suggest some sort of lower wall vents. Photograph by author, March 2015.
