Christ Church Cathedral

Materials, Conditions, & Preservation Recommendations

Preservation Technology (PRST6720)
Master of Preservation Studies
Tulane School of Architecture
Spring 2015

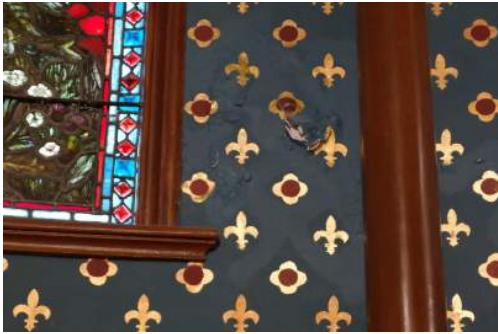
Figure 9.7: Blistering on Chancel Wall; Figure 9.8: Blistering on Vestry Wall. Joseph Newman and Fallin Steffen

Major areas of the finishes, both interior and exterior, are suffering from severe environmentally related damage. The major issue is blistering of the finishes due to water infiltration. Beginning in the rear of the church, several large areas of blistering have occurred where the wood molding separates the portion of the wall with the green background from the

portion of the wall with the blue background [Figure 9.7]. In most of these areas the finish has not fully detached from the substrate however there are places where the plaster substrate is clearly visible. The plaster in this location, and the plaster of other areas that are an original part of the church, is suffering relatively little damage and the issue is mainly with the finish itself. In newer additions to the church the plaster itself is suffering damage. This difference is related to the type of plaster used in the original construction versus the kind used for the 1962 addition to the ambulatory. The plaster used in the cathedral has a lime base that resists moisture related deterioration. The addition to the ambulatory has plaster made out of gypsum as in plaster of Paris and like its descendent "plaster board" will spall (the flaking process) in wet conditions.¹⁶

Portions of the vestry wall [Figure 9.8] closest to the 1960s addition are undergoing severe blistering, alligatoring, and finish-substrate separation. Similar problems of finishes blistering and peeling also exist in spots throughout the side aisle walls and nave walls of the main portion of the church. Considering these places are all part of the original areas of construction, it is assumed that the plaster substrate like in the chancel is also suffering from relatively little damage. A general finishes issue related to the damage seen might be the type of paint used [better assumption once finish analysis results are received]. Latex paint does not breathe as well as oil based paint¹⁷ and based on the moisture infiltration problems combined with finish deterioration it is assumed the paint used for newer decorations is a latex based paint.

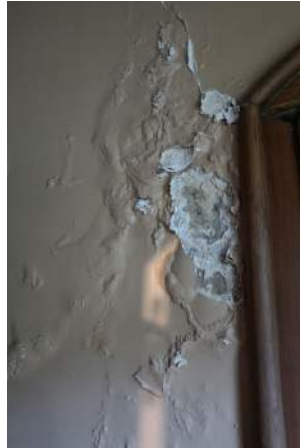
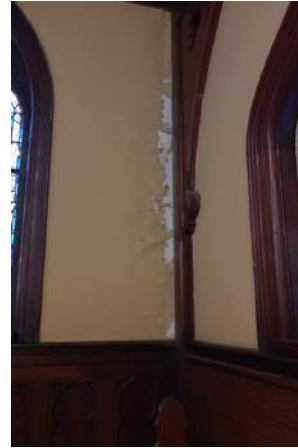
Figure 9.9: Blistering on Chapel Wall; Figure 9.10: Alligatoring on Exterior Window Frame. Joseph Newman and Fallin Steffen

and adjacent to the front entrance is undergoing blistering and peeling [Figure 9.9]. The overpainting of finishes was also seen in several areas around the window frames of the chapel.

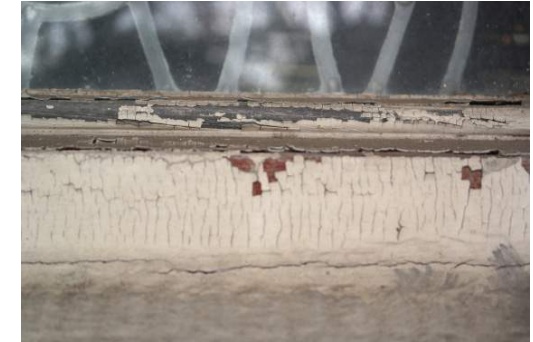
The wood finishes throughout the exterior façade are suffering from severe cracking, also called alligatoring, and in many areas the wood substrate is exposed [Figure 9.10]. This is most likely related to the installation of storm windows over the original stain glass windows. Sometimes this creation of a double glassed window, if not done correctly, creates a situation whereby moisture from the wall and inside space ventilates through the wooden frame causing the exterior paint to badly blister and wooden frames to rot.¹⁸ See “Windows” section for further discussion. From initial visual inspection no clear areas of rotting of the wooden frames was visible. The damage seemed limited to the finish itself. Exces-

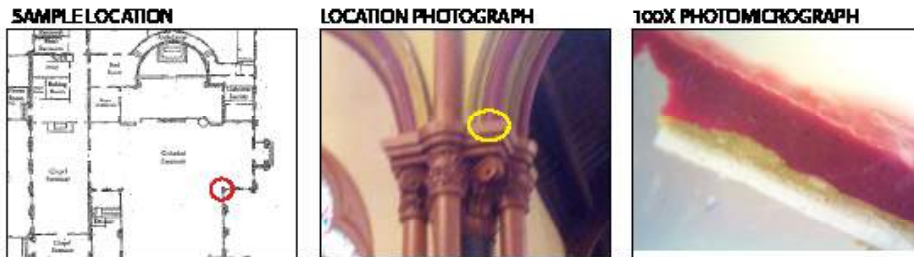
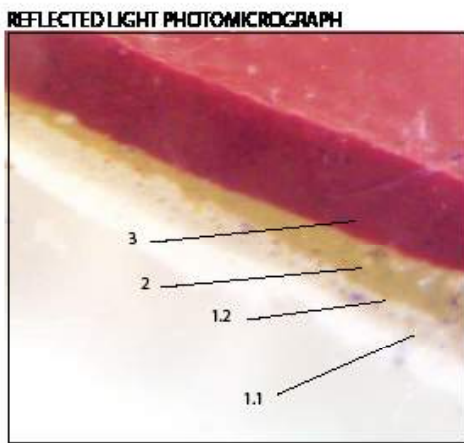
NOTES
Substrate is plaster; current paint is a deep red. Some white particles are visible in middle (tan) layer. Earliest color (beige) may have been applied in two layers (see lower right portion of photomicrograph). This is not consistent throughout the sample, but that may be explained by the location at the margins of paint coverage (flat surfaces above columns is unpainted).

LAYER	COLOR	SCHEME
3	Red	
2	Tan	
1.2	Beige	
1.1	Beige	
Substrate	Plaster (white)

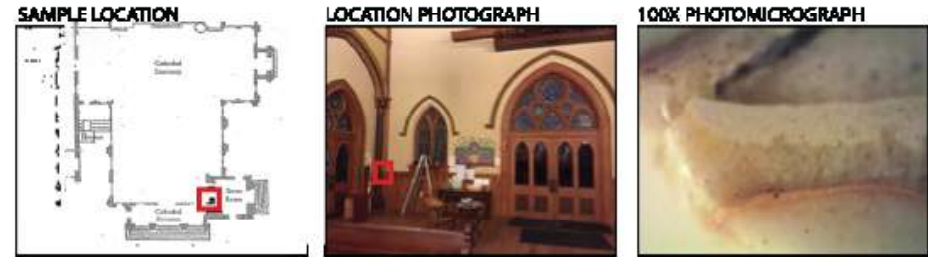
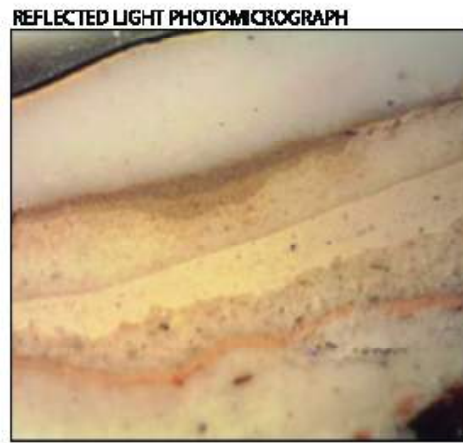
NOTES
A dirt layer was observed between the third and fourth layer of paint (indicated by the carrot, ^). A layer of repairwork is also evident (layer 8).

LAYER	COLOR	SCHEME
10	Dark green	
9	Butter yellow	
8	Repair	
7	Dark brown	
6	Light brown	
5	Beige	
4	White	
3 ^	Beige	
2	Beige (w/ sand?)	
1	Pink	
Substrate	Plaster

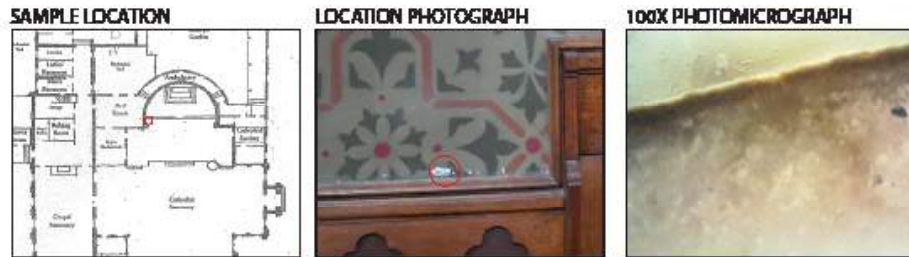
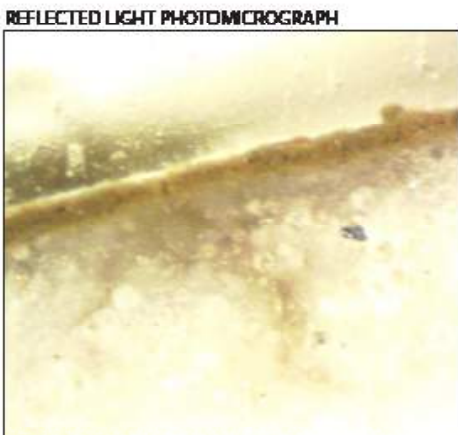
NOTES
Dark flecks present in the analysis images are most likely remnants of the sand paper grit which were not completely washed off after buffing the sample. Minimal layers of paint present suggest the area was completely stripped of previous finish layers before current painting took place. The first brown-green layer might be some kind of primer or sealant for the plaster.

LAYER	COLOR	SCHEME
2	green	
1	brown-green	
substrate	plaster

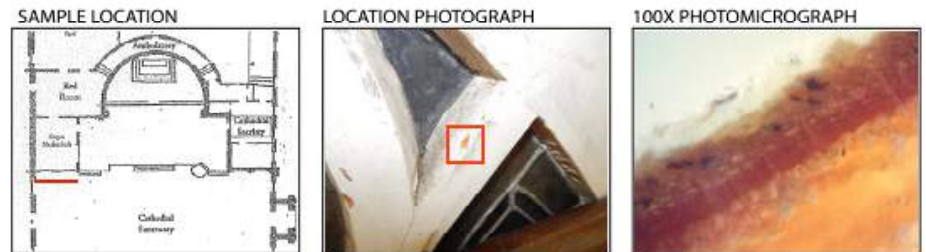
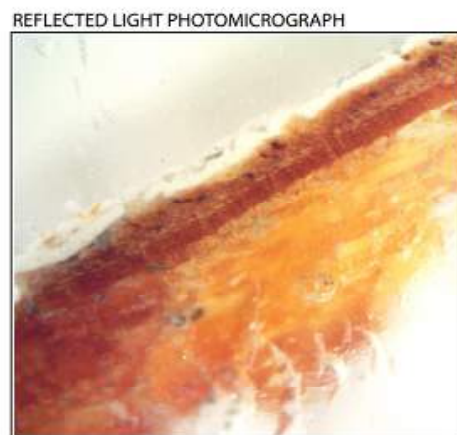
NOTES - Sample taken from one of a group of windows that were removed during the twentieth century to accommodate a large organ for the Cathedral. Windows have since been put into storage in the church tower. The sample location noted below shows the historic location of the window, located approximately twenty feet above floor level. - Sample clearly shows evidence of at least four paint layers prior to the window's removal, the earliest of which appears to be a hearty crimson, and the most recent of which is a thin layer of white. Beneath the red layer is a large chunk of the wooden substrate. - It appears as though some remnants of the smoothing agent were left on the sample.

LAYER	COLOR	SCHEME
-	Dirt Layer	
4	White	
3	Light Brown	
2	Brown	
1	Red	
Substrate	Wood

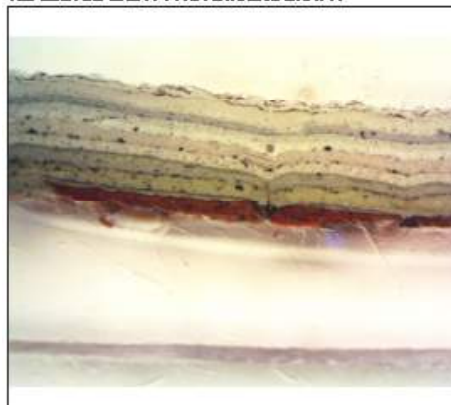
REFLECTED LIGHT PHOTOMICROGRAPH

The sample is missing the substrate due to the fact that it was peeling. The black specks are contributed to residue from the sanding/polishing process of the sample.

LAYER	COLOR	SCHEME
9	Grey	
*	Dirt line	
8	Yellow Beige	
7	Dark Grey	
6	White	
5	Taupe	
4	Beige	
3	Green Grey	
*	Dirt line	
2	Yellow Green	
*	Dirt line	
1	Red	
*	Substrate - Wood - not intact

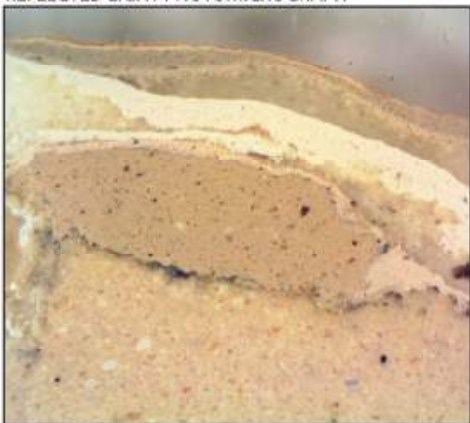
REFLECTED LIGHT PHOTOMICROGRAPH

LAYER	COLOR	SCHEME
12	dark brown	
11	yellow	
10	grey primer	
9	tan	
8	light brown	
7	white	
6	yellow	
5	white	
4	light brown	
3	pinkish tan	
2	dark blue	
1	light brown	
Substrate	plaster
