Georgia Conference of Home Inspectors

Pre-Closing Property Inspection Report

Client(s): **Ms. Andrea Devries**
Property address: **2049 Hatteras Way NW**
Atlanta, Georgia 30318
Inspection date: **Thursday, December 10, 2015**

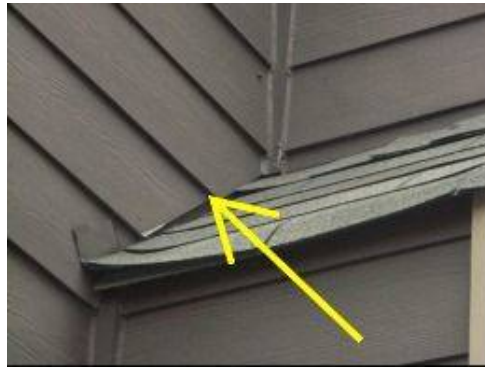
Photo 10-6
Flashing visible from rear yard.

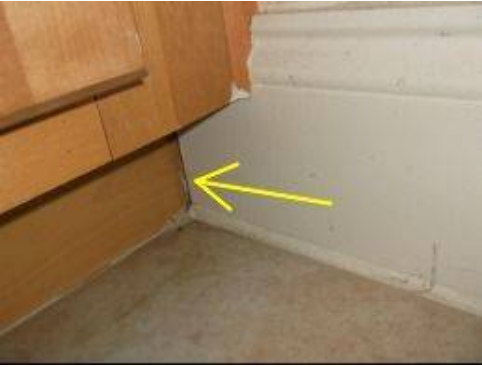
Photo 29-7
Caulk and seal joints at the bottom cabinet trim in the master bathroom.

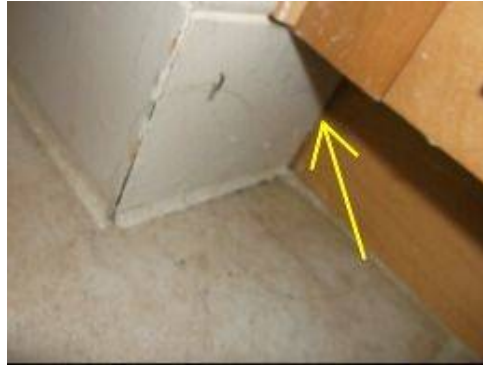
Photo 29-8
Seal spaces at the corners underneath bathroom cabinets.

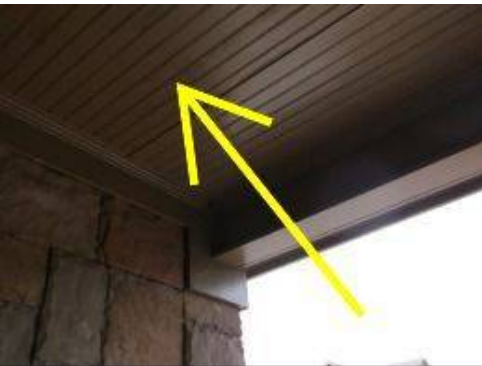
Photo 5-15
Front entrance porch ceiling appears to have mold spores forming. Recommend pressure washing with an anti-mold agent. This should be done periodically.....as the upper porch ceiling may not get adequate sunlight or ventilation to prevent moisture droplets from forming on the ceiling.

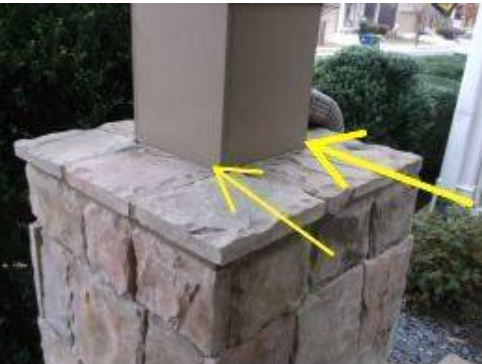
- The masonry (brick or stone) veneer was deteriorated or damaged in some areas. Where cracks or openings are exposed, water can enter the wall structure causing mold, fungal growth and structural damage. This is a conducive condition for wood-destroying organisms. Recommend that a qualified contractor repair as necessary. For example, by repointing mortar or replacing broken or missing masonry.

Photo 6-1
Mortar joints cracked at front porch support columns.

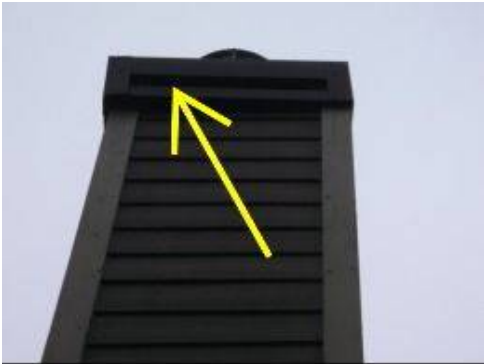
Photo 10-5
Metal chimney cap appears to be improperly installed from ground level. Further evaluation is recommended.

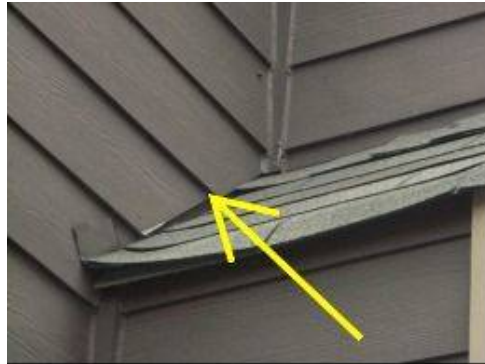
Photo 10-6
Flashing visible from rear yard.
