Pre-Closing Property Inspection Report

Client(s): **Mr. Jesse Shepherd**
Property address: **4070 Dinmont Chase**
Atlanta, Georgia 30349
Inspection date: **Tuesday, August 25, 2015**

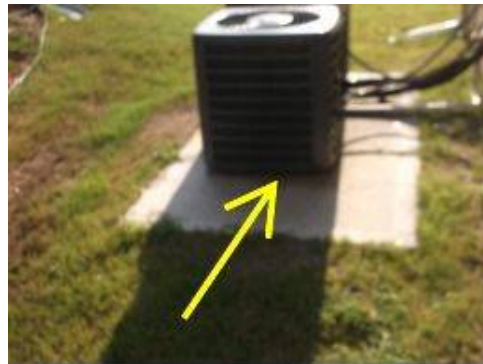
**Photo 15-2**

Air conditioning compressor condenser units should be raised a minimum of 3" above ground and resting level on a 'none'vibration' surface.

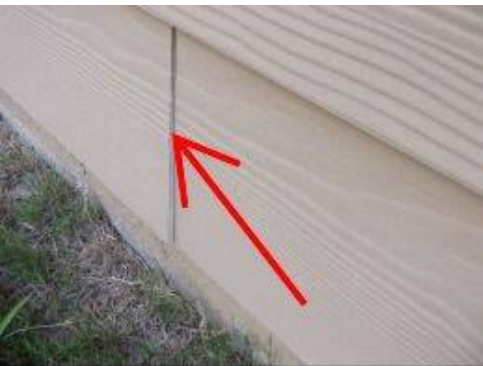
Photo 6-3

One or more holes or gaps were found in siding or trim. Vermin, insects or water may enter the structure. Recommend that a qualified person repair as necessary. Several siding butt joints were not properly fastened at the joints. These missing fasteners have caused the ends of the butt joints to pull away from the substrate.

Seal all siding butt joints and replace fasteners where needed.
