Georgia Conference of Home Inspectors

Pre-Closing Property Inspection Report

Client(s): **Mr. Jesse Shepherd**
Property address: **4070 Dinmont Chase**
Atlanta, Georgia 30349
Inspection date: **Tuesday, August 25, 2015**

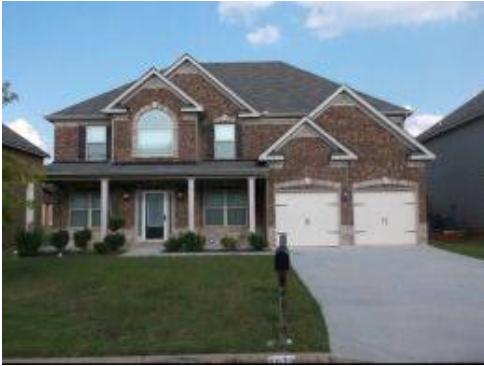
Photo X-1
Front entrance view from Dinmont Chase.

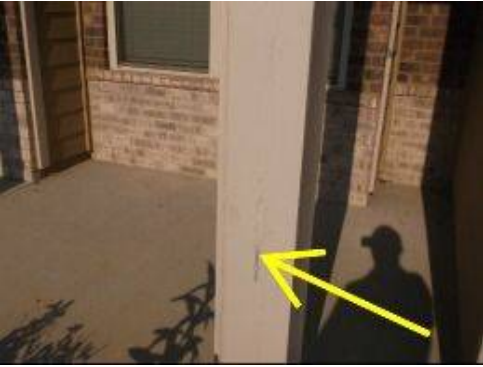
Photo X-11
Front porch support columns need re-painting with prime plus 2 coats of premium quality paint. Wood members are exposed to the weather. Re-paint where necessary.

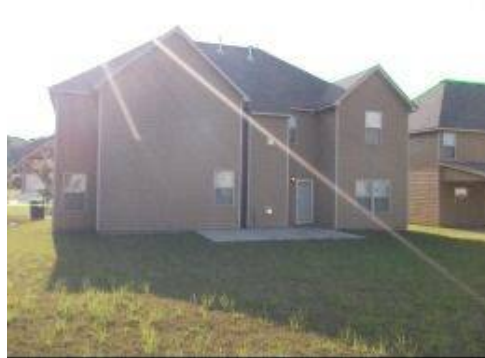
Photo X-42
Rear view of 4070 Dinmont Chase.

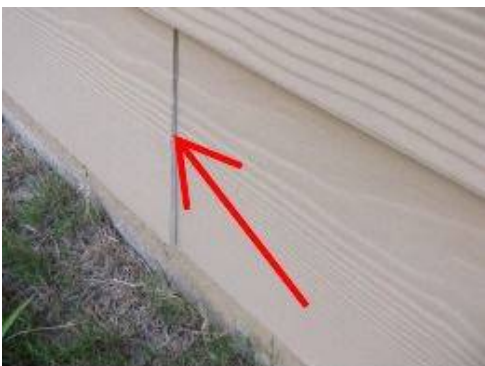
Photo 6-3

One or more holes or gaps were found in siding or trim. Vermin, insects or water may enter the structure. Recommend that a qualified person repair as necessary. Several siding butt joints were not properly fastened at the joints. These missing fasteners have caused the ends of the butt joints to pull away from the substrate.

Some siding members are pulling away from the sub-strate, due to missing fasteners. Replace and/or properly install fasteners at siding butt joints where needed.
