Georgia Conference of Home Inspectors

Summary

Client(s): **Ms. Greta Brotherton**
Property address: **24` Alexander Top Place**
Grayson, Georgia 30017
Inspection date: **Tuesday, December 08, 2015**

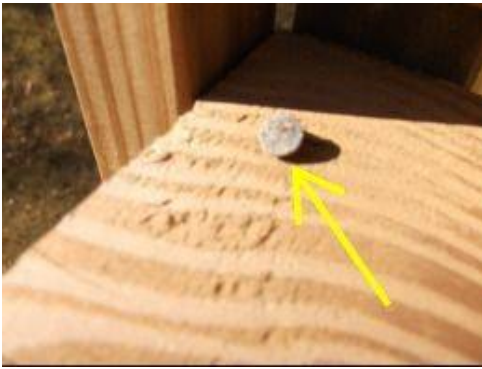
Photo 7-3

Nail heads are over-driven and have sunk into the deck top rail. Water can settle into the holes exposing the wood member to moisture. Recommend filling the over-sunk nails with epoxy or some other weather-resistant caulk or sealant.

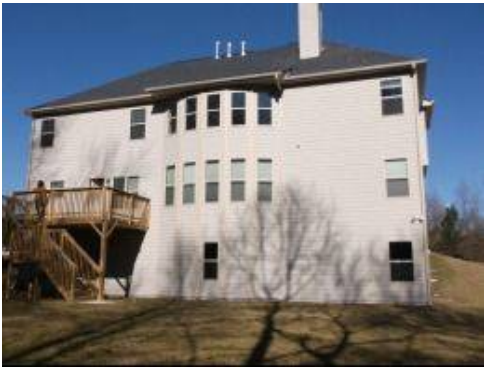
Photo 10-1
Rear view of 2411 Alexander Top Place.

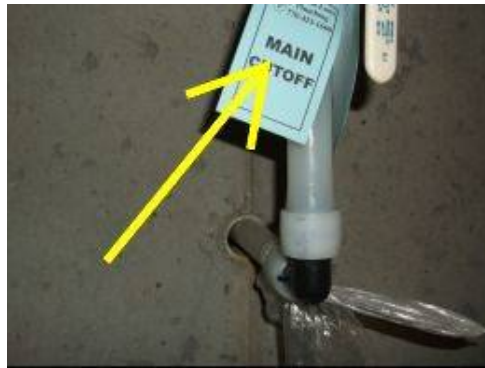
Photo 18-8
 Main water shut-off located in basement. This valve shuts off water to plumbing fixtures in the entire house, should it become necessary to interrupt service in an emergency.
