Georgia Conference of Home Inspectors

Summary

Client(s): **Ms. Greta Brotherton**
Property address: **24` Alexander Top Place**
Grayson, Georgia 30017
Inspection date: **Tuesday, December 08, 2015**

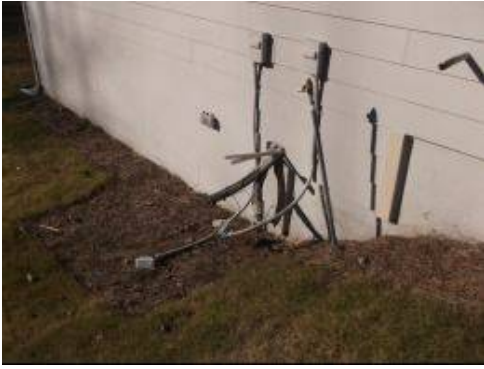
Photo 1-1

- The natural gas service was not turned on during the inspection. The inspector operates only "normal" controls such as thermostats, stove burner knobs, and on/off switches, and does not operate gas shut-off valves or activate pilot lights. As a result, items such as but not limited to the gas supply system, gas-fired water heater(s), gas-fired forced air furnace(s), gas fireplace(s), stove(s), and range(s) weren't fully evaluated. The inspector was unable to test for gas leaks. Recommend that a qualified person make a full evaluation of the gas supply system and gas-fired appliances after the gas supply is turned back on. Any problems that are found after this evaluation should be repaired by a qualified contractor. Furnace has been damaged and removed from service. Home is not equipped with a functional Heating, Ventilation and Air Conditioning System. Installation should include gas lines, supply vents, returns

registers, new thermostat, shut-offs and sediment traps.

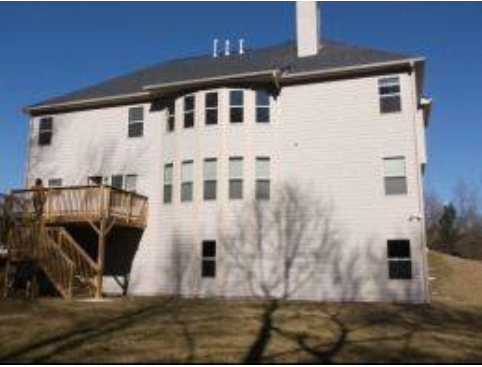
**Photo 10-1**

Rear view of 2411 Alexander Top Place.
