# Samanalawewa Dam Willowstick Survey

## Willowstick rapidly located leak at dam troubled for decades

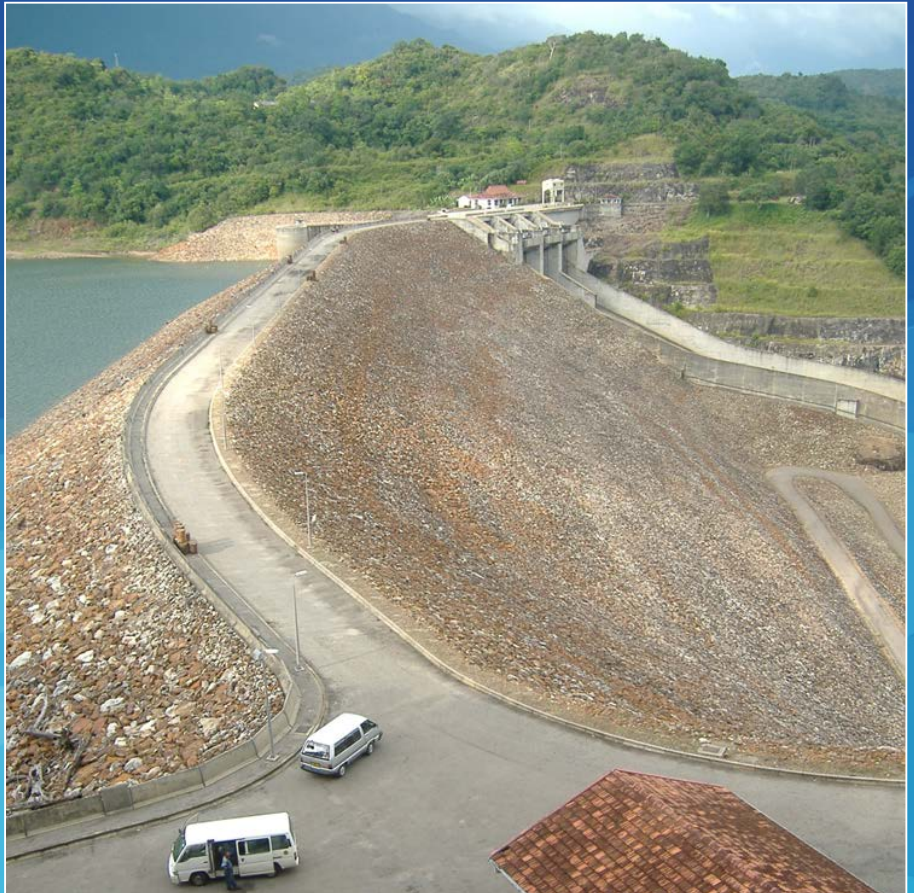
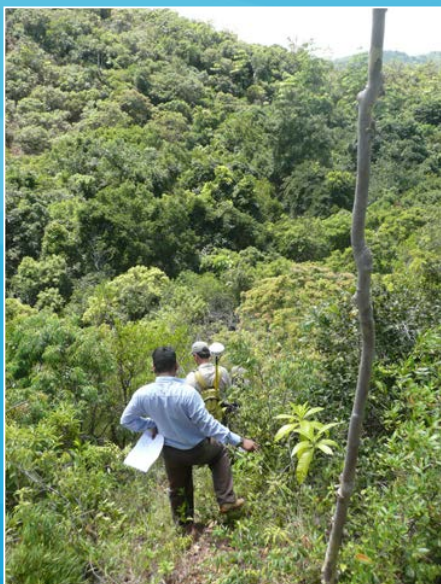
Signs of leakage through karstic terrain at the right abutment led to an extensive grouting program both during and after construction. A grout curtain was constructed from a 2km long tunnel drilled beneath the right abutment.

After first filling water burst out of an area downstream of the right abutment and an attempt to stop the leakage by dumping clay in suspected ingress areas was unsuccessful.
