Kauffman Stadium Assessment

JCSCA + Burns & McDonnell

This document contains information pertaining to the condition of Kauffman Stadium as documented by the Jackson County Sports Complex Authority (JCSCA), including descriptions, conditions, and exhibits which have been reviewed by Burns & McDonnell and documented in this report.

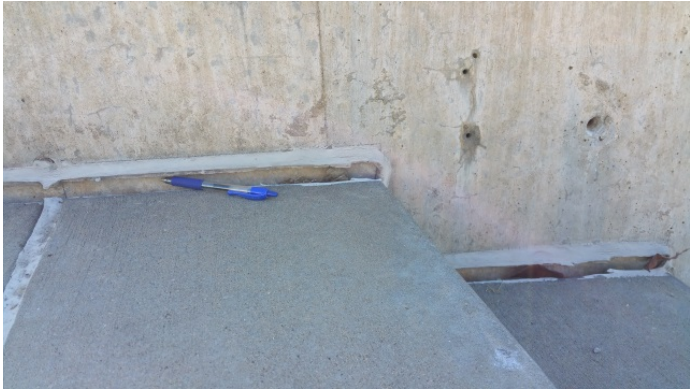
Figure C-4: Interface of Stairs and Retaining Wall at Stairs Outside Gate E

Joint distress is another common deficiency in concrete pavement that was observed in the pavement at Kauffman. At several locations, joint failure was observed both at the face of structures and within walkway pavement. At some of these joints missing sealant or differential settlement was observed, as shown in Figures 4 and 5. In locations where the paved surface or stairs settle at a different rate the adjacent structure, sealant has pulled away from the joint rendering it ineffective.

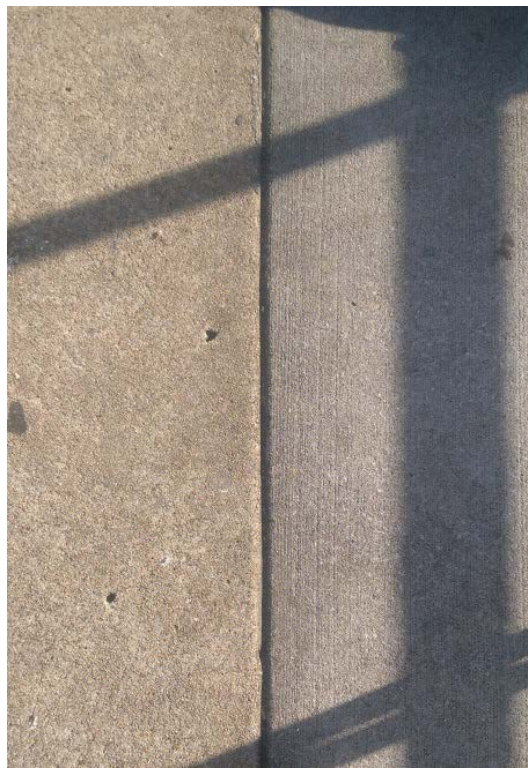
Figure S-1: Slab-On-Grade Control Joint

No significant settlement of the structure was observed. The slab-on-grade is primarily in satisfactory condition. No major cracks or spalling of the concrete were observed. Control joints and expansion joints are in satisfactory condition, as shown in Figure S-1.

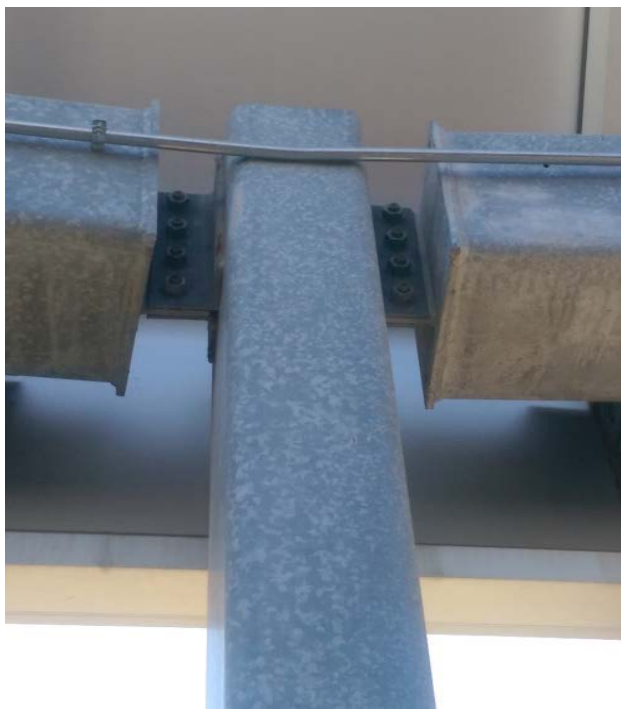
Figure S-3: HSS Beams, Column and Connections

The reinforced concrete walls of the renovation stage are in satisfactory condition. No major cracks or spalling was observed. The vertical wall surface is flat and smooth. The steel wide flange and HSS beams and columns as well as the connections of the renovation stage are in satisfactory condition. No corrosion or significant deflection was observed as shown in Figure S-3. Pulling out of concrete anchors of steel beam connections were observed at a few locations, as shown in Figure S-4. This image was captured outside of the broadcast booths at the Press Level.

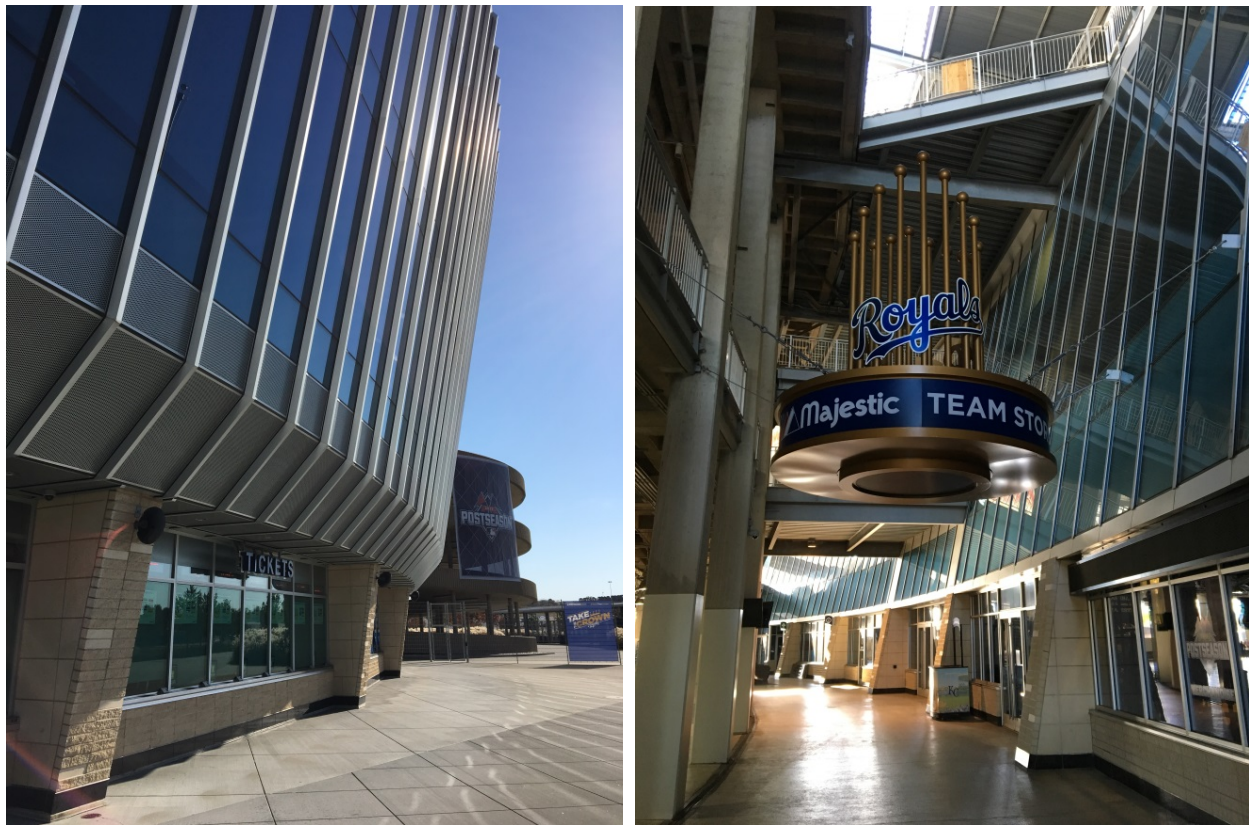
Figure AF-2: External (left) and Internal (right) Storefront, Curtainwall, and Stone Veneer

All facades, in general, appear to be in satisfactory condition. Glass storefronts and curtainwall systems appear to be in satisfactory condition, as shown in Figures AF-2 and AF-3. Aluminum frame and mullions were observed to be free of staining, fading, or degradation of any kind. Seals and flashing around storefront appear to be in satisfactory condition.

Stone cladding systems appear to be in satisfactory condition, as shown in Figure AF-2. No chipping or staining of the stone or grout was observed.

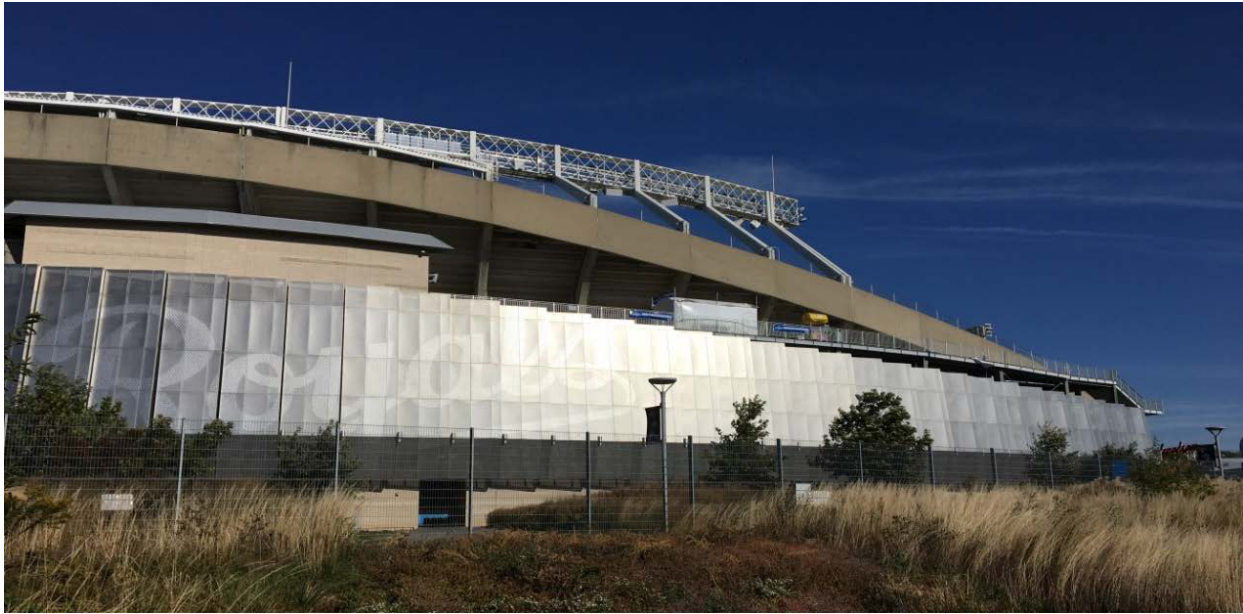
Figure AF-3: External Perforated Metal Panel System

Perforated metal panels and graphic mesh systems appear to be in satisfactory condition, as shown in Figures AF-3 and AF-4. No oil canning, staining, or degradation of any kind was observed. The galvanized sub-structure for the perforated metal panel system appears to be free of corrosion or rust, as shown in Figure AF-5.

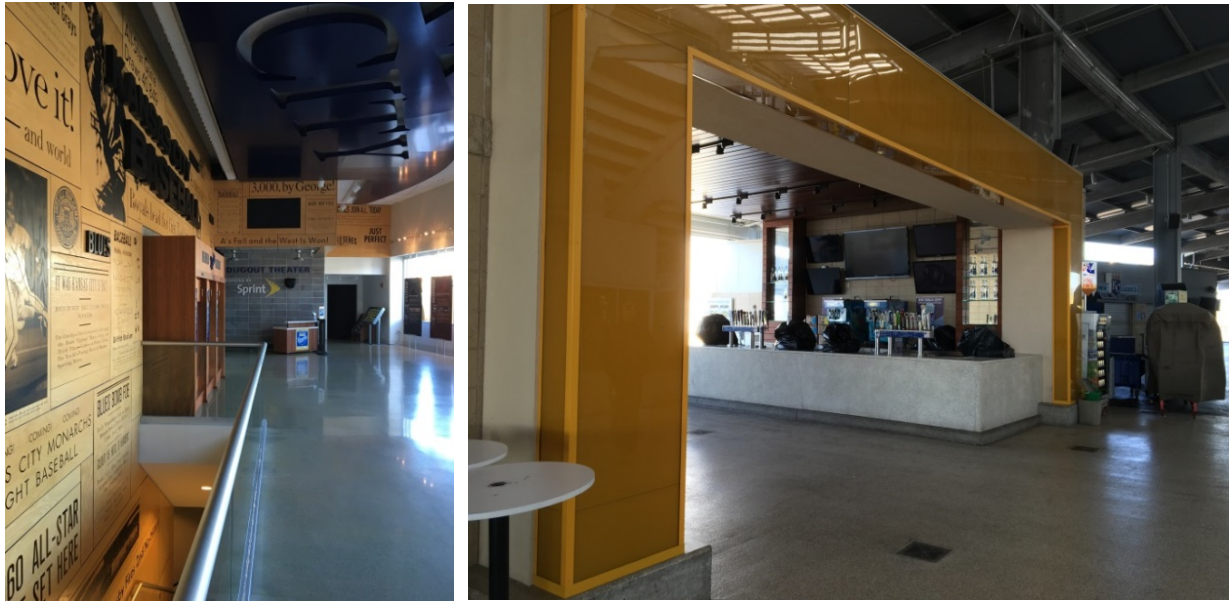
Figure AI-1: Sealed Concrete Flooring (left) and Epoxy Topping (right)

Interior finishes within Kauffman Stadium encompass a broad range of materials for floors, walls, and ceilings. The primary flooring systems are composed of epoxy and sealed concrete, as shown in Figures AI-1. These surfaces were observed to be in satisfactory condition, typically. Minor cracking was observed at various locations throughout the facility, which is considered normal given the expansion and contraction properties of the materials. No excessive cracking was observed during the walk-through.

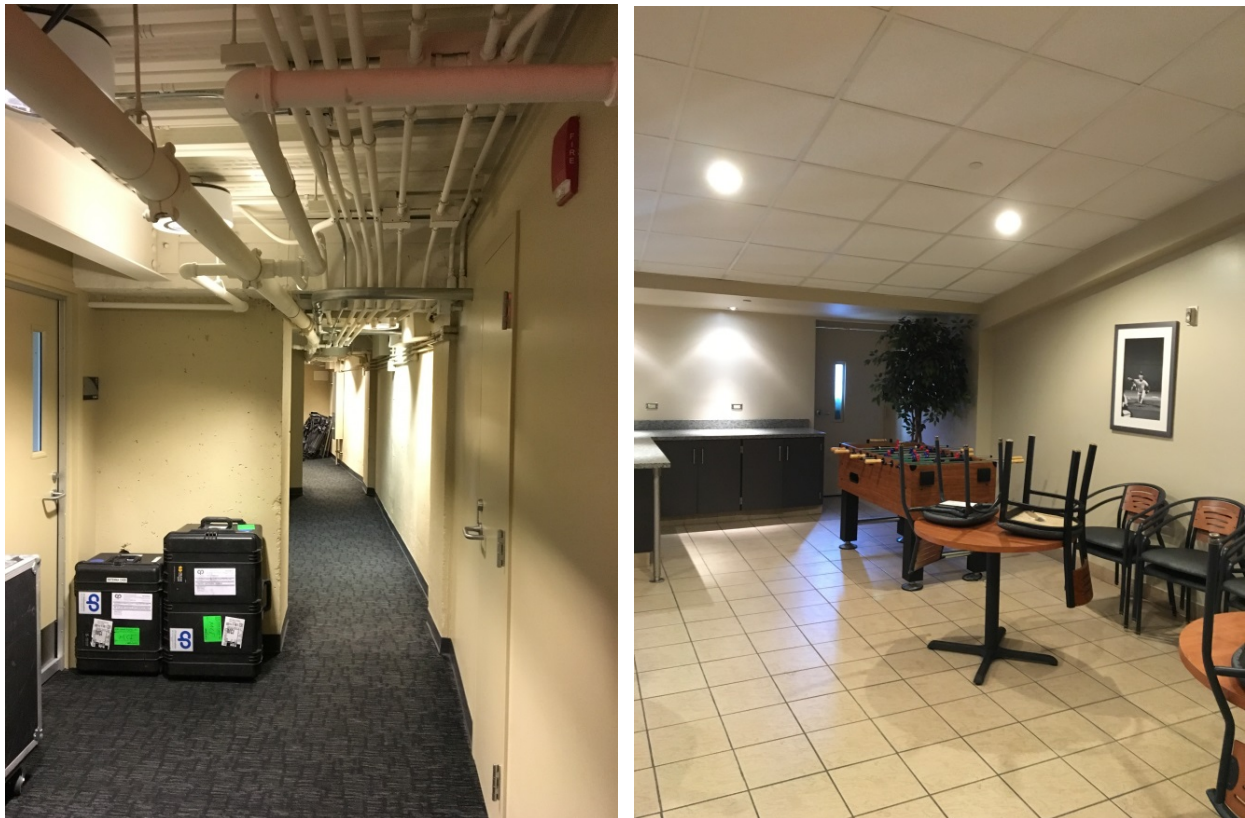
Figure AI-2: Carpet Flooring (left) and Ceramic Tile Flooring (right)

Carpet flooring was generally observed to be in satisfactory condition. No signs of rips, tears, stains, or discoloration were observed, as shown in Figure AI-2 (left image). Porcelain/Ceramic tile flooring areas appear to be in satisfactory condition, as shown in Figure AI-2 (right image). No signs of grout discoloration or cracking were observed.

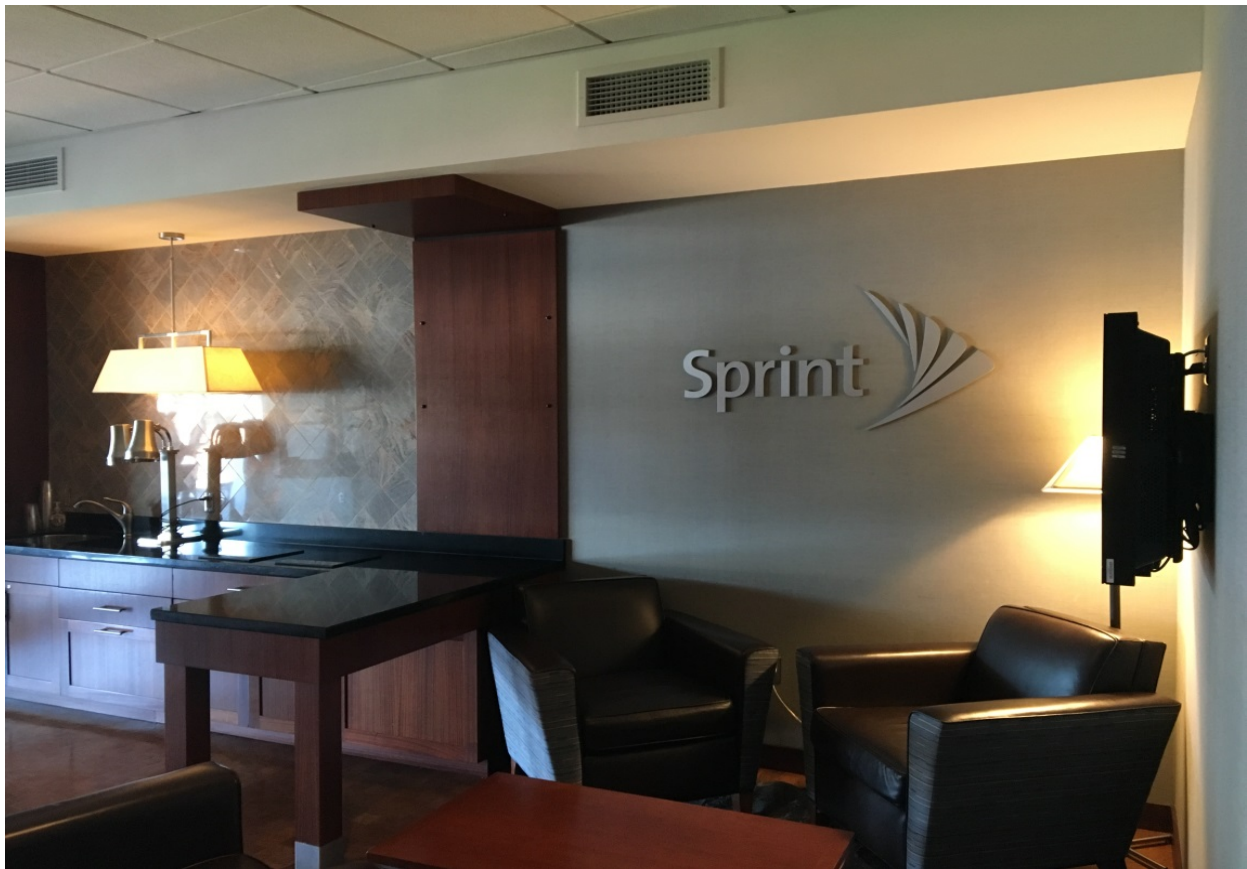
Figure AI-3: Ceramic Tile and Gypsum Board Walls

In general, interior wall surfaces were observed to be in satisfactory condition. Painted gypsum board walls appear to be in satisfactory condition, as shown in Figure AI-3. No punctures, holes, or scratches were observed.

Ceramic tile walls appear to be in satisfactory condition, as shown in Figure AI-3. No visible chipping, flaking, or cracking of the tile or grout was observed.

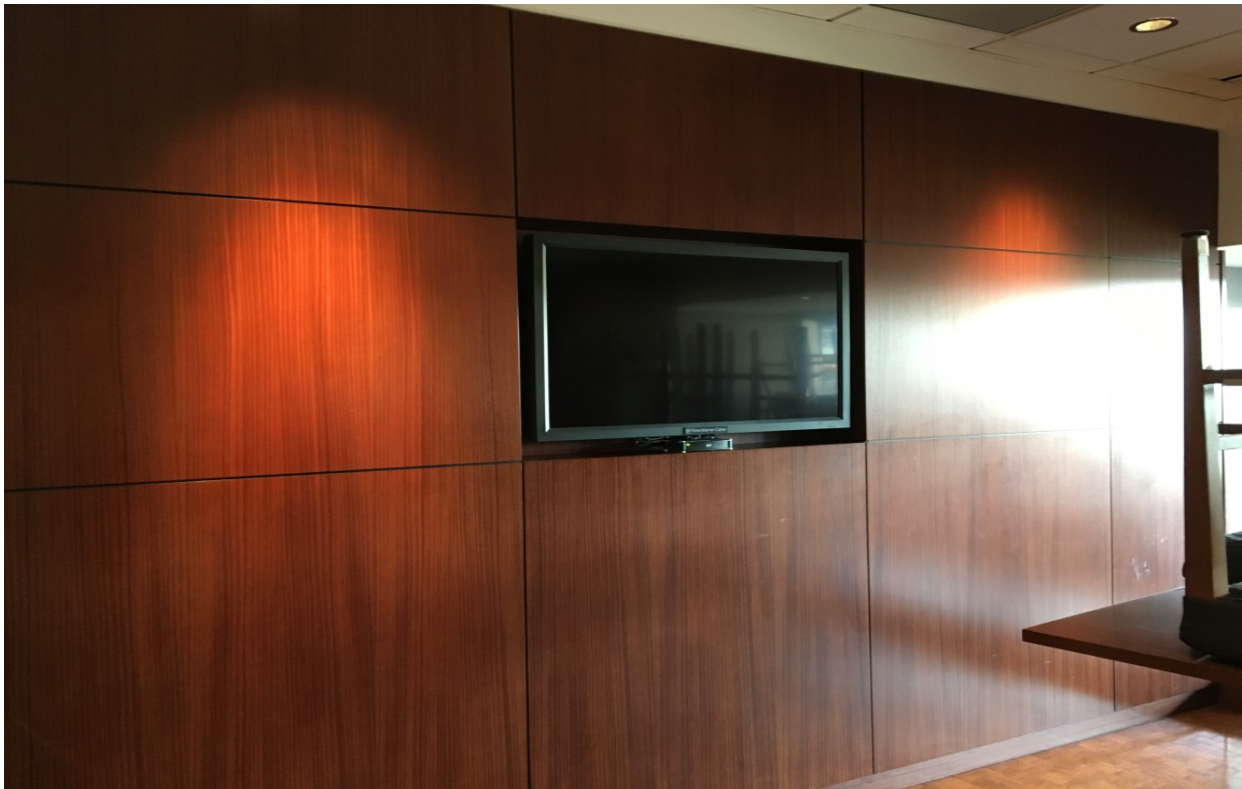
Figure AI-4: Wood Veneer Panel Wall

Wood paneling, typically, is in satisfactory condition. As shown in Figure AI-4, no signs of scratching, fading, or deterioration of any kind were observed.

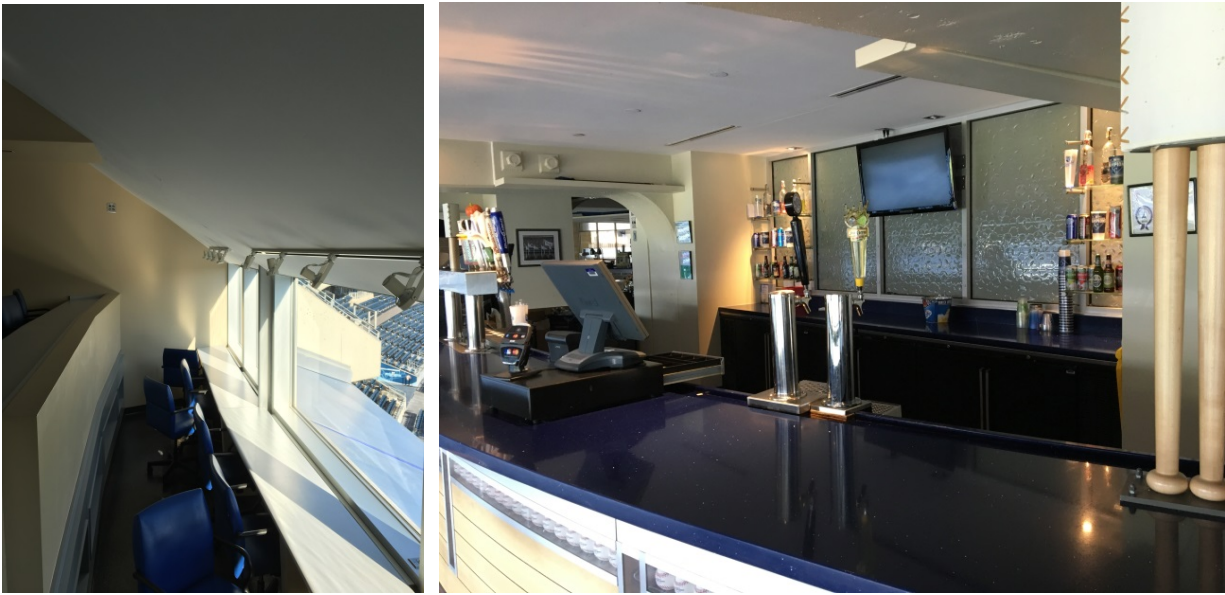
Figure AI-6: Gypsum Board Ceilings at Diamond Club and Writing Press Areas

Gypsum board ceilings appear to be in satisfactory condition, typically. No punctures, stains, scrapes, or tears were observed. Refer to Figure AI-6 for typical conditions.

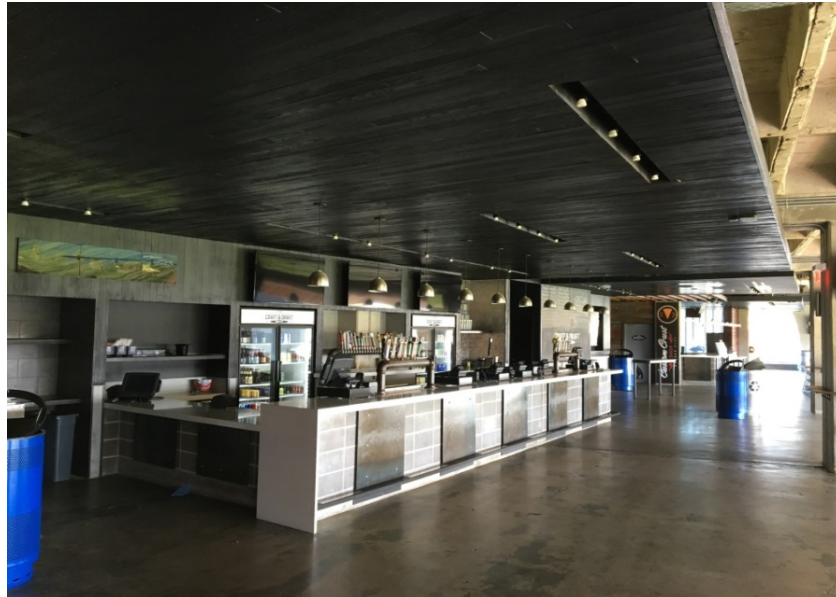
Figure AI-8: Wood Plank Ceiling at Craft & Draft Area

Wood ceiling panels, where present, were observed to be in satisfactory condition. Surface conditions appear to be new and are free of scuffs, scratches, or deterioration as shown in Figure AI-8 and AI-9.

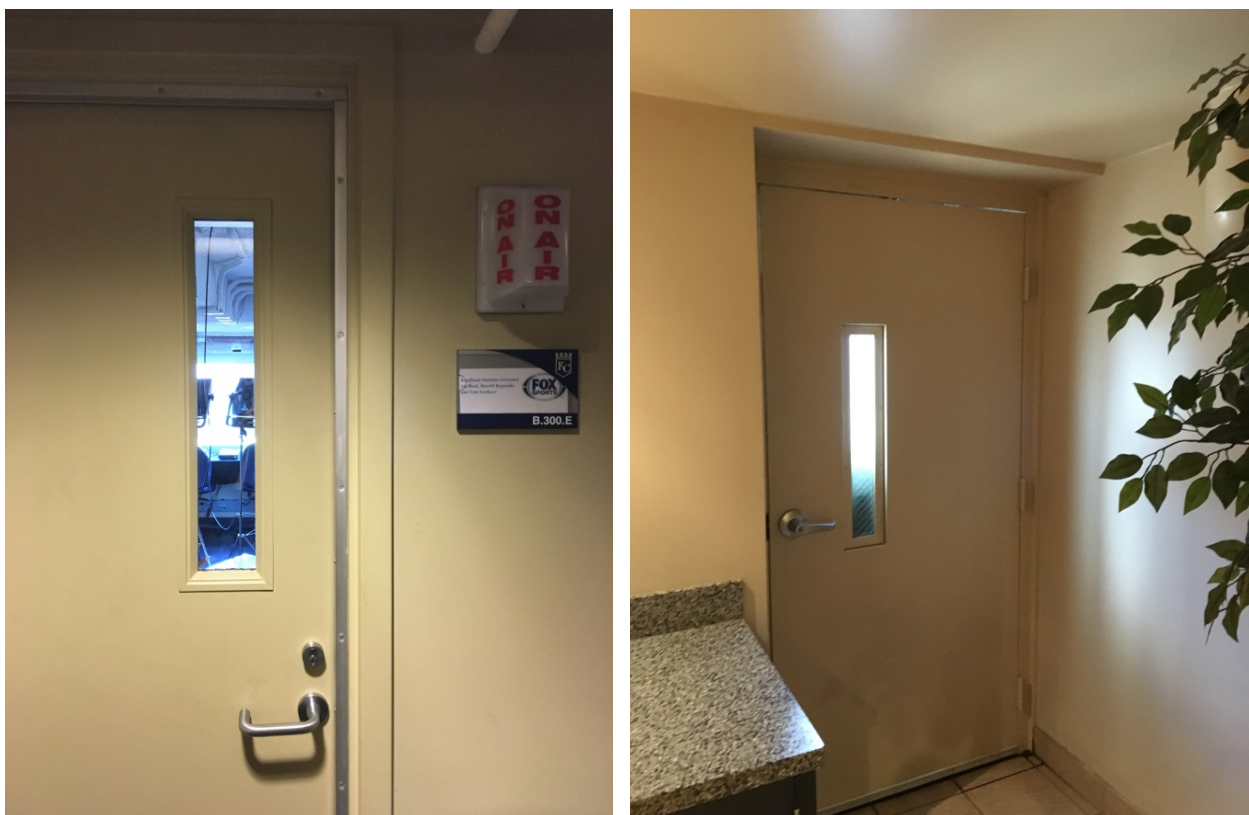
Figure AI-10: Typical Hollow Metal Door Conditions

Generally, painted hollow metal doors were observed to be in satisfactory condition, as shown in Figure AI-10. Doors observed were free of scratches and rust, paint appeared to be in satisfactory condition.

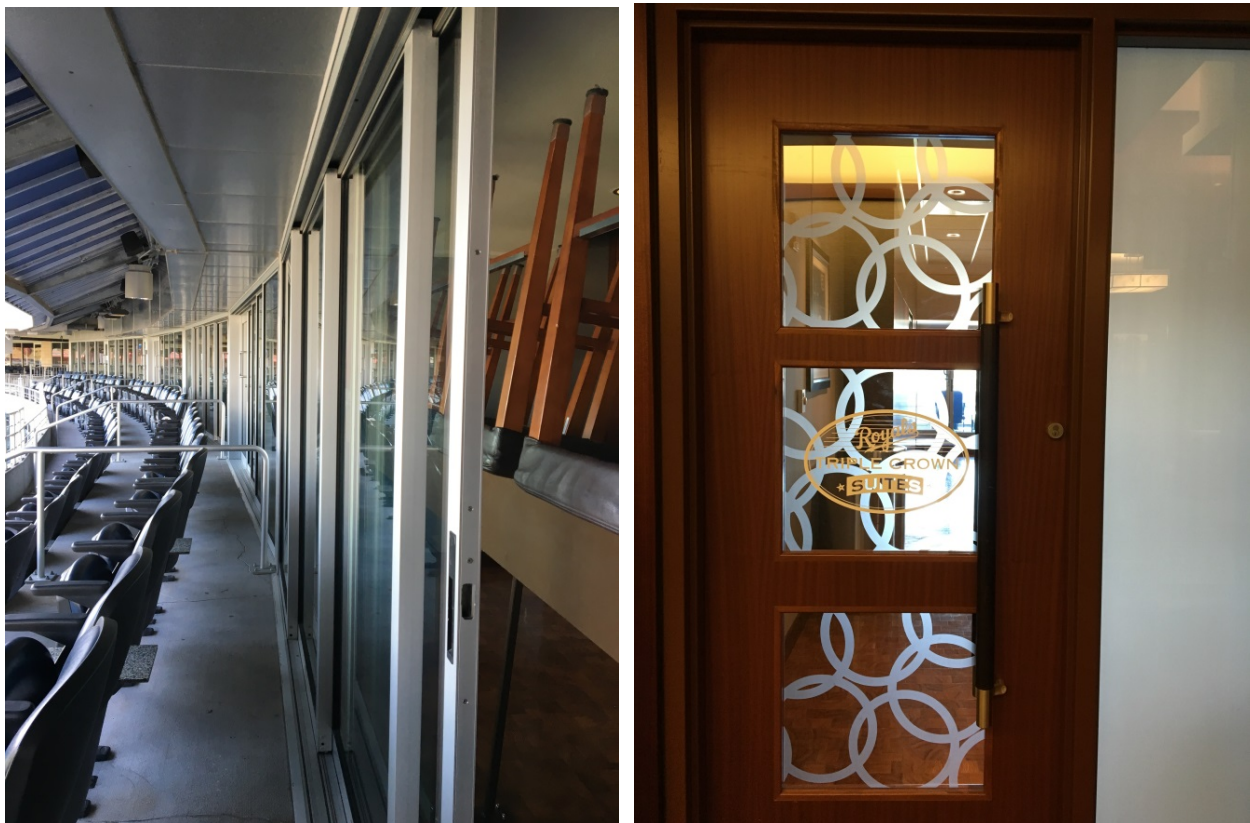
Figure AI-11: Typical Sliding Glass Wall System (left) and Wood Framed Glass Door (right)

Sliding glass wall systems at the Triple Crown Suites were observed to be in satisfactory condition, as shown in Figure AI-11 (left image). No signs of scratches were noticeable on the frames, glass appeared to be free of cracks or chips, and operable tracks were free of dirt and grime that would prevent the door from sliding.

Wood framed glass doors were typically observed to be in satisfactory condition, as shown in Figure AI-11 (right image). These doors were generally found to be free of scratches to the surface and no defects were observed.

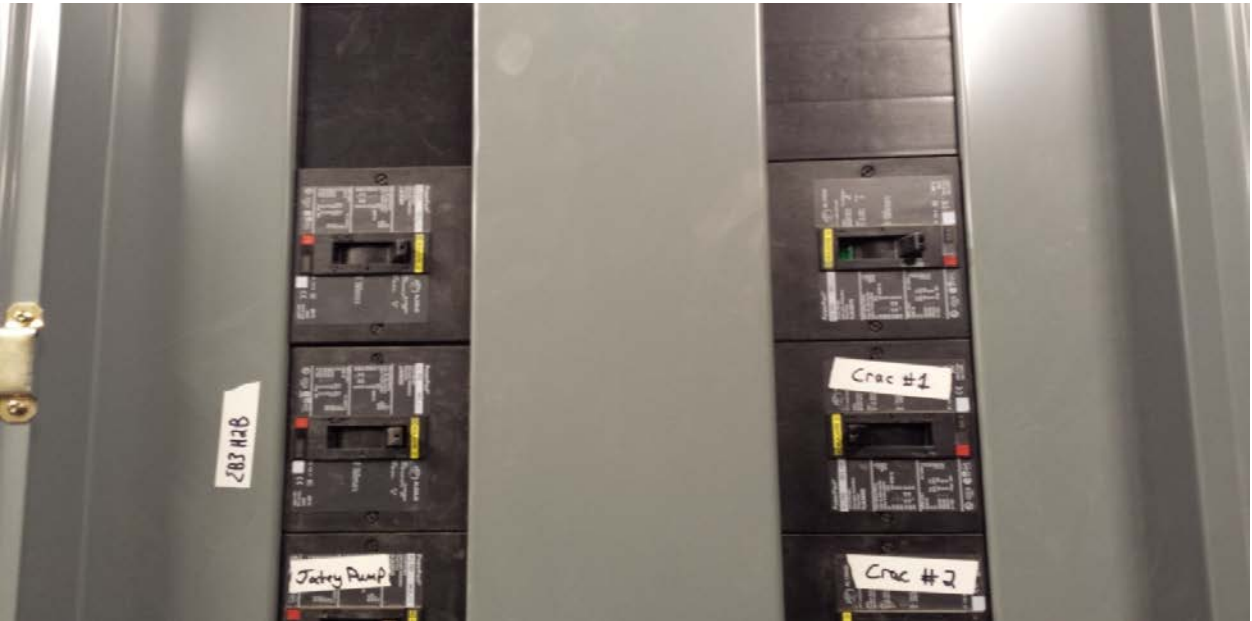
Figure E-3: Distribution Board EB3H2B

All breakers in distribution board EB3H2B are not labeled. See Figure E-3, as shown below.

Directory for EB3H2B shall match and be labeled to match installation in board. See Figure E-4, as shown below.
