FINAL REPORT ~ FHWA-OK-17-03

OVERTURNING FORCES AT BRIDGE ABUTMENTS AND THE INTERACTION OF HORIZONTAL FORCES FROM ADJACENT ROADWAYS

January 2018

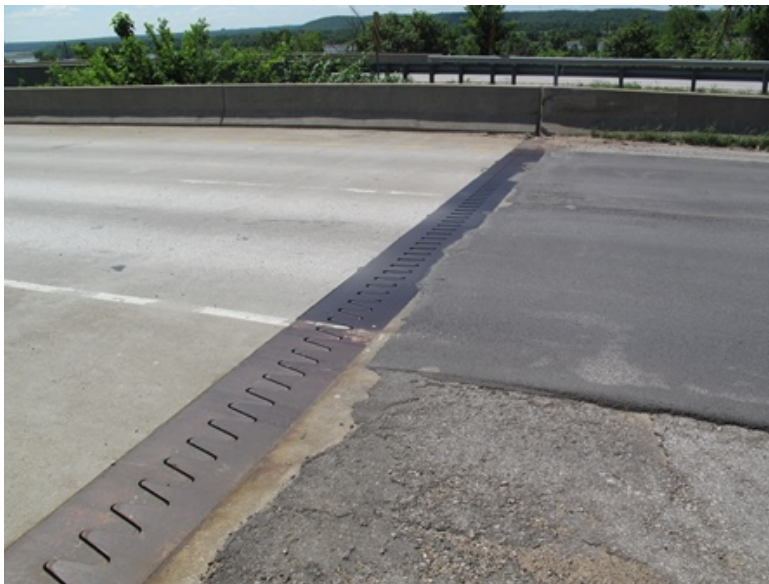
The US 64 Westbound over Shell Creek (NBI No. 18141) is located in Tulsa County, Oklahoma. This bridge is experiencing number of problems related to the interactions between bridge abutments and adjacent roadways. These problems include, expansion joints closing (Figure 13), roller support bearings tilting (Figure 14), and beams pushing against abutment backwalls (Figures 14 and 15).

Figure 13. A closed expansion joint on the Shell Creek Bridge

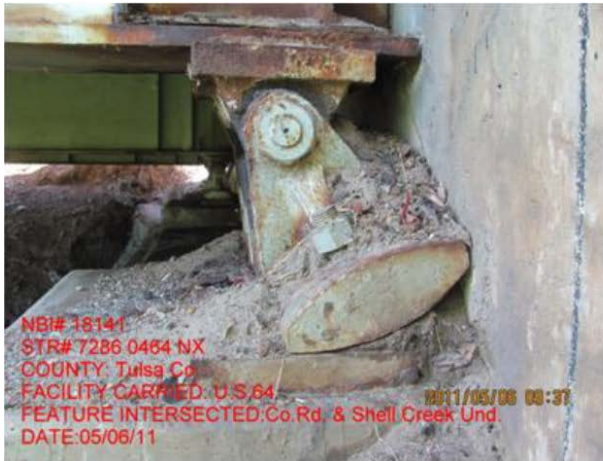
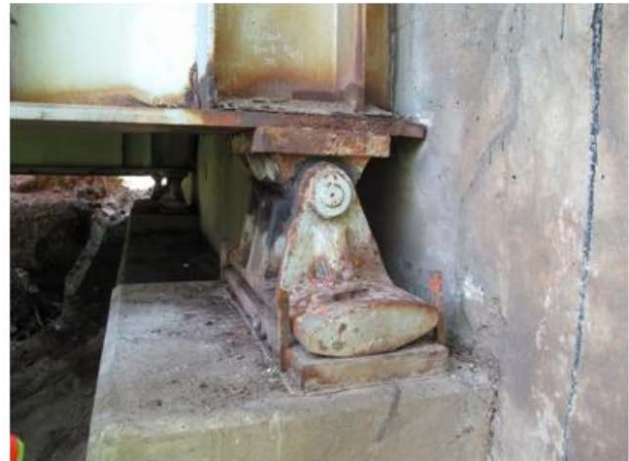
Figure 14. Northern most rocker bearing (before and after straightening) and girder on the west abutment of the Shell Creek Bridge

The Shell Creek Bridge is experiencing number of problems related to the interactions between bridge abutments and adjacent roadways, including expansion joints closing, roller support bearings tilting, and beams pushing against abutment backwalls. It is likely that these problems are related to both pavement pressure and lateral displacements of the approach embankments. The tilting of the bearings (Figure 14) indicate that the major contributing factor for the distresses observed is the pavement pressure.

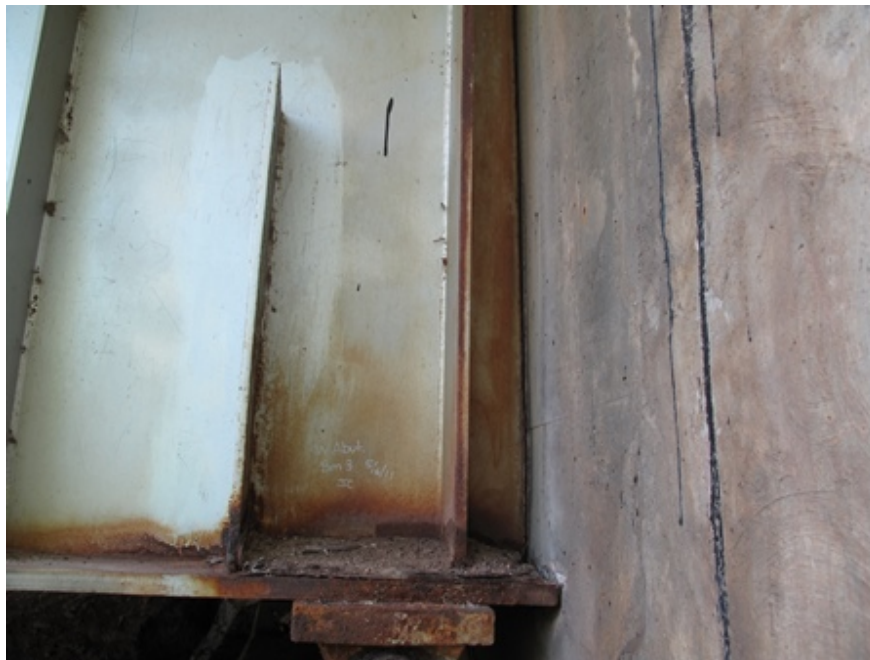
Figure 15. A beam pushing against an abutment backwall on the Shell Creek Bridge

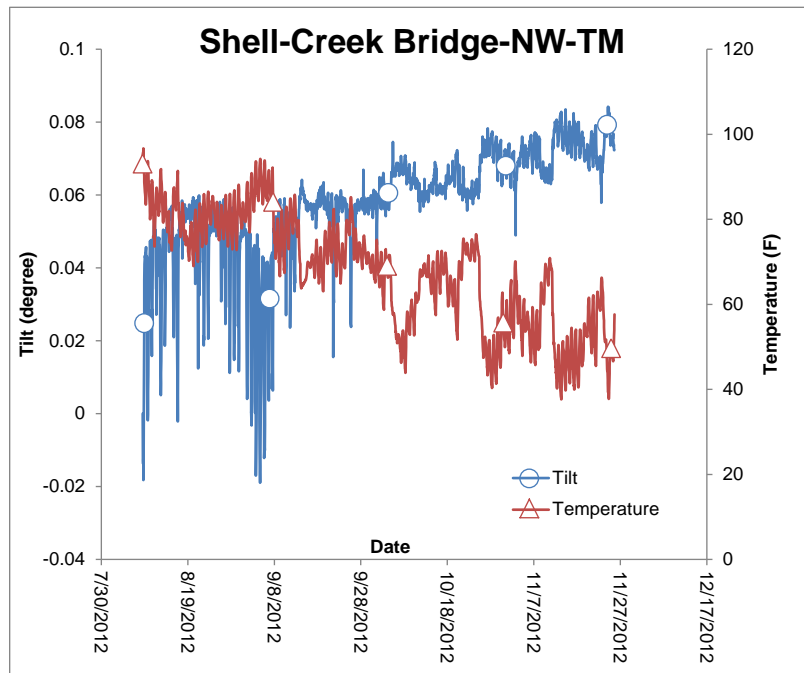
Figure 17 depicts SW-TM tiltmeter data on the south side of the abutment backwall. The spikes seen in the tiltmeter data are caused by vehicle vibrations. It can be seen that the trend in the tiltmeter data corresponds inversely with temperature trends. As the average temperature decreases from July through October, the tilt increases. Similar trend can also be seen in for the tiltmeter on the north side (Figure 18). These data indicates that as the deck cools the abutment backwall is rotating towards deck.

Figure 18. US 64 over Shell Creek Bridge – Northwest Tiltmeter data (NW_TM)

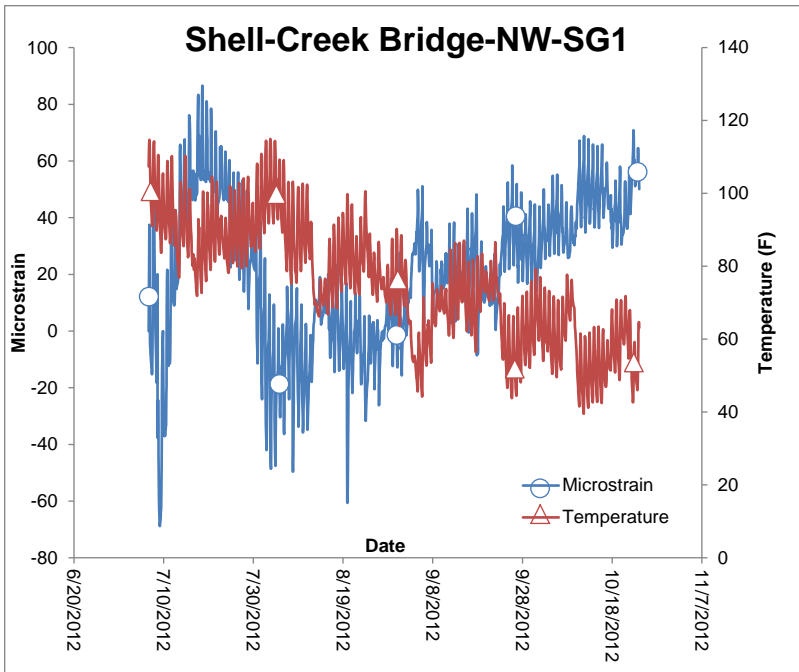
Strain gages were installed with a thermistor at different locations as shown in Figure 16. Figure 21 and Figure 22 show strain trends for strain gage NW-SG1 (located on the approach slab) and NW-SG3 (located under the bridge deck), respectively. It can be seen from these figures that as the temperature decreases the strains in the approach slab increases and the strain in the deck decreases and vice versa. These trends indicate that the deck and the approach slab are locked into each other near the expansion joint and as the deck shrinks during cooling, the approach slab is expanding into the gap created by the shrinking deck. This also indicates that there will be compressive stresses transmitted between the deck and the approach slab during heating.

Figure 21. US 64 over Shell Creek Bridge – Northwest Strain Gage 1 (NW_SG1)

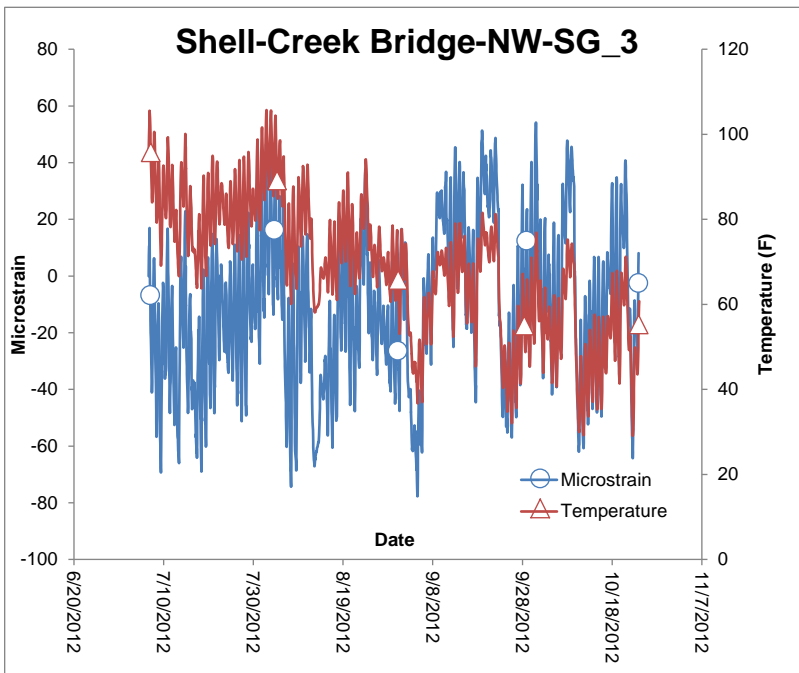
Figure 22. US 64 over Shell Creek Bridge -Northwest Strain Gage 3 (NW_SG3)

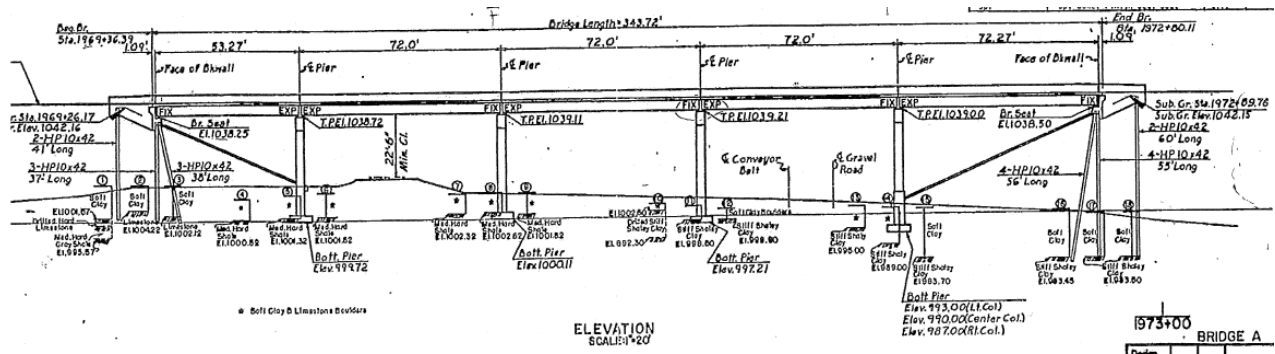
backwalls (Figures 36 and 37). These problems were noticed as early as in 1983. It is believed these problems were related to the lateral deformation of the embankments on top of the soft clay layer (see Figure 35) early in the life of the bridges. Rotation of the top of the anchor bolts towards the abutment backwall (Figure 36) and buckling/cracking of the slope wall (Figure 37) are strong evidence for lateral deformations of the approach embankments.

Figure 35. Elevation of the SH-3 north bridge over BNSF railroad

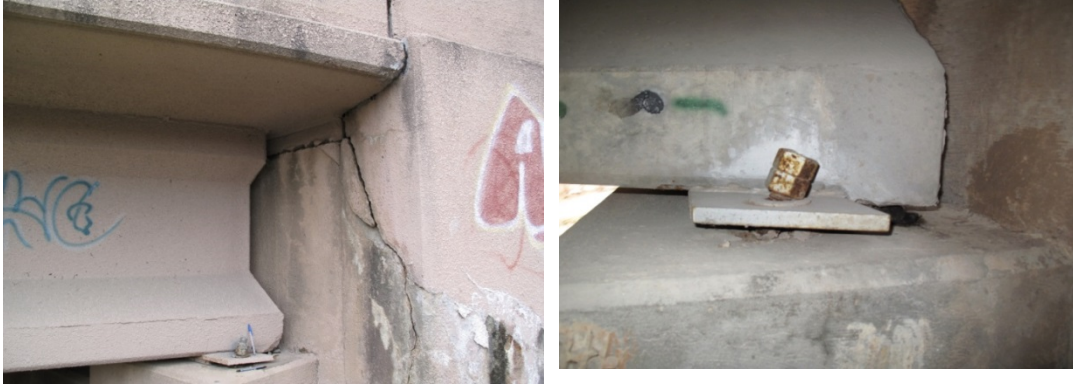
The SH-3 bridges over BNSF railroad are located near Ada, Oklahoma. These five span bridges are 344 ft long and were built in 1980 (Figure 34). The elevation of the SH-3 North Bridge is shown in Figure 35. These bridges have experienced a number of problems related to the interactions between bridge abutments and adjacent roadways. These problems included expansion joints closing, roller support bearings tilting, and beams pushing against abutment

Figure 36. Beams pushing against abutment backwalls and a bent anchor bolt

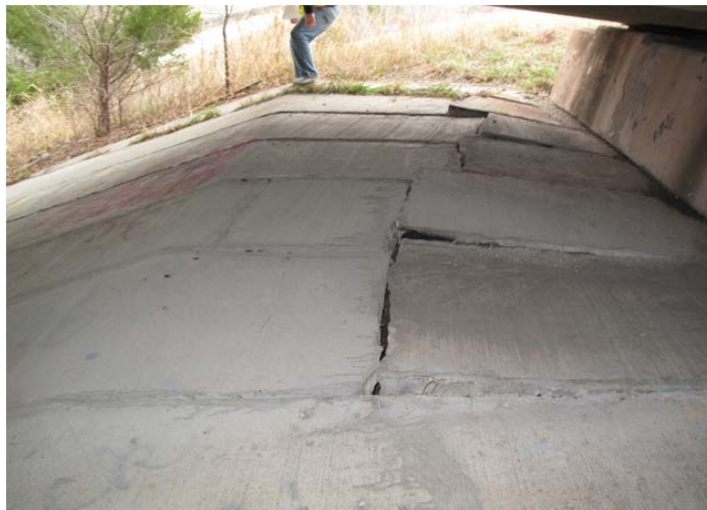
Figure 37. Cracks in the slope-wall

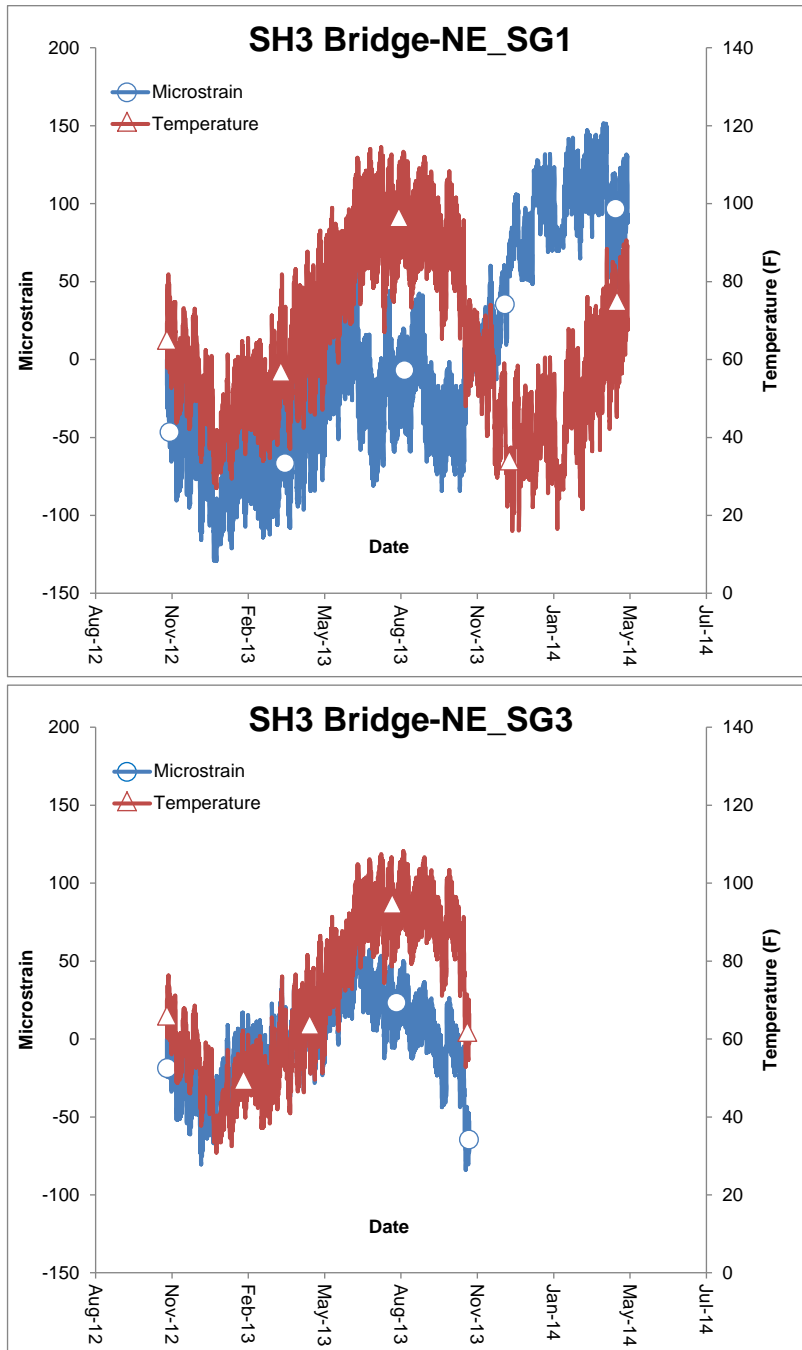
By looking at the seasonal trend for NE_SG1 and NE_SG3, it can be seen that, in general, when the temperature increases there is also an increase in axial strain and when the temperature decreases, the strain decreases. The opposite is true for NE_SG2 and NE_SG4; increasing temperatures cause a decrease in axial strains and vice versa.

These observed trends seem to indicate that while the approach slab is behaving as expected, that is, expanding as the temperature increases (likely away from the bridge) and contracting as the temperature decreases, the deck near the abutment is behaving in the opposite manner. As the temperature increases, the deck is compressing near the abutment due to the closed expansion joints and vice versa as shown in Figure 49.

Figure 47. Eastern side of SH-3 north bridge over BNSF railroad – NE_SG1 and NE_SG3 strain gage data before repairs

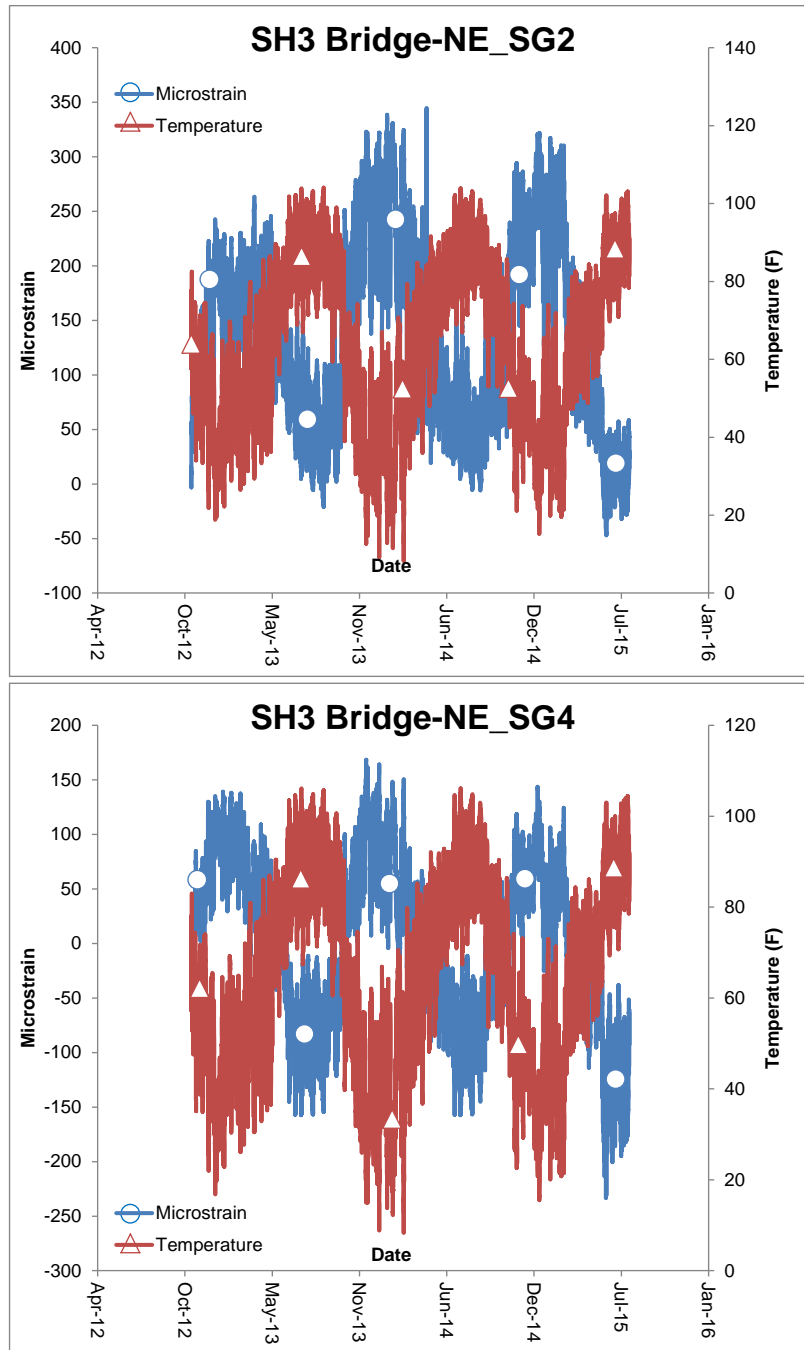
Figure 48. Eastern side of SH-3 north bridge over BNSF railroad – NE_SG2 and NE_SG4 strain gage data before repairs

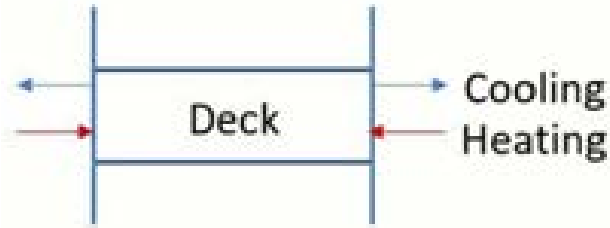
Figure 49. Stresses in the bridge deck near the abutments during heating and cooling due to closed expansion joints

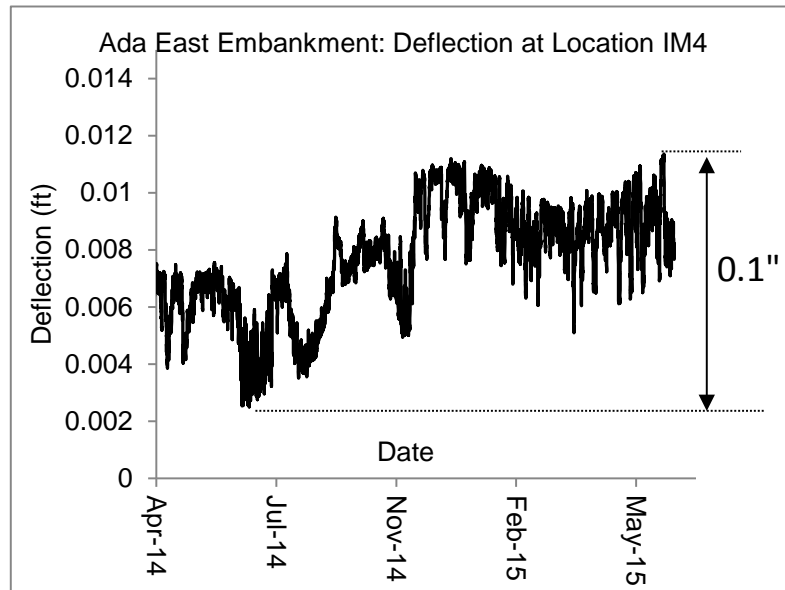
It is also believed that the lateral movements of the approach embankments on top of the underlying soft clay layer soon after the construction of the bridge caused the expansion joints to close. Very small east to west movement in the soft clay layer can still be seen in Figure 54 (note that positive deflection values imply movement from the approach pavement towards the middle of the bridge or east to west movement).

Figure 54. SH-3 bridges over BNSF railroad – eastern embankment deflection at location IM4

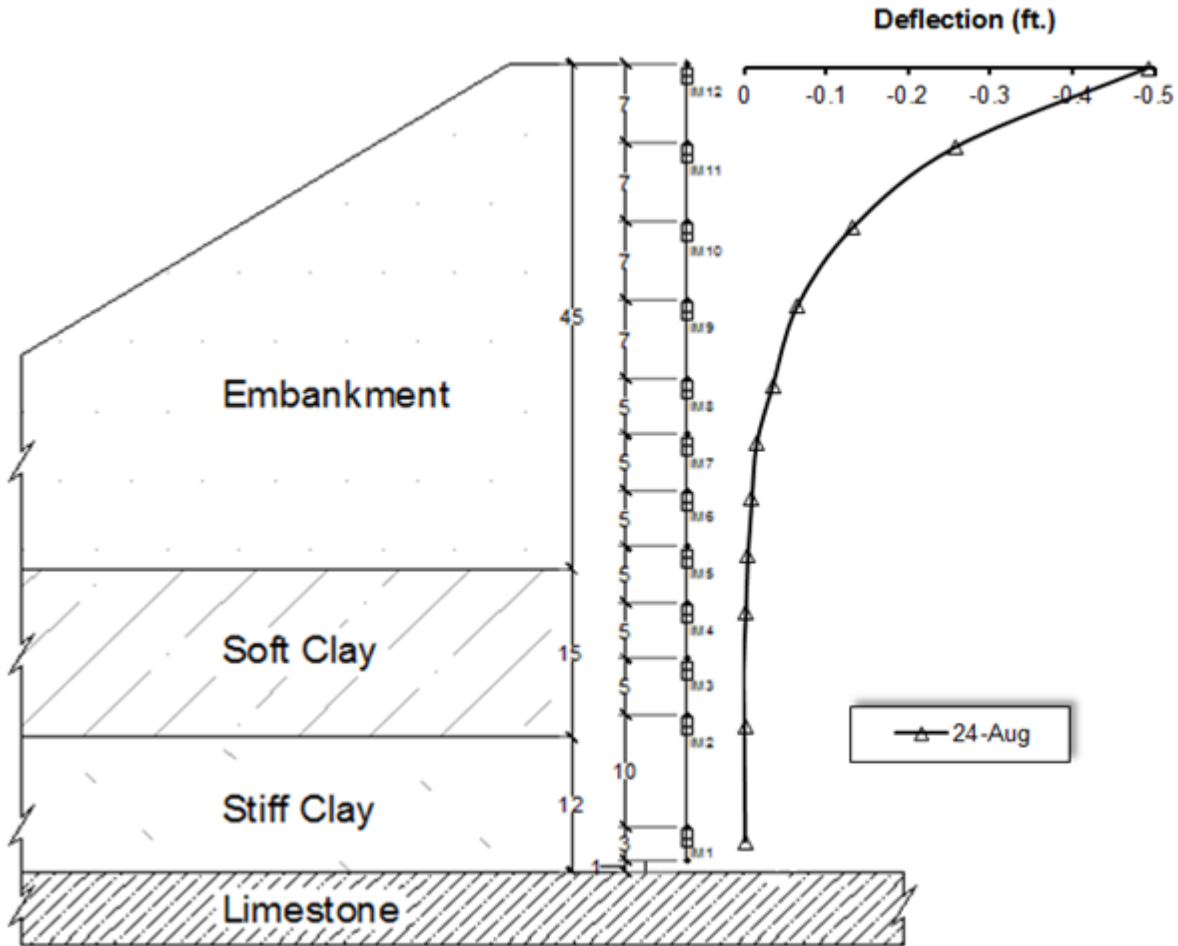
Selected inclinometer data are presented in Figures 53 and 54 (see Figure 39 for the locations). The deflection profile of the embankment on August 24, 2013 is shown in Figure 55. The data from the instruments indicate that the expansion joints are essentially closed and as the bridge heats the deck is pushing against the approach slab which in turn is transmitting these forces into the abutment and the approach embankment. As the bridge cools, the deck, abutment, and the embankment are all relaxing. While the trend in the measured inclinometer data is consistent with the above described behavior, the deflection magnitudes need further analyses and verification.

Figure 55. SH-3 bridges over BNSF railroad – eastern embankment deflection profile on August 24, 2013

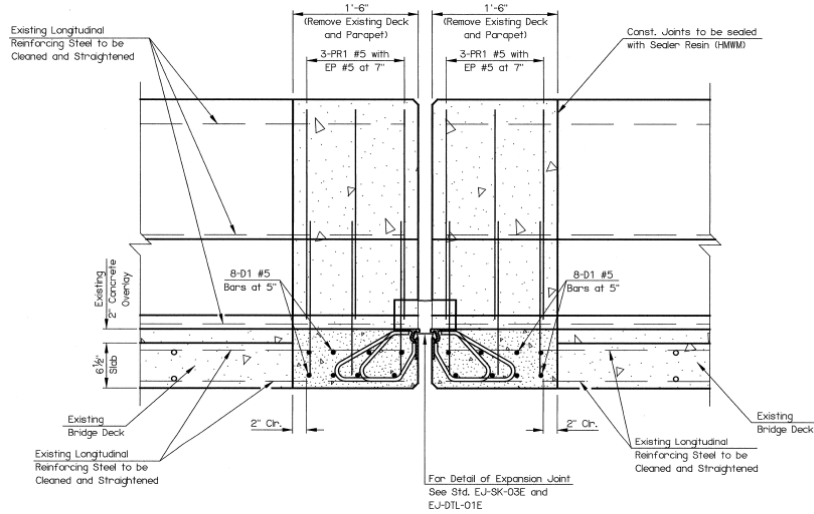
Figure 69. Details of the new sealed expansion joints at Pier No. 1 and Pier No. 4 for SH-3 north bridge over BNSF railroad

The repairs to SH-3 north bridge, as shown in Figure 68, were done from August 2015 to January 2016. Two new sealed expansion joints were constructed at Piers No.1 and No.4. The design details of these expansion joints are given in Figure 69. The existing expansion joints at Piers No. 2 and No. 3 were eliminated and construction joints were created at these locations. The design details of these construction joints are given in Figure 70. The construction joints at the abutments were also rehabilitated. The design details of the rehabilitated construction joints at the abutments are given in Figure 71. In addition, several bearing assemblies and beam pedestals were repaired.

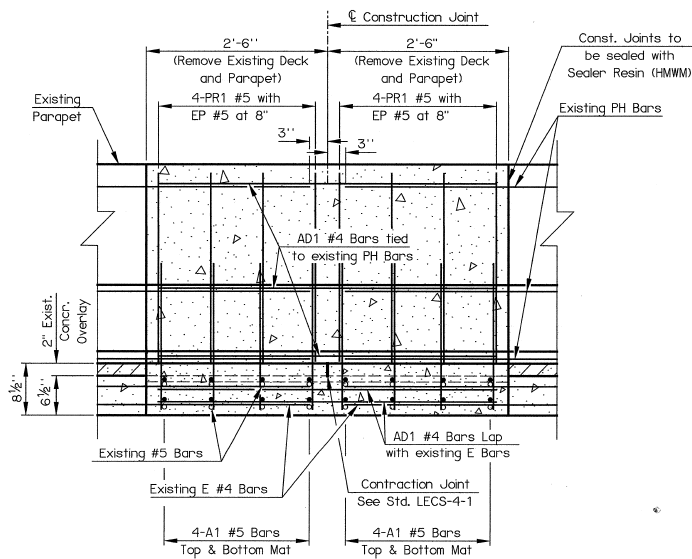
Figure 70. Details of new construction joints at Pier No. 2 and Pier No. 3 for SH-3 north bridge over BNSF railroad

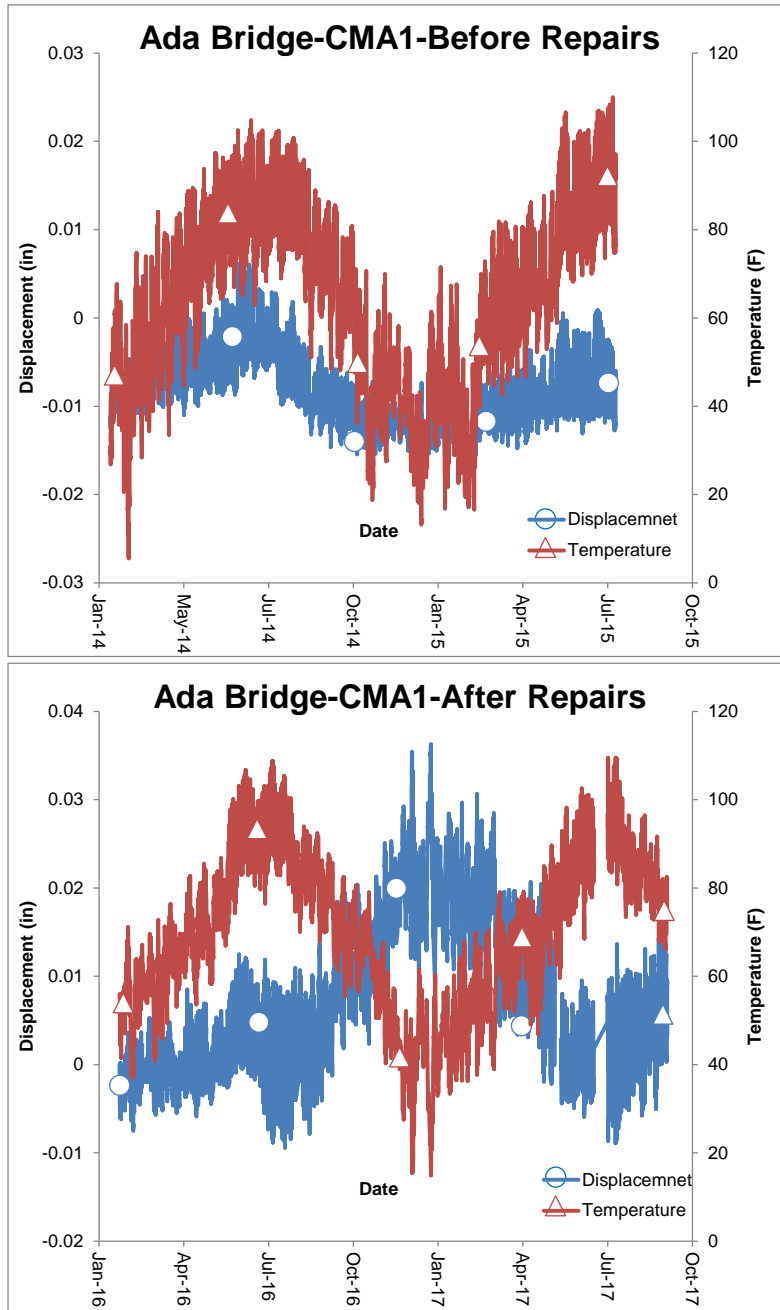
Figures 73 and 74 show the trends in displacements and temperatures for the crackmeters CMA1 and CMA2 (Figure 38). In general, the opposite trends in displacements and temperatures can be observed before and after the repairs for CMA1. When the temperature increases there is a decrease in the relative displacement between the bridge deck and the abutment wing wall and when the temperature decreases, the displacements increase. For CMA2, similar trends in displacements and temperatures can be observed before and after the repairs. Substantially more daily variations in displacements can be seen

after the repairs for CMA1 and CMA2, especially when the cooling trend starts in July/August 2016. This likely means that there is additional room at Pier No. 4 for expansion and contraction of the bridge deck to occur. The results seem to indicate that the new expansion joint at Pier No. 4 is working as intended.

Figure 73. East abutment of SH-3 north bridge over BNSF railroad – comparison of CMA1 crackmeter data before and after repairs

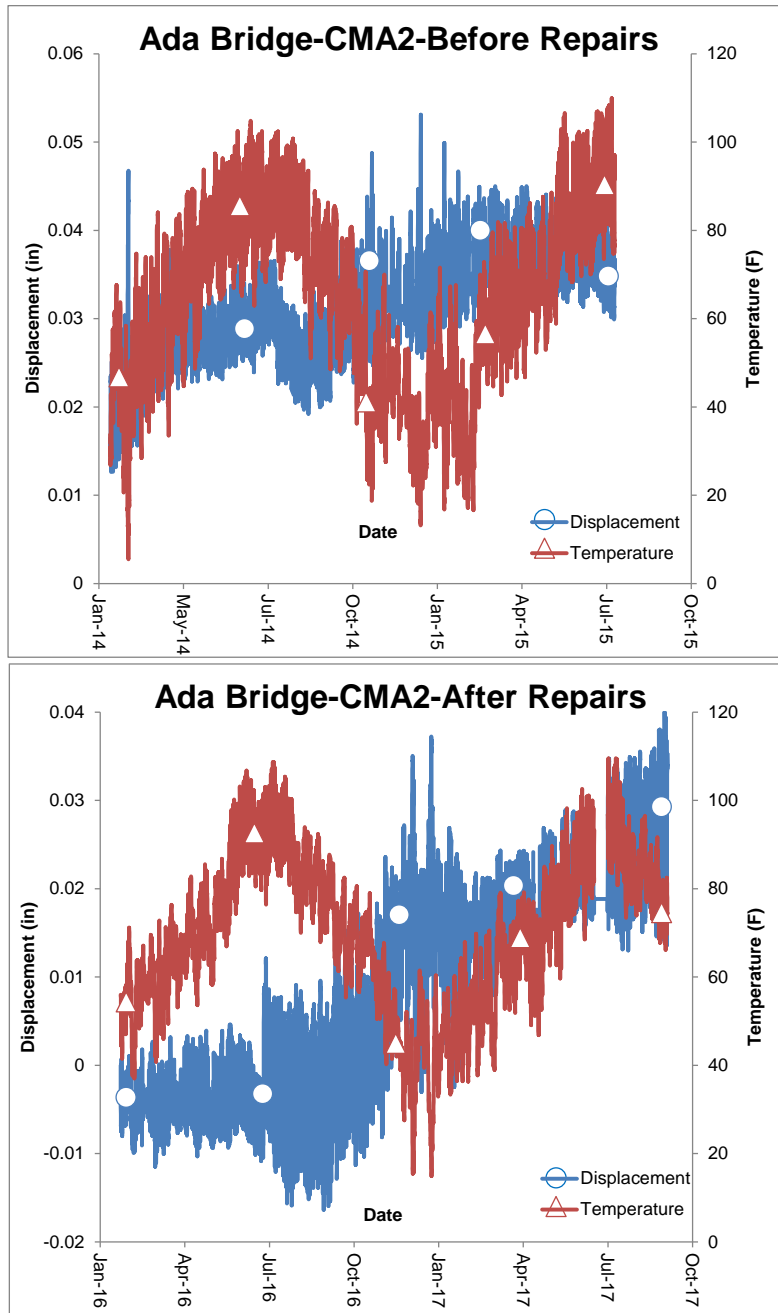
Figure 74. East abutment of SH-3 north bridge over BNSF railroad – Comparison of CMA2 crackmeter data before and after repairs

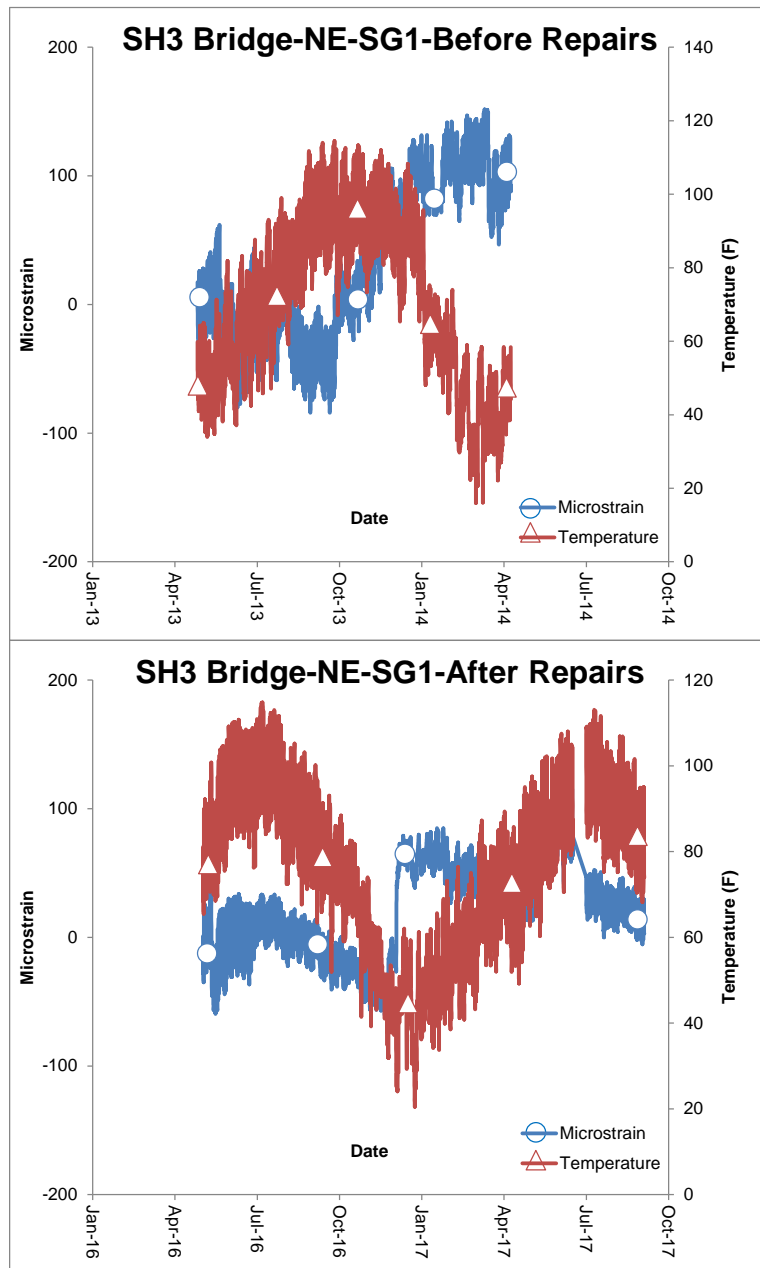
Figures 75 and 76 show strain and temperature trends for the strain gages NE_SG1 and NE_SG2 (Figure 38) before and after repairs. The trends in axial strains at NE_SG1 (approach

pavement) and NE_SG2 (under the deck) are similar before and after repairs, i.e., increasing temperatures cause an increase in axial strains at NE_SG1 and a decrease in axial strains at NE_SG2. Smaller strains at NE_SG1 and at NE_SG2 are recorded after the repairs. These observations indicate that the eastern most portion of the deck is now freely expanding and contracting into the new expansion joint at Pier No. 4.

Figure 75. Eastern side of SH-3 north bridge over BNSF railroad – comparison of NE_SG1 strain gage data before and after repairs

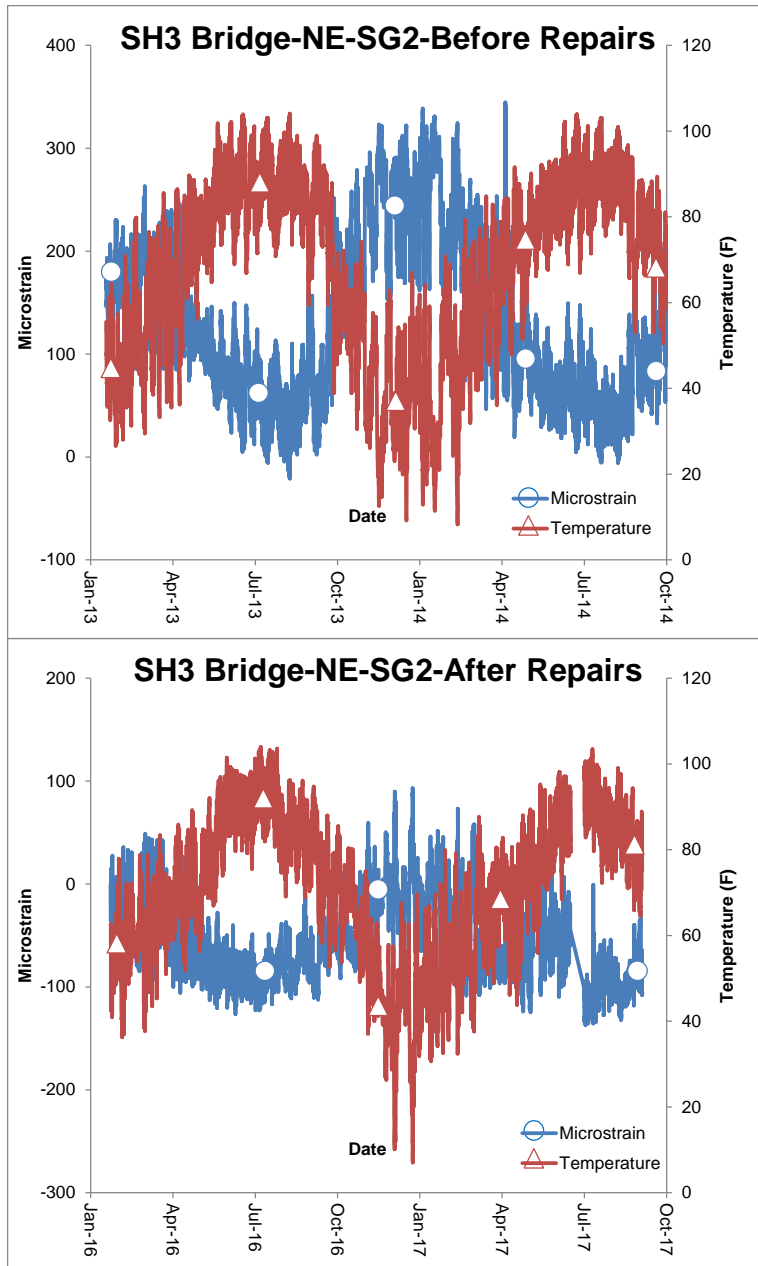
Figure 76. Eastern side of SH-3 north bridge over BNSF railroad – comparison of NE_SG2 strain gage data before and after repairs

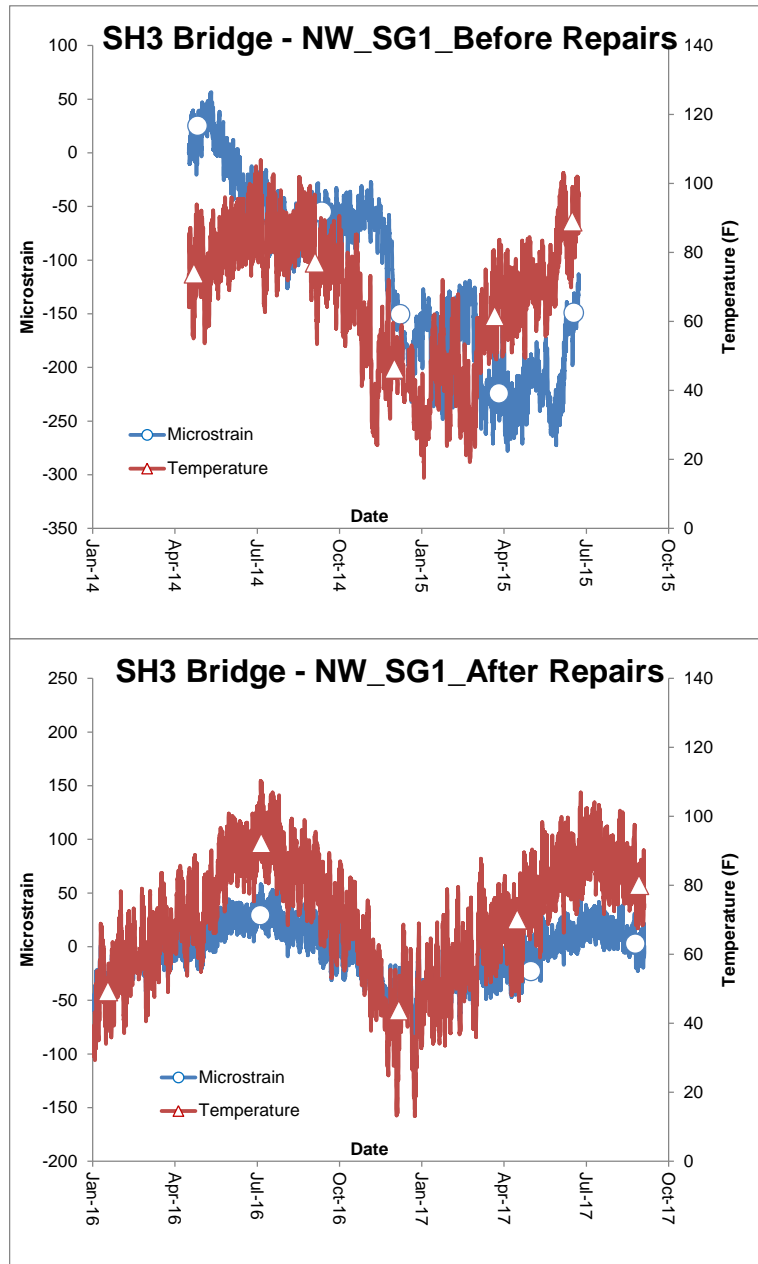
Data from NW_SG1, NW_SG2 and NW_SG3 and corresponding thermistors on the western side of the north bridge before and after repairs are shown in Figure 77, 78 and 79, respectively. NW_SG3, installed on the approach pavement, shows somewhat smaller

strains after the repairs. Smaller strains are also recorded in NW_SG1 and NW_SG2 installed underneath the deck after the repairs. These observations indicate that the western most portion of the deck is now freely expanding and contracting into the new expansion joint at Pier No. 1.

Figure 77. Western side of the SH-3 north bridge over BNSF railroad – Comparison of NW_SG1 data before and after repairs

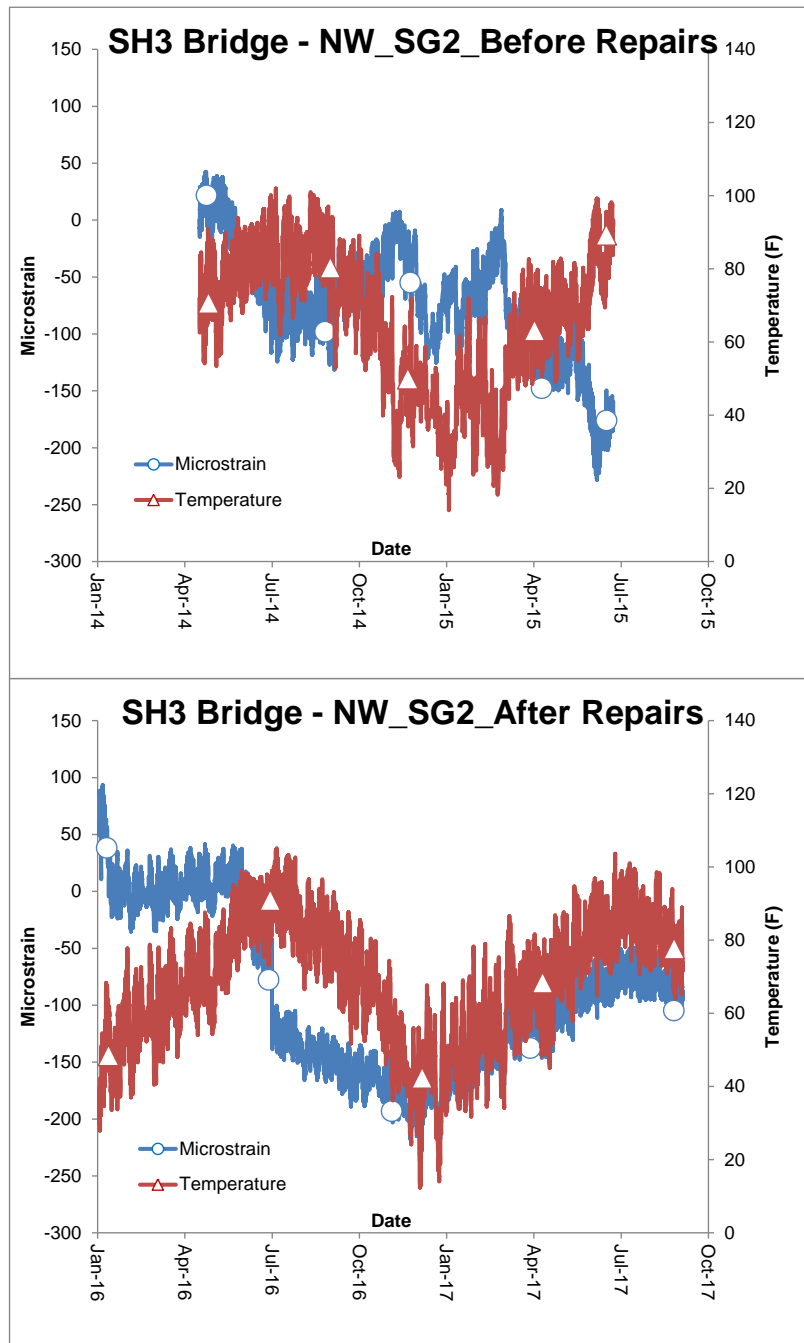
Figure 78. Western side of the SH-3 north bridge over BNSF railroad – comparison of NW_SG2 data before and after repairs

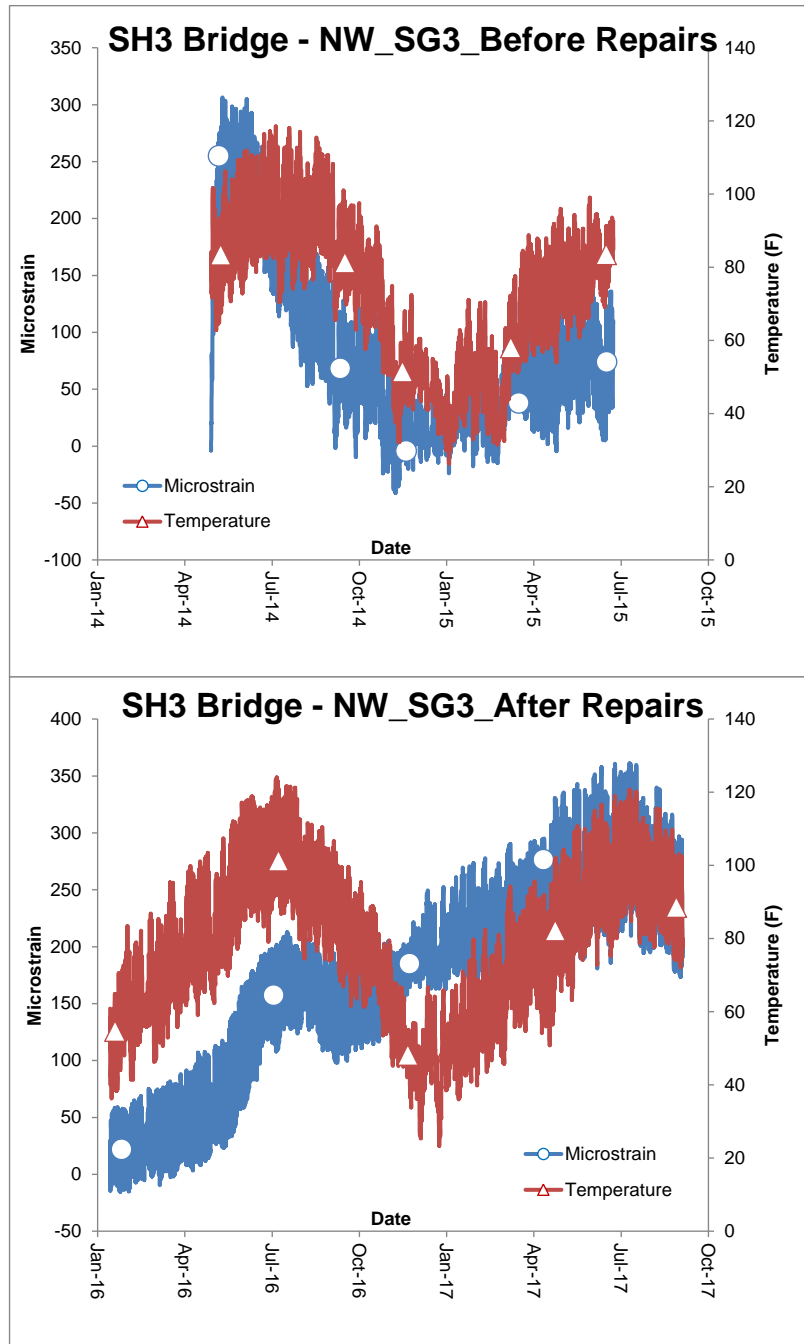
Figure 79. Western side of SH-3 north bridges over BNSF railroad – comparison of NW_SG3 data before and after Repairs
