FINAL REPORT ~ FHWA-OK-17-03

OVERTURNING FORCES AT BRIDGE ABUTMENTS AND THE INTERACTION OF HORIZONTAL FORCES FROM ADJACENT ROADWAYS

January 2018

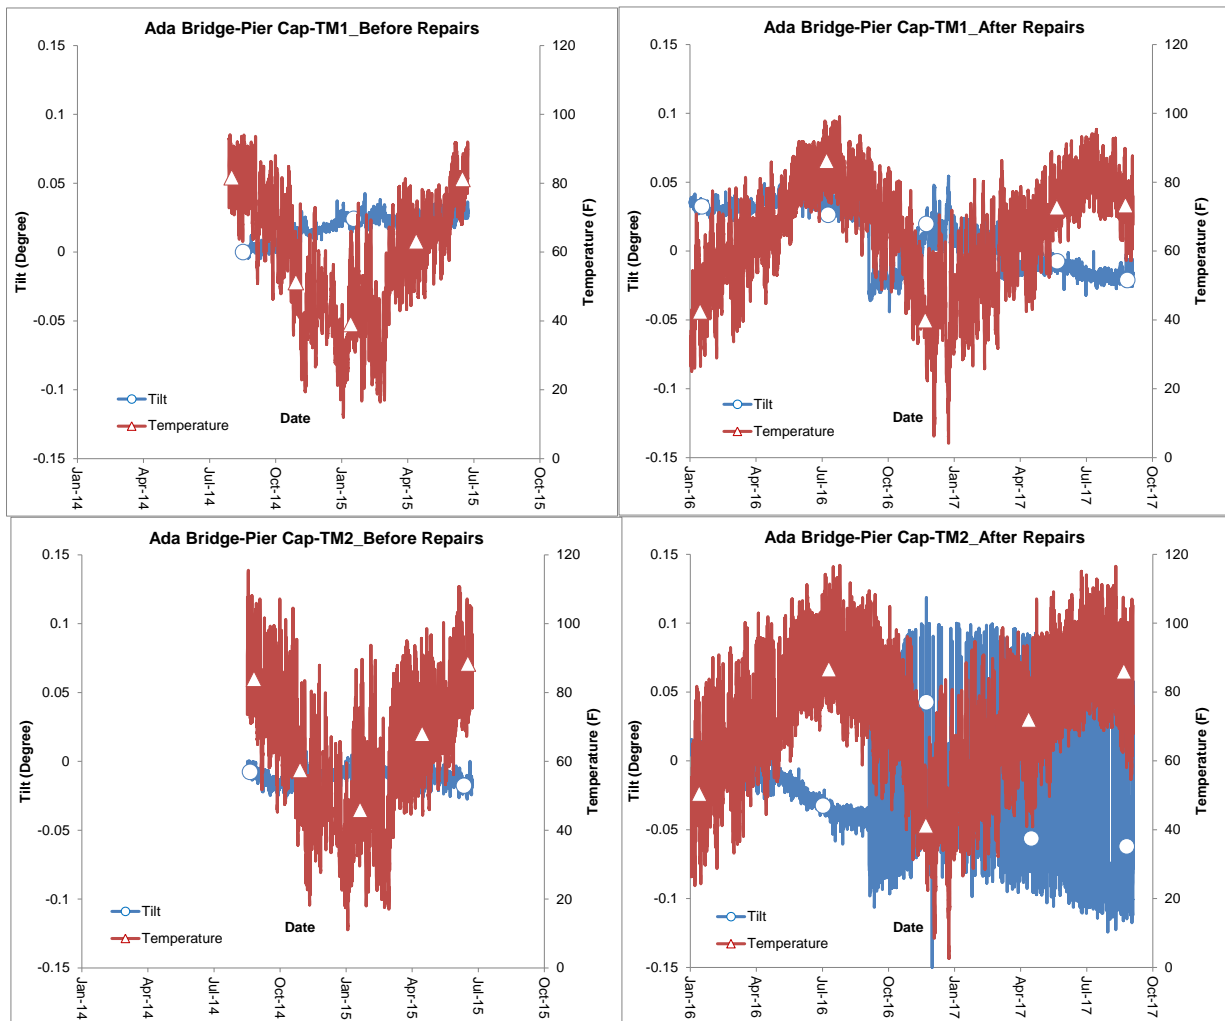
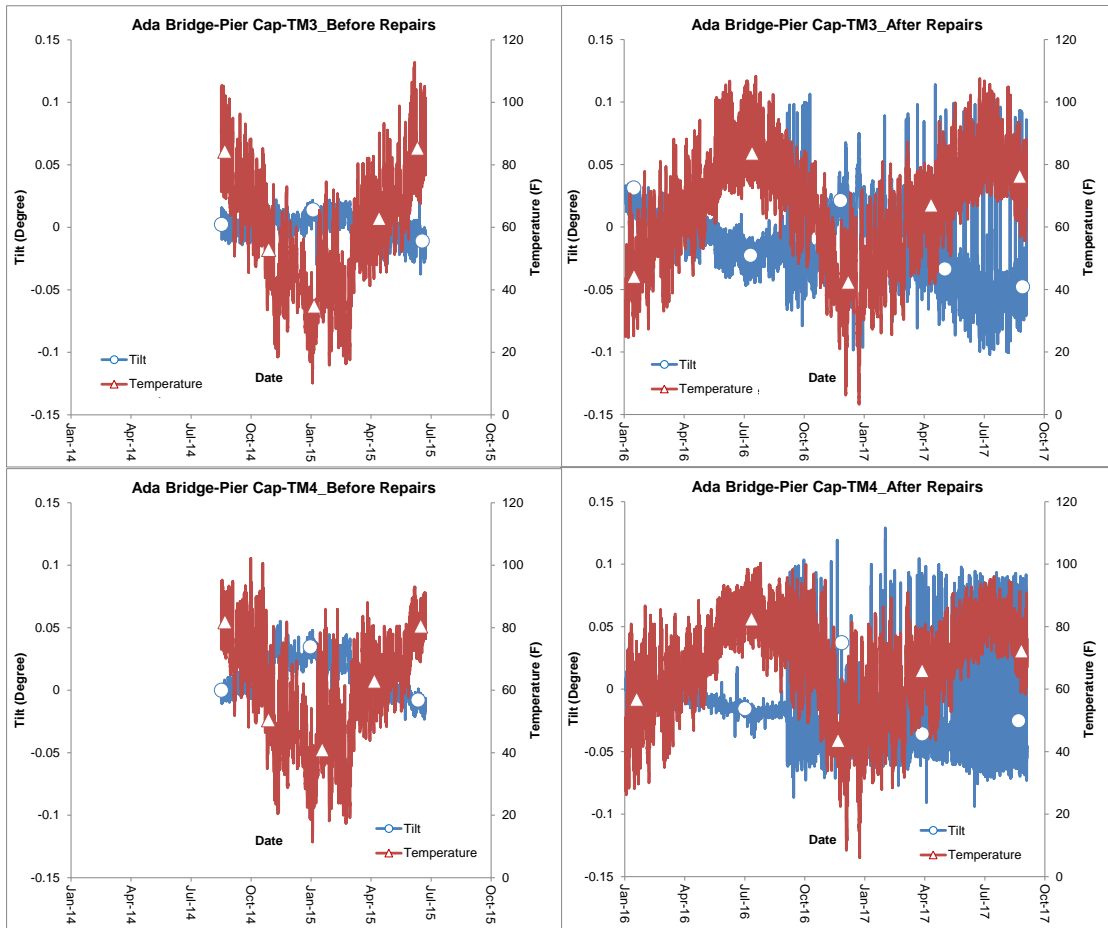
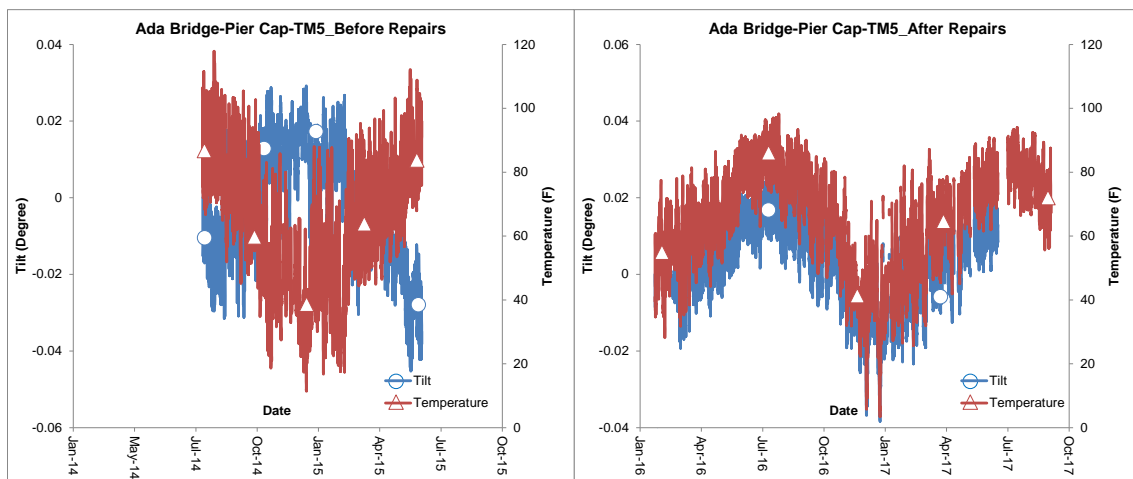
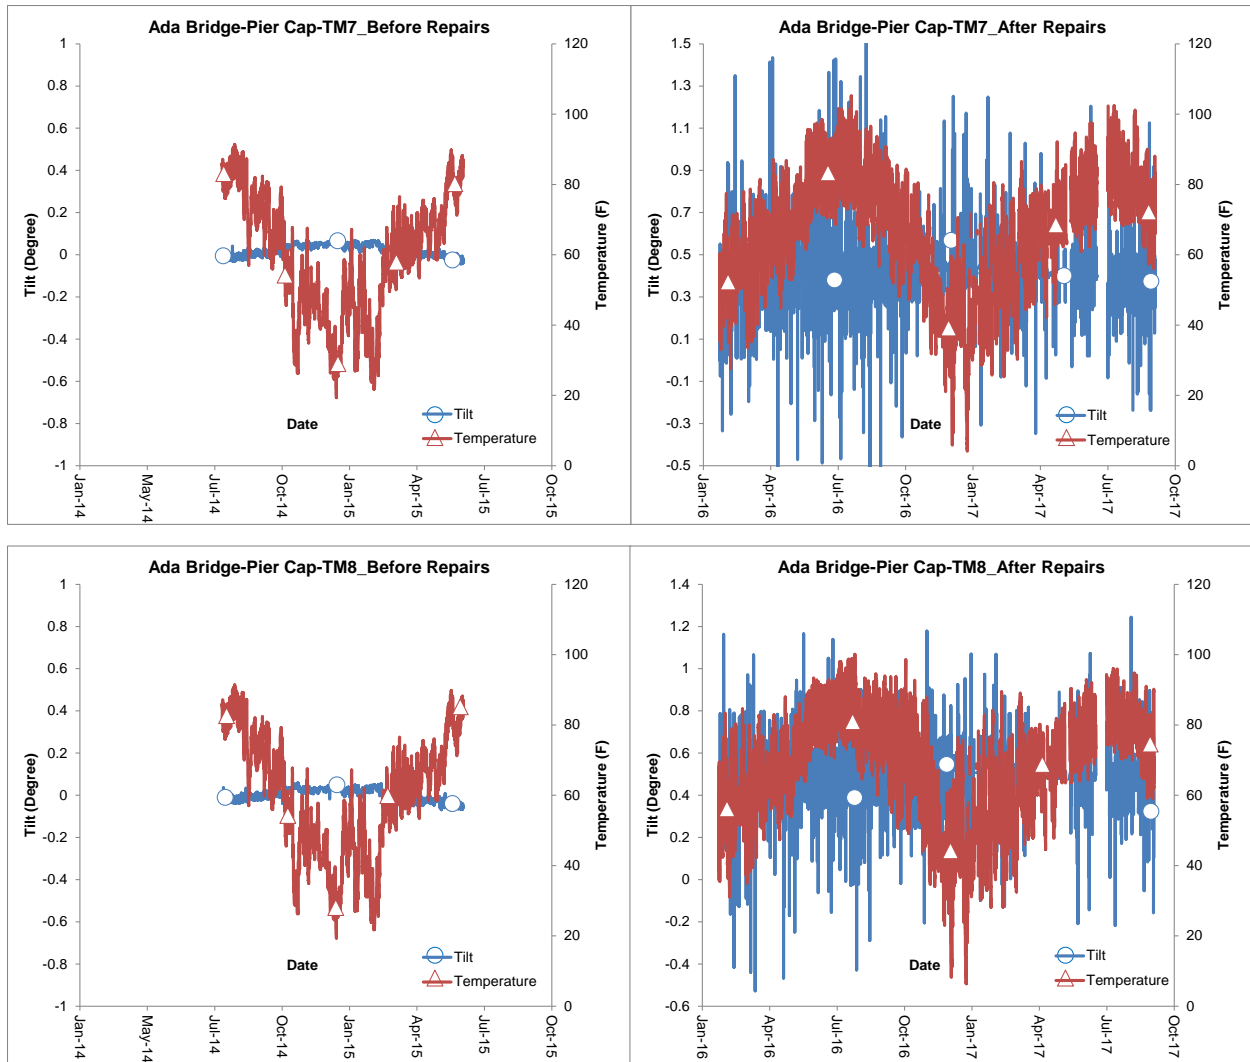
All tiltmeter data and corresponding temperature data for tiltmeters installed on pier caps of the north bridge are presented in Figures 80 – 83. Some of the tiltmeter data is too noisy and may indicate malfunctioning tiltmeters. There is generally an opposite trend between tilt and temperature variations for TM1-4 and TM7-8. Substantially more daily variations in tilt can be seen after the repairs. Same trend between tilt and temperature variations is observed for TM5. When the temperature increases, the Pier No.3 is tilting away from Abutment No. 2 (eastern abutment). These observations seem to indicate that the repairs to SH-3 North Bridge are working as intended.

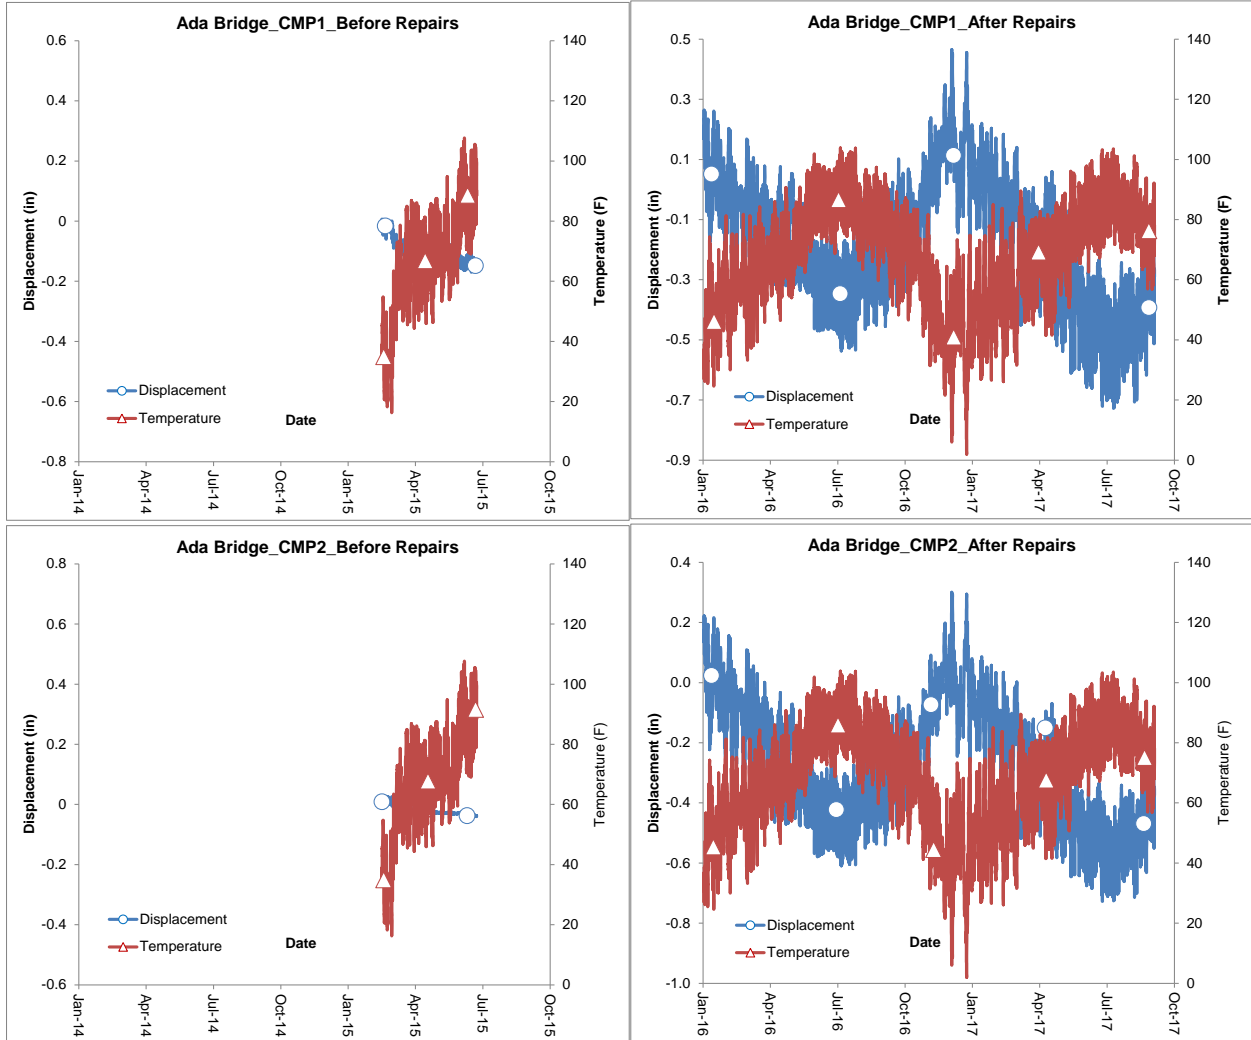
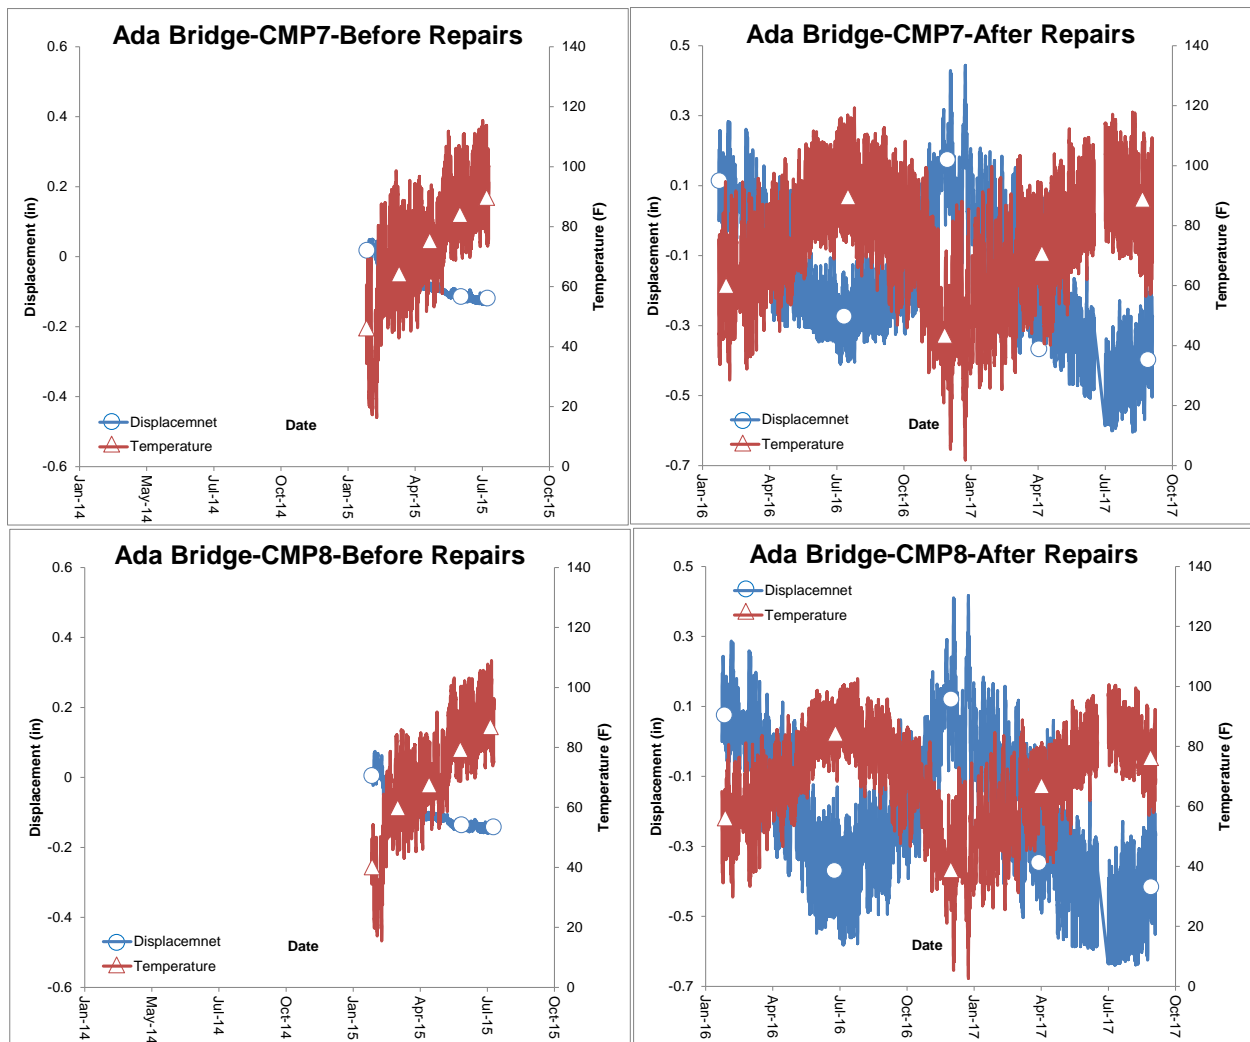
Expansion joint movements along with temperature variations before and after repairs at Pier Nos. 1 (CMP1 and CMP2) and 4 (CMP7 and CMP8) are compared in Figures 84 and 85, respectively. Substantially more daily variations in expansion joint movements can be seen after the repairs. Based on the recorded data during the monitoring period in 2016 and 2017, temperature varied between 2° F and 104° F at Pier No. 1 and between 28° F and 120° F at Pier No. 4. The measured displacements at CMP1, CMP2, CMP7, and CMP8 for these temperature variations were 1.19”, 1.03”, 1.05”, and 1.06”, respectively. The calculated displacements at

these locations are 1.13", 1.19", 0.94", and 0.84". The calculated displacements match the measured values reasonably well. It appears that the newly installed expansion joints are functioning well.

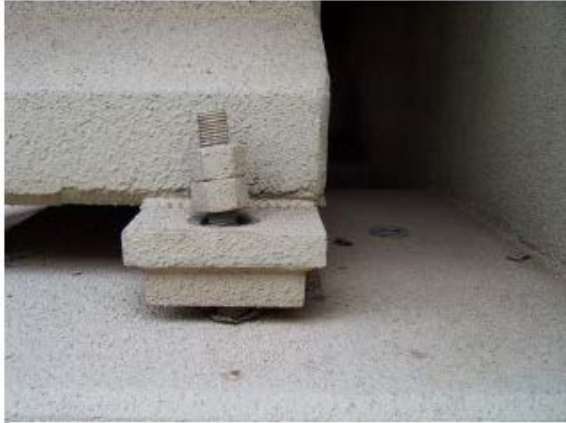
a) Bent anchor bolts on the eastern abutment bridge seat

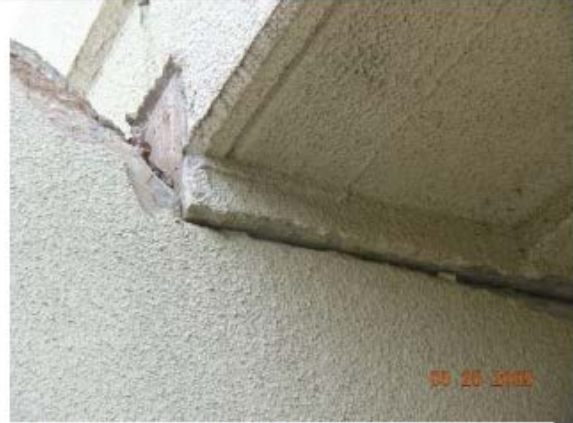
b) Approach slab overhang with eastern abutment wing wall spall

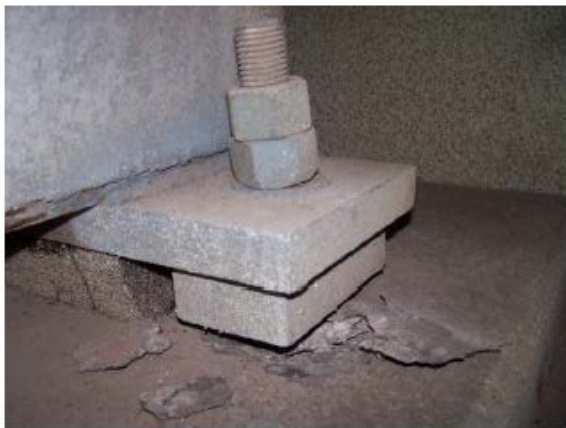
c) Bent anchor bolts with deformed elastomeric bearing pads on the eastern abutment bridge seat

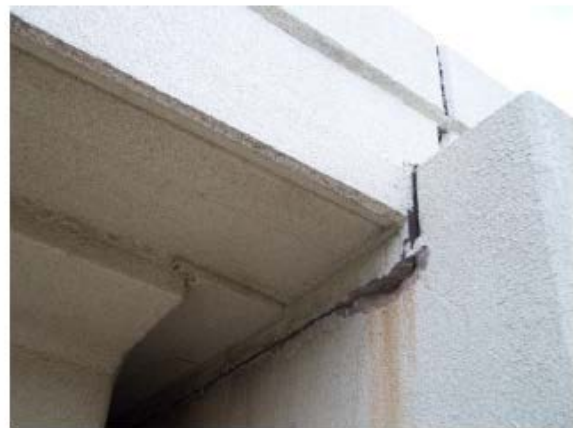
d) Large crack in the eastern abutment back wall

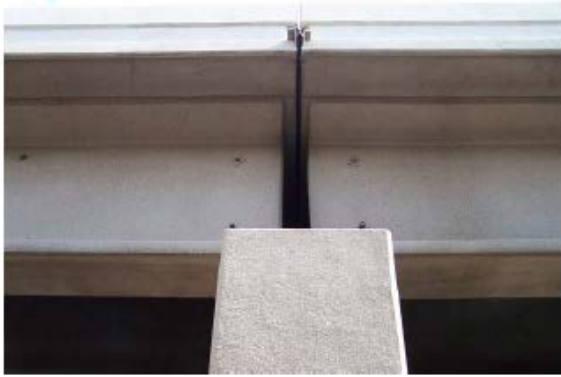
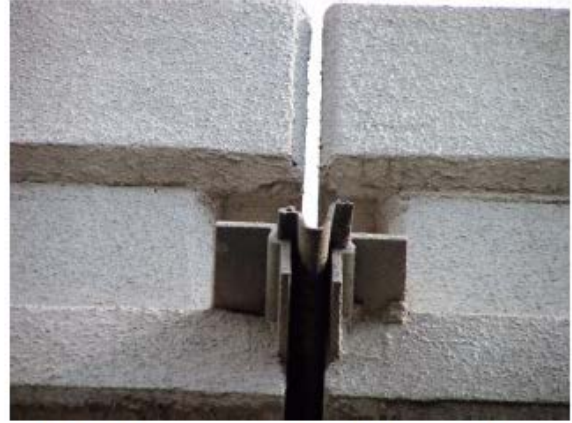
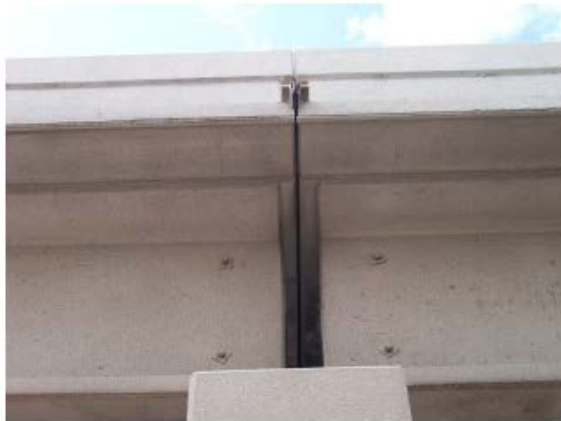
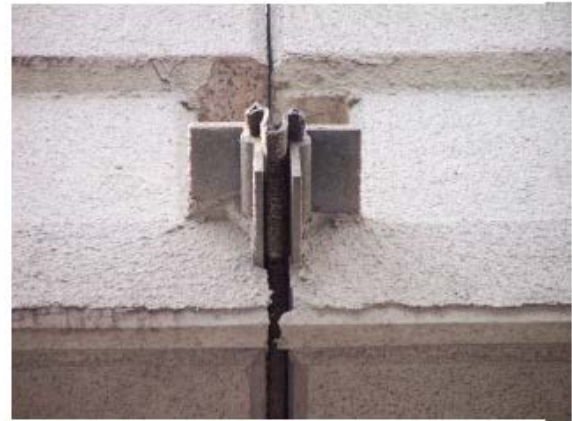
- The center expansion joint is full of debris, is closed, and requires cleaning.
- There is a 6 inch spall at the top of the north east wing wall due to 1 inch approach slab movement.
- There is a longitudinal crack in the eastern approach slab.

Figure 88. Center expansion joint on north and south Bridge at 19th Street/I-35 in 2005

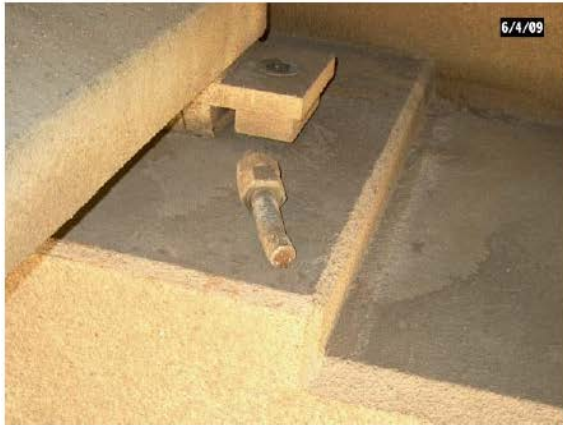
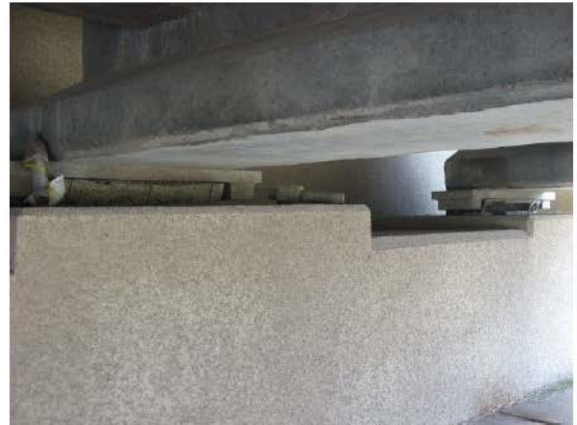
abutments were merged. During construction of the center turning lane it was likely discovered that the anchor bolts on the eastern abutment bridge seat had gone from a bent condition to a sheared condition as shown in Figure 89. Figure 90 shows heavy cracking of the south eastern approach slab adjacent to south bridge deck in 2009. In 2009, after the center turning lane construction, a bridge inspection was carried out and noted the same maintenance issues previously discussed. Site visits were carried out jointly by the University of Oklahoma (OU) and ODOT personnel on January 28, 2011 and by OU personnel on June 24, 2011. During these site visits, U-shaped cracks, shown in Figure 91 were discovered on the eastern abutment back wall similar to that shown by Burgueño and Li (2008).

Figure 89. 19th Street/I-35 Bridge sheared anchor bolts in 2009

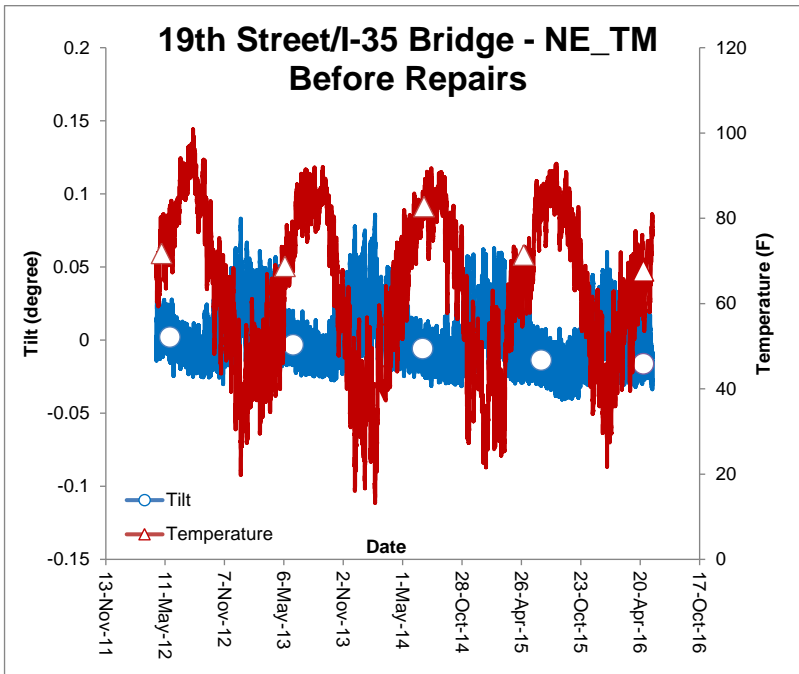
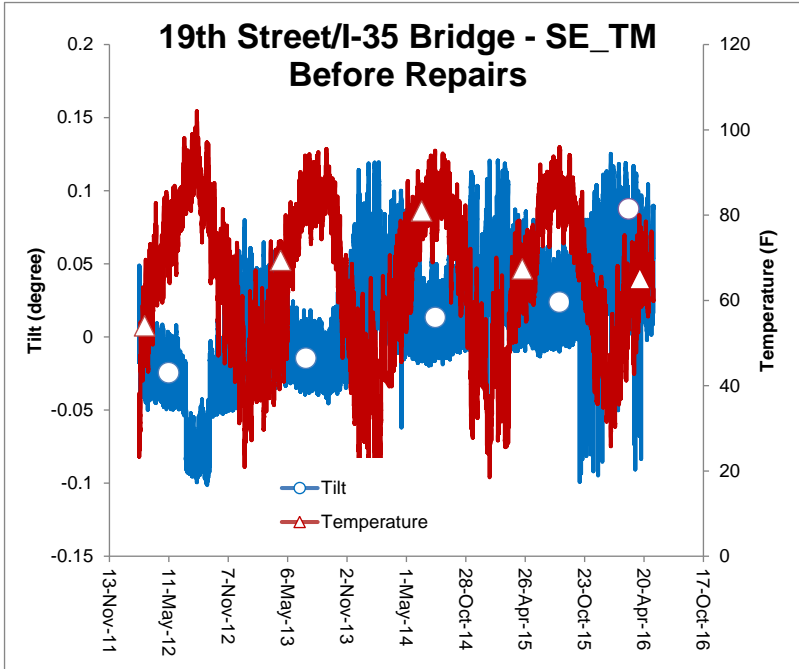
Figure 97 shows the data collected by the northeast tiltmeter. It can be seen that as the temperature increases the tilt decreases and vice versa. This indicates as the temperature rises from winter to summer the abutment tilts toward the approach pavement. Same behavior can also be observed in the southeast tiltmeter (Figure 98) as well as the tiltmeters located on the western abutment (see for example, Figure 99 and 100). The maximum measured tilts are, however, larger for the southeast and southwest tiltmeters than for their northern counterparts.

It appears from the data presented that thermal expansion of the bridge deck is controlling the behavior of the abutment backwall. It can be assumed that at this point the bridge deck

cannot thermally expand toward the center because of the closed center expansion joint. As a result, as the temperature rises, the bridge deck expands outward and pushes on the both eastern and western approach slabs. The opposite is true when the temperature decreases. As the approach slabs moves toward the approach pavements the friction from the approach slabs and bridge deck “drags” the abutment back walls with the approach slabs. Figure 101 shows a cross-section through the bridge deck, abutment back wall, and approach slab. As seen from this figure, the bridge deck and the approach slab are tied together with reinforcing steel. This means that for all practical purposes the bridge deck and approach slab are acting together as a single structural element.

As seen from the eastern tiltmeter data (Figures 97 and 98), the south section of the eastern abutment backwall tilts more than the north section. This is likely because on the south side of the eastern pavement, there is additional space between the approach slab and approach pavement along the construction joint for the bridge deck/approach slab to thermally expand and contract during temperature cycles. An observation that supports this interpretation is that there is far more spalling of concrete/U-shaped cracks on the southern side of the east abutment backwall than the northern side. As the overstressed abutment backwall tilts back and forth, it leads to U-shaped cracks and eventual spalling of concrete. Therefore, more tilting on the south side leads to more cracking and spalling on this side. As mentioned earlier, prior to

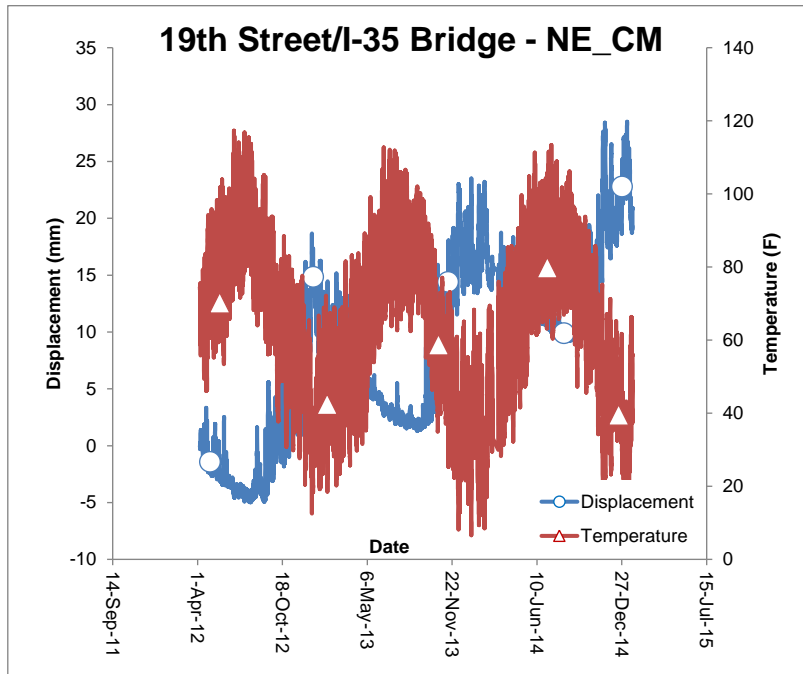
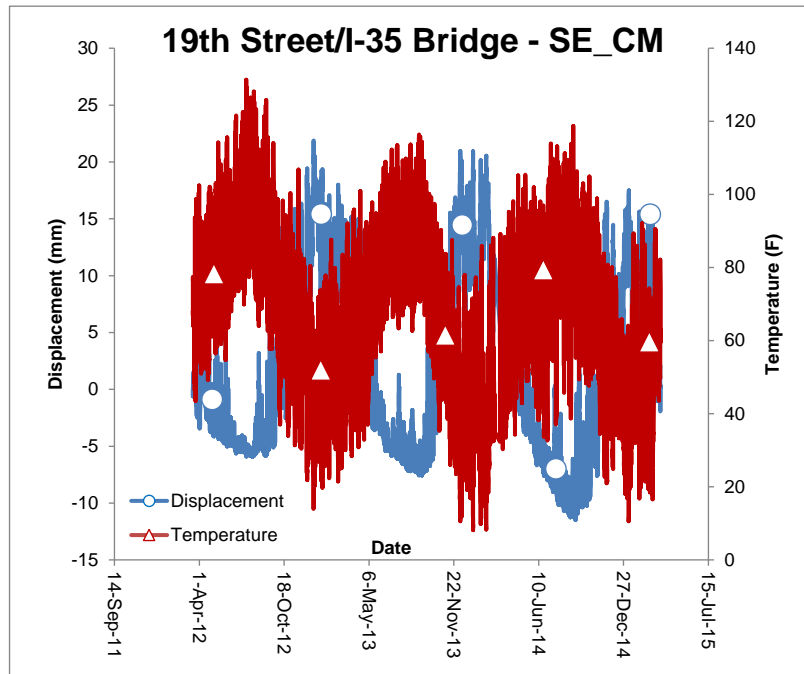
If Figure 103 is compared with Figure 104, larger amplitudes can be seen in the southeast crackmeter when compared to the northeast crackmeter. This comparison is similar to that made between the northeast and southeast tiltmeters. This likely means that there is additional room at the construction joint between the east approach slab and the east approach pavement at the south side for expansion and contraction of the approach pavement to occur. The amplitude of expansion or contraction is larger on eastern side than the western one. The reason for this may be that the approach slab and the approach pavement are locked together more on the western side.

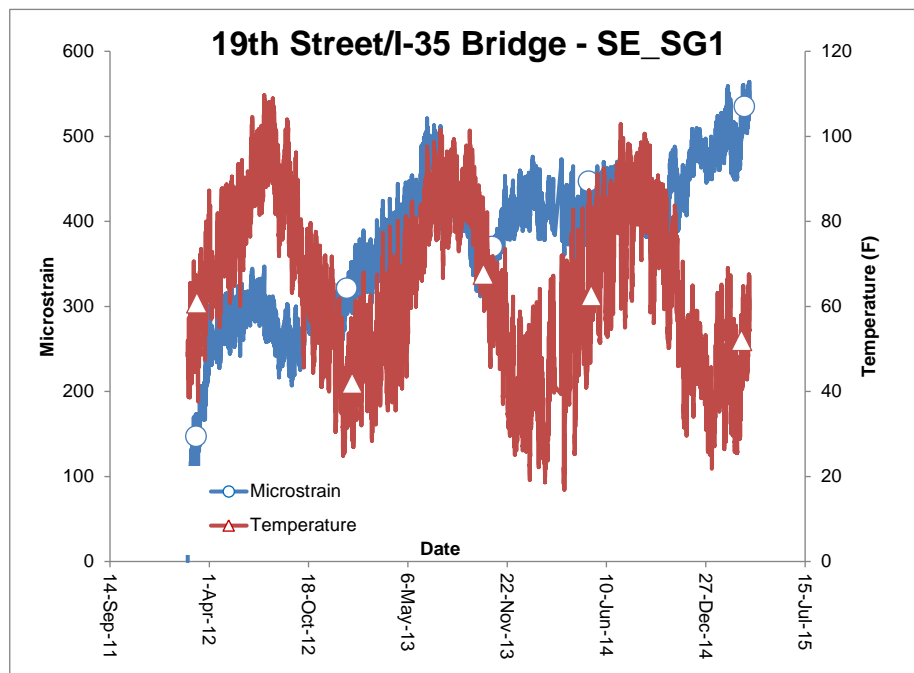
Figure 112 and 113 show schematically the behavior seen in Figures 108 and 109. The southeast strain gage SE_SG1 expands as the temperature increases indicating that the surrounding approach pavement is also expanding, when the temperature decreases the approach pavement contracts and the southeast strain gage 1 (SE_SG1) registers a contraction. This behavior is not seen in the northeast strain gage 1 (NE_SG1), when the temperature increases the strain gage contracts indicating that the surrounding pavement also is contracting.

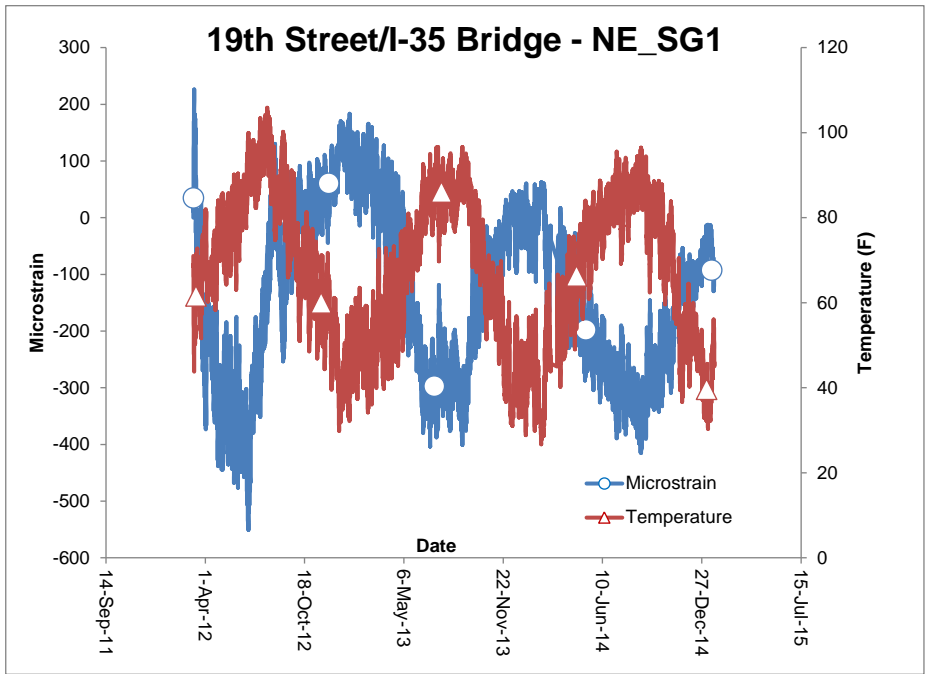
Figure 109. Eastern side of the 19th Street/I-35 Bridge – northeast strain gage NE_SG1 before repairs

Temperature increases ► Approach Slab and Bridge Deck Expands ► Approach Slab pushes against Approach Pavement ► Approach Pavement Compresses ► Strain Gage Contracts ► Negative trend in the NE SG 1 data

Temperature decreases ► Approach Slab Contracts ► Approach Pavement Relaxes toward Approach Slab ► Strain Gage Expands ► Positive trend in the NE SG 1 data

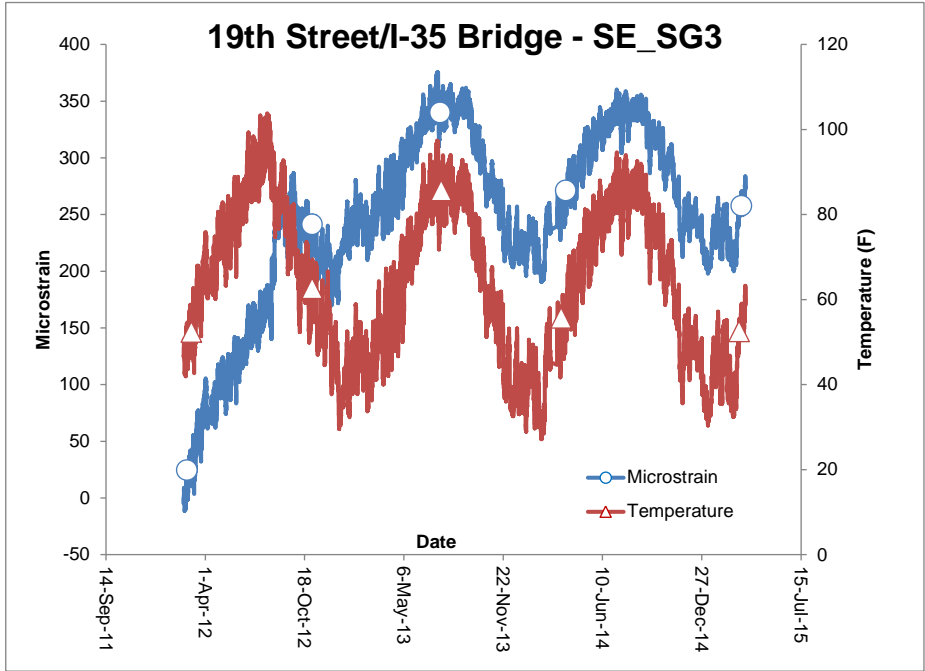
Figure 110. Eastern side of the 19th Street/I-35 Bridge – southeast strain gage SE_SG3 before repairs

the construction joint in the eastern area for both the approach pavement and approach slab to expand and contract with temperature change. The above mentioned compression of the approach pavement with a temperature increase is also not seen in the data for the strain gages that are located away from the bridge (Figures 110 and 111).

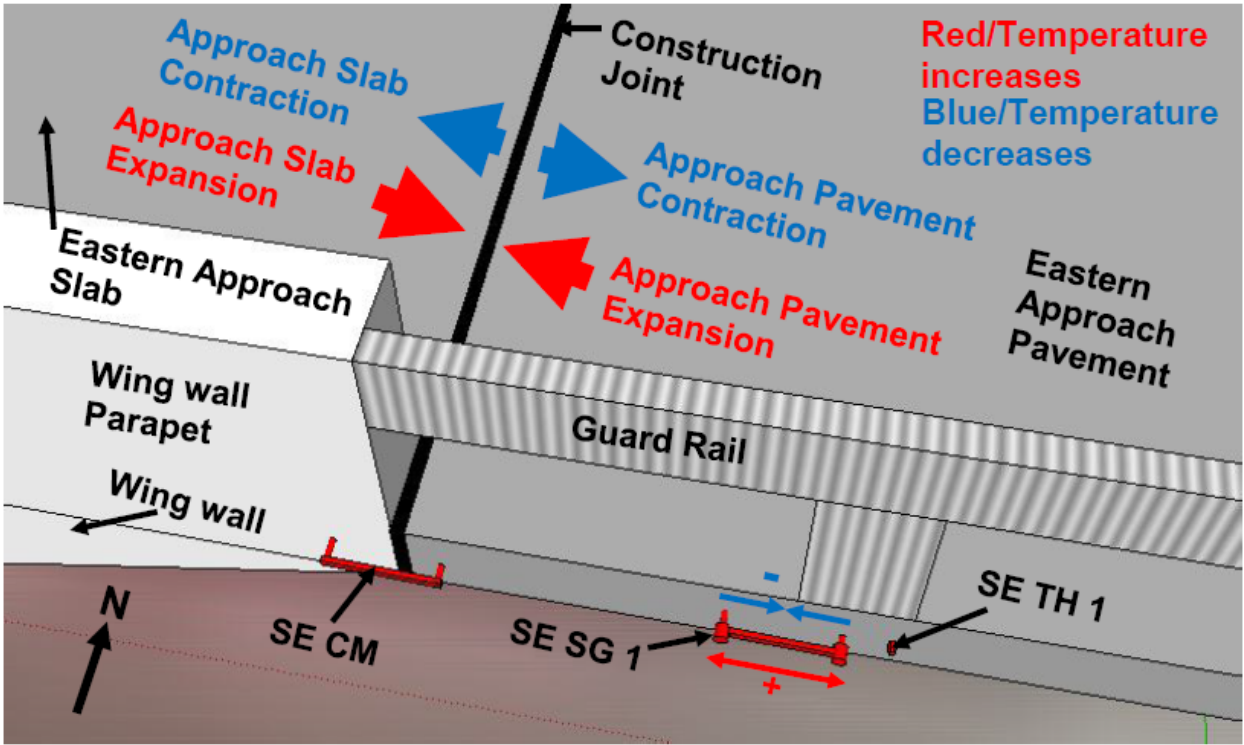
Figure 112. Southeast strain gage SE_SG1 trend illustration (Bright, 2012)

Temperature increases ► Approach Slab Expands ► Approach Pavement Expands ► Strain Gage Expands ► Positive trend in the SE SG 1 data

Temperature decreases ► Approach Slab Contracts ► Approach Pavement Contracts ► Strain Gage Contracts ► Negative trend in the SE SG 1 data

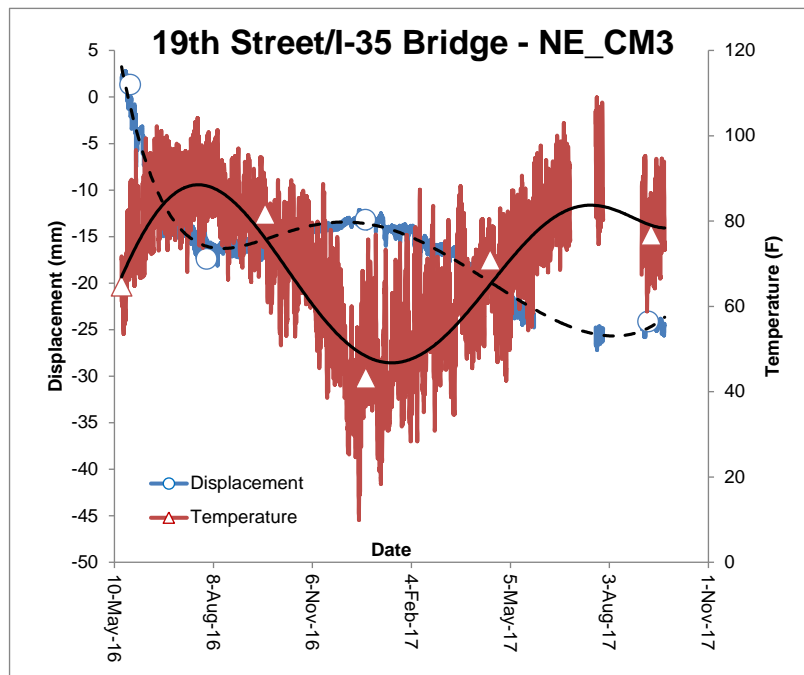
Figure 120. Eastern side of the 19th Street/I-35 Bridge – northeast crackmeter NE_CM3 data after repairs

Data from new crackmeters installed across the pressure relief joint (northeast crackmeter NE_CM3 and southeast crackmeter SE_CM4) are shown in Figure 120 and 121. It can be seen that the width of the pressure relief joint reduced since its installation in May 2016 until August 2016 as the temperatures increased and the stresses in the bridge were relieved. As the temperatures reduced, starting in Aug 2016, the pressure relief joint rebounded somewhat. It was noticed that the construction joint shown in Figure 118 also began to open as the temperatures reduced. This full-depth construction joint opened as much as 1 in. on Dec. 7, 2016. This explains why that the pressure relief joint only rebounded partially. As the temperatures increased again starting in Jan. 2017, the width of the pressure relief joint began to reduce again, but the construction joint remained opened. The rate of reduction of the width does, however, appear to be smaller than the initial rate of reduction in 2016. This may indicate that the width changes of the pressure relief joint is stabilizing. The construction of the new pressure relief joint provides room for the approach slab to move toward the approach roadway. Since there is additional room across the construction joint in the southeastern area, the displacement of the southeast area is larger than that of northeast area. .

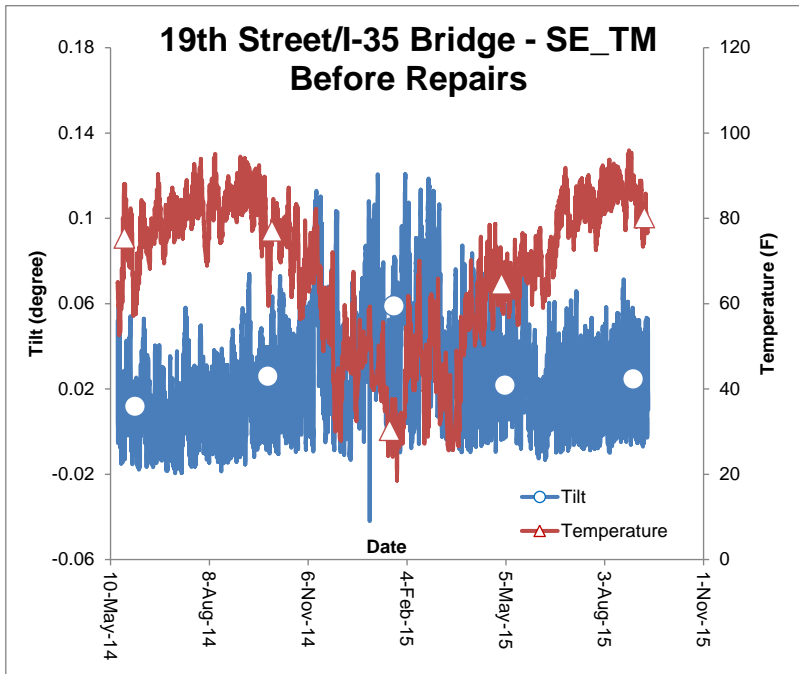
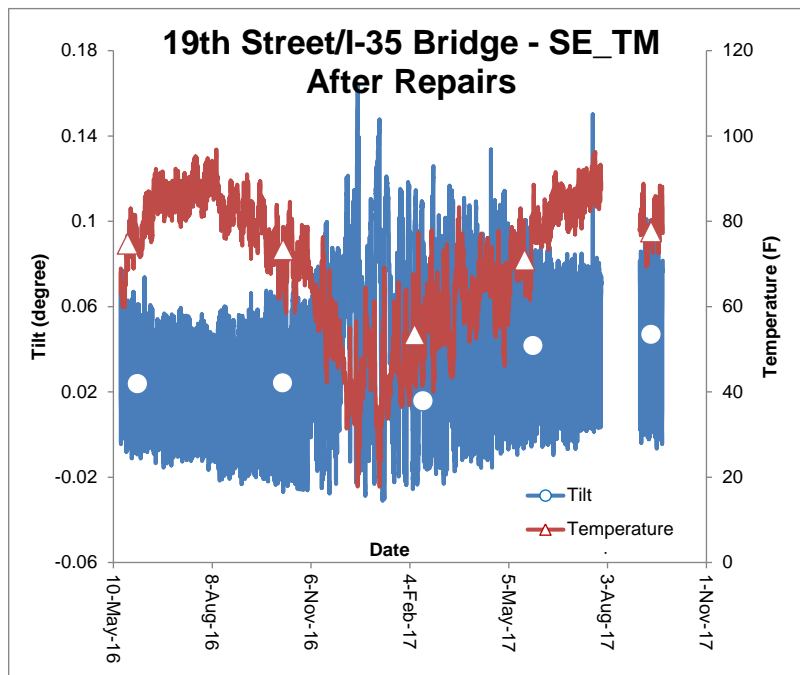
Figure 122. Eastern side of the 19th Street/I-35 Bridge – comparison of southeast tiltmeter SE_TM data before and after repairs

Figures 122 and 123 show the data trends for tiltmeters located on each corner of the eastern abutment backwall before and after repairs. The same time period from 2014 and 2016 is used to compare data from before and after repairs. Same trend in tilt can be observed before and after repairs, i.e., as the temperature increases the tilt decreases and vice versa. Substantially more daily variations in tilt can, however, be seen after the repairs. This is likely because the deck/approach slab has now more space to expand/contract into the pressure relief joint.

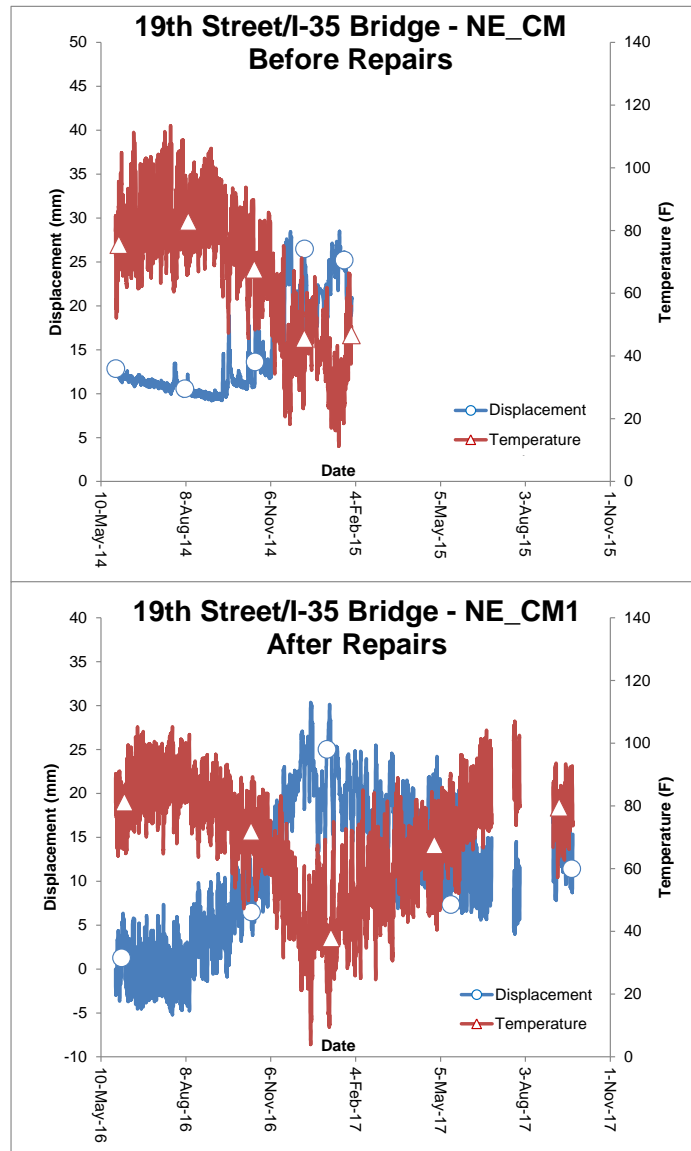
Figure 124. Eastern Side of the 19th Street/I-35 Bridge – comparison of northeast crackmeter data before and after repairs

Figures 124 and 125 show the data collected by the northeast and southeast crackmeters before and after repairs. While the trends are similar, substantially more daily variations in displacements can be seen after the repairs. These results indicate that the new expansion joint is performing as intended.
