FINAL REPORT ~ FHWA-OK-17-03

OVERTURNING FORCES AT BRIDGE ABUTMENTS AND THE INTERACTION OF HORIZONTAL FORCES FROM ADJACENT ROADWAYS

January 2018

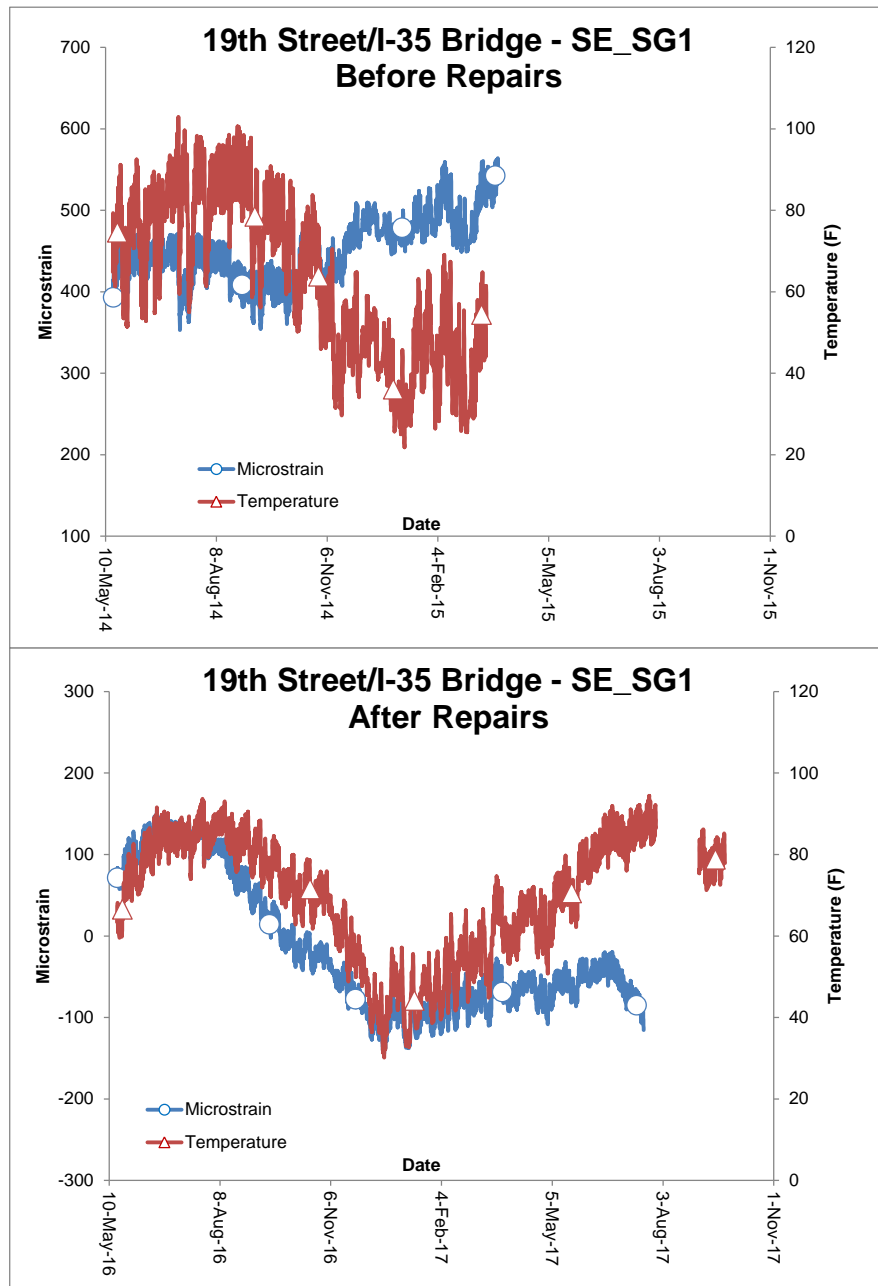
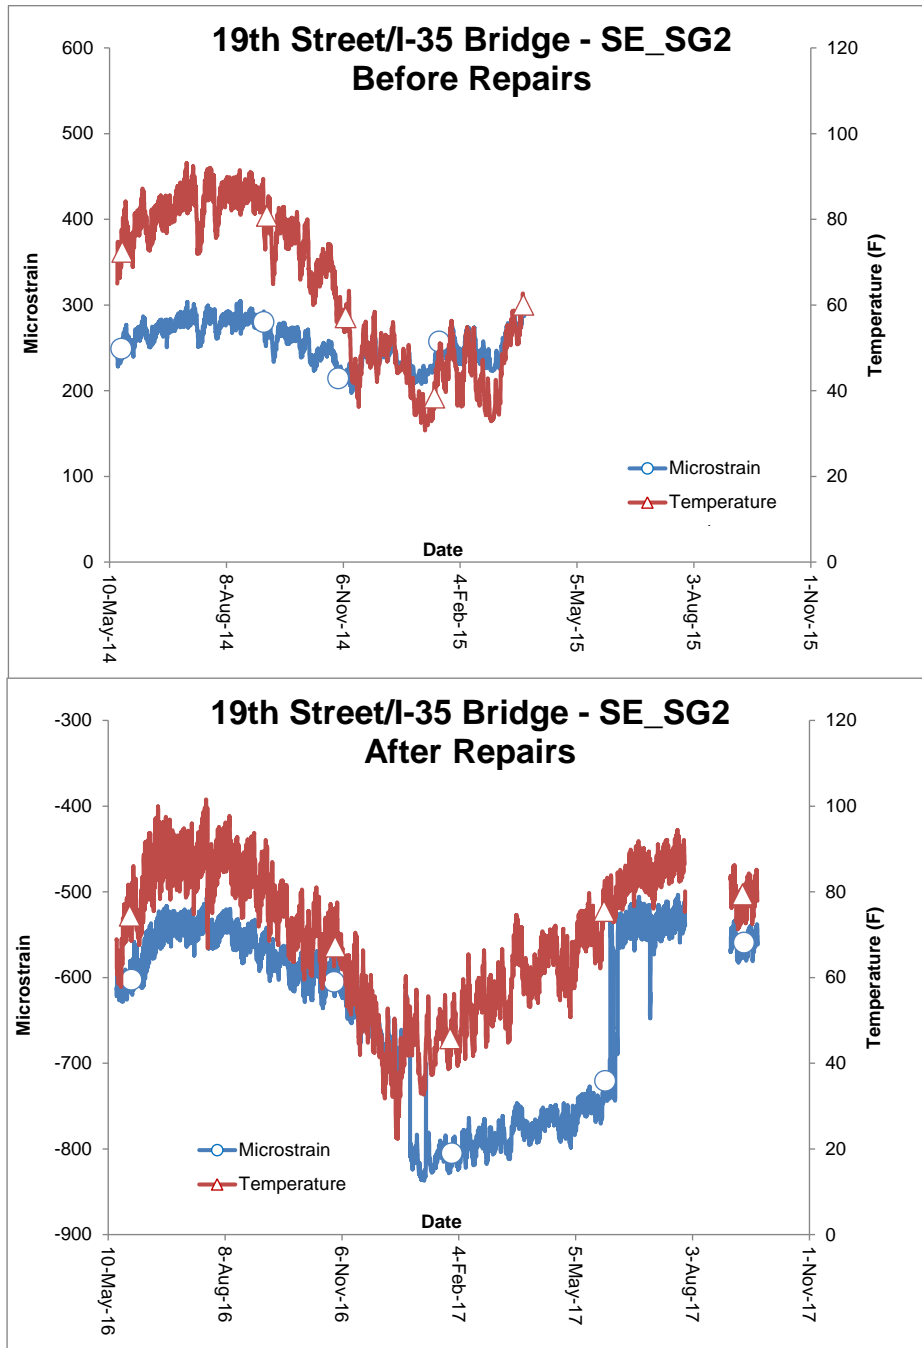
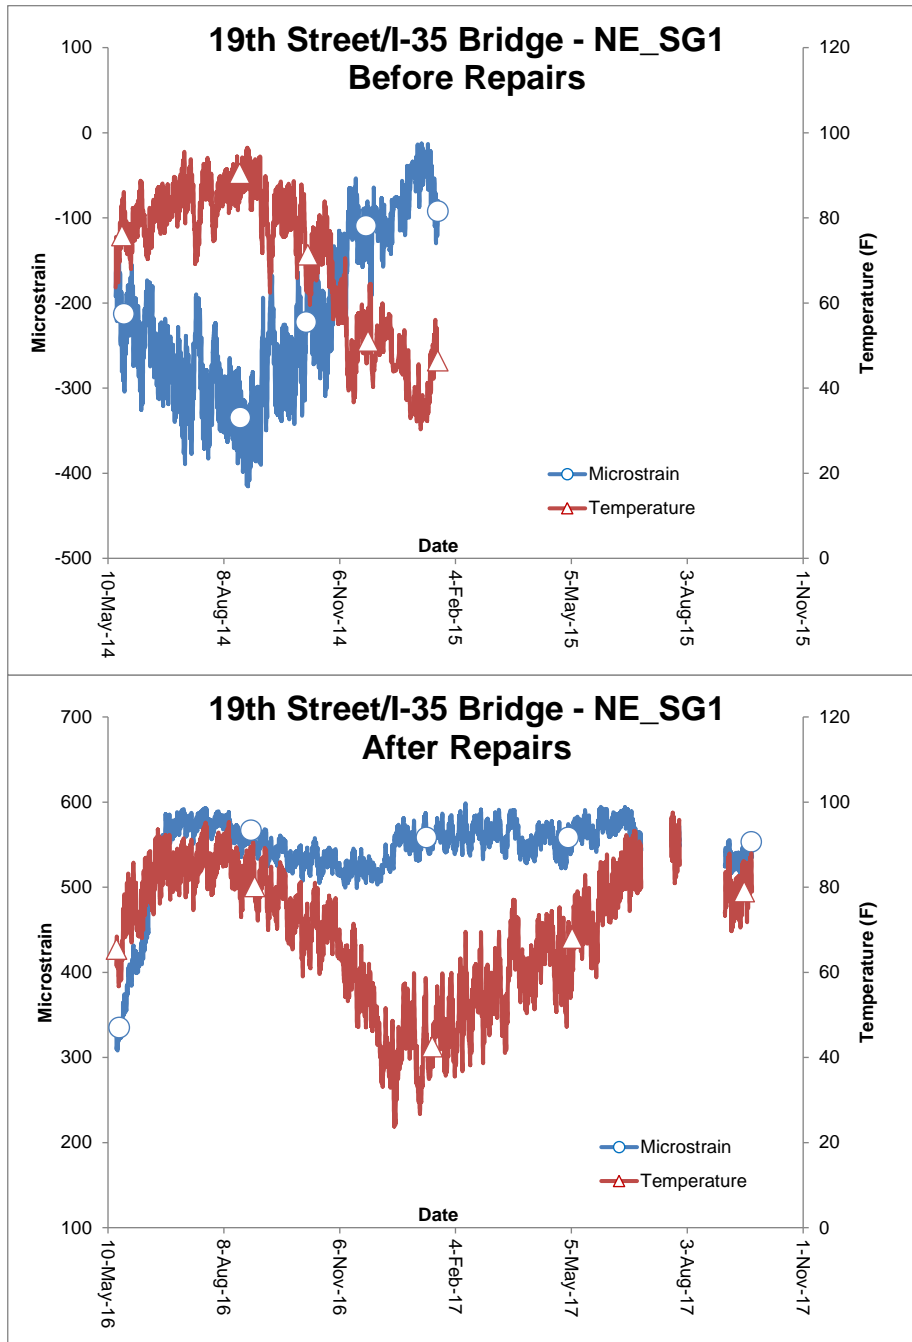
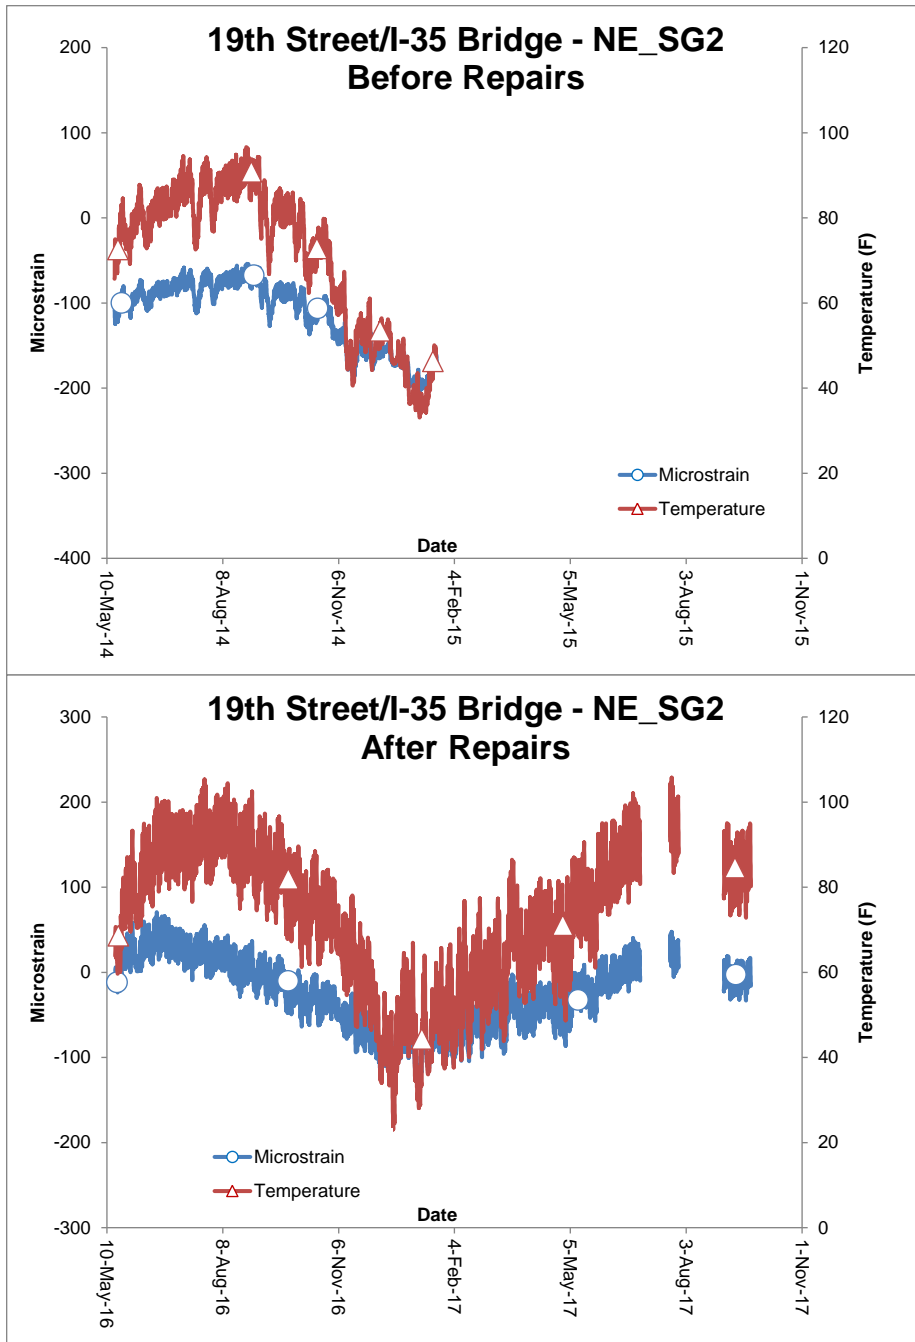
Figures 126 -129 show axial strain variations with temperature for selected strain gages before and after repairs. It can be seen that when the temperature increases there is an

increase in strain and vice versa for all the strain gages after repairs. This means that the approach pavement is expanding when the temperature increases and vice versa after repairs. The opposite trend was observed at NE_SG1 before the repairs. As described earlier, pavement pressure at the northeast corner was the reason for this opposite trend. This pressure is now seemed to have been relieved.

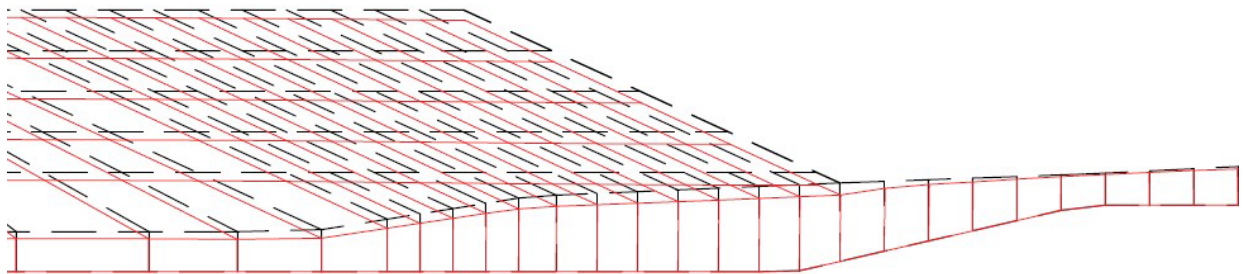
Figure 131. Unsaturated finite element analysis deformed mesh

The results for the unsaturated analysis showed a horizontal displacement at the crest of the embankment of 0.415 feet or 5 inches. The vertical displacement calculated was around 2.31 feet. This vertical and horizontal displacement of the embankment near the crest can be seen in Figure 131 below. In the figure the original mesh is shown by dash lines and is slightly taller than the deformed mesh which is shown by solid lines.

While the bridge does have some asphalt patch and apparent filling at the east abutment, it is not believed that the embankment actually settled 2.31 feet. The horizontal movement of 5 inches at the crest of the embankment on the east side with about 3 inches coming from the west side would have completely closed all the expansion joints on the bridge.

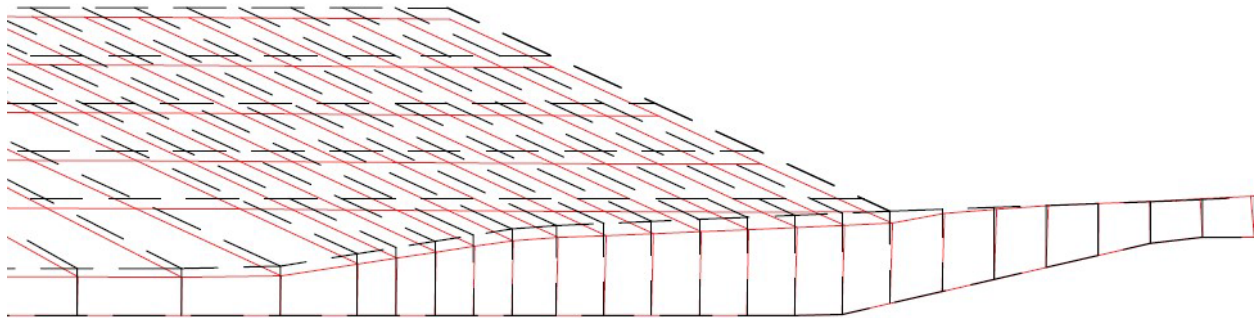
Figure 132. Saturated finite element analysis deformed mesh

The results of the saturated analysis showed a horizontal displacement at the crest of the embankment of 0.512 feet or 6 inches. The vertical displacement for the saturated analysis was calculated at 2.25 feet. As mentioned previously it is not believed the embankment settled this

entire amount. This vertical and horizontal displacement of the embankment near the crest can be seen in Figure 132 below. In the figure the original mesh is shown by dash lines and is slightly taller than the deformed mesh which is shown by solid lines.
