**SEPTIC SYSTEM □  
SANITARY SURVEY □  
for □  
Santa Barbara County □  
California □**

**Prepared For:  
Santa Barbara County  
Environmental Health Services**

**March 2003**

Project #210029

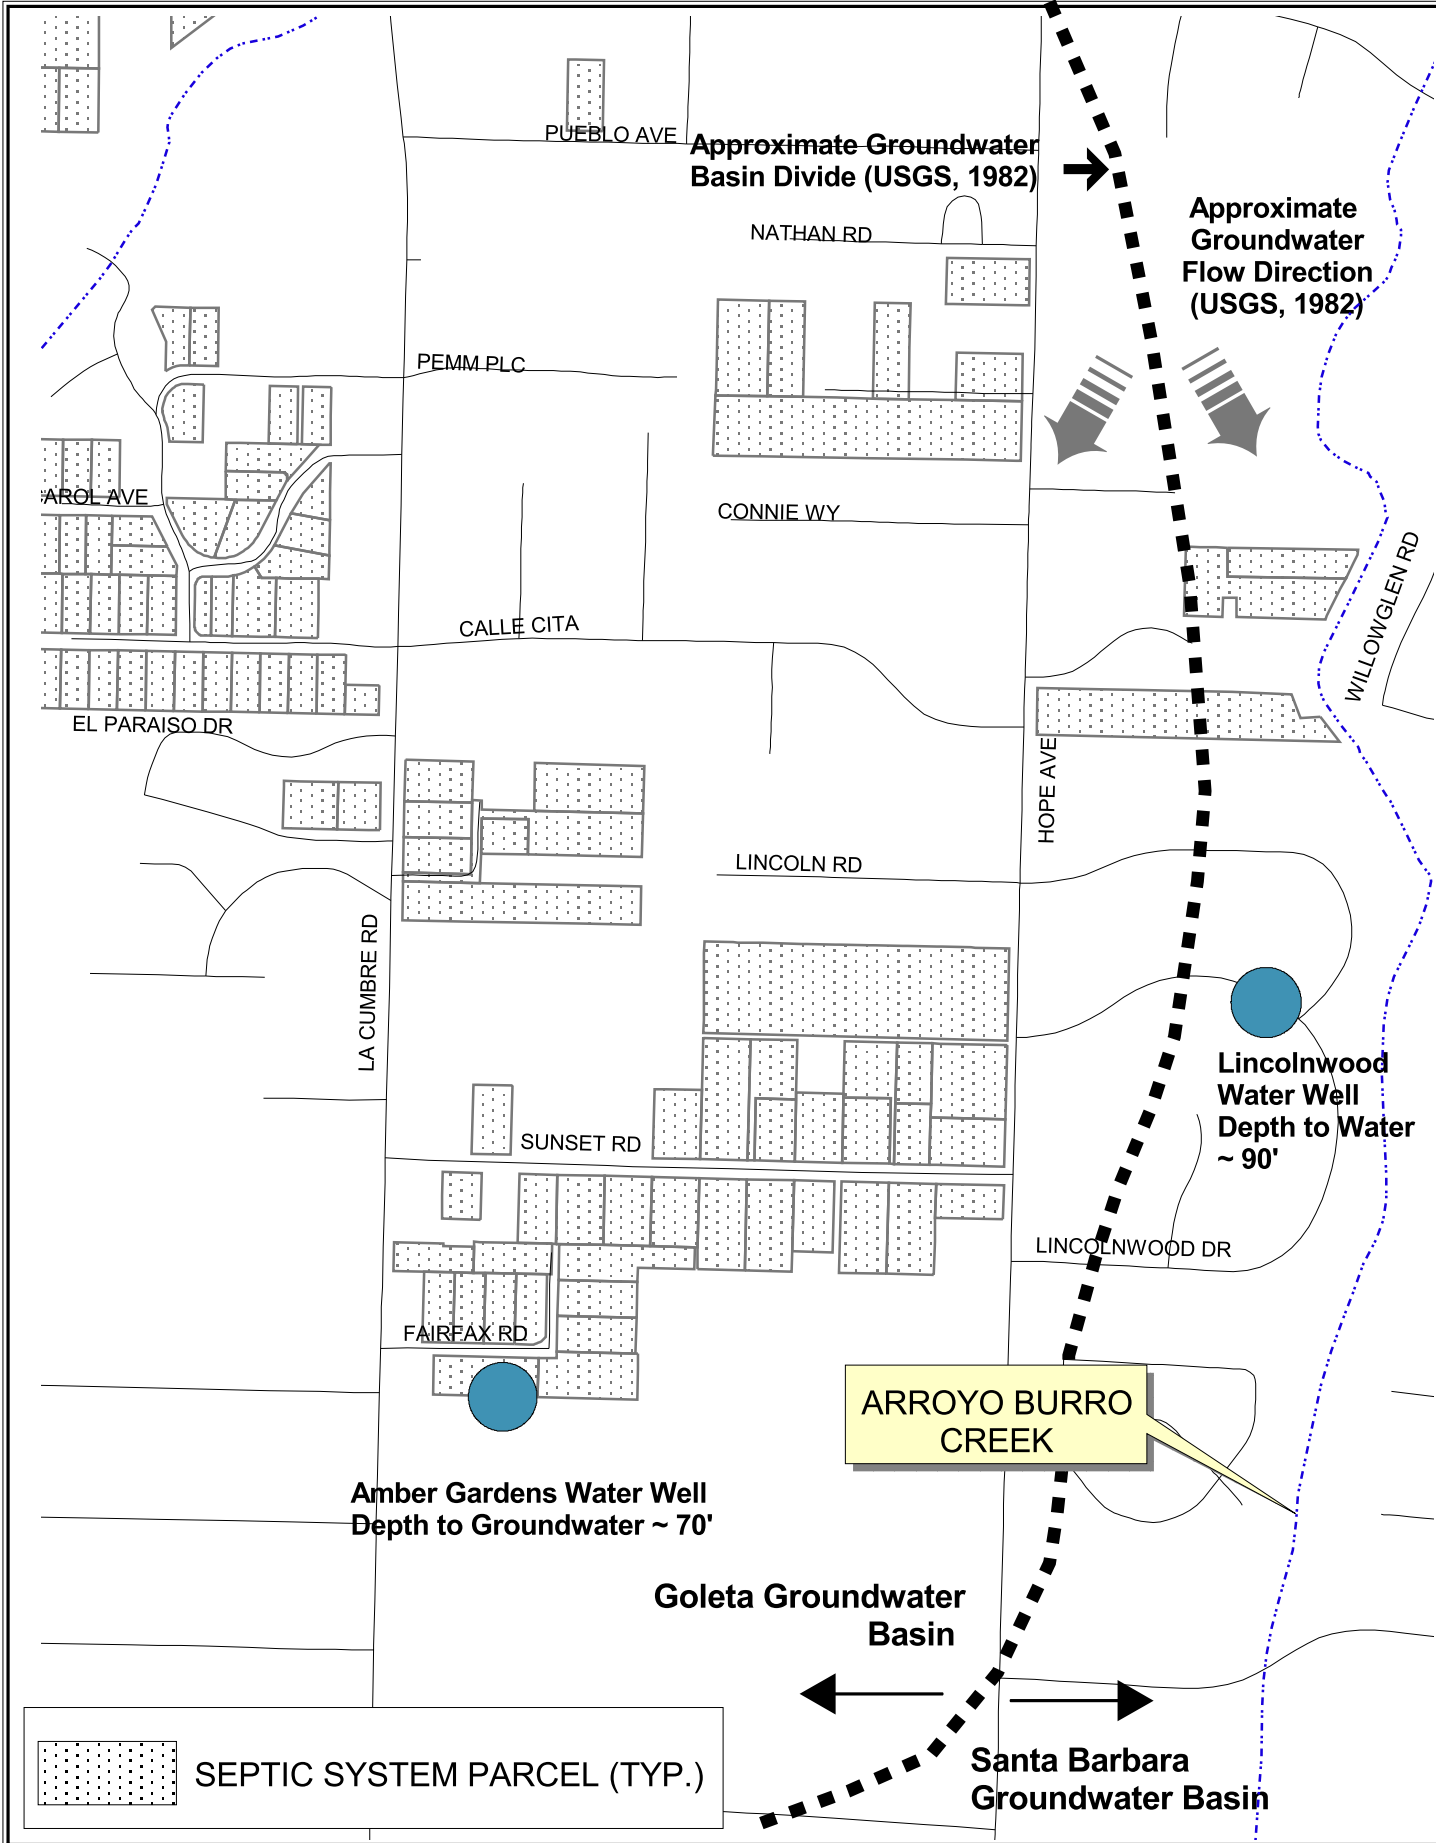
**FIGURE  
7-4**

2. **Sunset Road/Carol Avenue Area.** Nitrate data for the Amber Gardens and Lincolnwood Subdivision water wells in the Sunset Road/Carol Avenue area of Santa Barbara show an increasing trend in nitrate concentration over the past 20 years, as displayed graphically in **Figure 7-3**. A map showing the location of these wells in relation to the septic systems in the Sunset Road/Carol Avenue area is provided in **Figure 7-4**. Also shown are the approximate groundwater flow directions in the area. As can be seen, the Amber Gardens well lies downgradient of the main concentration of septic systems in this area, which is otherwise primarily an urbanized sewered area. The Lincolnwood well lies approximately at the groundwater divide (between the Goleta and Santa Barbara Basins) according to a 1982 U.S. Geological Survey study; and the recharge influence of septic systems is not as clear for this well. However, there may be localized drawdown effects from the well that are not reflected in the 1982 USGS study.

According to available record, many of the systems in this remaining “pocket” of septic systems utilize drywells. The water depth reported in the supply wells ranges from about 70 to 90 feet. Given the dense concentration of septic systems on relatively small lots so close by, there is a reasonable likelihood that the elevated nitrate concentrations in these wells is due mainly to septic system discharges.
