Inspection Report for John Smith

Property Address: 123 Main St, Anywhere, BC V1Z1Z1

Gold Star Home Inspections

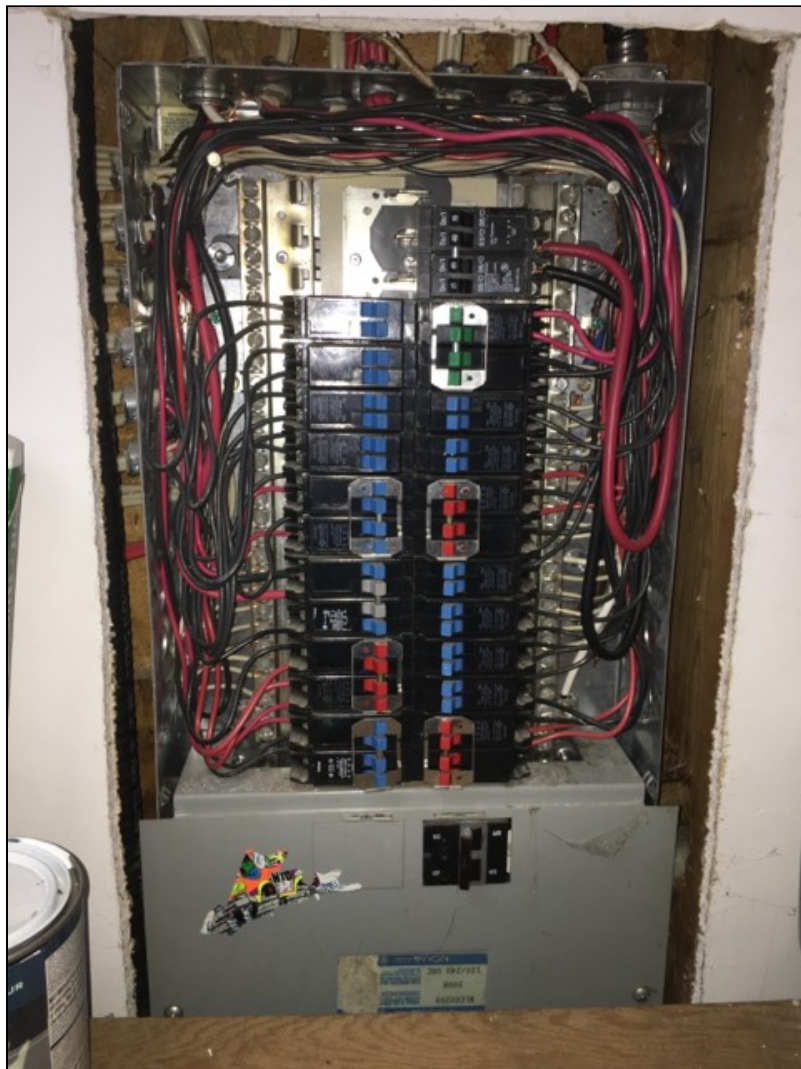
8.2 Item 3(Picture) Inside panel

Electrical panels should have three feet of clearance in front of them and one foot either side to provide access during normal and emergency access situations.
