REPORT NO: BNR32-XXXXXX

1990 NISSAN SKYLINE GT-R NISMO (SAMPLE)

Report generated on 2020-05-14

CONDITION SHEET & PHOTOS

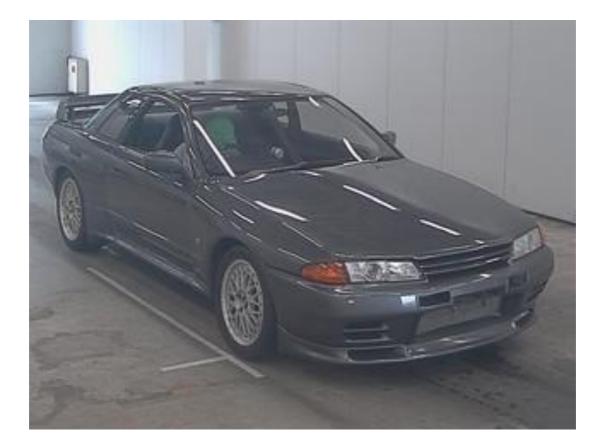
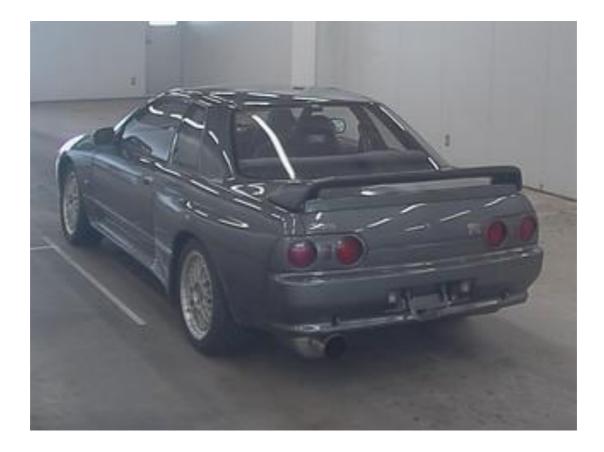
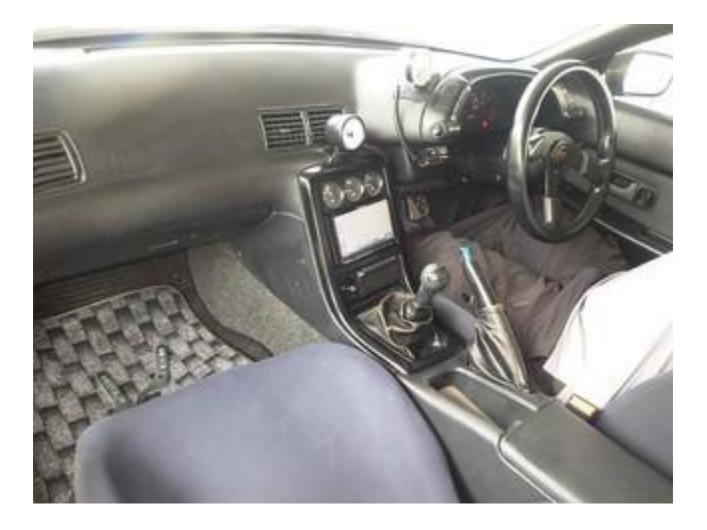
** Verified Photos

Hood has been replaced XX

Front right fender replaced XX

Front left fender replaced XX

Repair history on both left & right body W
