Repairing TR6 Taillight Sockets

TR6 Taillight Sockets

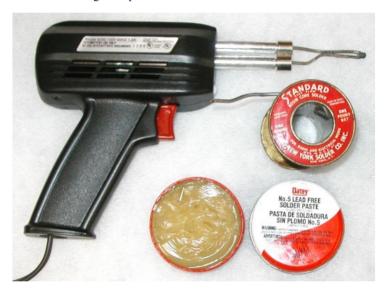
The tools I use for the actual soldering are shown in next photo. If a soldering gun is used, a minimum of 100 watts is required. If you are lucky enough to have one of the big old irons with the large copper tip, great! The copper tip stores the heat so a smaller heating element, like 30 or 50 watts is adequate. You just have to wait a while for the tip to reach operating temperature. Don't use a propane torch; you'll melt the plastic parts of the socket. Rosin core electrical solder is used. The solder diameter shown here is larger than recommended; I normally use a much finer diameter solder but couldn't find that roll when taking these pictures.

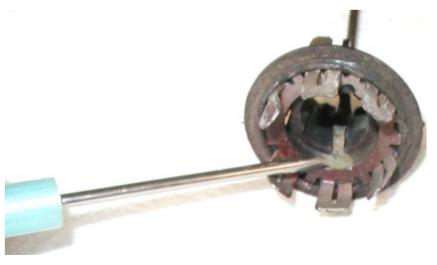
The flux in the can is usually found in the plumbing section of the hardware store, Home Depot, etc. A small screwdriver is used to put a small amount of flux in the joint.
