TR250 & TR6 Steering & Suspension Adjusting Rear Suspension Camber

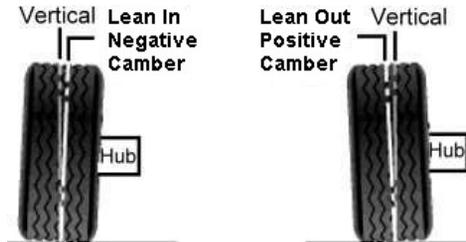
The concept of camber is illustrated in the following sketch. The most common camber misalignment is excess negative camber, where the top of the wheel leans in toward the car.

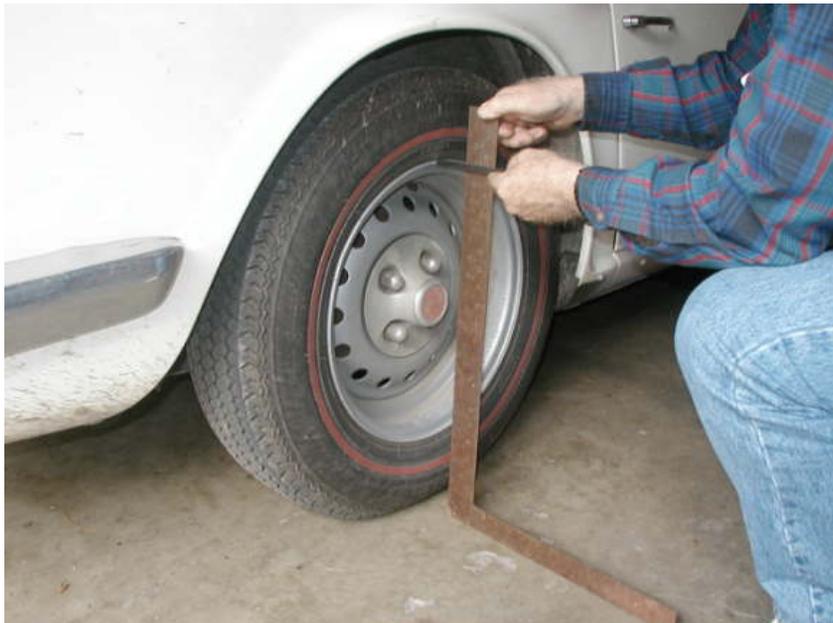
Measuring Camber: The first thing I did is determine if the camber is misaligned and if so, how much and in what direction. (Remember, if it ain't broke, don't fix it --- or, don't treat a well patient cause you might make him sick.) All that is needed to get a rough measure of the camber is a flat surface such as a garage floor, a large square and a ruler, preferably calibrated in tenths. The next photo shows these tools in action. (Notice the clean hands, almost like a surgeon.)

Next, the square is set on the floor and positioned near the tire with the vertical side of the square aligned with the center of the hub and as nearly vertical as possible. Oh, forgot to mention to remove those wheel trim rings. Next, measure and record the distance between the square and lip at the top of the wheel. Then, without moving the square, measure and record the distance between the square and lip at the bottom of the wheel. Next, subtract the measurement at the top from the measurement at the bottom. If the two measurements are equal, then the camber is zero, great! If the difference is negative (top measurement larger than the bottom measurement) the camber is negative; the top of the wheel is leaning in. A positive difference indicates a positive camber; the wheel is leaning out. I take three sets of measurements for each side. If the computed difference varies more than ten percent on one side I keep taking the measurements until I get consistency. One more measurement that is needed is the diameter of the wheel between the points where the other two measurements were taken. My wheels measured 16 1/8 inches. The subsequent calculations work only if the diameter and the other measurements are in the same units (inches, feet, millimeters, furlongs, etc). I also measure the height of the lip of each fender (both front and back) directly over each wheel at the same time I take these measurements.

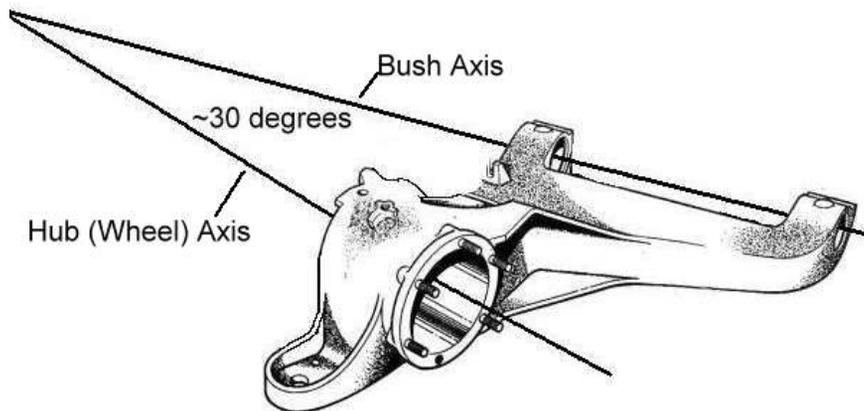
If you look closely at the sketch you'll see that the axis of the bushes is not parallel to the axis of the hub that fits in the round cylinder with the studs protruding. The next sketch shows this more clearly. Because of the ~30degree angle between the bush axis and wheel axel, as the trailing arm moves up and down the camber changes. For example, when load is added like people getting in, the back of the car goes down and the camber changes in a negation direction. A slight positive camber with no load will give a nearly vertical wheel under moderate load.
