Archaeological Excavation and Repair at Nordy Bank Hillfort, Clee Liberty

| Project | Historic Landscape Survey and Audit of Clee Liberty Common |
| Doc ref | 034-NordyBank-fieldwork082021-v1.0.docx |
| Author | Matthew Williams |

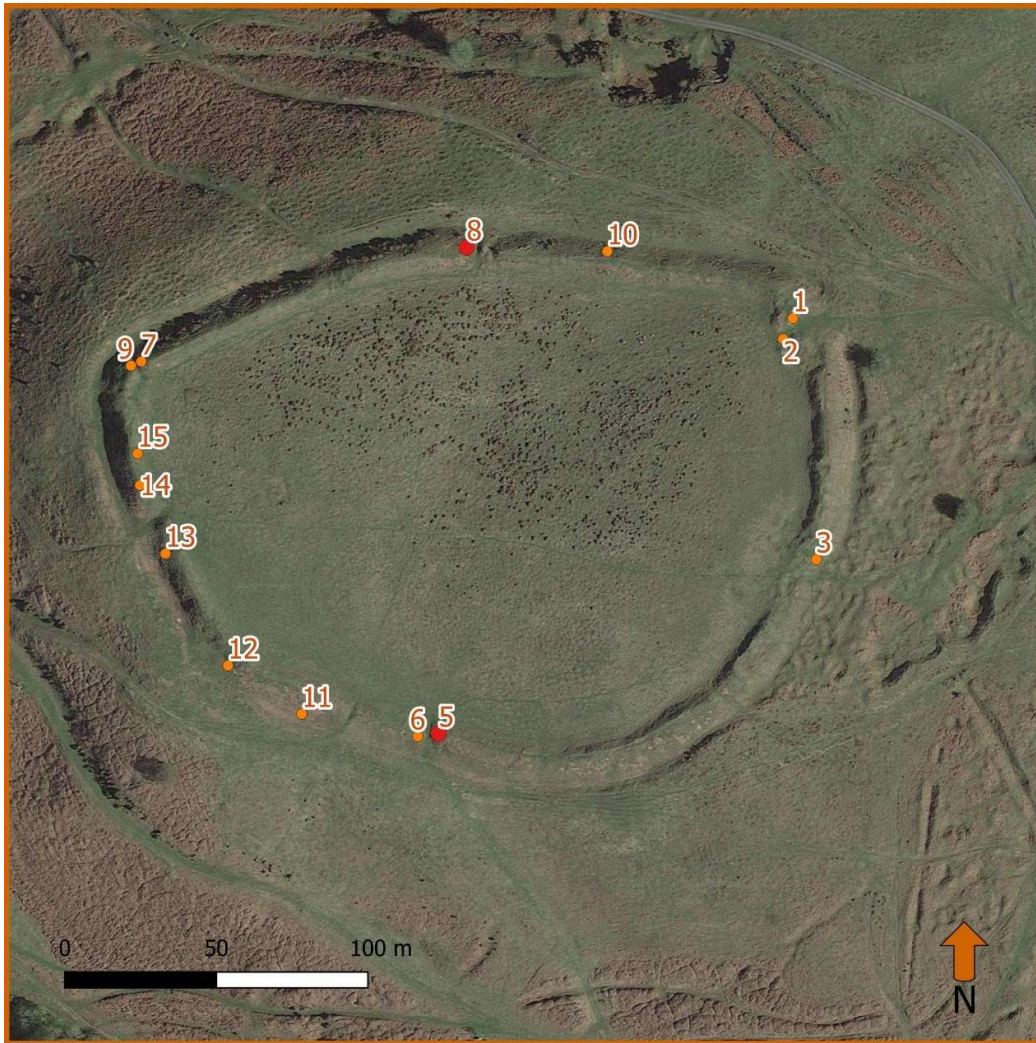
Fourteen scrapes were identified during the work (numbered 1 – 3, 5 – 15). Eight scrapes were identified in the method statement but no. 4 could not be located on the ground when the work started, and has therefore been voided. A further seven small scrapes or areas of damage were identified and these were repaired. The scrapes are shown in figure 2.

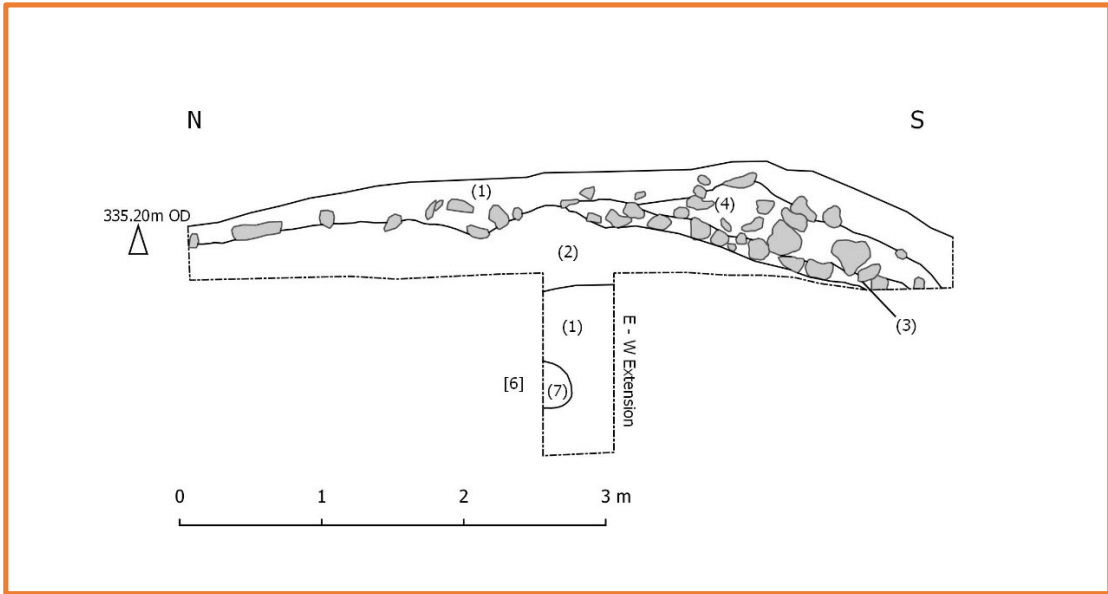
Figure 3 - Scrape 5 section 1

The results from the main section show a large homogeneous deposit of clay (2) forming the core of the rampart. It is clean and there are no obvious laminations, indicating it was probably deposited quickly e.g. by an organised workforce. Some clay may have come from the ditch excavation on the outside of the rampart bank, although most must have been imported as much of the ditch appears to have been cut through rock. The profile across the top of (2) is uneven; this may be the result of structures on the bank or wear from a path.

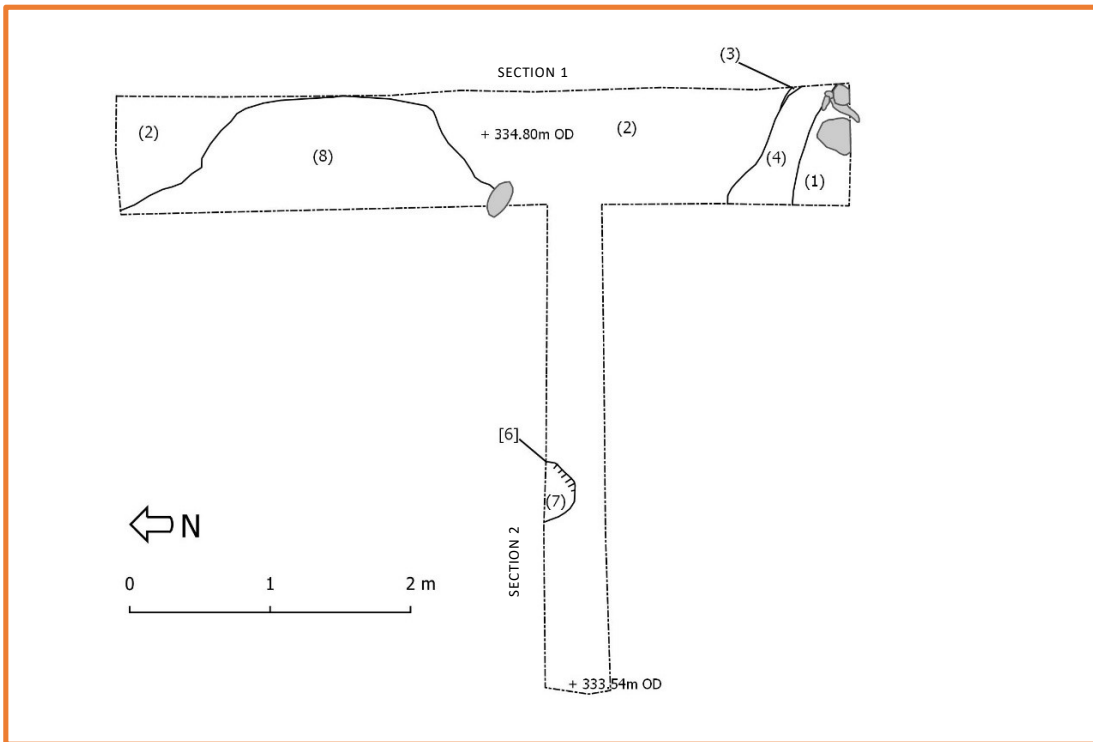
Figure 4 - Scrape 5 plan

Scrape 5 was located on the east side of the southern entrance to the fort (Figure 2). This is thought to be an original entrance as there is a break in the outer ditch (ie it was not excavated) suggesting an original, planned causeway into the fort (Historic England 2021).
