Subject: Geotechnical Investigation and Geologic Hazard Report Proposed Felisky Single Family Residence 79532 Ray Brown Road Arch Cape, Clatsop County, Oregon EEI Report No. 20-186-1

GEOTECHNICAL INVESTIGATION AND GEOLOGIC HAZARD REPORT

Proposed Felisky Single Family Residence 79532 Ray Brown Road Arch Cape, Clatsop County, Oregon

EEI Report No. 20-186-1

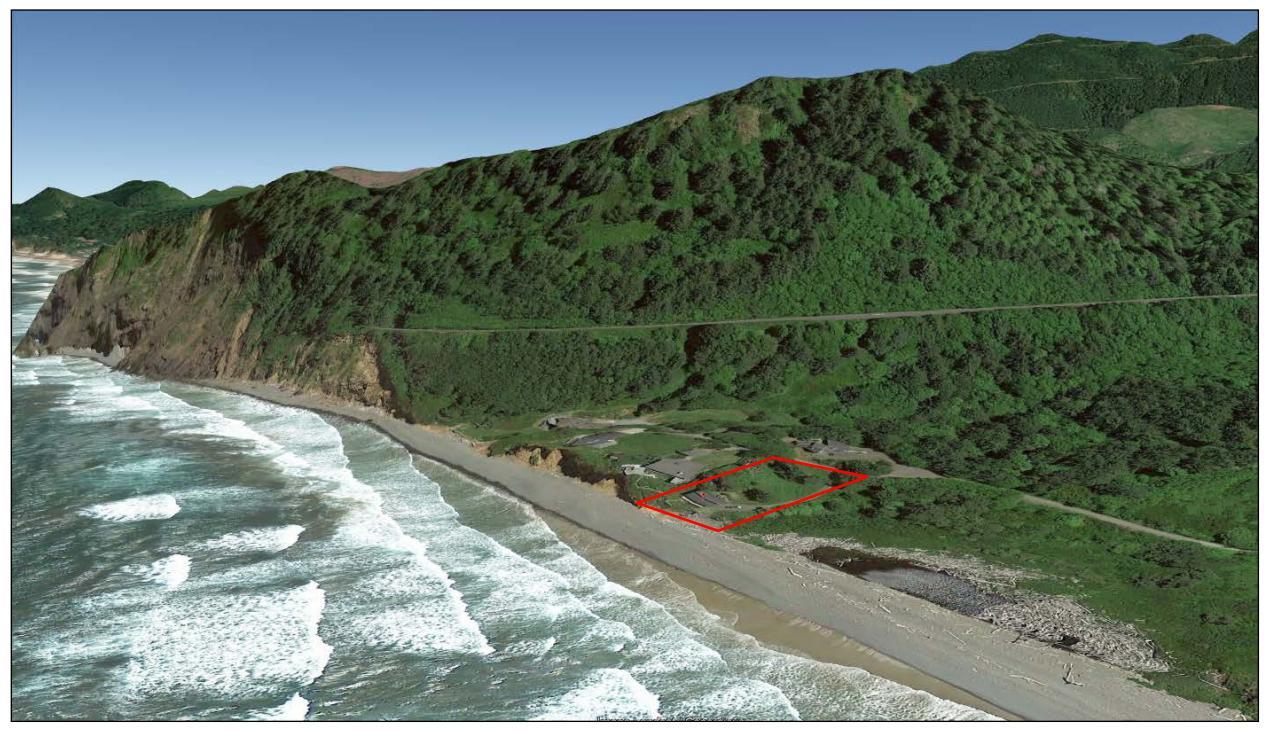
Figure 5: Isometric view of subject property and surrounding geography from Google Earth.

During our site reconnaissance, EEI Senior Geologist Ken Andrieu, R.G., walked along the beach immediately west of the subject property. The beach consisted of rounded basalt cobbles and exposed surfaces of landslide debris (i.e. silty sand with sandstone gravel and cobbles pieces) overlying what appeared to be intact weathered to decomposed sandstone (see Photo 5 below). Unprotected portions of the bluff display extensive signs of active erosion and mass wasting processes as evidenced by bare soil head scarps along the upper reaches of the bluff. See Figure 5 for an isometric view of the subject property.
