Vendor Pre-Sale Building & Timber Pest Inspection Report

In accordance with Australian Standard AS 4349.1 - 2007 and AS 4349.3-2010 32 Broadfoot Avenue Marsden Park 2765 New South Wales Australia

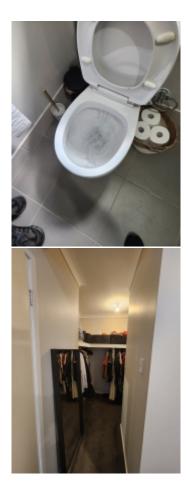
Ensuite

Defect Severity	Major Defect
Defect Classicfication	C - Water Penetration, Damp Related
Defective Item	Bathroom Shower
Defect	Moisture above permissible limits.
Comment	Please engage plumber to for detail inspection.
