Assessment Overview

Mere Point, Brunswick, ME

Mitchell Field, Harpswell, ME

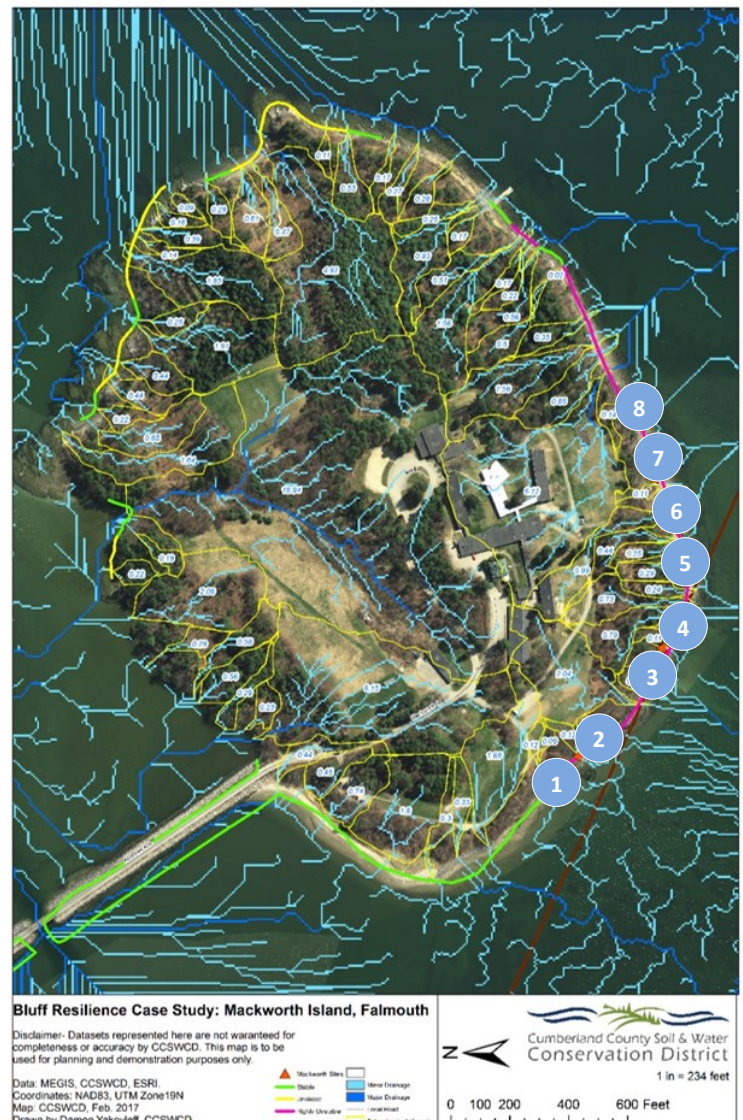
Figure 1. Eight Study Sites at Mackworth Island, Falmouth, ME

4	Coordinates: 70° 13' 59.900" W, 43° 41' 11.285" N			
C-Value: 0.30 210° SW Exposure	Trees/Grass 35-40' Bluff, Terrace @ 15' to 10' 15' (up) @ 47° 10' (up) @ 32°-90°	10'-90' Bank Failure	Undercutting, Bank Beach w/ sand	
Stable Material:	Some tree loss	Tree Loss	Flanked by Bedrock	
Rating:	Fair (2)	Fair/Poor (2.5)	Poor (3)	Total Rating: 8.5
5+6	Coordinates: 70° 13' 56.679" W, 43° 41' 10.476" N			
C-Value: 0.30 Vegetation change with wetland plants on banks 170° SW	150' -45° with distinct terrace @ top	80' Receding in places, 40- 48°	40' Undercut Bank failure, Sand at beach Hydraulic Change in soil 90° @ Cuts Otherwise 40-48°	
Stable Material:	N/A	N/A	N/A	
Rating:	Good/Fair (1.5)	Fair/Poor (2.5)	Poor (3)	Total Rating: 7
7	Coordinates: 70° 14' 6.506" W, 43° 41' 15.032" N			
C-Value: 0.30 Stormdrain Gully Outfall 116° SE	20' Cutback from shoreline 80°-90° 15" Diameter Clay	Clay Exposed, eroded pipe pieces from outfall failure 20' Back. 15' Wide undercut	Toe is stable, due to material Water Running Granite

Stable Material:	N/A	N/A	N/A	
Rating:	Poor (3)	Poor (3)	Poor (3)	Total Rating: 9
8	Coordinates: 70° 13' 52.056" W, 43° 41' 11.612" N			
C-Value: 0.30 Gully Cutback 30' to terrace 180° S	60' Back, 30' Wide, Loam Soil, Tree Failure, 75°, Undercut Failure top 20'	Very Wet, Swamping. Trees missing, Hydraulic Soil Change, Plants are wetland, 12-30° stepped	Sand-Cobble beach, framed by bedrock, 80-90°	
Stable Material:	N/A	N/A	N/A	
Rating:	Poor (3)	Poor (3)	Fair/Poor (2.5)	Total Rating: 8.5

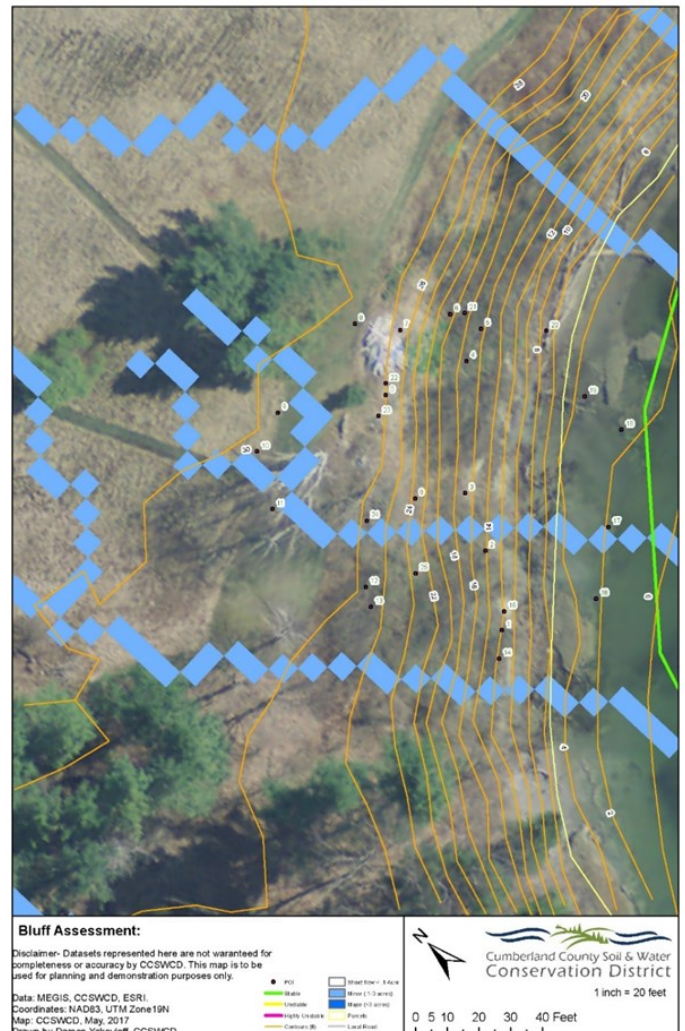
Figure 1. Mere Point Case Study Location, Brunswick, ME

Top Perimeter: 200 feet
Toe Length at high tide: 185 feet
Vertical height from high tide: 15 feet
Conditions observed: The location has a large mass wasting failure.

Three large trees visible at the top of the bluff in the 2007 aerial imagery (Figure 1) and through spring 2016 have slid downslope and maintained upright growth by holding the failure block together during movement. These trees are birch and scotch pine, all of which are growing and appear to be healthy. Reduced vegetation in the upland area has reduced any potential for root structure to assist in binding soil near the bluff-upland interface. Smaller herbaceous bushes have also moved with the failure. Some have continued to grow upright, while others are currently growing at an angle. This is likely due to the shallower root structure of these plantings.

- Plant additional woody and herbaceous planting throughout the terraces of the failure.
- Establish both woody and herbaceous vegetation in the upland areas of the bluff.
- Consider heavy planting in the concentrated flow path areas with plants that will provide large water absorption in the vadose zone.

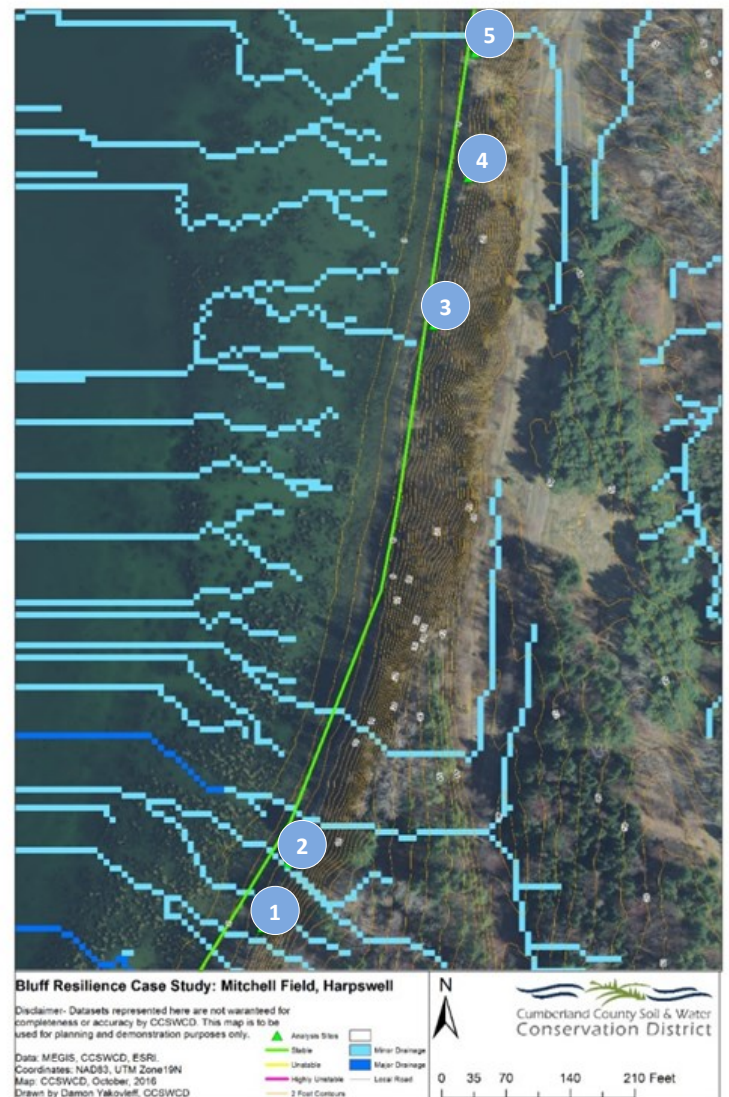
Figure 1. Five Study Sites at Mitchell Field, Harpswell, ME

The site has various shoreline failures ranging in size from upper bank shallow failures to toe erosion due to wave scour. Five of these failures were analyzed, as shown on Figure 1. The largest shallow failure is located at study site 3 and is approximately 50 feet long by 20 feet wide.

- Upland top length:** 1,485 feet
- Toe length at low tide:** 1,060 feet
- Vertical height from high tide:** 49 feet (15 meters)
- Conditions observed:** Multiple top of bank shallow failures and multiple toe erosion sites.

Site	Treatment Concept
1	Stabilize toe and lower bank. Mitigate surf runup.
2	Stabilize toe and lower bank. Mitigate surf runup.
3	Stabilize upper slope with vegetation. Investigate hydrology runoff pattern in upland.
4	Stabilize toe and lower bank. Mitigate surf runup.
5	Stabilize toe and lower bank. Establish vegetation in lower bank.
