Robust Internal Thermal Insulation of Historic Buildings

Project no.:	637268
Project full title:	Robust Internal Thermal Insulation of Historic Buildings
Project Acronym:	RIBuild
Deliverable no.:	D3.2 (not yet approved by the European Union)
Title of the deliverable:	Monitoring Data Basis of European Case Studies for Sound Performance Evaluation of Internal Insulation Systems Under Different Realistic Boundary Conditions

Contractual Date of Delivery to the EC	31.01.2019 (M49)
Actual Date of Delivery to the EC	29.04.2019 (M52)
Organisation name of lead contractor for this deliverable	TUD
Author(s)	Peggy Freudenberg (TUD)
Participants(s)	DTU, RTU, AAU, UNIVPM, HES-SO
Internal reviewers	Morten Ørsager (EMA), Sébastien Lasvaux (HES-SO), Ernst Jan de Place Hansen (AAU)
Work package contributing to the deliverable	WP3
Nature	R
Version	1.0
Total number of pages	103
Start date of project	01.01.2015
Duration of project	31.12.2019

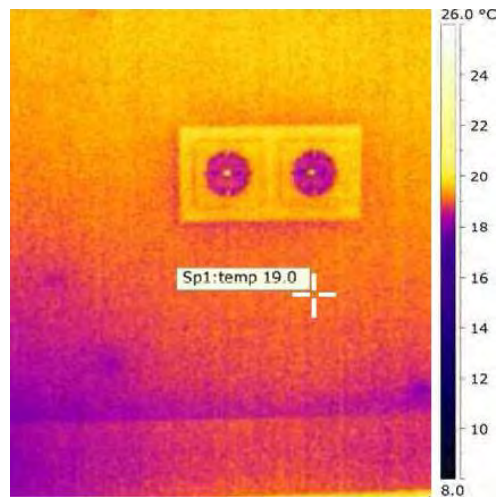
Figure 35: Impact of insulation system perforations on the temperature field. The wall was supplemented with power sockets that degrade the insulation layer. Dark areas in this infrared image show areas of lower temperature and give a hint to thermal bridges resp. leakages (Oswald, Zöllner, Liebert, & Sous, 2011).

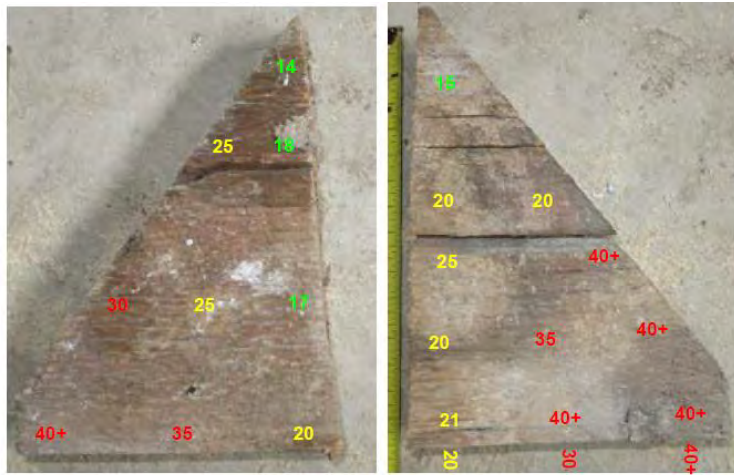
There are not only measurements, which evaluate the damage risk approaches but also measurement that analyse the spatial distribution of damage risk within the building and within the beam end itself. Measurements showed that the critical situation for wooden joist ends varied among different azimuth directions of the facades and between different positions within the beam end. A remarkably higher risk was given for beam-ends that suffer a reduced solar radiation (local shading, north direction etc.). Small-scale spatial distribution within the joist end is shown in Figure 36, where two samples from a southeast façade were extracted from a case study building. Higher moisture contents (red IDs) are given for the lower measurement points close to contact face with the masonry. Less critical is the upper area of the beam end and the front face.

Figure 36: Moisture content in southeast oriented joist end faces in a case study building located in Ottawa, Canada. IDs represent measurement points with a colour-decoded moisture content (red= high, yellow= moderate, green= low). The bottom side of the samples was the horizontal bearing surface. The samples show left and right side of the beam end. The beam ends were bevelled cut off at an angle of 45° and the long side was placed on the masonry, thus the long sloped side is was the front face (in contact with cavity air) of the beams in the masonry. All red (critical) points are located outwards (closest to the outer surface of the wall).

Another issue is the difficulty of sealing at the connection area between joist end and the wall construction. Joist ends underlay a shrinkage process. After installation, the usage conditions are typically dryer. In case of renewed beams, the initial moisture of the wood is higher and a drying process follows as well. The same is true for the masonry joints, which underlay the shrinkage process, too. Both shrinkage processes (in the masonry: joints and the wood: longitudinal and radial within the timber) cause cracks and thus an infiltration air change. This risk of unwanted air inlet is normally reduced with (precompressed) joint tapes, filling material insertion, collars etc. for the joist end connection. (Scheffler, 2016) The masonry quality (joints) should be inspected and improved additionally.
