Town of Orleans

Snow Library Current Facility Conditions

Hale Associates, Architects with Mary Braney, Library Consultant
Boston, MA

Executive Summary - Current Facility Conditions Report

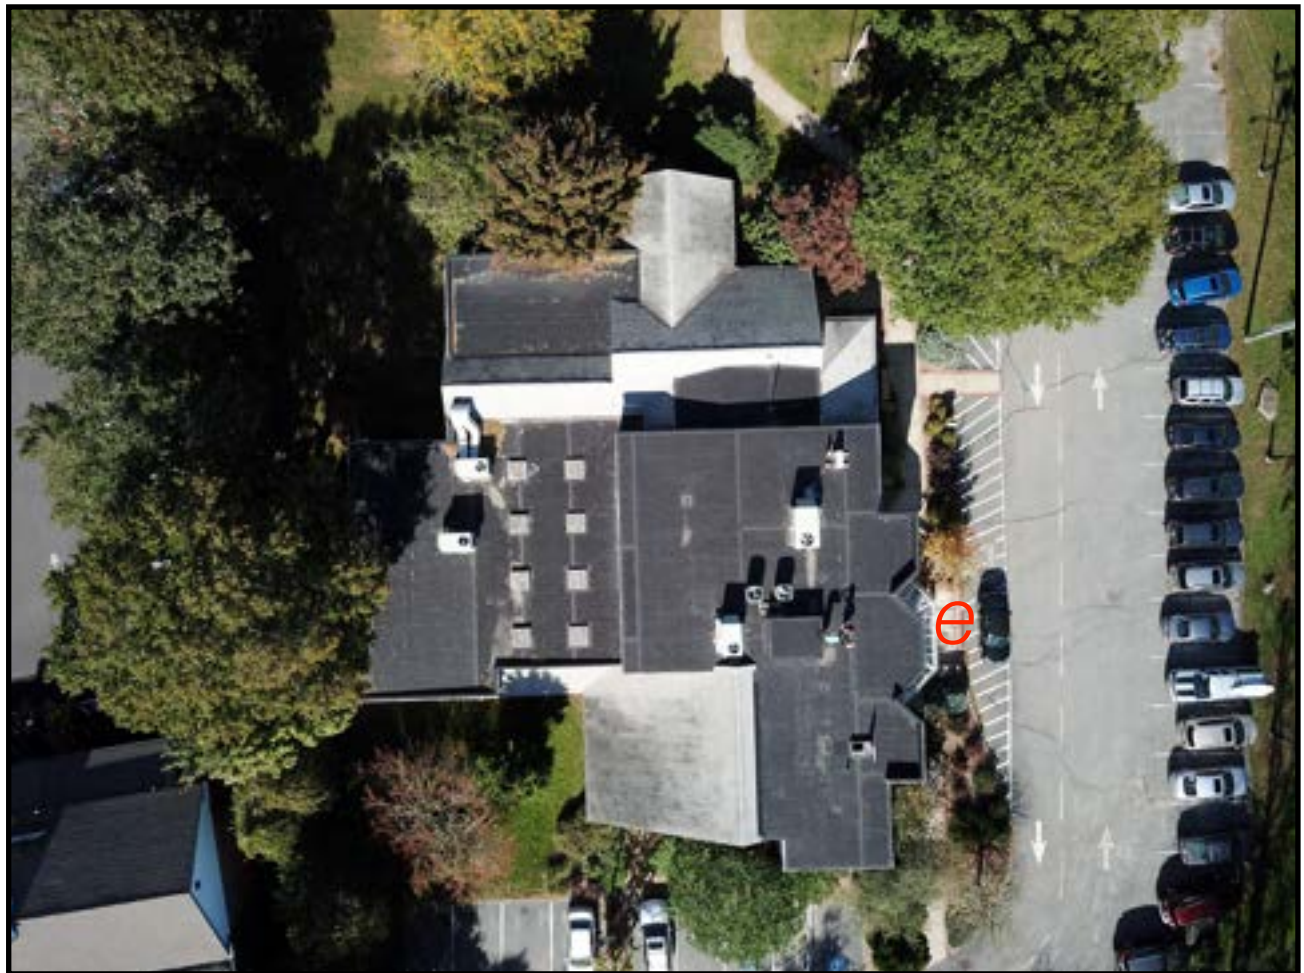
Rooftop view. Black areas are flat membrane roofing. Gray areas are sloping asphalt shingle.

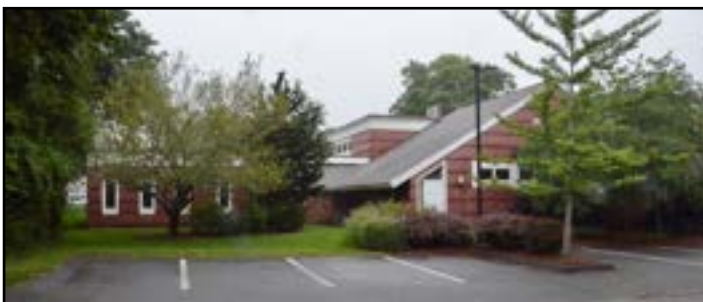
Rear corner (from rear Parking area)

Library rear: Meeting Room exit door (right) and Adult Reading Room (left). Students cut through this back corner to quickly access Main Street and the Friends Market. This is a very secluded pathway.

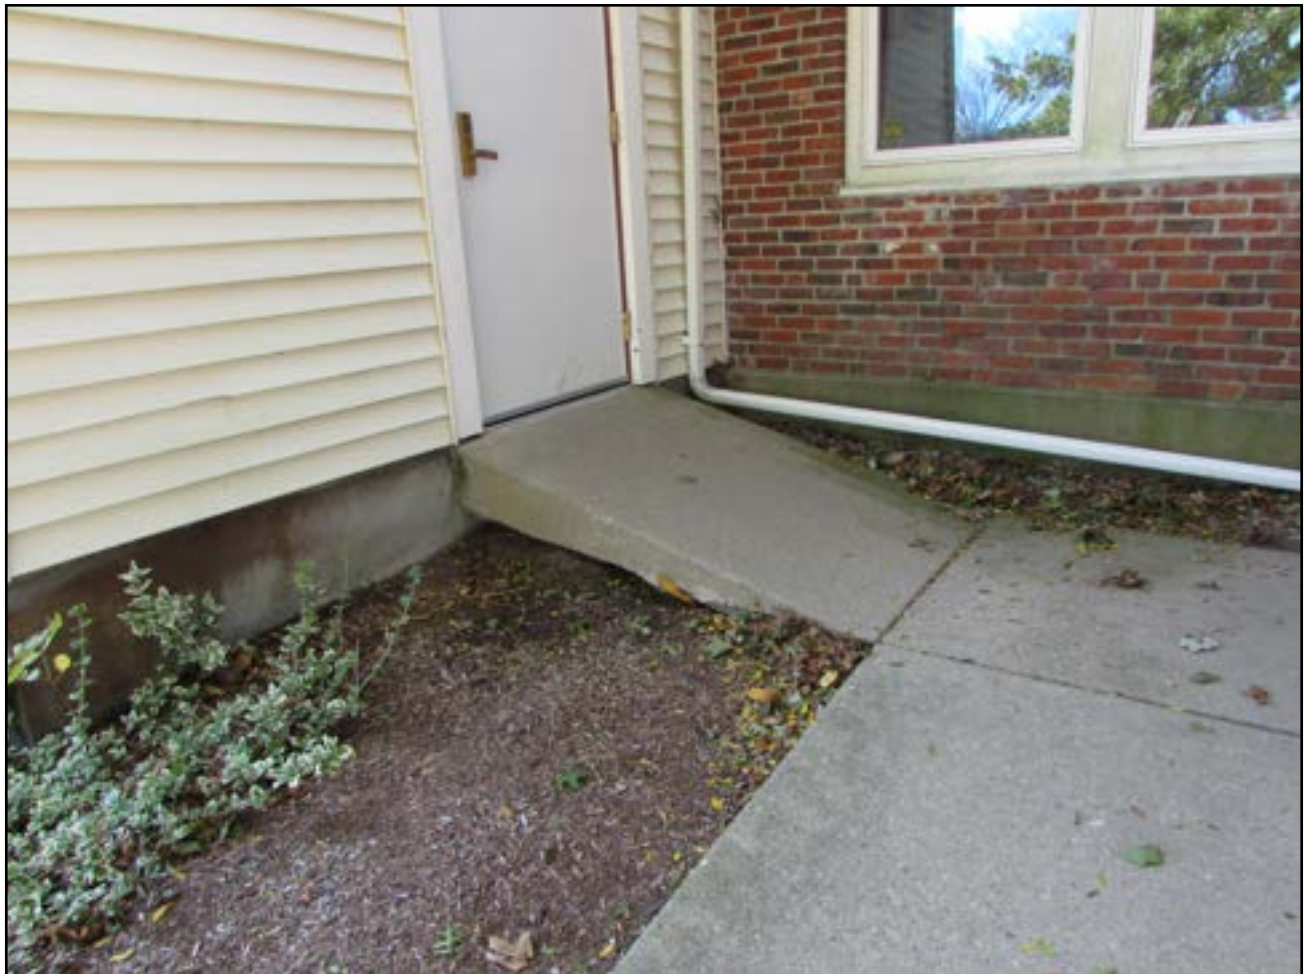
Service Entrance landing outside Receiving and Staff Work Room areas.

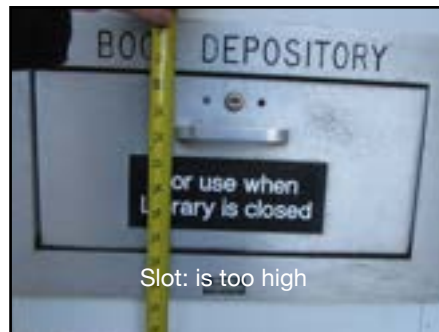
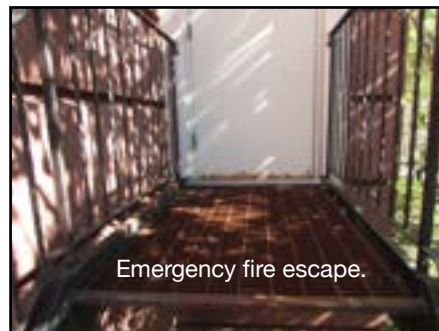
Emergency fire escape.

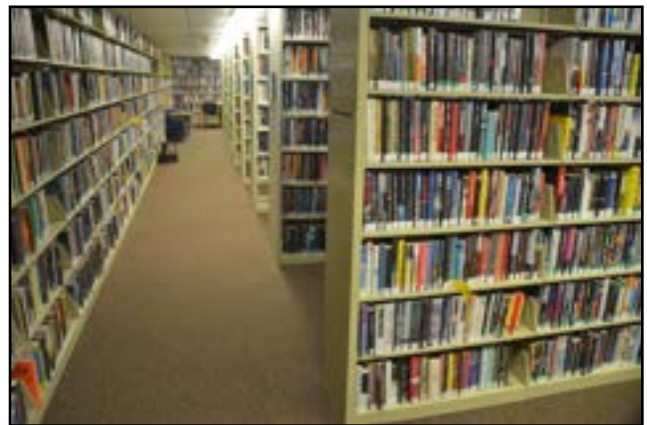
Adult steel stacks.

At the Snow Library, the existing Adult collection shelving has reached their maximum capacities and are becoming crowded and compromised, frustrating patrons who want to linger and enjoy the library. Adult book shelving units are maxed out, (ex.) forcing (7) shelf heights in the Adult Collections. This is extremely difficult for patrons who simply can't reach to 80" heights to fetch a book. In the Children's room seating and displays are at a premium.

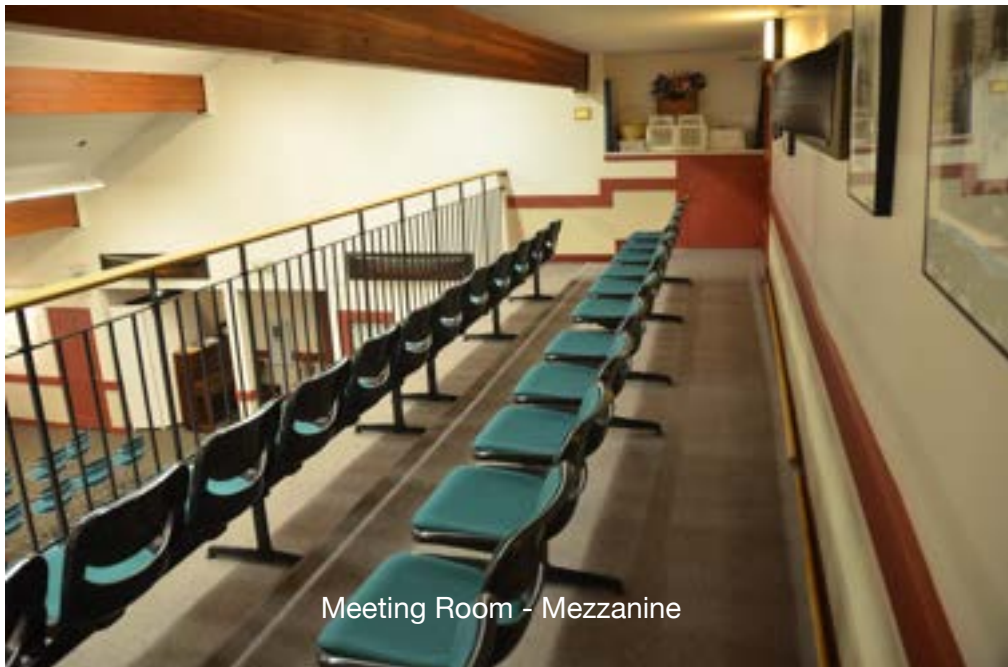
Meeting Room - Mezzanine

The Craine Meeting Room is very popular and in constant demand. Today's functioning capacity is approximately 80 persons, the future library programming calls for 200. It is heavily booked by the library and outside groups looking for adequate space - anywhere in town. Tables, chairs and equipment storage is teensy for a meeting room of this size that is expected to serve a wide variety of program furnishing configurations. The original architectural layout did not intend this room to be used as a meeting room.

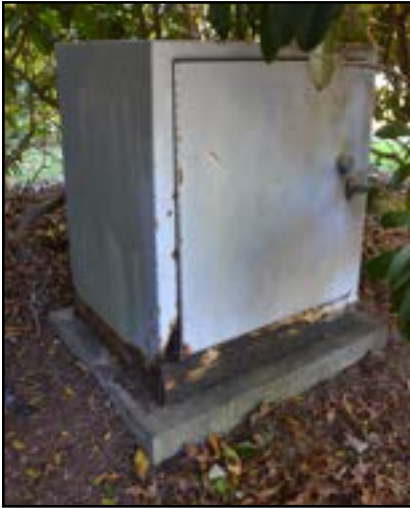
Book delivery box. (defunct)

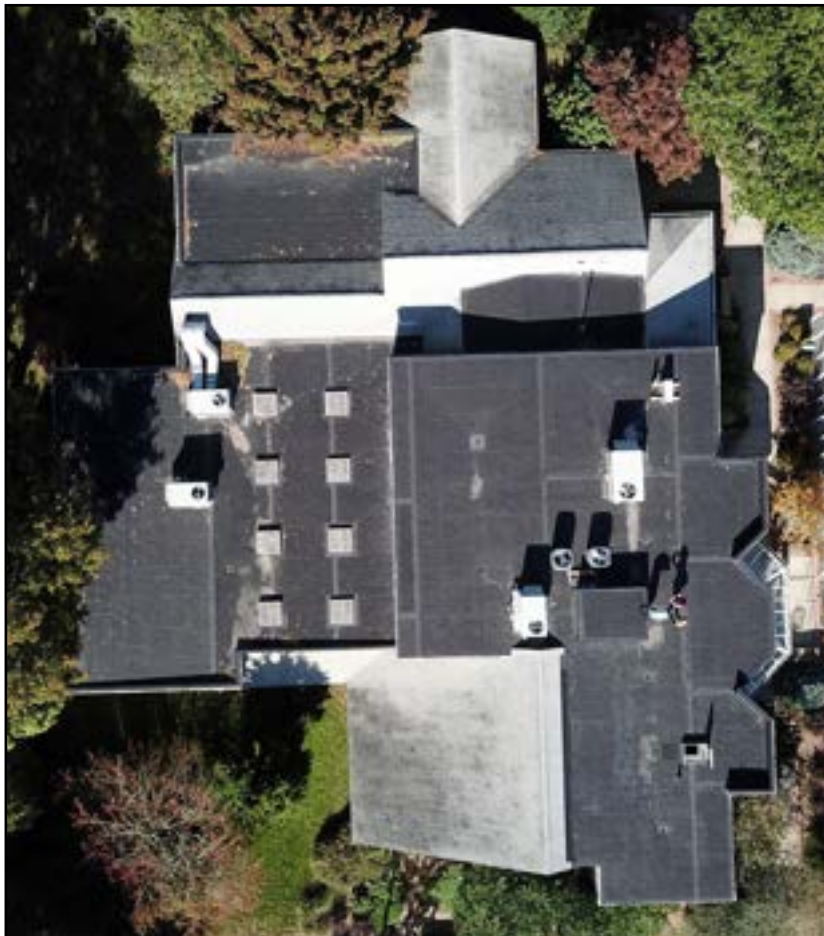
The Meeting Room, and sloping mansard and gable roof (gray) areas are finished with architectural asphalt strip shingles.

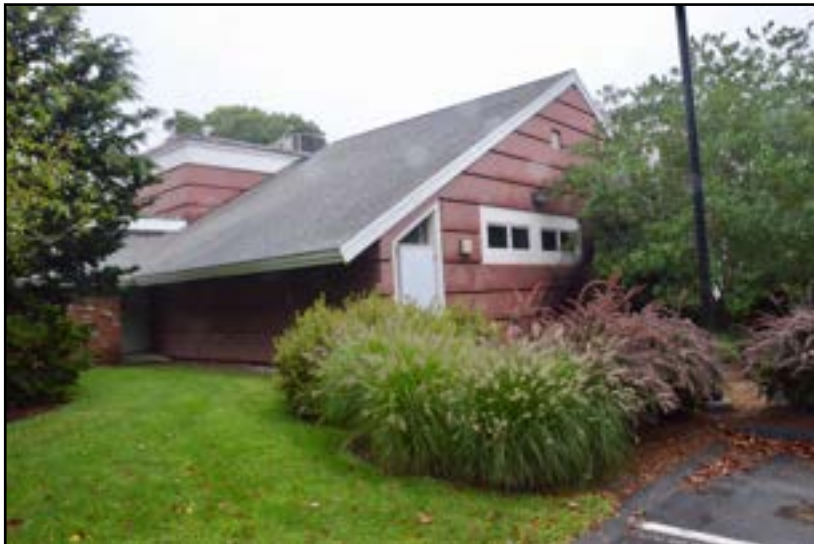
The 'Stucco' Exterior Insulation System used on the North, West and South exterior walls was specified for being inexpensive and for its thermal efficiency; but has been problematic to achieve water tightness, repair and maintain in the past.

In New England Exterior Insulation Systems are primarily used as a foundation insulation; but has gained popularity as a wall finish in low budget markets; and in warmer US climates.

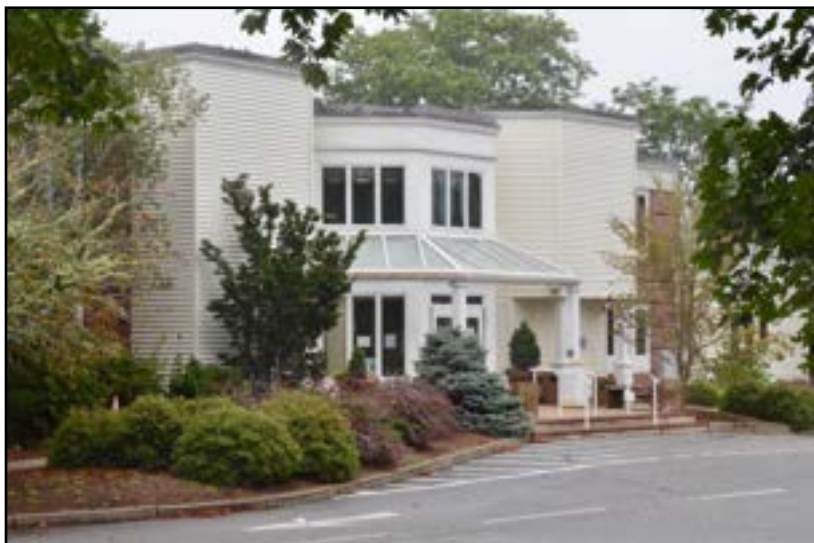
The Snow Library's entrance is distinguished by its use of low maintenance, inexpensive wall cladding; and a glass canopy rendering the entranceway in a 'dreamy' creamy color.

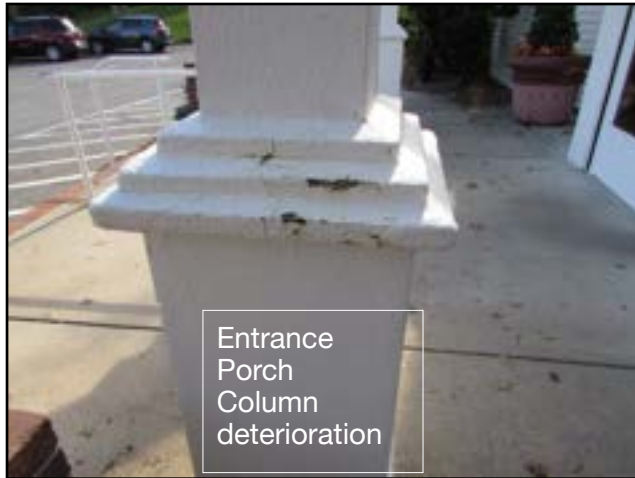
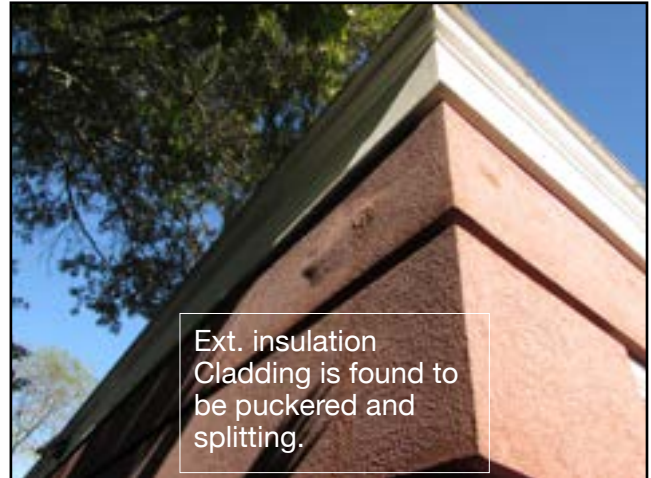
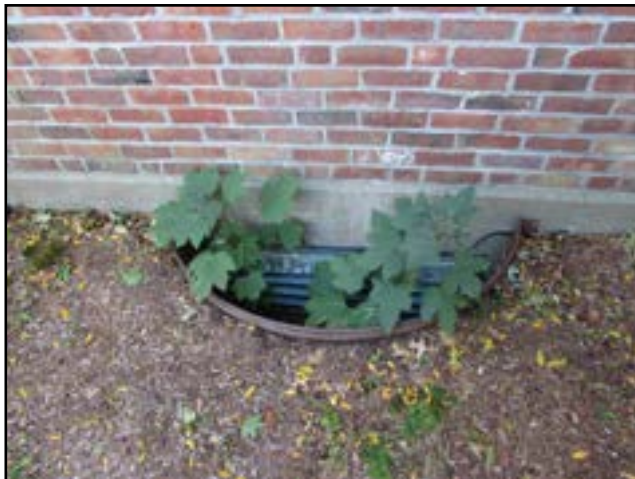
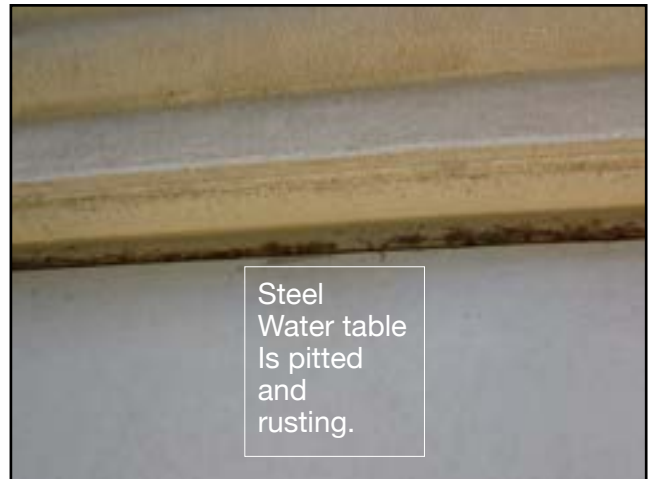
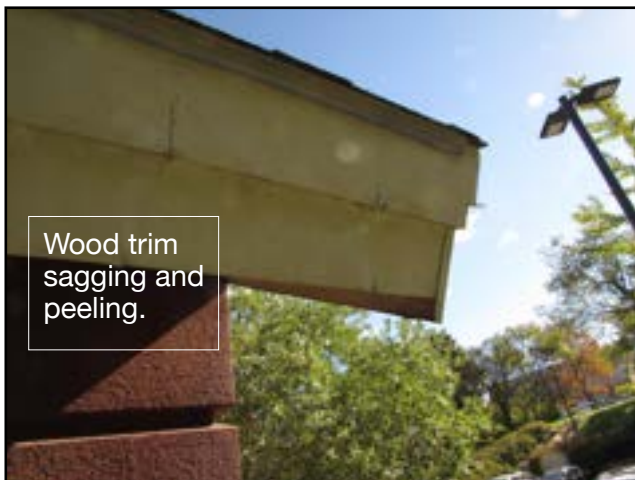
Exterior Envelope Conditions

The exterior envelope shows weathering typical for a structure that has been exposed to nearby Cape Cod salt air and humidity over a span of 27 years. All ferrous metals show considerable rusting.

Exterior insulation wall cladding is dull but in average condition. Light colored trim details show built-up stains and embedded soil and grime.

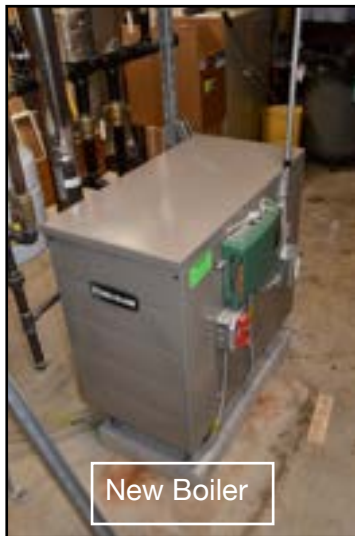
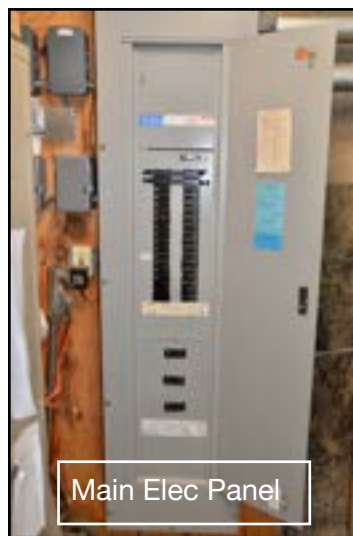
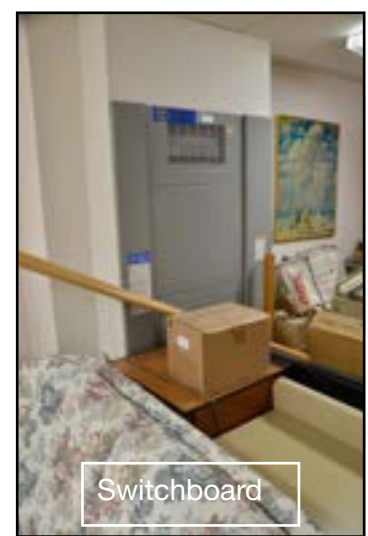
- The mechanical and technical systems at the Snow library although well maintained are unlikely to meet current Codes. The town's maintenance and replacement strategy has been to replace with current industry quality equipment as necessary.

- The Craine Meeting Room does not meet current Code requirements for make up (fresh) air requirements in public assembly, gathering-type spaces.

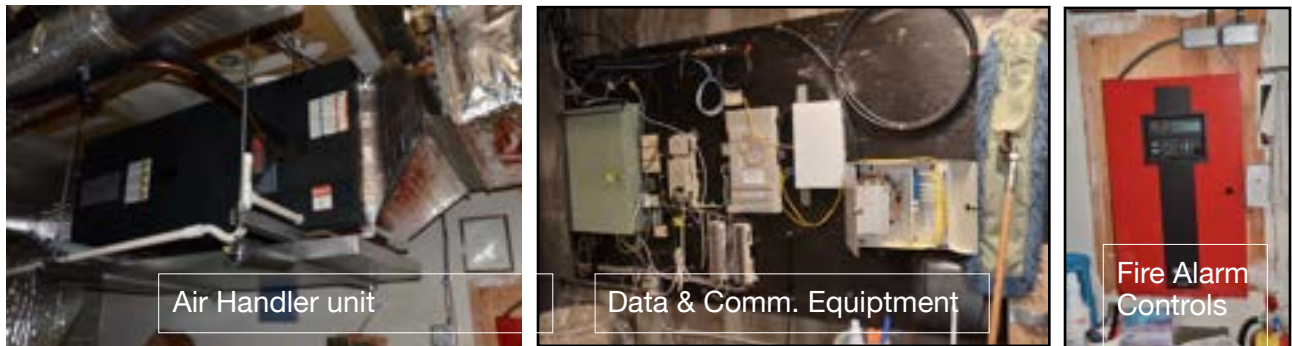
- In 2016 HVAC replacement equipment was installed including a hot water boiler to feed a baseboard heating system for certain areas of the library. An indirect domestic hot water system for potable hot water was added to the new boiler equipment .
- In 2017 new gas-fired rooftop units were installed. They meet original building specs but weren't selected to meet Orleans' newly adopted (and more stringent) Stretch Code requirements.

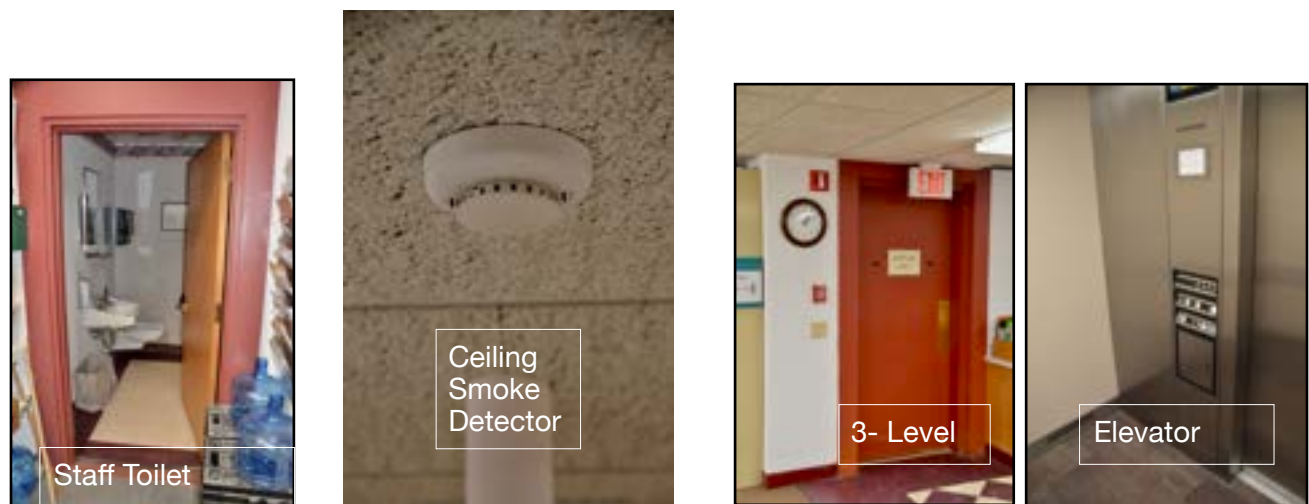
- The Staff toilet space is extremely tight and narrow, eliminating the possibility of ever becoming ADA compliant. (4) Public toilets are unisex style and primarily ADA code compliant. The three level elevator is well maintained and meets today's ADA requirements.
- The fire alarm system is comprised of a smoke and rate-of-temperature-rise sensor system. Currently, code requires all Assembly type structures over 7,500 gsf to have an automatic fire suppression system. There is none installed in the Snow Library.

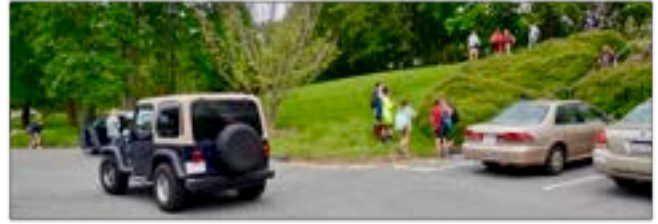
Students pour over the Library parking lot.
