Audit Report for December 30, 2021
Sewer Collapse and Wastewater Spill in the City of Carson

Los Angeles County Sanitation Districts

4 May 2022

On December 30, 2021, the Districts' 216th Street Relocation Trunk Sewer experienced a critical failure in the City of Carson causing a Sanitary Sewer Overflow (SSO) event that impacted local residents on 212th Street and caused closure of some local beaches.

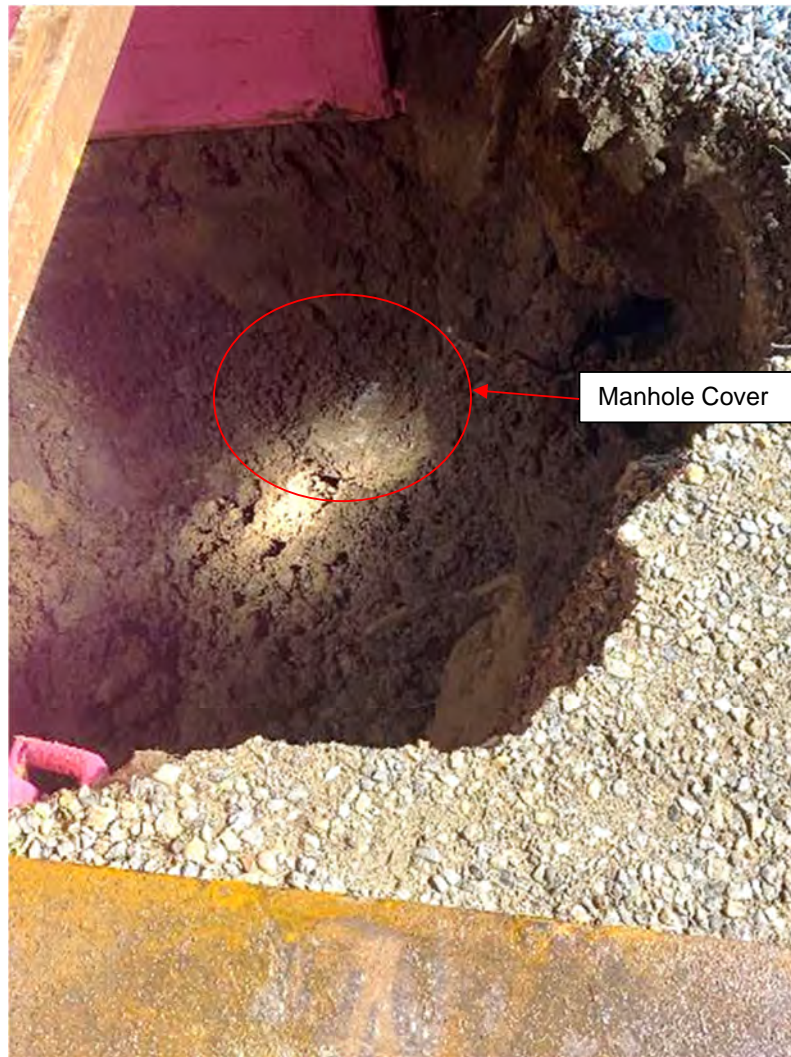
Photo 3-6 Excavation in the Failure Area

On January 14, 2022, GHD interviewed a Construction Management Section (CMS) staff member to gain an understanding of the collapse and restoration operations. Of note from this discussion was that the downstream manhole (476) appears to have collapsed on itself (the manhole cover was in about the same horizontal position but located several feet underground). This is illustrated in **Photo 3-4** (before the failure), **Photo 3-5** (after the failure), and **Photo 3-6** (during excavation). No manhole shafting was observed during excavation operations.

Once excavated, the CMS staff observed the pipe condition and noted that the entire crown of the pipe was collapsed, the walls were as thin as approximately 1-inch, and minimal reinforcement was observed. **Photo 3-7** shows the pipe condition when first exposed.

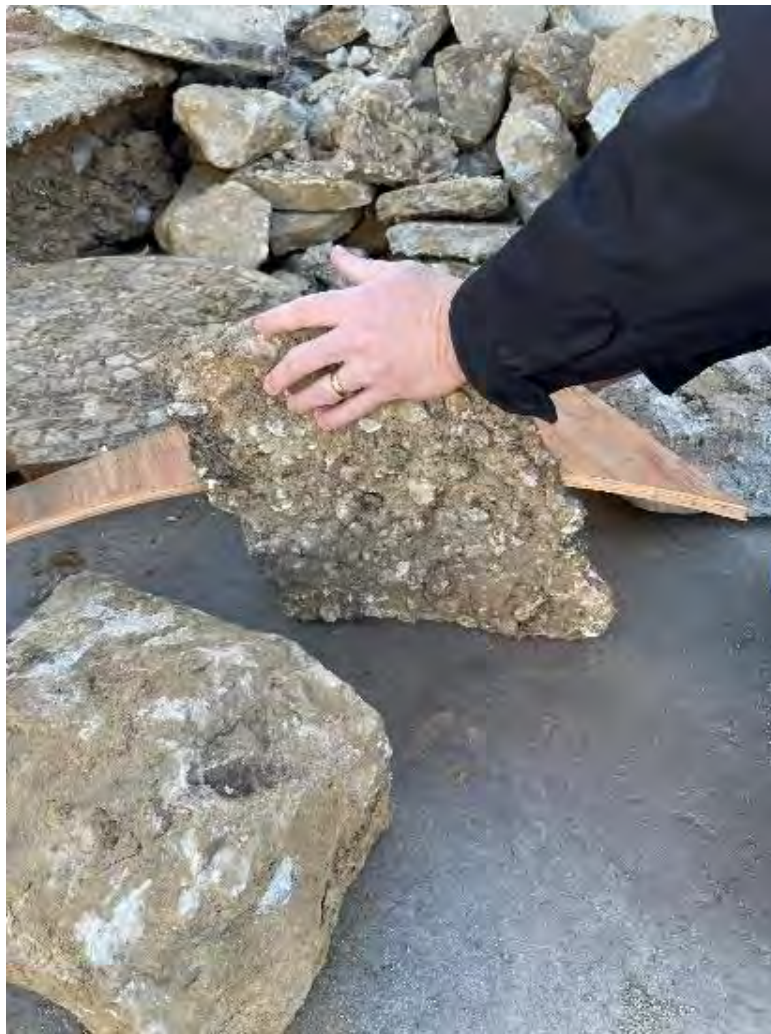
Photo 3-10 Corroded Pipe Section with Radius Template

Photo 3-9 shows a corroded pipe segment that has a wall thickness of under 1-inch. During the repair phase of the project, the CM group drilled a hole in the collapsed pipe below the spring line and measured a thickness of 3.5 inches, leading to a theory that the pipe walls were originally 3.5 inches thick. In an attempt to determine if the concrete debris could have been from the pipe or manhole shafting, two plywood templates were cut with radii of 27.5 inches for a 48-inch pipe with 3.5-inch thick walls and 21.5 inches for a 36" shafting with 3.5-inch walls (refer to **Photo 3-10**). No definitive determination of the outside wall diameter was established with the templates. Currently, 48-inch RCP typically has 5 to 6-inch-thick walls depending upon the design and manufacturer. None of the pipe pieces at the Compton Yard were found to have embedded reinforcement or rust stains from reinforcement. Later, core samples were taken from below the spring line of the existing 48-inch pipe installed under the same construction contract as the collapsed section and the thickness was measured to be 4.5-inches thick and reinforcement was observed in the samples (refer to **Photo 3-11**). This indicates that the collapsed pipe likely had 4.5-inch thick walls.
