Stapleton Rowhome Association
Hail Damage Evaluation
10045 Martin Luther King Boulevard
Denver, CO 80238
Farmers File: 5010168593
Haag File: 1121000002-128

Re: Stapleton Rowhome Association
Hail Damage Evaluation
10045 Martin Luther King Boulevard
Denver, CO 80238
Farmers File: 5010168593
Haag File: 1121000002-128

In accordance with your request, we inspected the Stapleton Rowhome Association buildings to determine the extent of hail-caused damage to the building exteriors and when the damage occurred. We inspected the sites on February 1, 2, and 3, 2021.

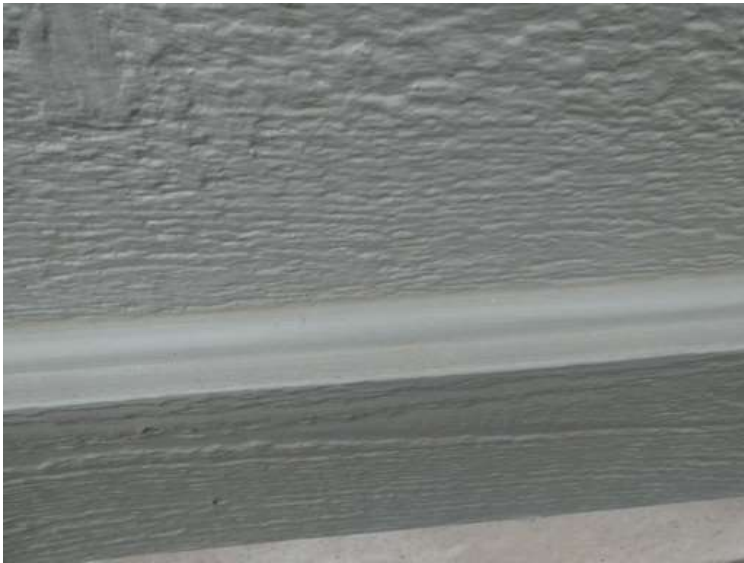
3. Building 01. Paint was not chipped by hail.

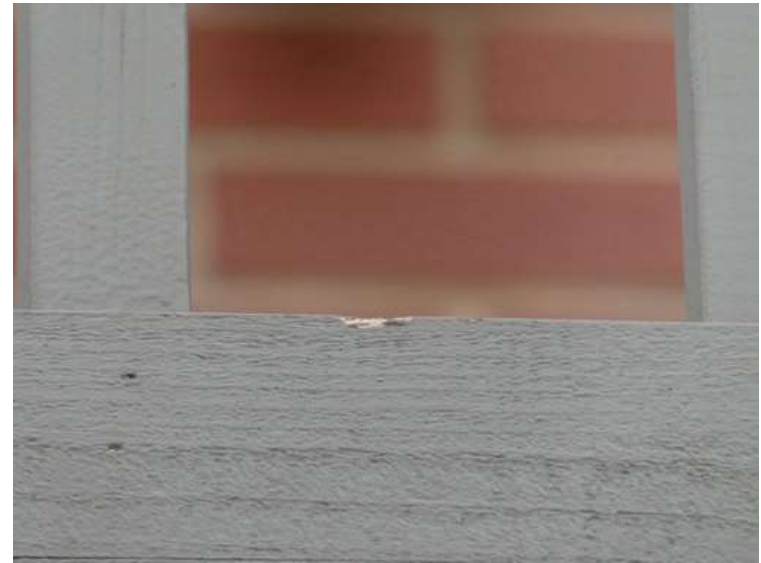
Hail chipped paint finishes on top surfaces of protrusions such as windowsills, trim pieces, and hand railings. Paint chips were most pronounced on south and west surfaces, but there also were isolated chips on horizontal surfaces on north and west elevations. Paint finishes on vertical fiber cement siding were not fractured by hail. Hail scuffed stain finishes on wood fences around backyards. The sills, trim pieces, railings, and fences can be repainted.

6. Building 01. Chip in paint on a railing.

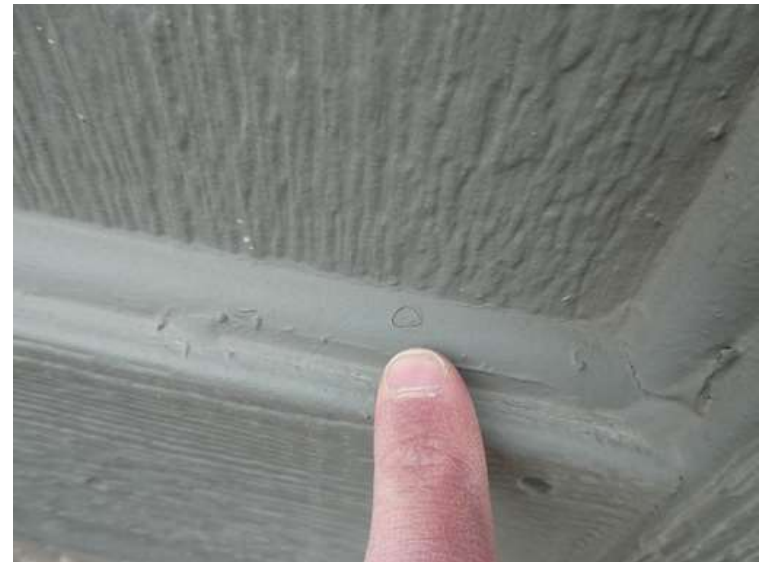
Hail chipped paint finishes on fiberboard windowsills on south and west elevations. Hail also chipped paint on a few north and east elevation windowsills. Paint finishes on vertical surfaces of fiber cement siding boards were not chipped by hail. Hail chipped paint on hand railings around balconies and rooftop patios. Hail scuffed stain finishes on fences around backyards. Several properties had painted iron fences with a durable factory-applied paint finish. Those paint finishes had mechanical scrapes from handling and from thermal affects where two pieces of iron were integrated, but the paint was not fractured by hail.

8. Building 01. Chip in paint from hail.

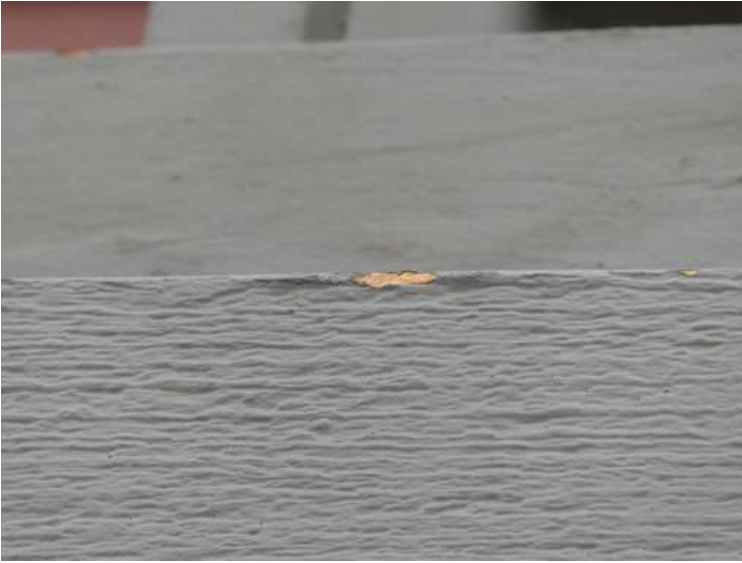
9. Building 01. Chip in paint from hail.

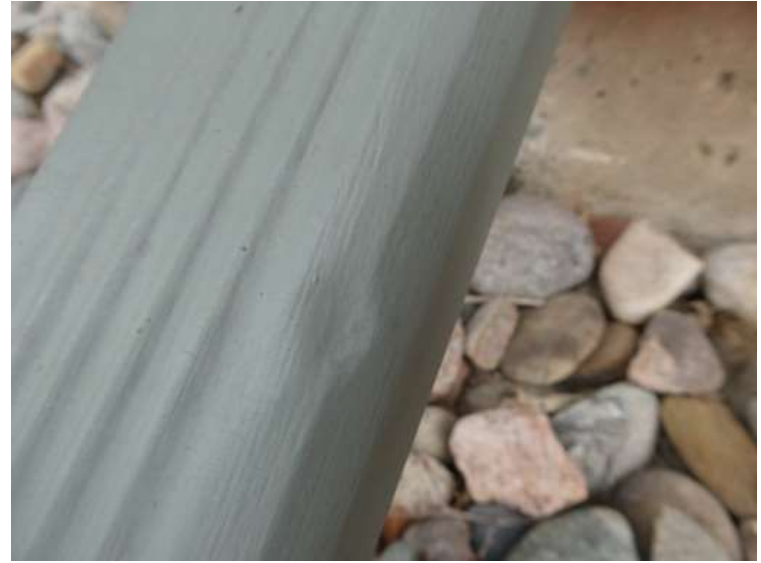
10. Building 01. Dent in a downspout extension from hail.

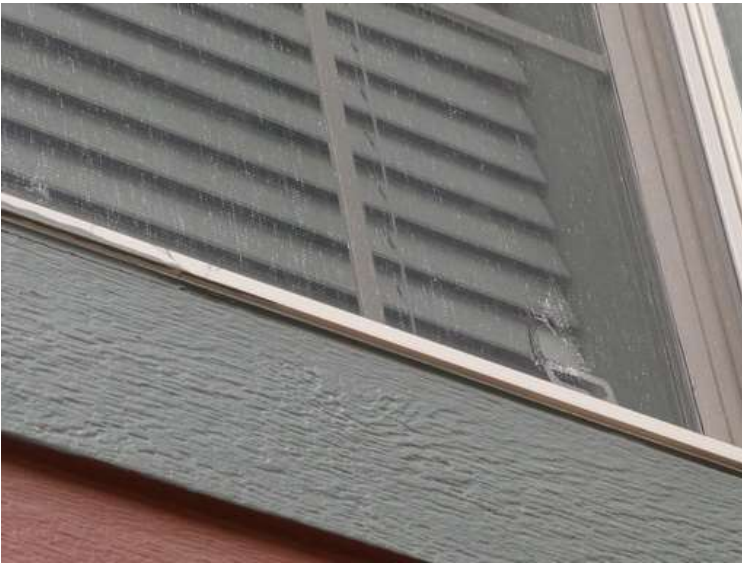
Impacting hailstones tore window screens on elevations facing each direction. Screens on south and west elevations had the most tears and the largest tears. Screens on north and east elevations had small tears or, in many instances, no tears. A few of the dwelling buildings had fractures in their vinyl window frames or in the beading of windows from hail. We did not closely inspect every window, but we confirmed fractures in frames of windows on Buildings 19, 20, 21, 22, and 24, and fractures in glazing bead of windows on Buildings 5, 6, 11, 12, 13, and 18. Hail fractured plastic shutters on south and west elevations, and a few shutters on north elevations. Several shutters also were fractured from vibrating in wind, and some shutters were missing altogether. Hail created small shallow dents in the top lips of steel gutters and on downspout extensions. Hail folded over the fins of certain air conditioning condenser units. Fins of other condenser units were protected by louvers and were not dented.

11. Building 01. Tears in a screen from hail.

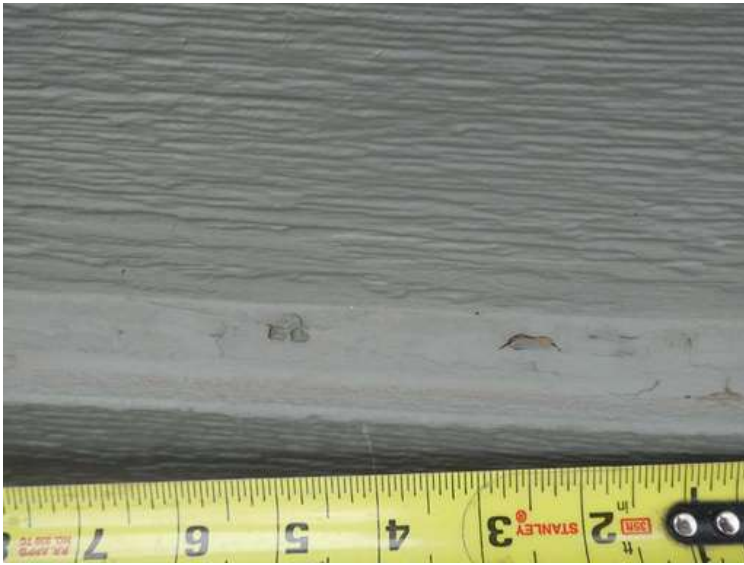
13. Building 01. Chips in paint from hail.

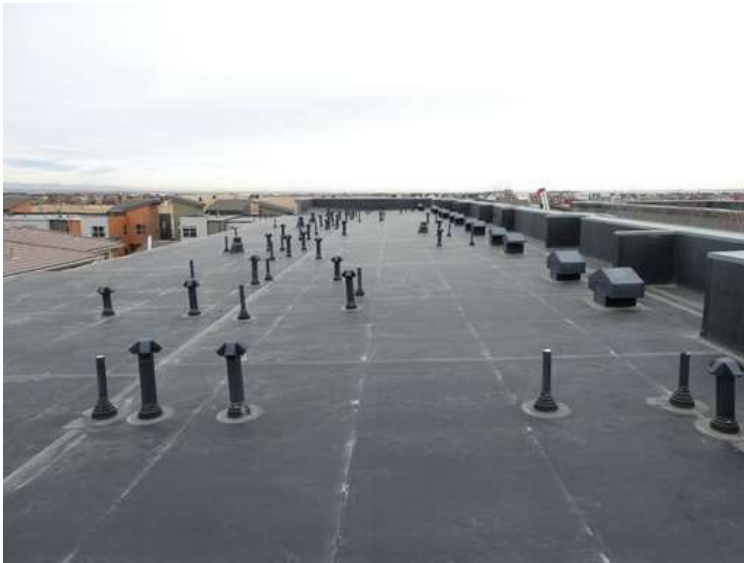
15. Building 01. View looking north. The roof was covered with an adhered EPDM membrane.

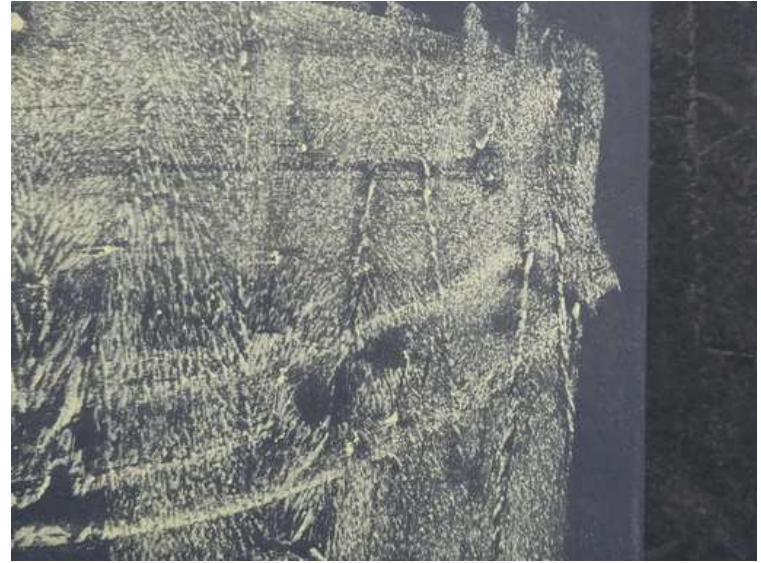
18. Building 01. Dents in an exhaust hood from hail.

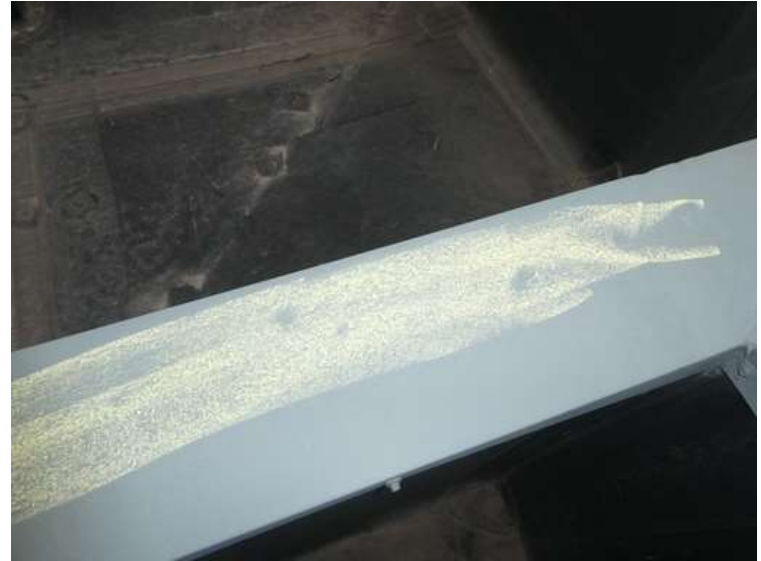
20. Building 01. Dents in a steel cap from hail.

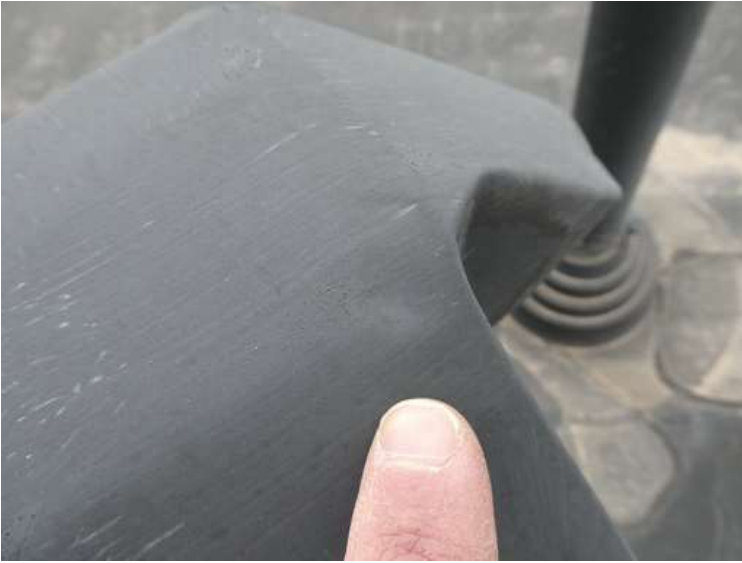
21. Building 01. Dent in a flue cap from hail.

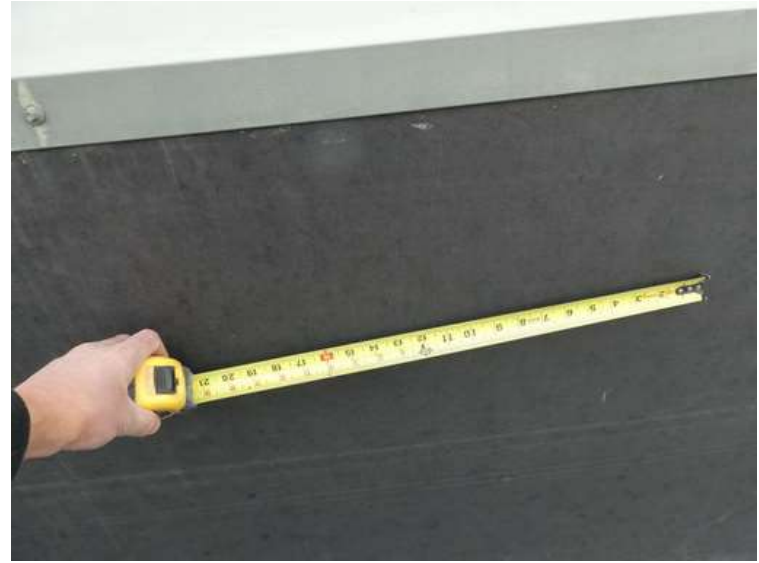
The Stapleton Rowhome Association buildings had been struck by hail as indicated by dents in various metal items, fractures in plastic shutters, tears in screens, and chips in paint finishes. Metal surfaces had spatter marks where hail falling recently had removed oxidation. Spatter marks were present on surfaces facing each direction. The largest spatter marks were on south and west surfaces. Spatter marks fade away with time as surfaces re-oxidize and thus provide information about hail falling in the past 2 years or so. The actual length of time a spatter mark is visible depends on the nature of the material with the spatter marks, exposure to sunlight, and other weathering affects. Dents in metal are permanent and provide a record of all the hail to fall at a site.

22. Building 01. Spatter marks on membrane extending up a parapet.

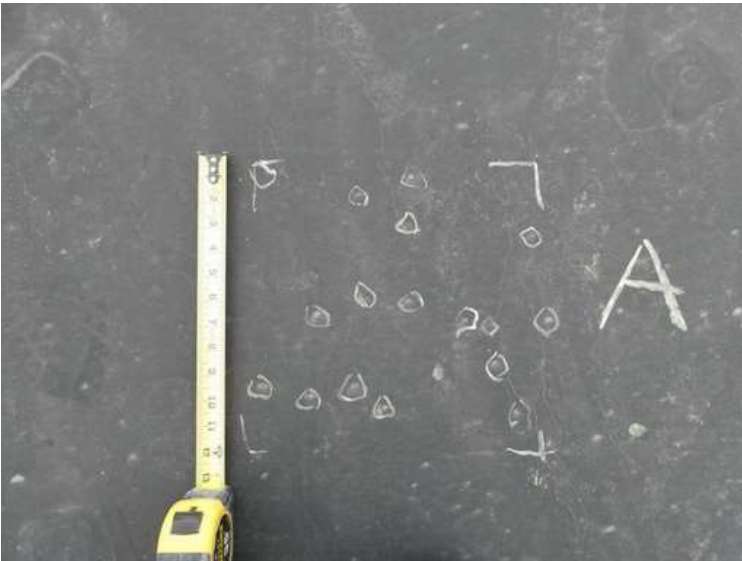
Hail had created small shallow dents in the gypsum substrate beneath the EPDM membranes. Hail dented approximately 2 to 12 percent (6 percent on average) of the gypsum surface area. The EPDM roof membranes on the Stapleton Rowhome Association roofs are debonded from the gypsum substrates. At samples we evaluated on four separate roofs, the facer sheet on the top side of the gypsum provided little resistance to lifting the EPDM membrane. The gypsum boards were soft and powdery so that the facer sheet remained adhered to the EPDM membrane, and the gypsum board stayed on the deck. The deteriorated condition of the gypsum was caused by persistent wetting from condensation formation on the underside of the membranes over the life of the roofs. If not for the deteriorated condition of the gypsum substrate from condensation, the roofs would have had reliable adhesion despite the hail-caused dents in the gypsum. Addressing

23. Building 01. Test area. Circular chalk marks denote dents in the substrate.

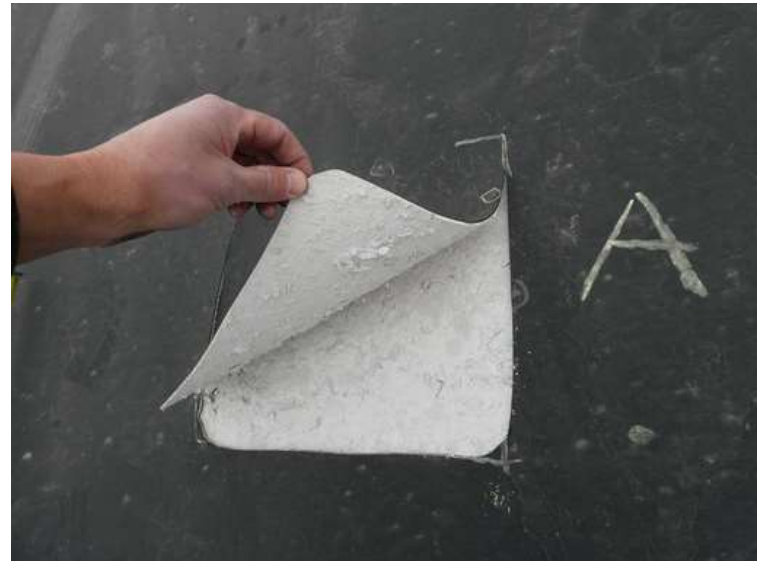
24. Building 01. Sample after cutting. The substrate provided little resistance to uplift.

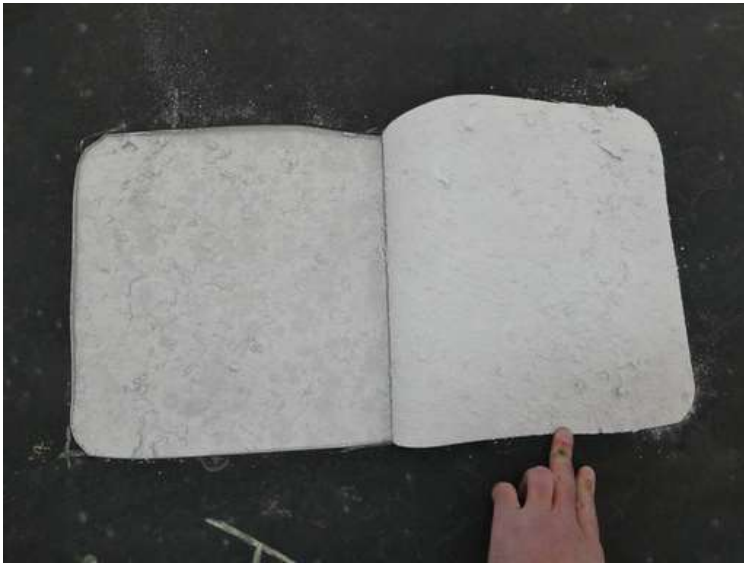
25. Building 01. Membrane folded back. The gypsum was powdery.

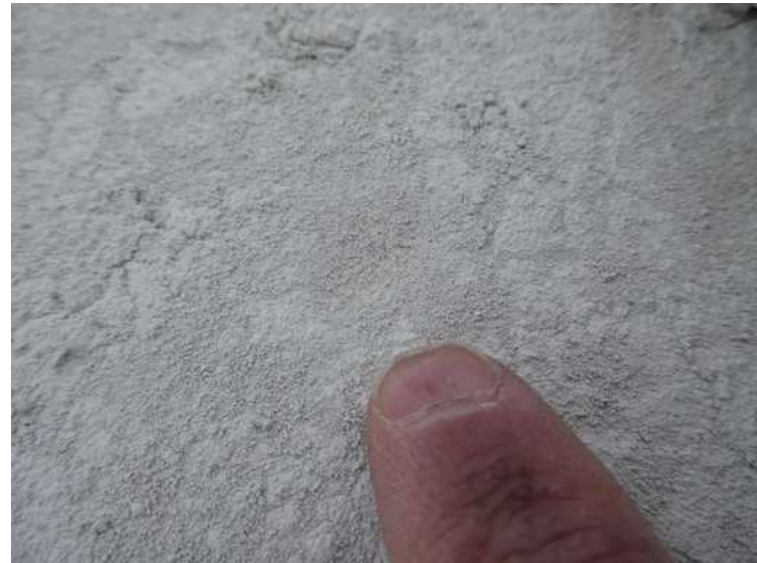
26. Building 01. Powdery gypsum.

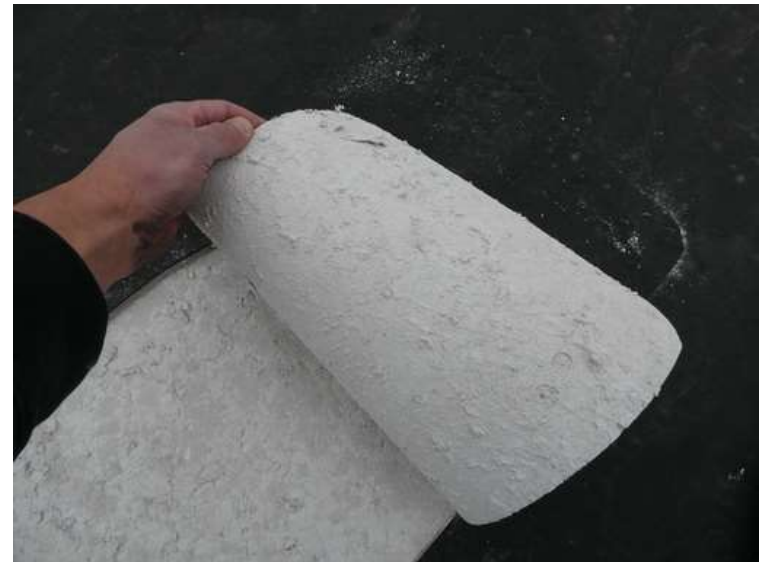
30. Building 01. Facer sheet stuck to the underside of the membrane.

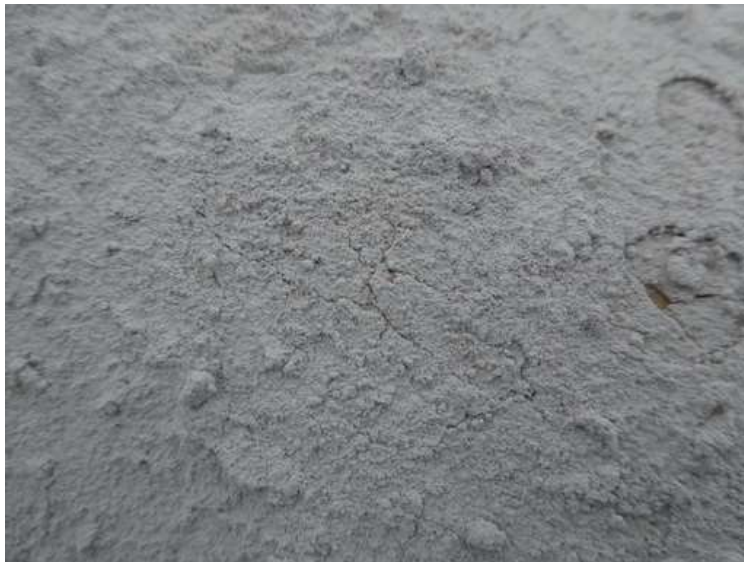
31. Building 01. Tear in the facer sheet from hail.

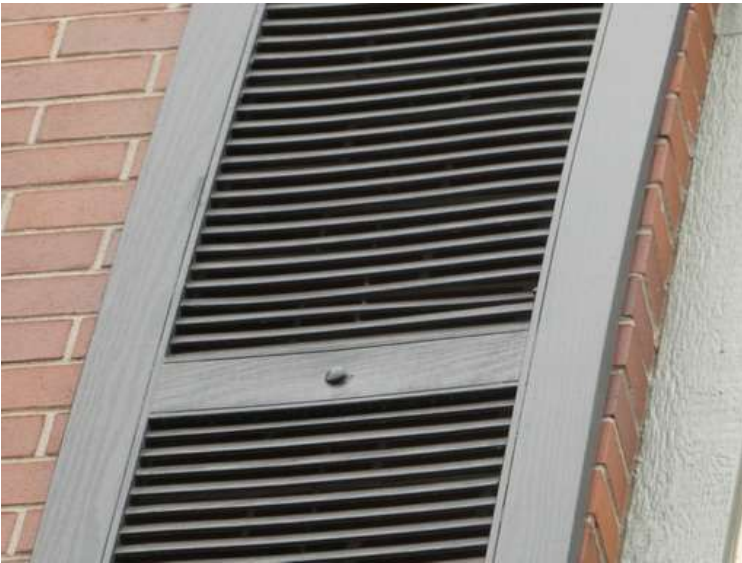
35. Building 02. Fracture in a shutter.

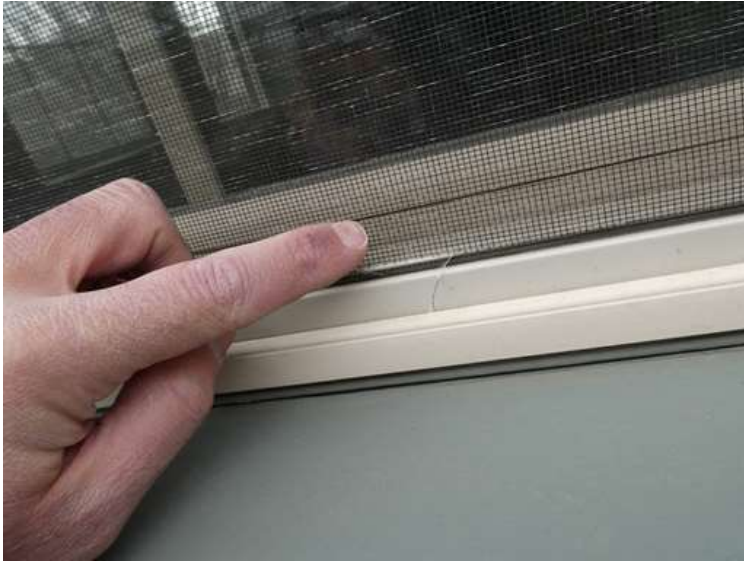
37. Building 02. Tear in a screen from hail.

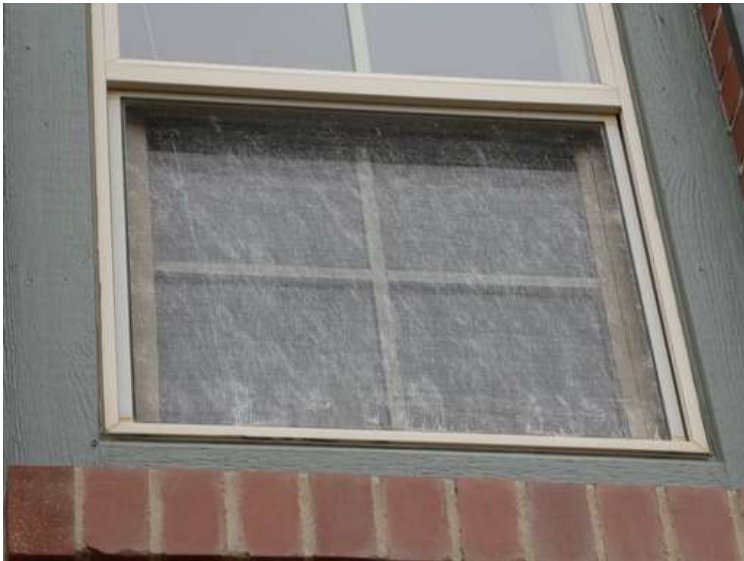
39. Building 02. Tears in a screen from hail.

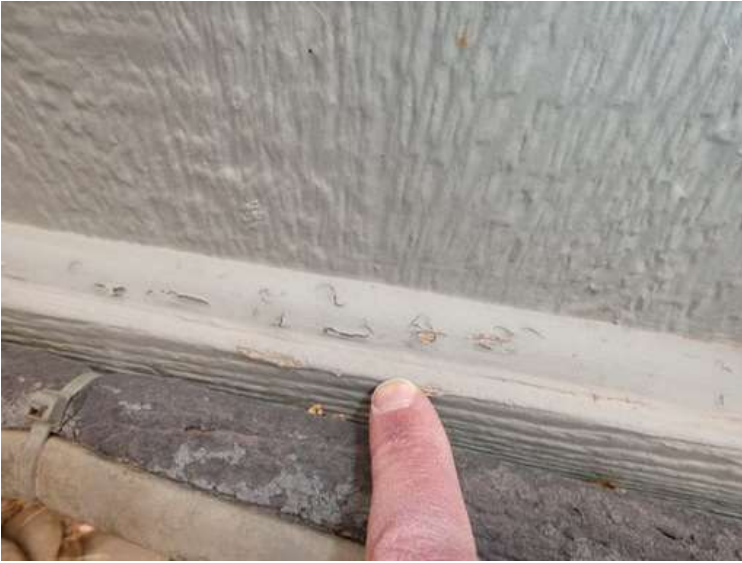
41. Building 02. Chips in paint on a south elevation.

6. Hail chipped paint on top surfaces of protrusions such as windowsills, trim pieces, and railings. Paint finishes on vertical fiber cement siding were not fractured by hail. Hail scuffed stain finishes on wood fences around backyards. The sills, trim pieces, railings, and fences can be repainted.

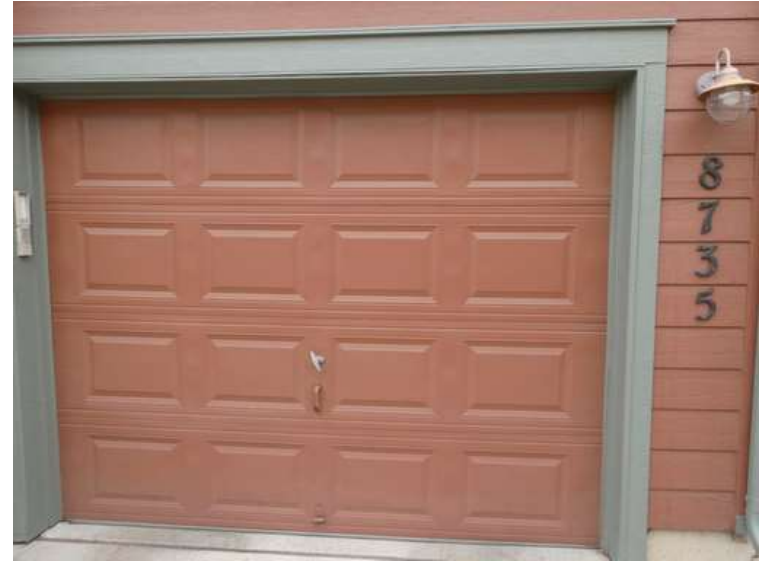
42. Building 02. Garage doors were not dented by hail.

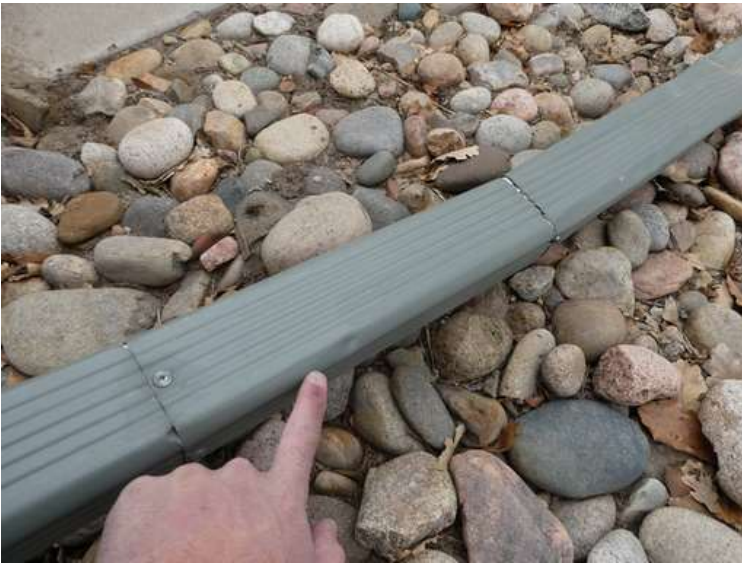
43. Building 02. Dent in a downspout extension from hail.

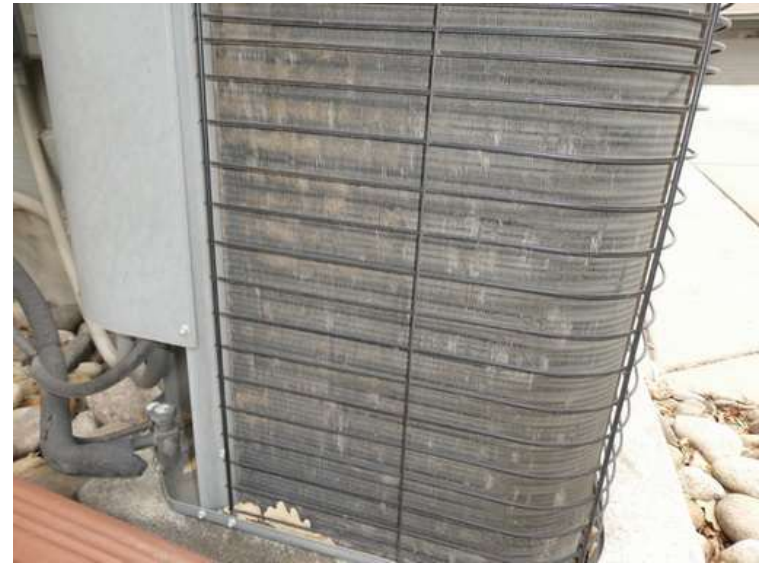
44. Building 02. Dents in condenser fins from hail.

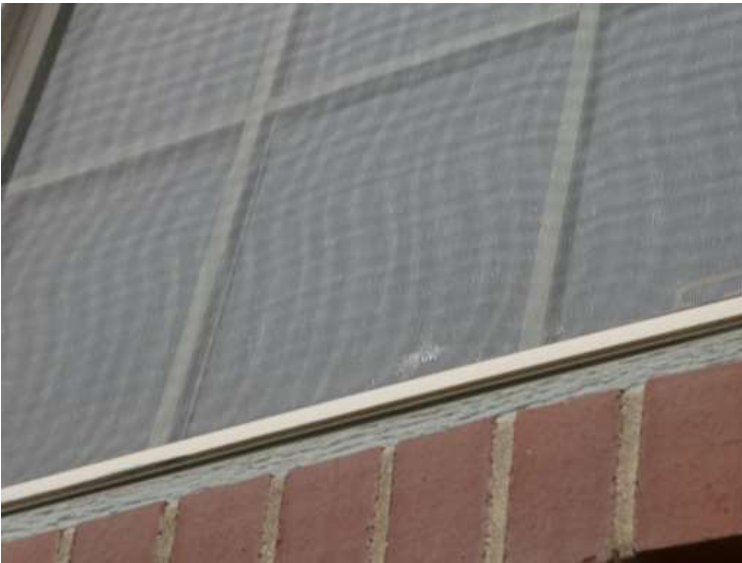
47. Building 02. Tears in a screen.

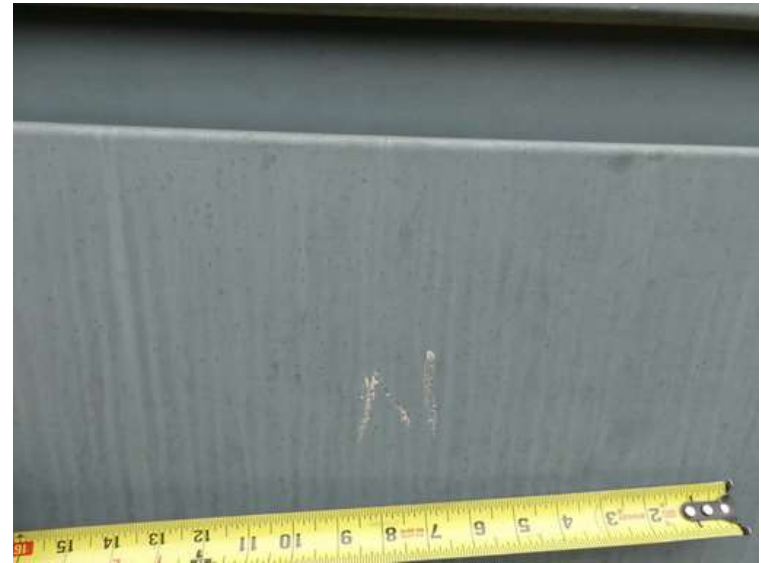
48. Building 02. Faint spatter marks on the north side of a transformer cabinet.

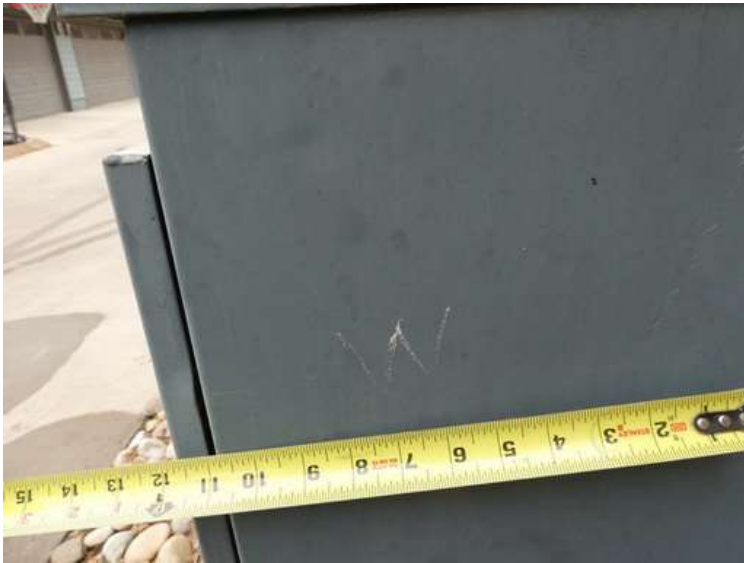
49. Building 02. Spatter marks on the west side of the cabinet.

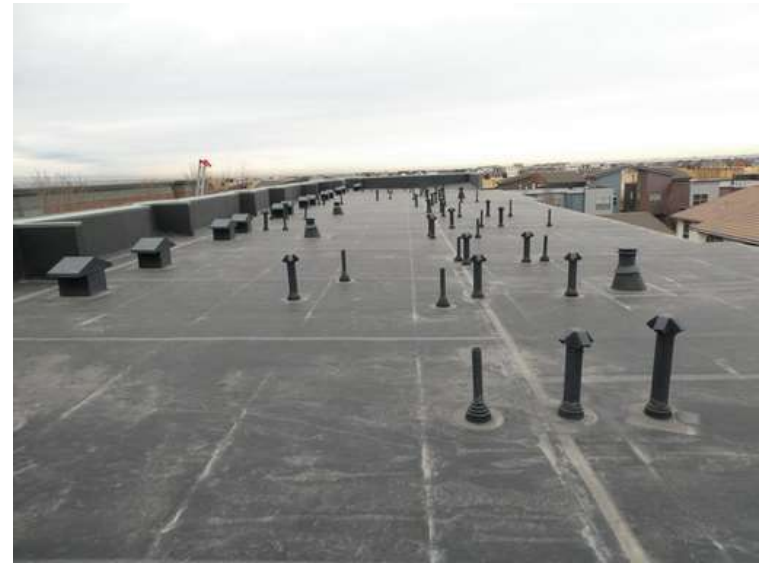
50. Building 02. View looking north. The roof was covered with an adhered EPDM membrane.

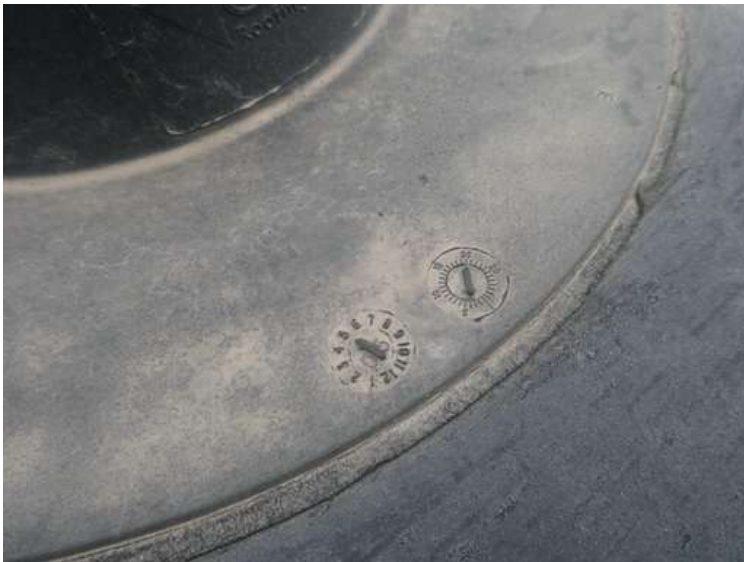
51. Building 02. Flashing boot dated, '05'.

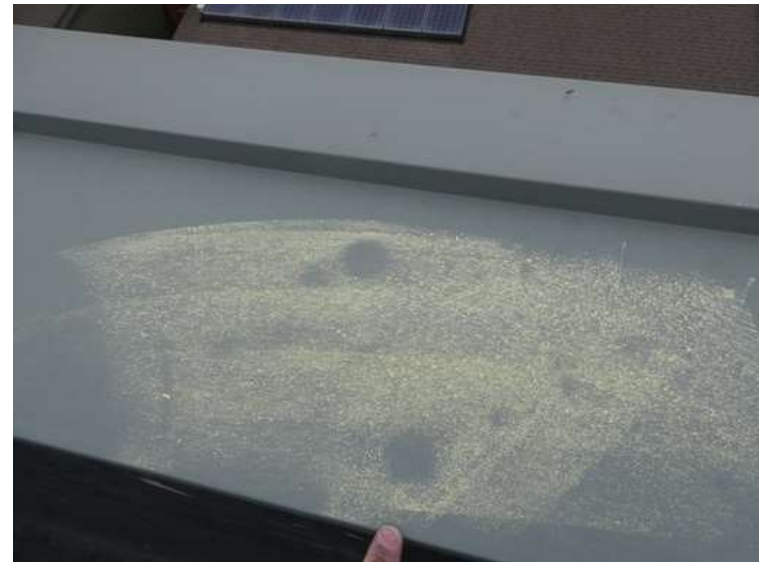
8. Dents in the gypsum substrates, steel coping, and vent caps on the low-sloped roofs likely were an accumulation from multiple hailstorms, including a recent storm. The asphalt shingles were relatively new and only would have been exposed to recent storms. Effects of hail on the exterior elevations of the buildings corresponded with the wind-blown direction of recent hail. The most recent dates where hail possibly struck and contributed to the conditions at the sites were August 21, 2019, July 1, 4, and 5, 2019, May 26 and 27, 2019, June 19, 2018, May 28, 2018, and May 8, 2017.

52. Building 02. Dents in coping.

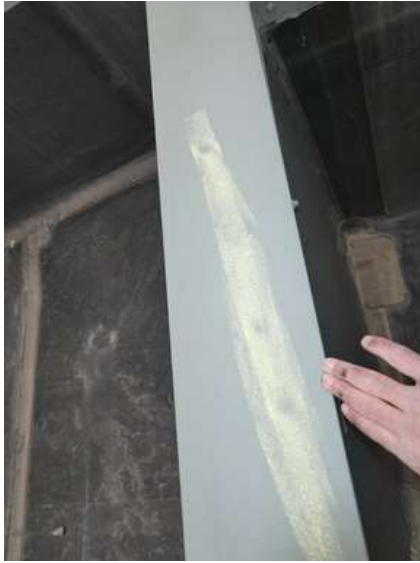
53. Building 02. Dents in a metal cap.

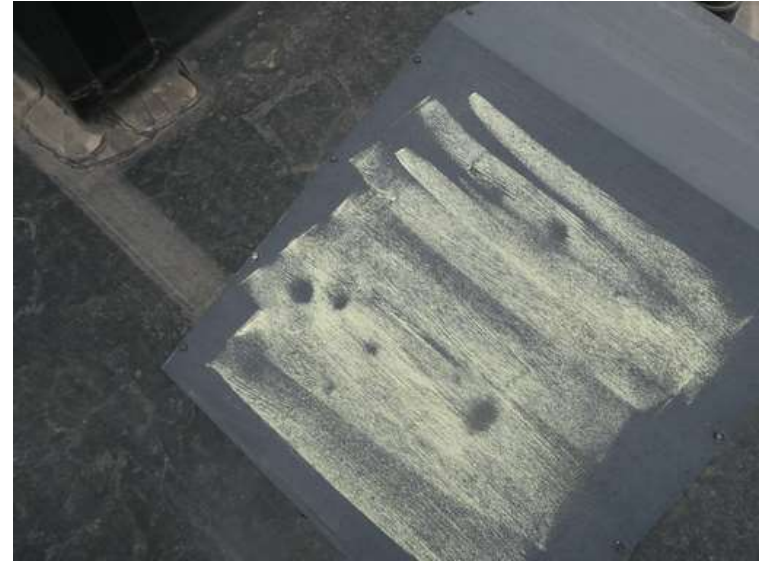
54. Building 02. Dents in an exhaust hood from hail.

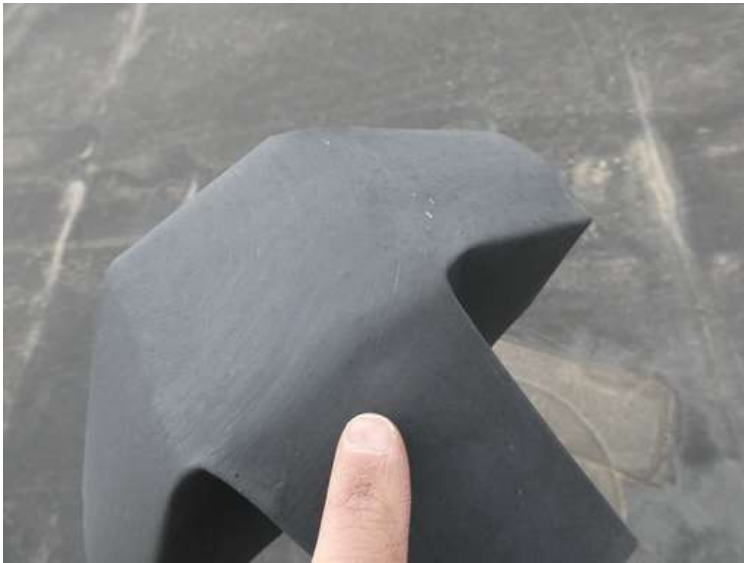
55. Building 02. Dent in a flue cap from hail.

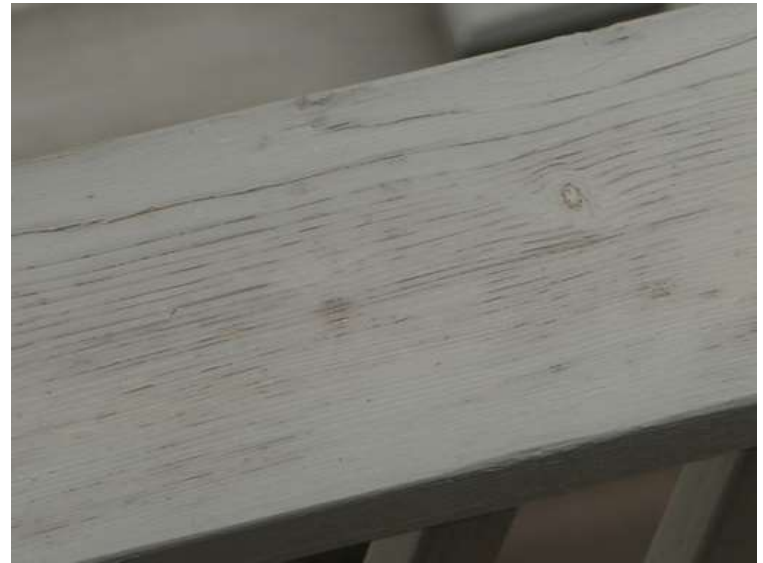
60. Building 02. Scuffs in paint on a railing from hail.

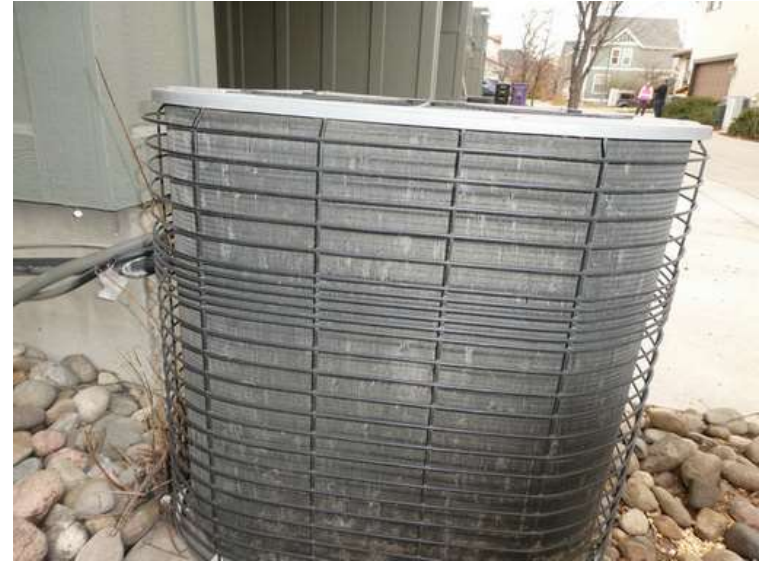
66. Building 03. Dents in condenser fins from hail.

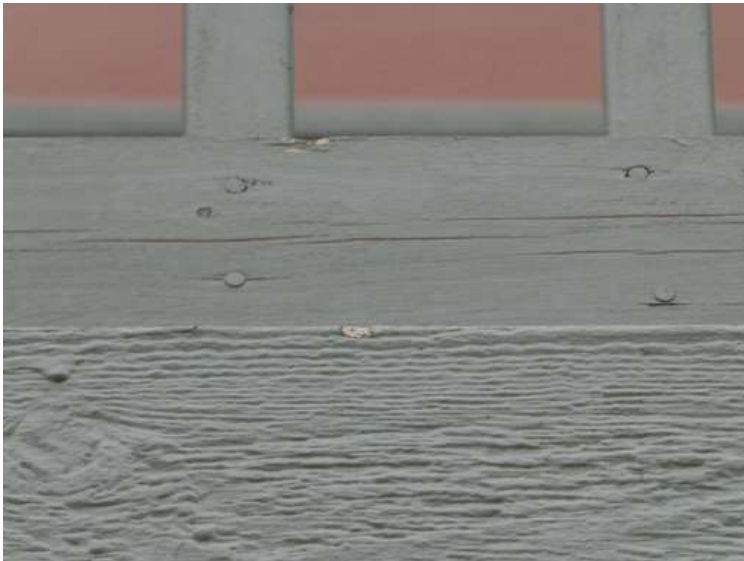
67. Building 03. Chips in paint from hail.

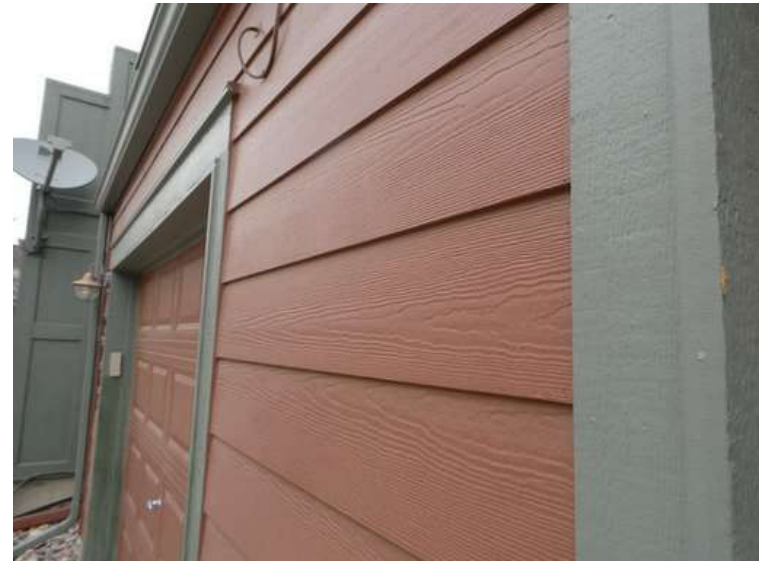
68. Building 03. Paint on siding was not chipped by hail.

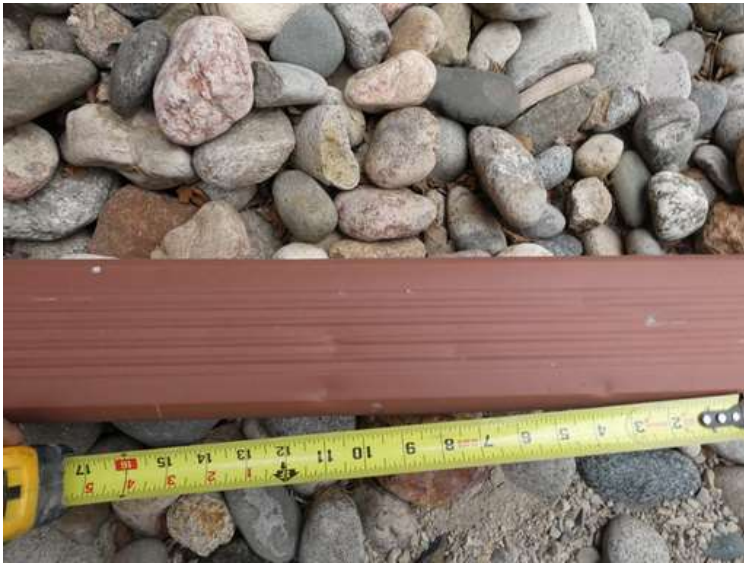
69. Building 03. Dents in a downspout extension from hail.

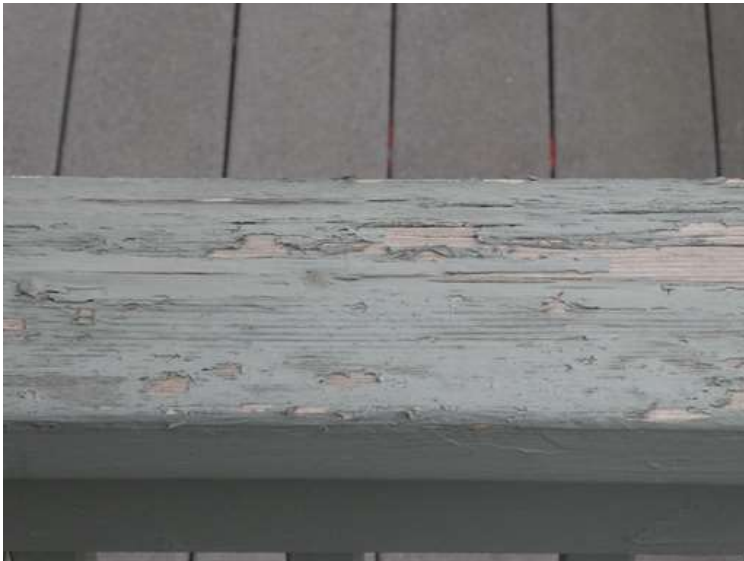
71. Building 03. Chips in worn paint on a hand railing from hail.

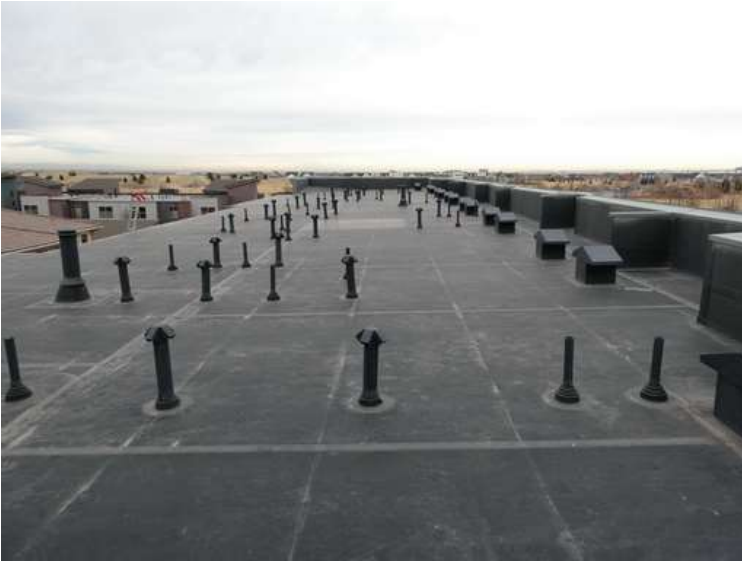
73. Building 03. View looking north. The roof was covered with an adhered EPDM membrane.

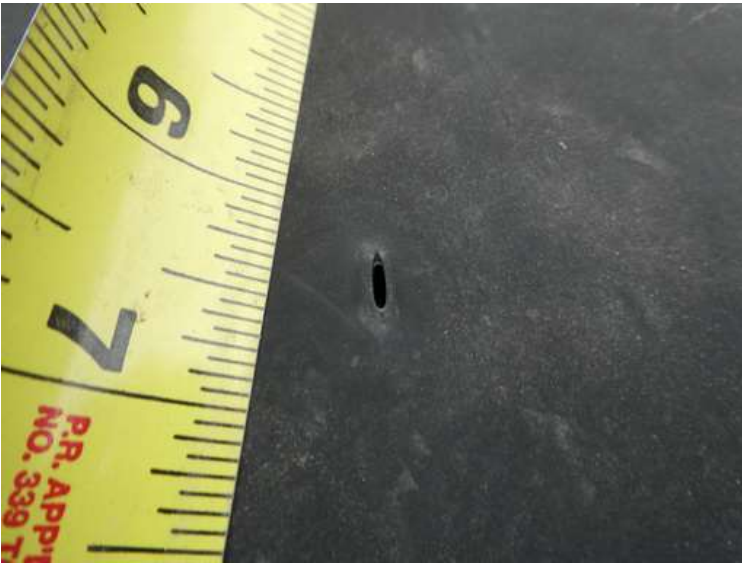
75. Building 03. Mechanical cut in the membrane.

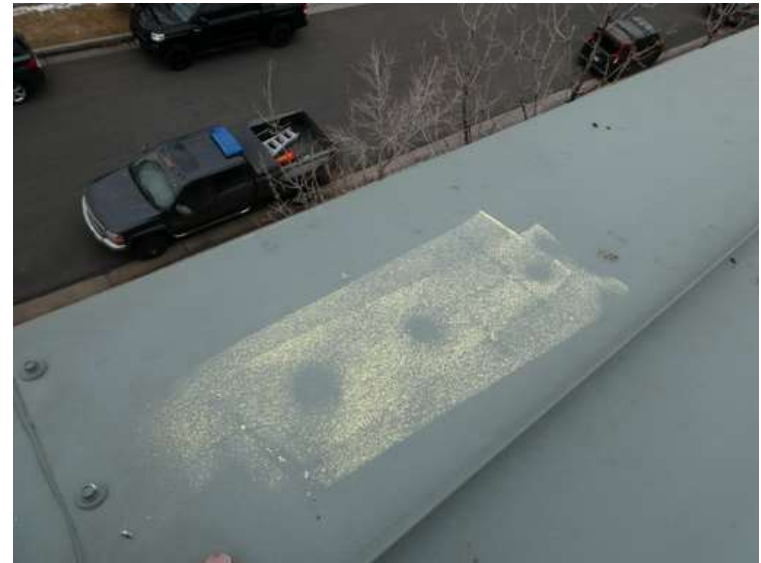
76. Building 03. Dents in coping from hail.

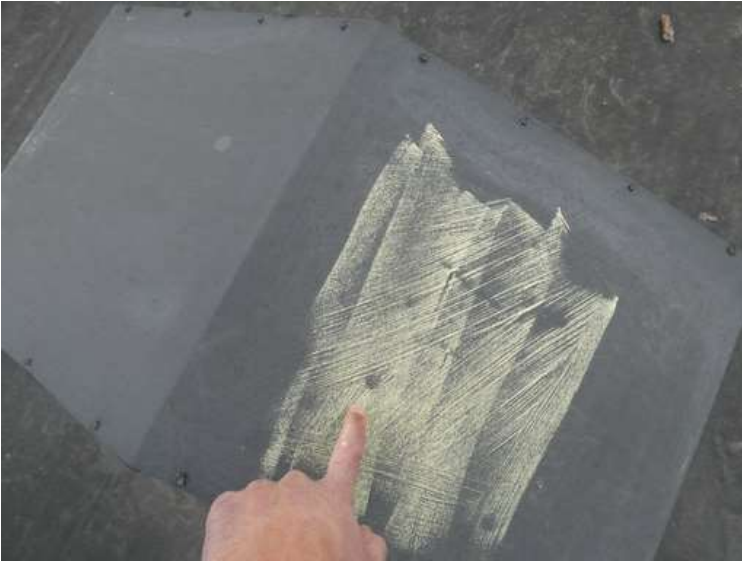
77. Building 03. Dents in an exhaust hood from hail.

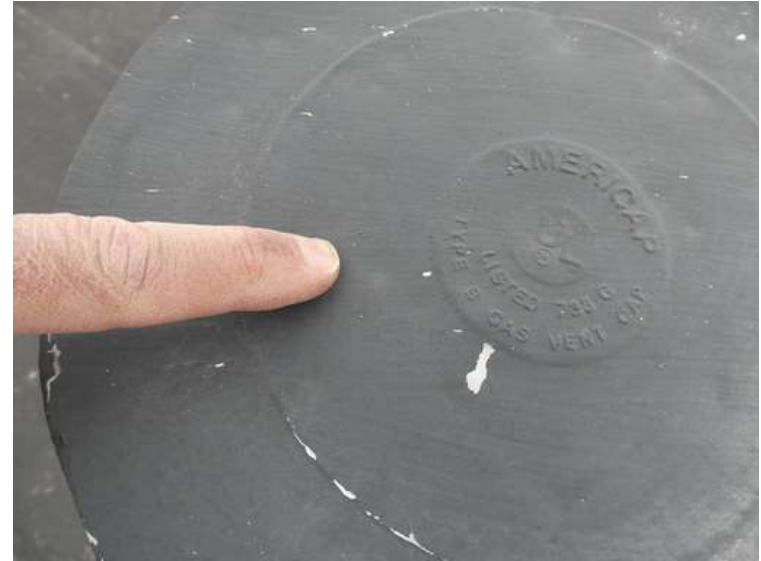
78. Building 03. Dents in a flue cap from hail.

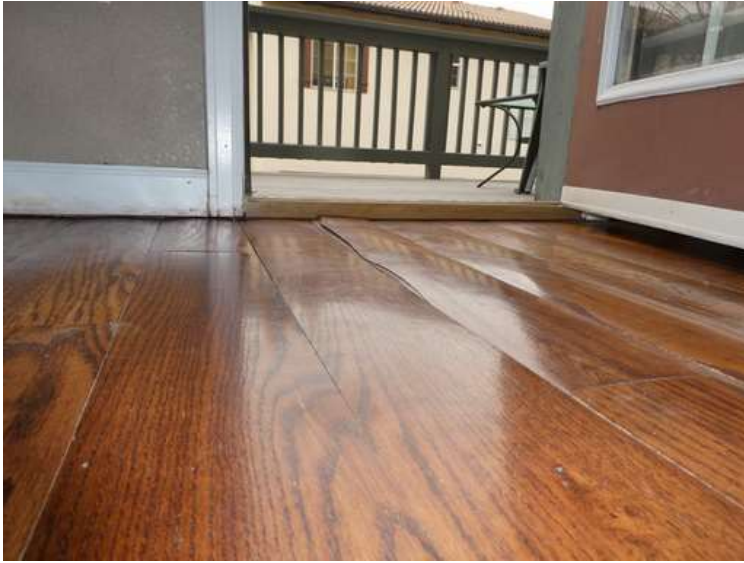
81. Building 03. Warped flooring in the dining area on the second floor.

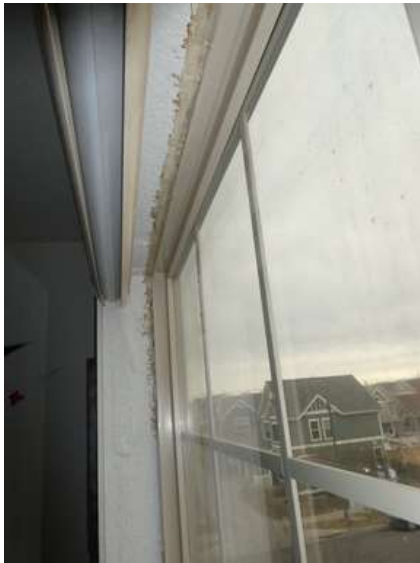
83. Building 03. Water leaked from above this window on the third floor.

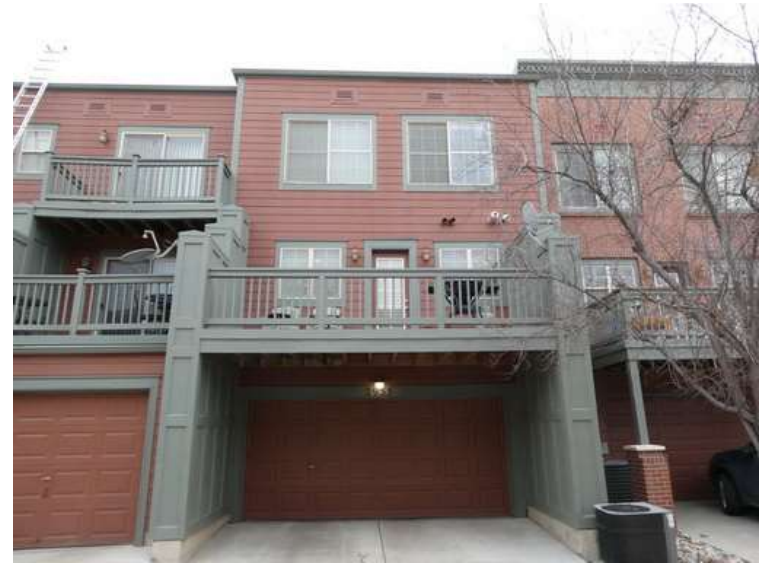
86. Building 03. Unit 2955, west elevation.

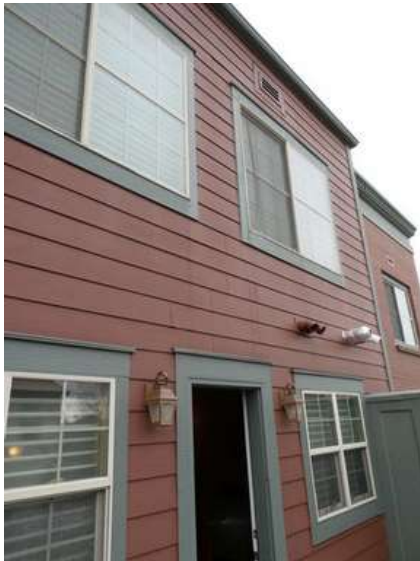
87. Building 03. Perimeter wall.

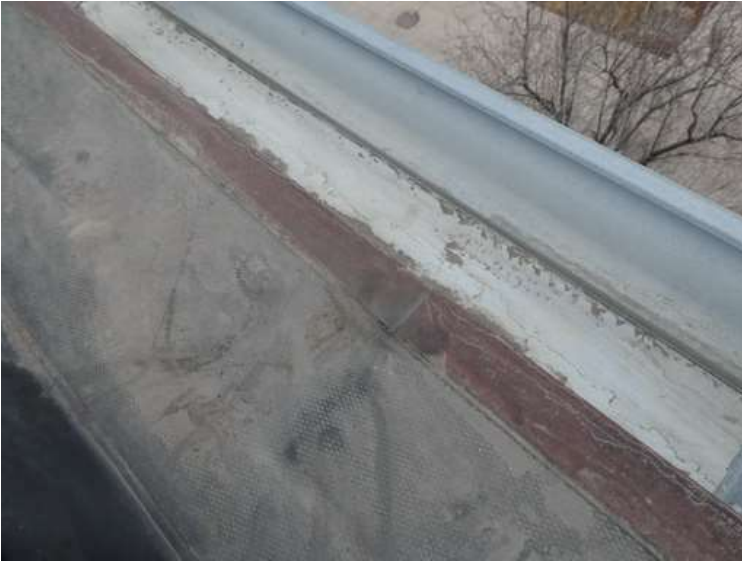
89. Building 03. Joint in edge metal. Edge metal was rusted where water pooled at the perimeter of the roof.
