Stapleton Rowhome Association
Hail Damage Evaluation
10045 Martin Luther King Boulevard
Denver, CO 80238
Farmers File: 5010168593
Haag File: 1121000002-128

Re: Stapleton Rowhome Association
Hail Damage Evaluation
10045 Martin Luther King Boulevard
Denver, CO 80238
Farmers File: 5010168593
Haag File: 1121000002-128

In accordance with your request, we inspected the Stapleton Rowhome Association buildings to determine the extent of hail-caused damage to the building exteriors and when the damage occurred. We inspected the sites on February 1, 2, and 3, 2021.

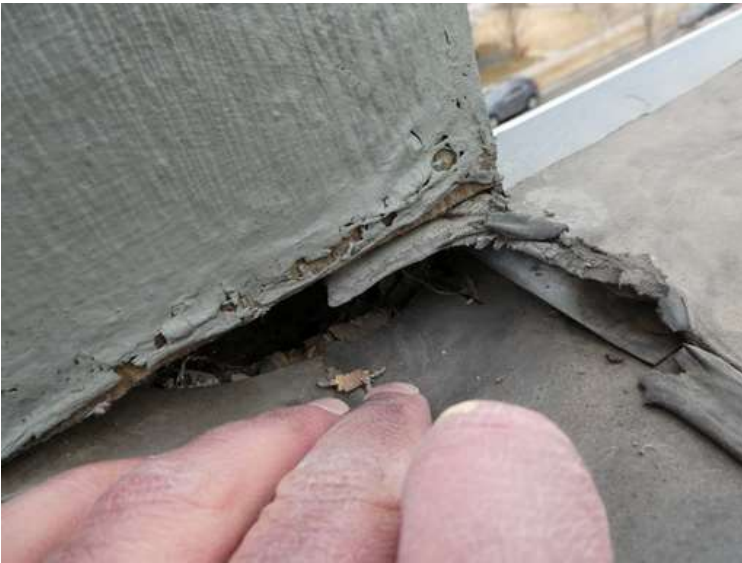
91. Building 03. Opening where water could leak past the roof.

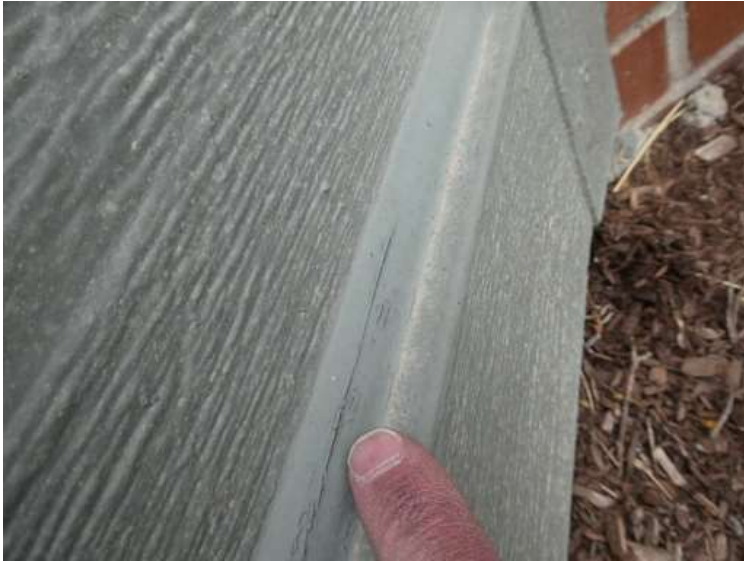
93. Building 04. Chips in paint from hail.

6. Hail chipped paint on top surfaces of protrusions such as windowsills, trim pieces, and railings. Paint finishes on vertical fiber cement siding were not fractured by hail. Hail scuffed stain finishes on wood fences around backyards. The sills, trim pieces, railings, and fences can be repainted.

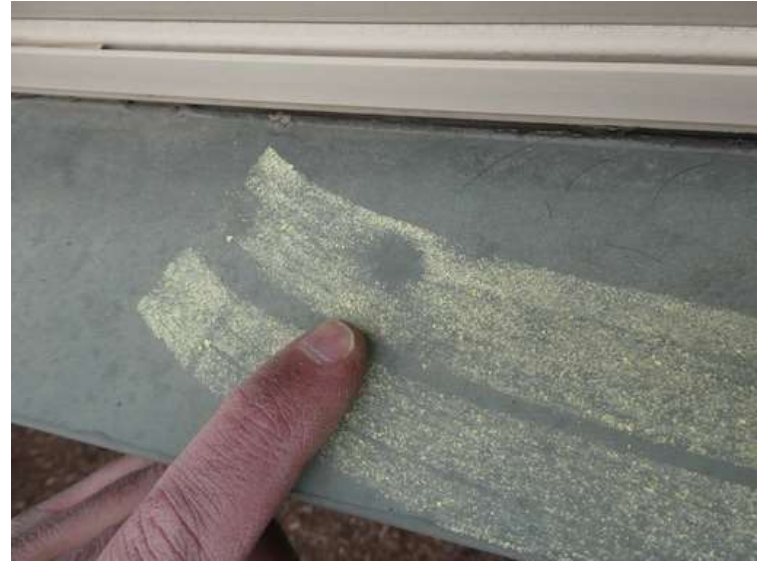
94. Building 04. Dent in steel flashing a ledge.

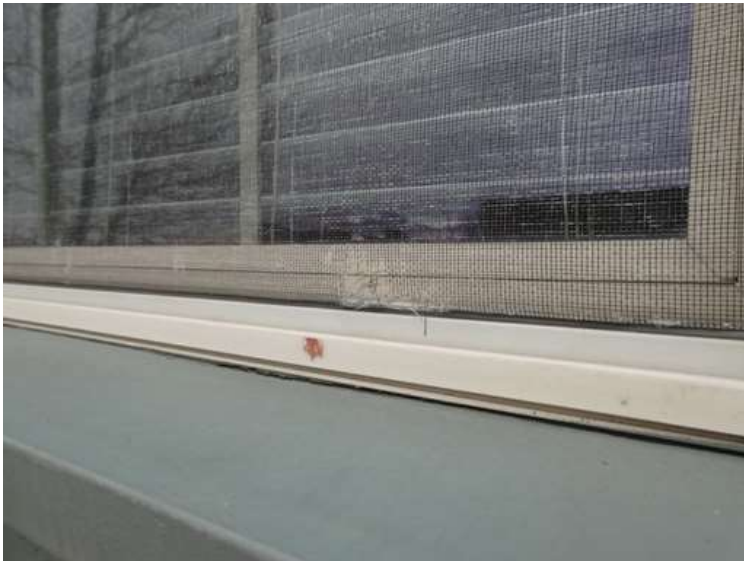
95. Building 04. Tears in a screen.

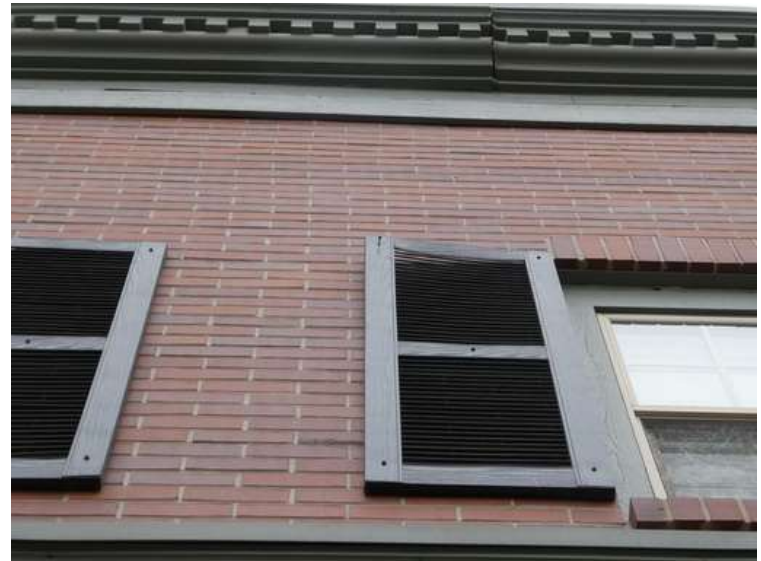
96. Building 04. Warped shutter.

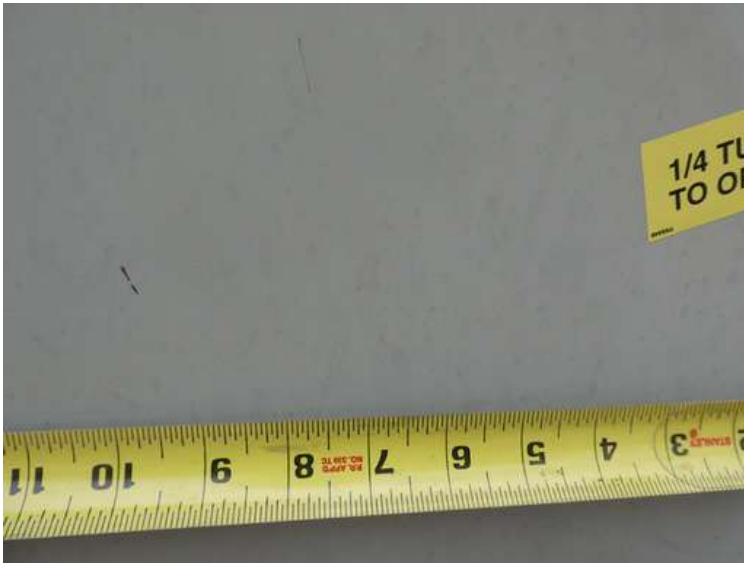
97. Building 04. Spatter marks on an electrical cabinet.

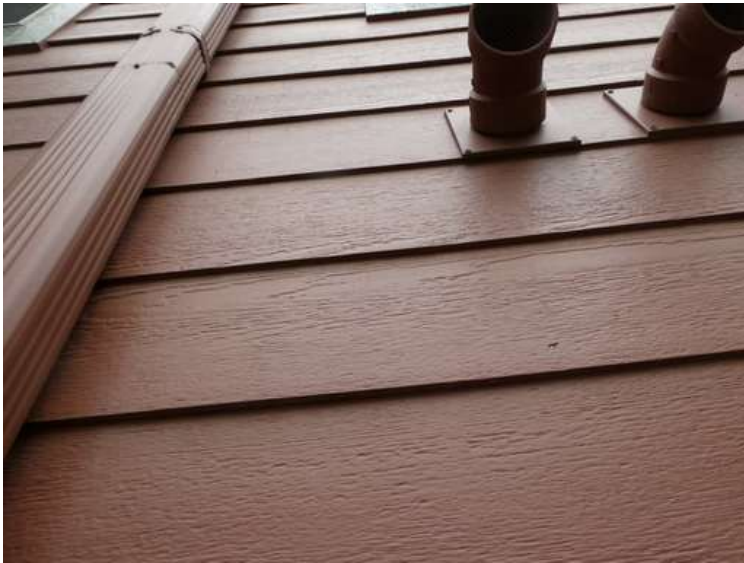
99. Building 04. Paint finishes on fiber cement siding were not chipped by hail.

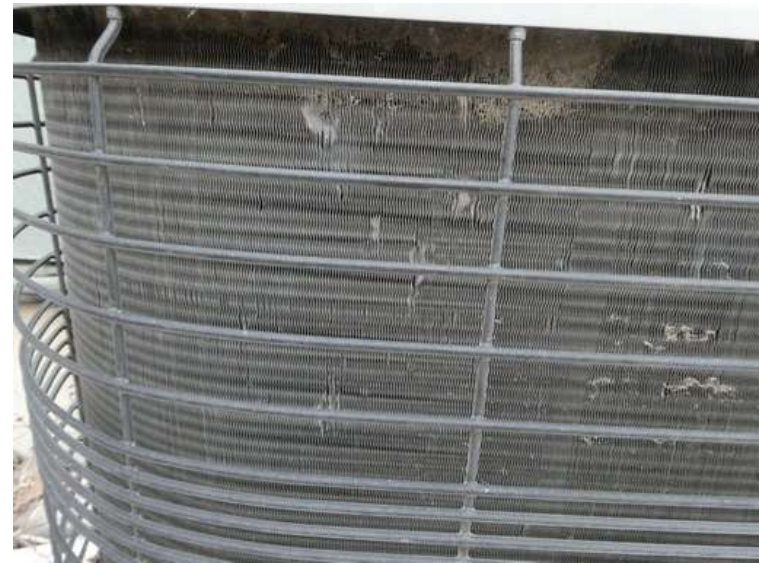
100. Building 04. Small dents in condenser fins.

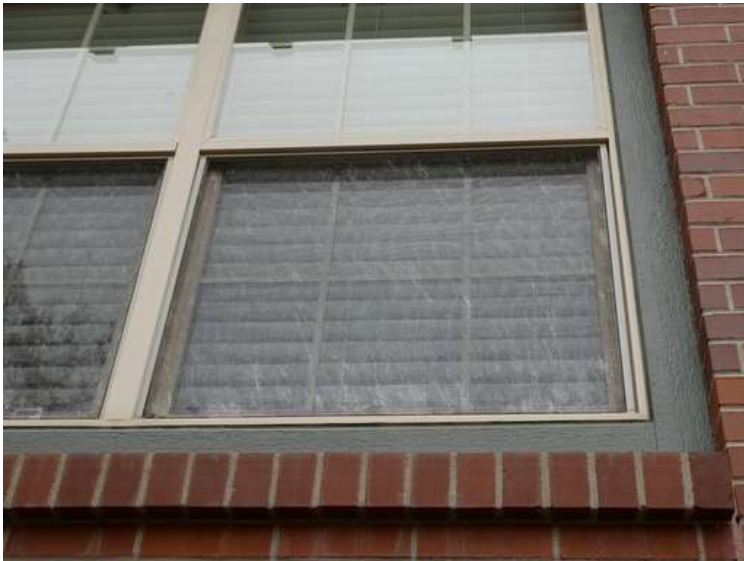
103. Building 04. Tear in a screen from hail.

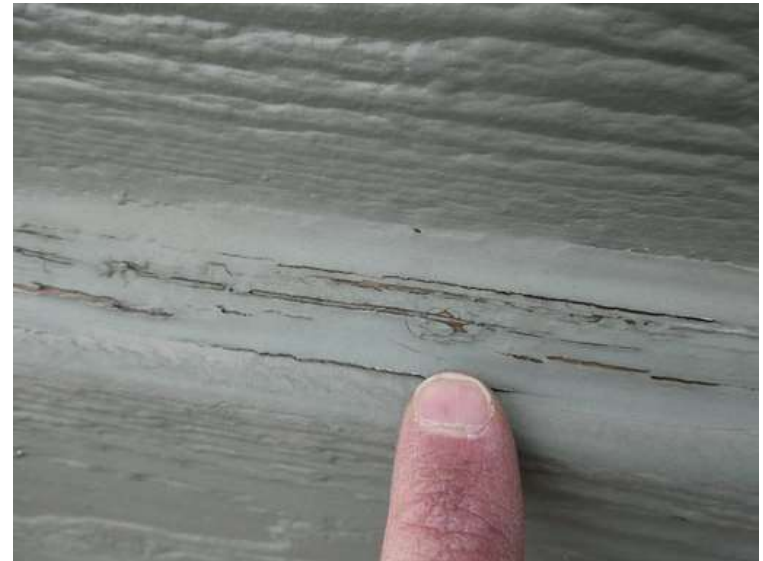
104. Building 04. Chips in paint from hail.

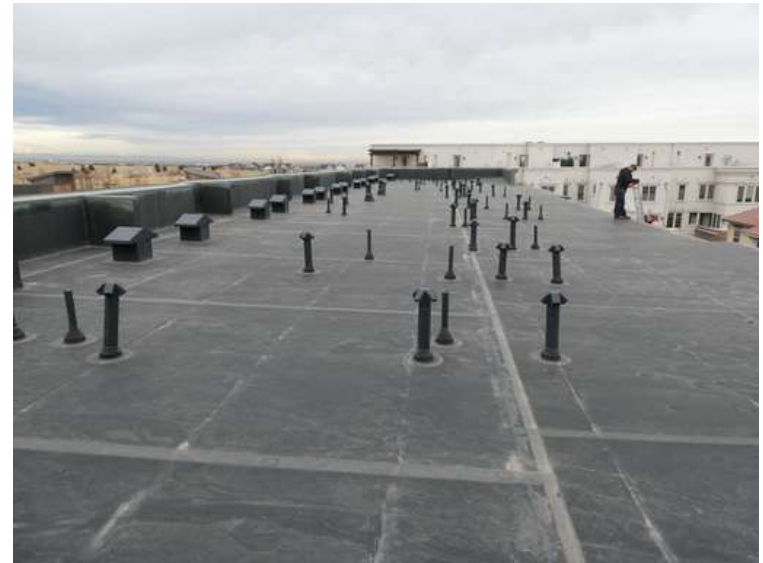
106. Building 04. View looking north. The roof was covered with an adhered EPDM membrane.

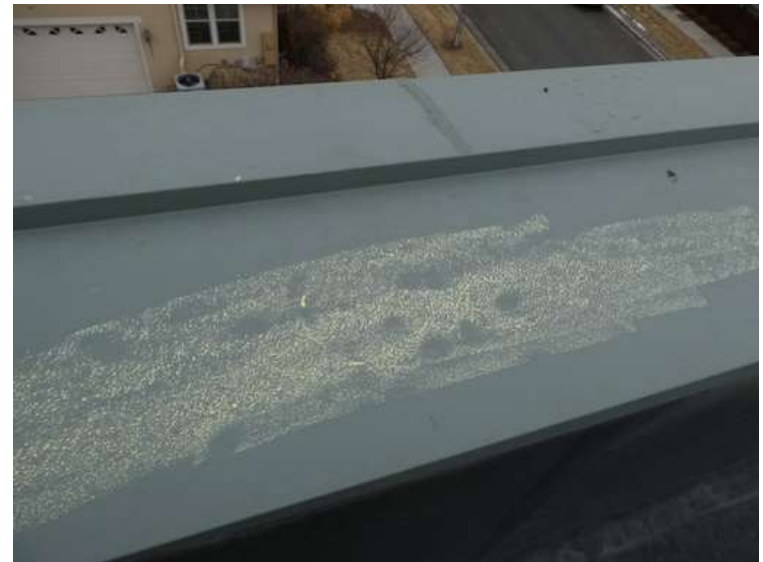
8. Dents in the gypsum substrates, steel coping, and vent caps on the low-sloped roofs likely were an accumulation from multiple hailstorms, including a recent storm. The asphalt shingles were relatively new and only would have been exposed to recent storms. Effects of hail on the exterior elevations of the buildings corresponded with the wind-blown direction of recent hail. The most recent dates where hail possibly struck and contributed to the conditions at the sites were August 21, 2019, July 1, 4, and 5, 2019, May 26 and 27, 2019, June 19, 2018, May 28, 2018, and May 8, 2017.

108. Building 04. Dents in coping from hail.

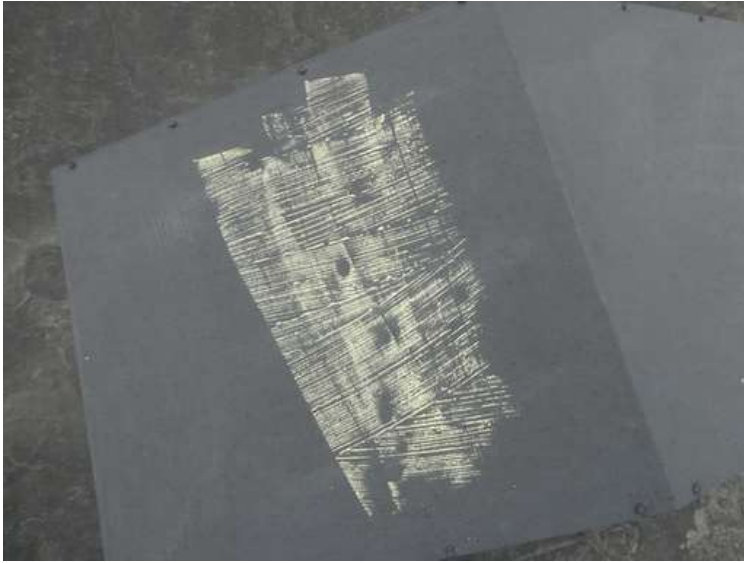
109. Building 04. Dents in an exhaust hood from hail.

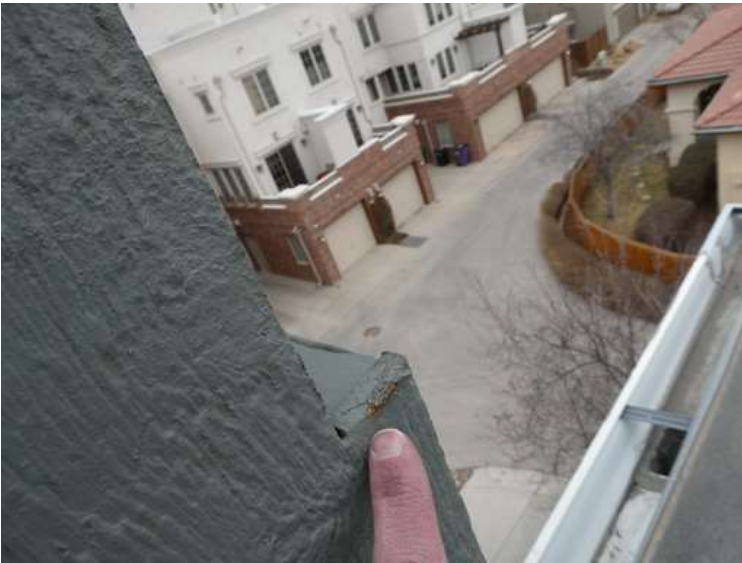
113. Building 04. Paint chipped by hail.

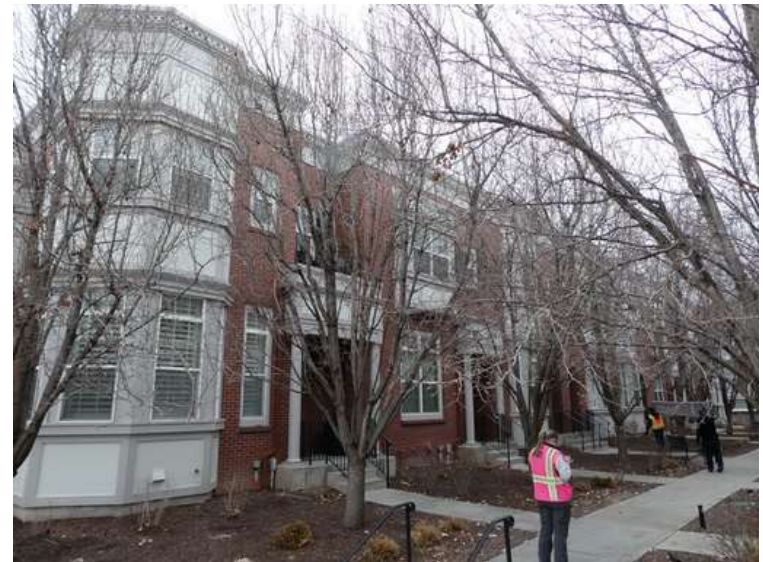
116. Building 05. East elevation.

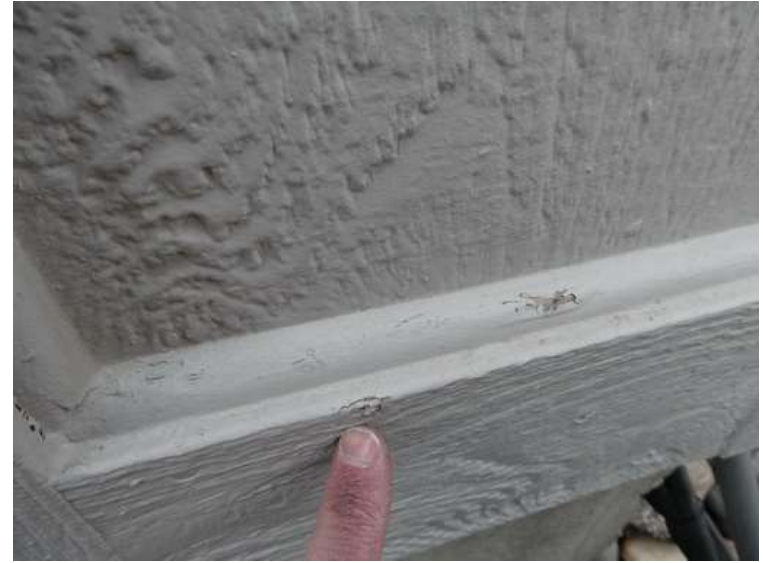
118. Building 05. Chips in paint from hail.

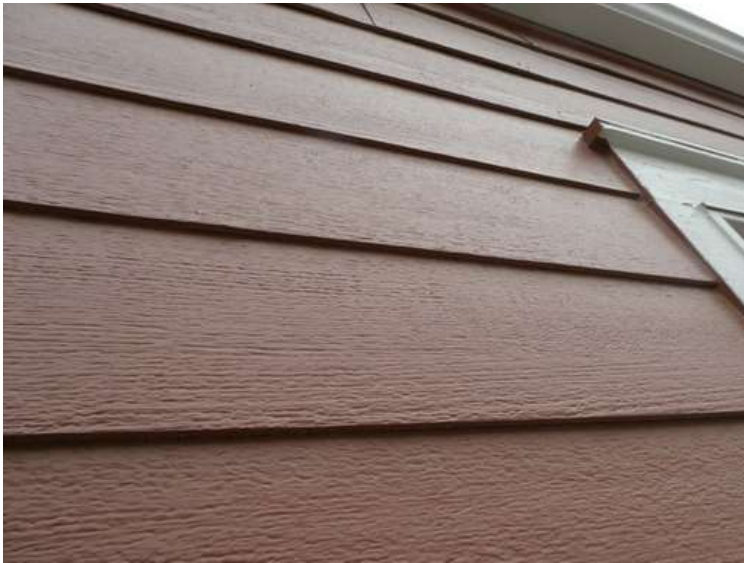
119. Building 05. Paint on fiber cement siding was not chipped by hail.

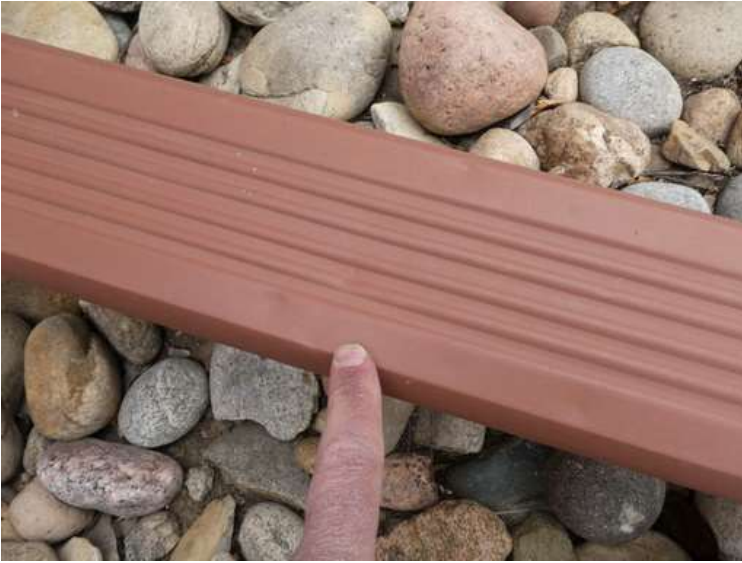
121. Building 05. Dents in a downspout extension from hail.

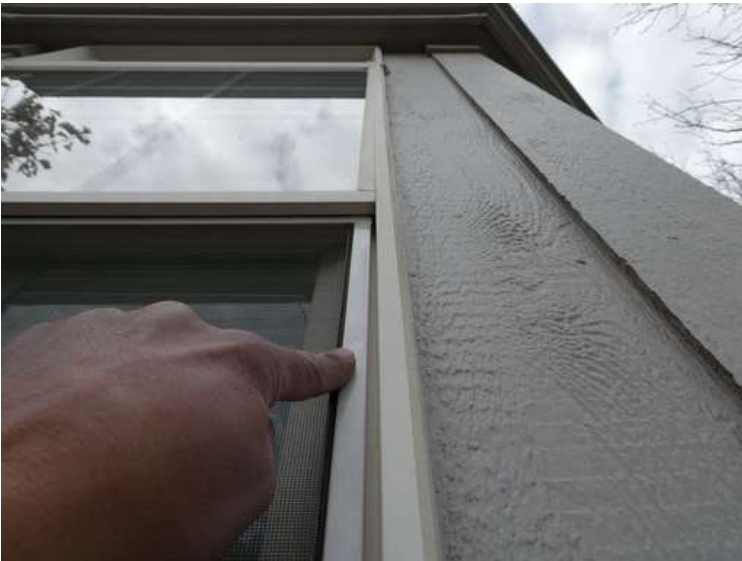
123. Building 05. Dent in a screen frame.

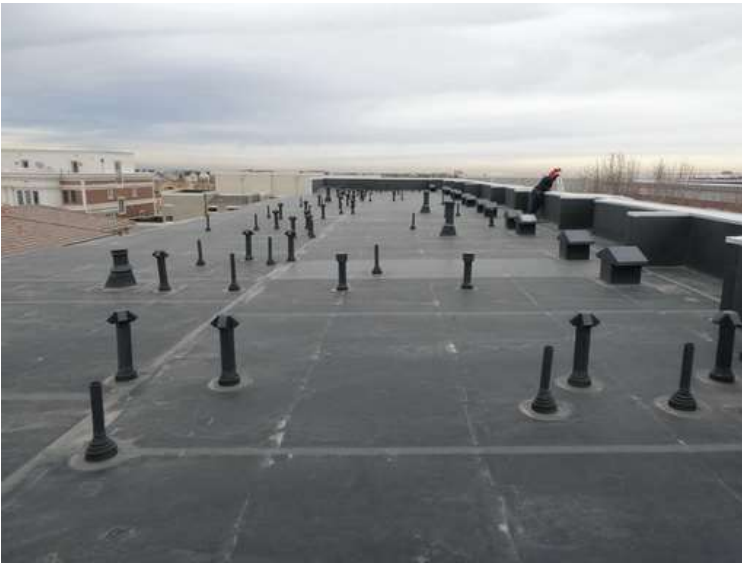
125. Building 05. View looking north. The roof was covered with an adhered EPDM membrane.

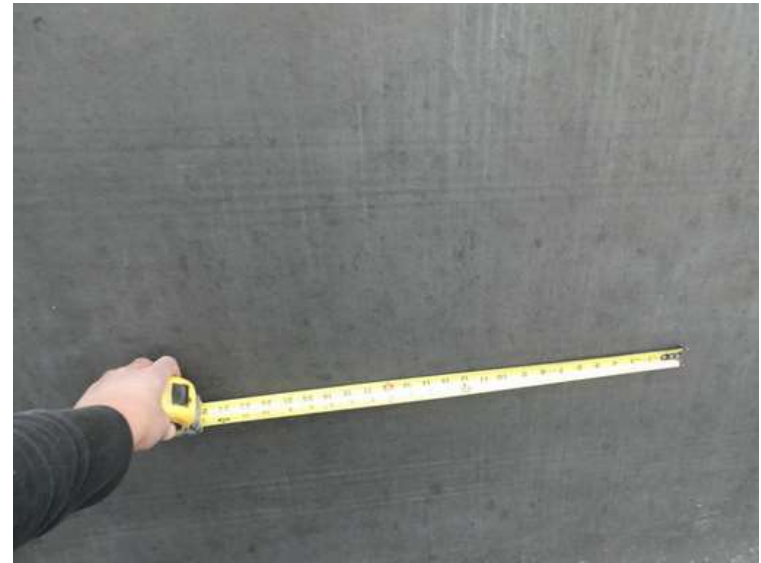
128. Building 05. Spatter marks on membrane turned up a parapet.

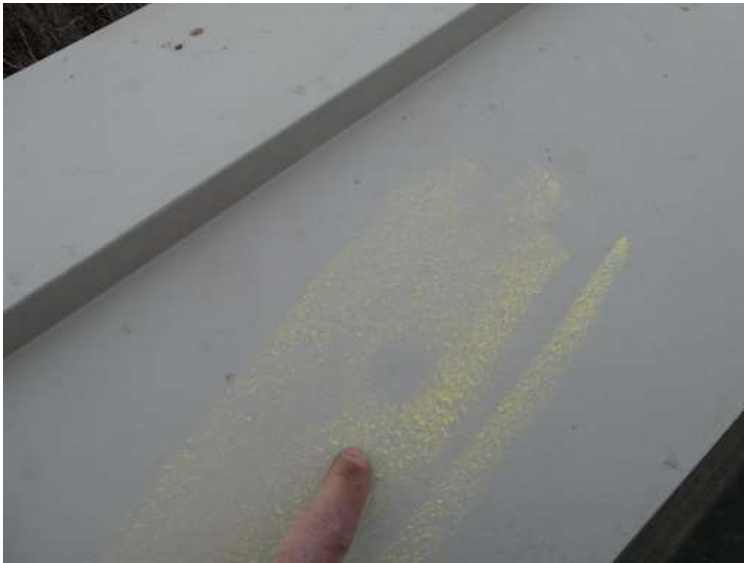
129. Building 05. Dent in coping from hail.

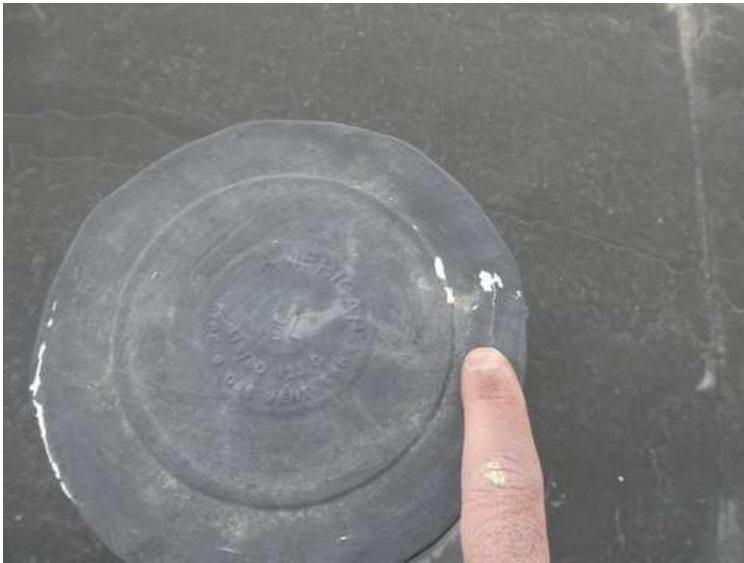
131. Building 05. Dents in a flue cap from hail.

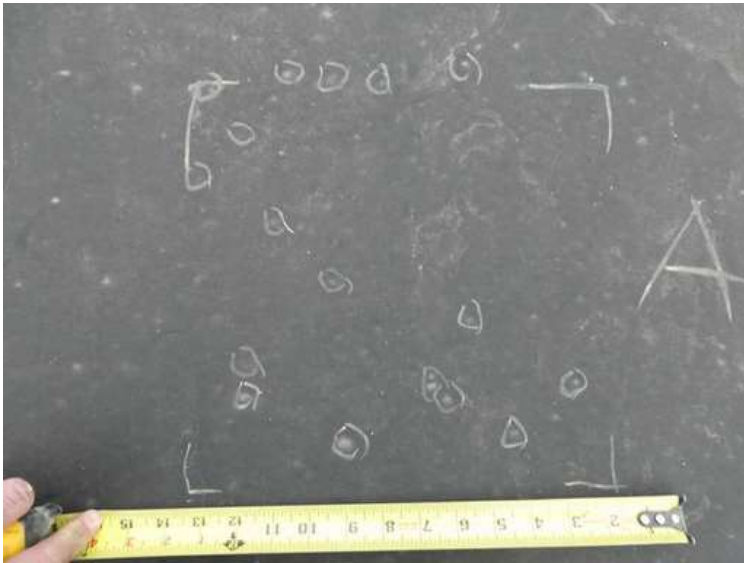
133. Building 05. Test area. Circular chalk marks denote dents in the substrate.

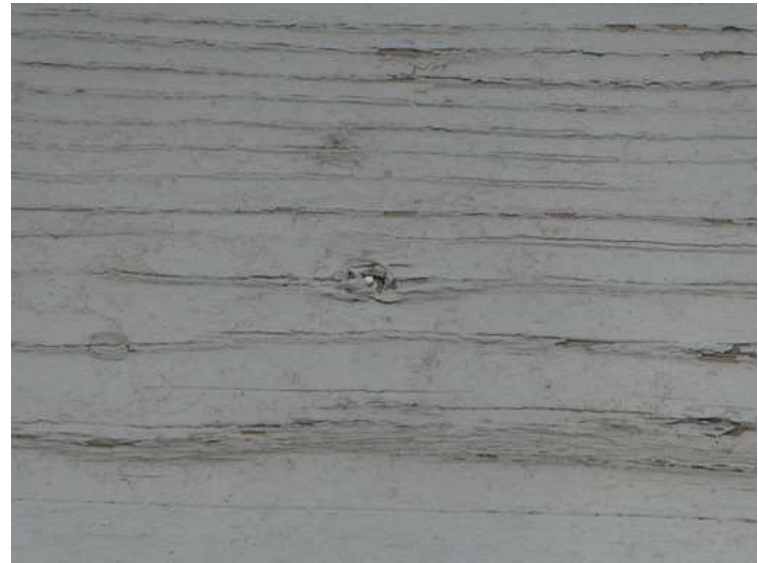
136. Building 05. Chips in paint on a railing from hail.

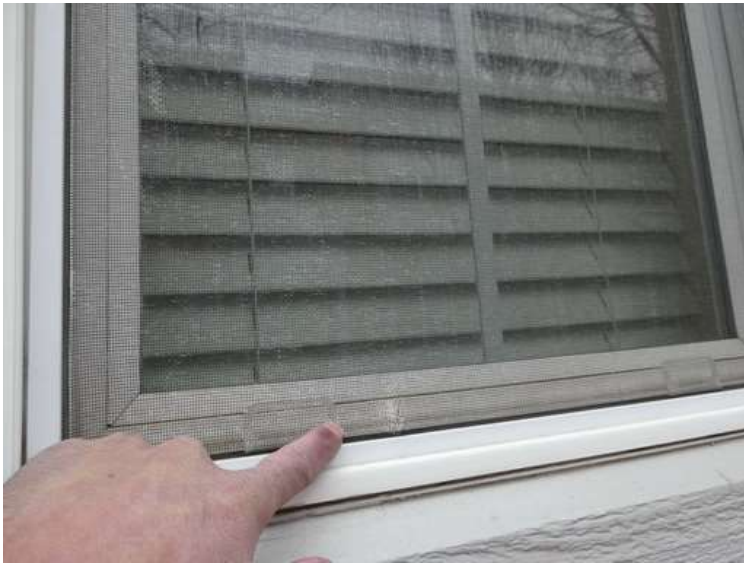
139. Building 06. Tears in a screen from hail.

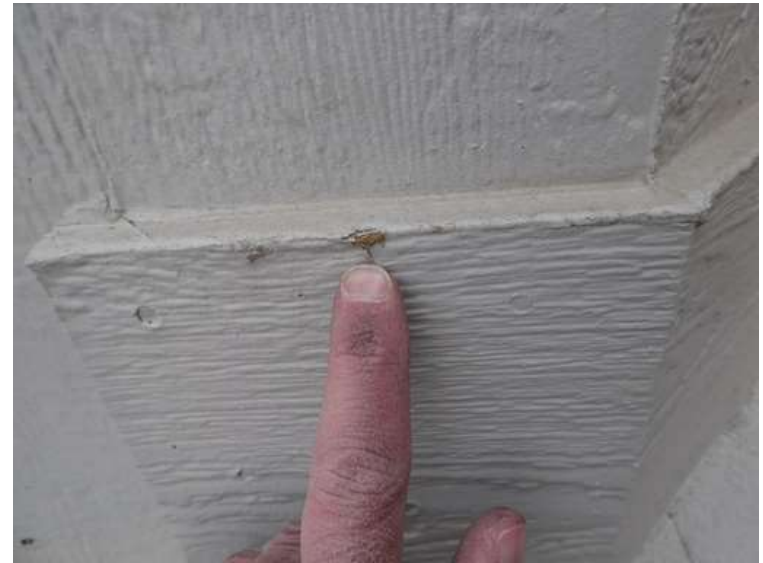
144. Building 06. Chip in paint from hail.

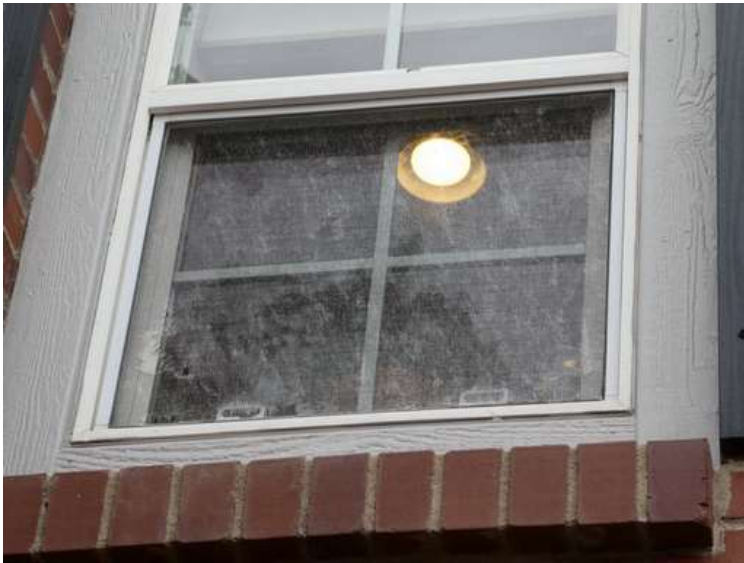
145. Building 06. Tears in a screen from hail.

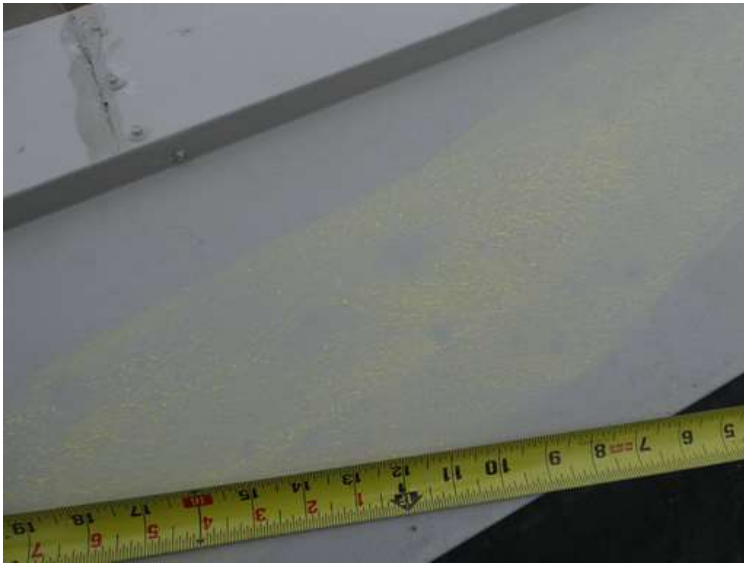
149. Building 06. Dents in coping from hail.

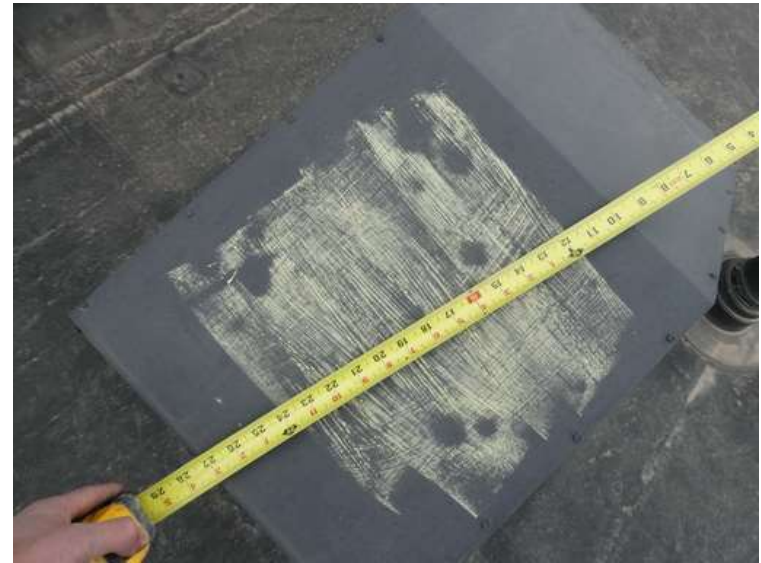
150. Building 06. Dents in an exhaust hood from hail.

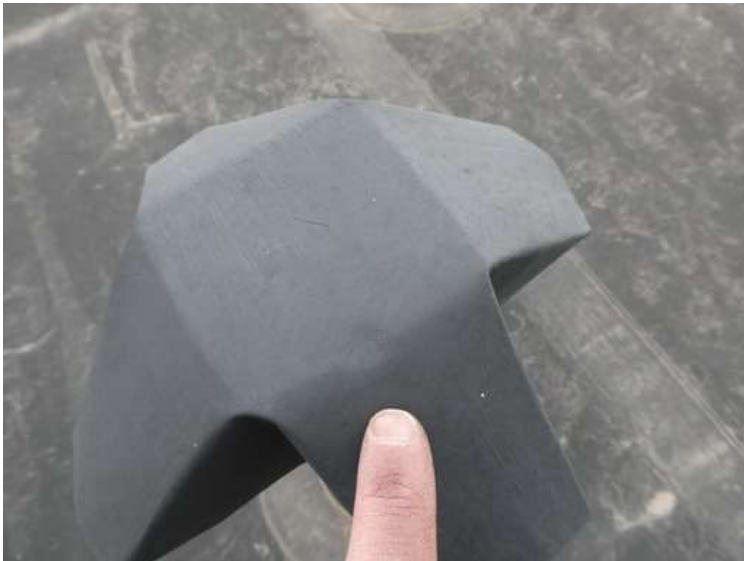
151. Building 06. Dent in a flue cap from hail.

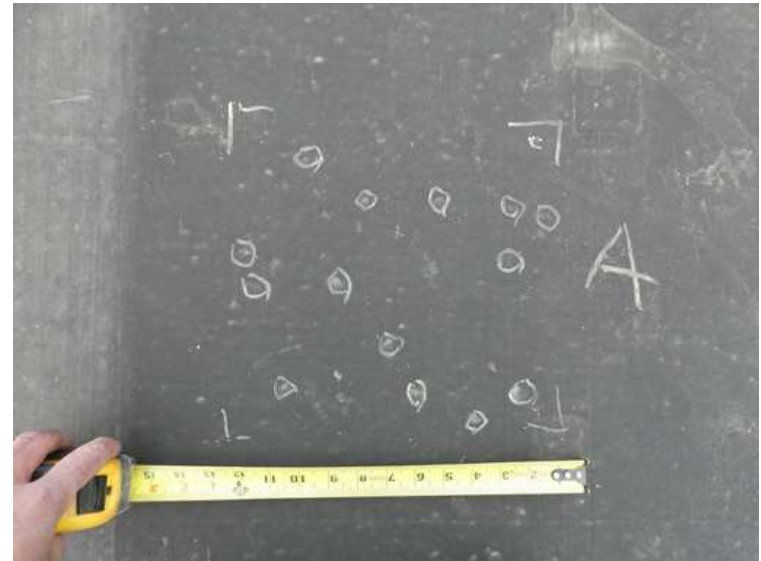
152. Building 06. Test area. Circular chalk marks denote dents in the substrate.

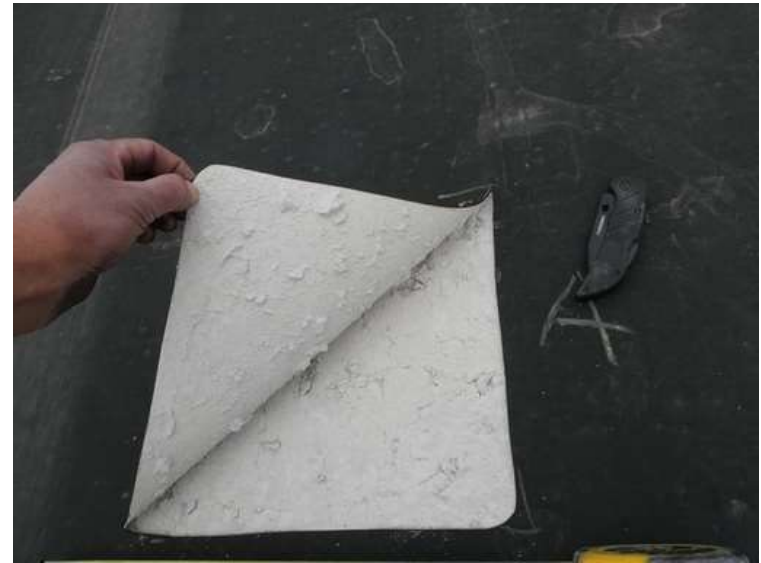
154. Building 06. The substrate provided little resistance to uplift.

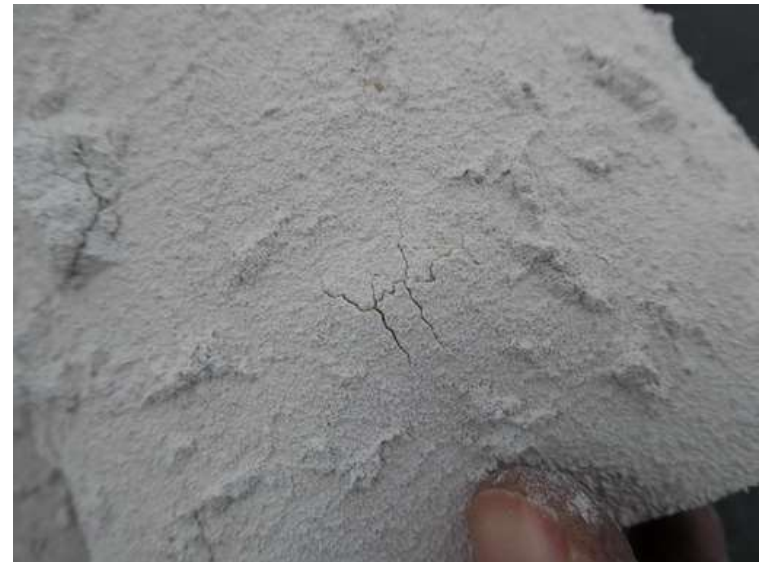
160. Building 06. Tear in the facer sheet adhered to the EPDM membrane from hail.

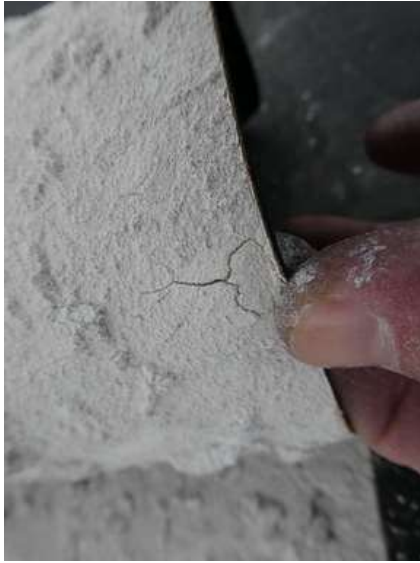
161. Building 06. Tear in the facer sheet from hail.

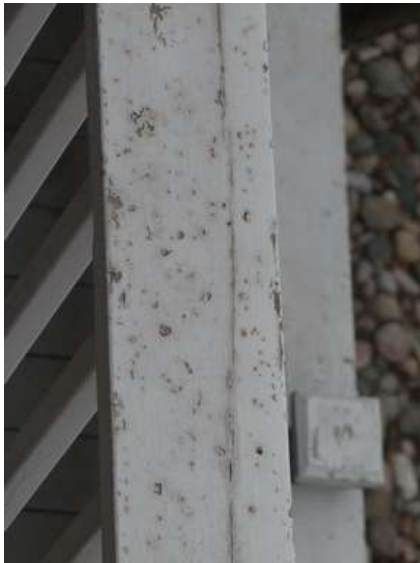
163. Building 06. Chips in paint on a hand railing from hail.

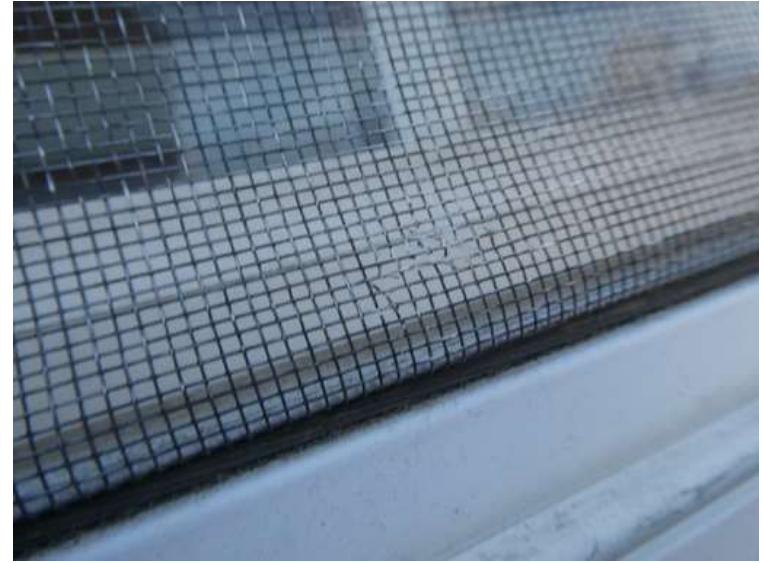
166. Building 07. Tear in a screen.

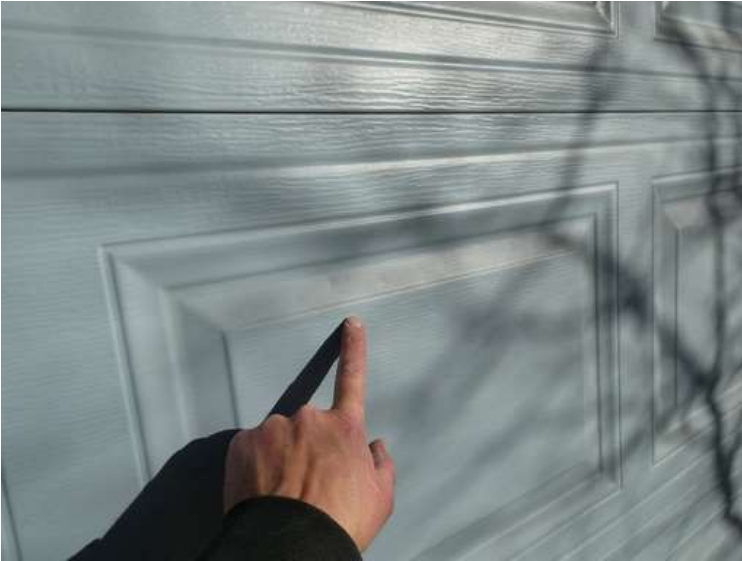
173. Building 07. Dents in a garage door from hail.

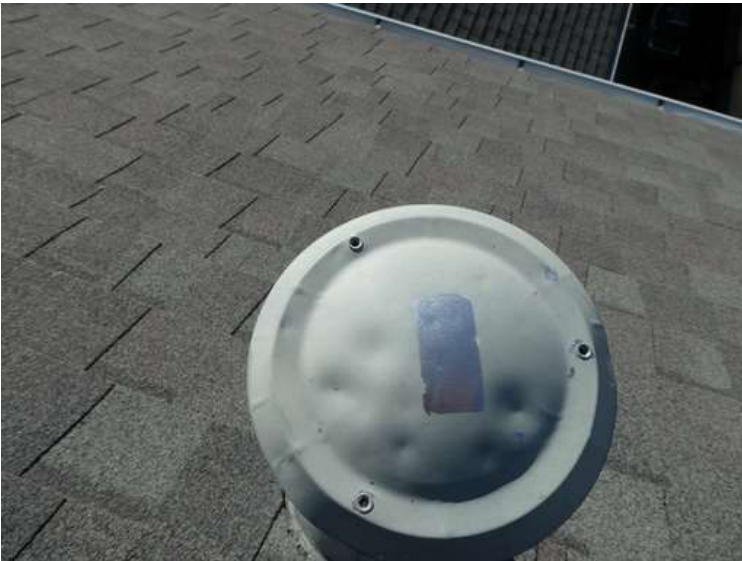
175. Building 07. Dents in a flue cap from hail.

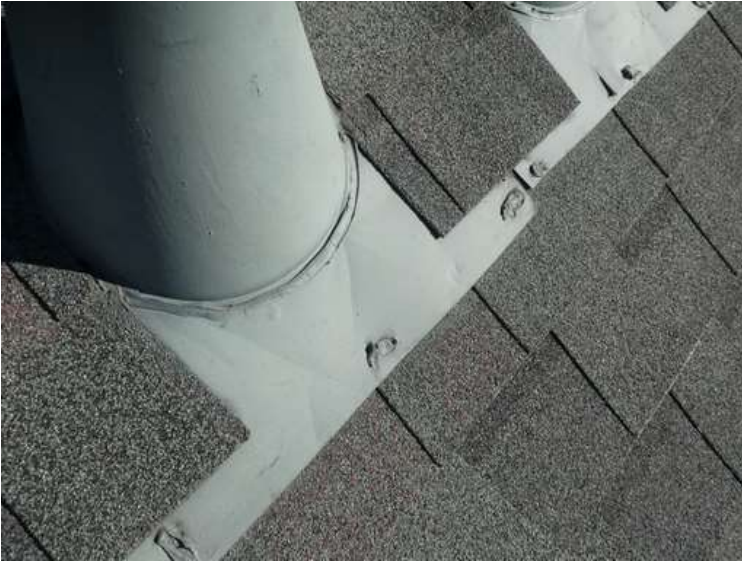
177. Building 07. Re-used base flashing.

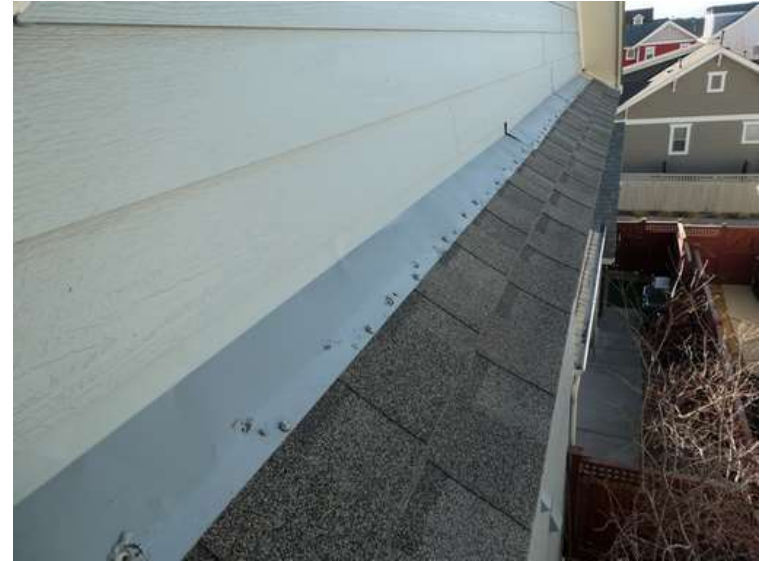
178. Building 07. Re-used headwall flashing.

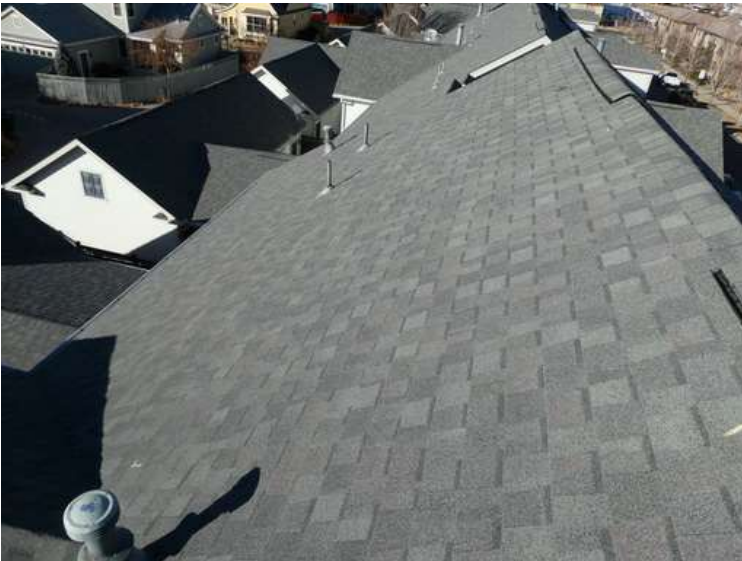
179. Building 07. West test area. No shingles within the test area were bruised by hail.

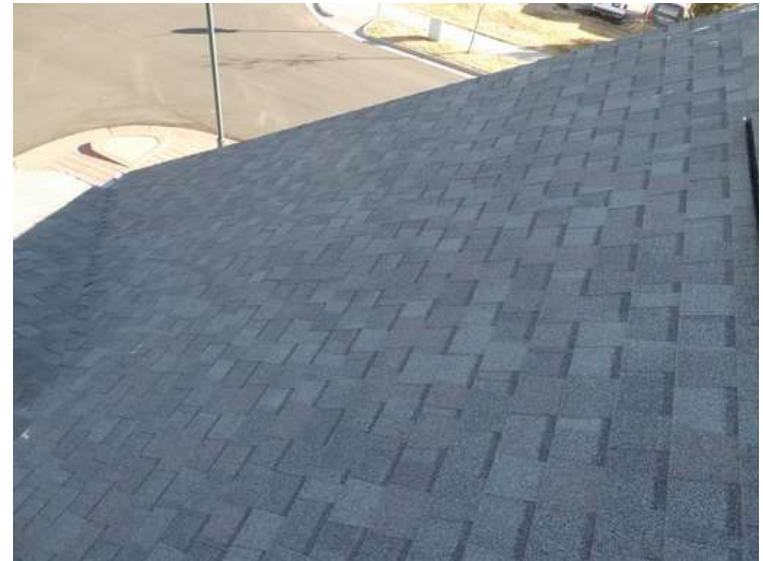
180. Building 07. East test area. No shingles within the test area were bruised by hail.

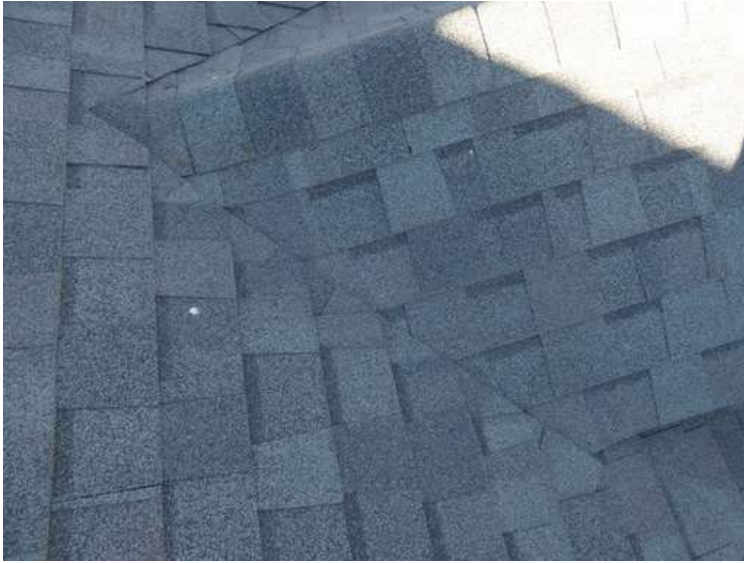
181. Building 07. Shingles draped over valleys were not bruised by hail.

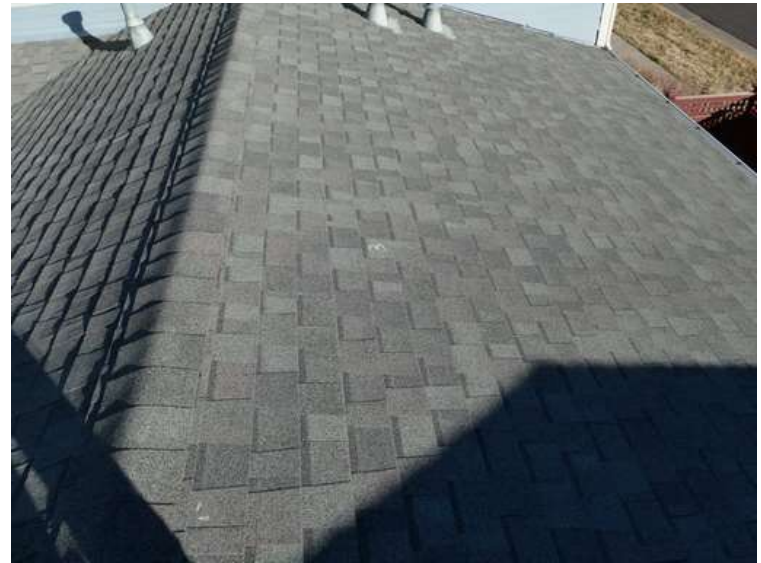
186. Building 07. South test area. No shingles within the test area were bruised by hail.

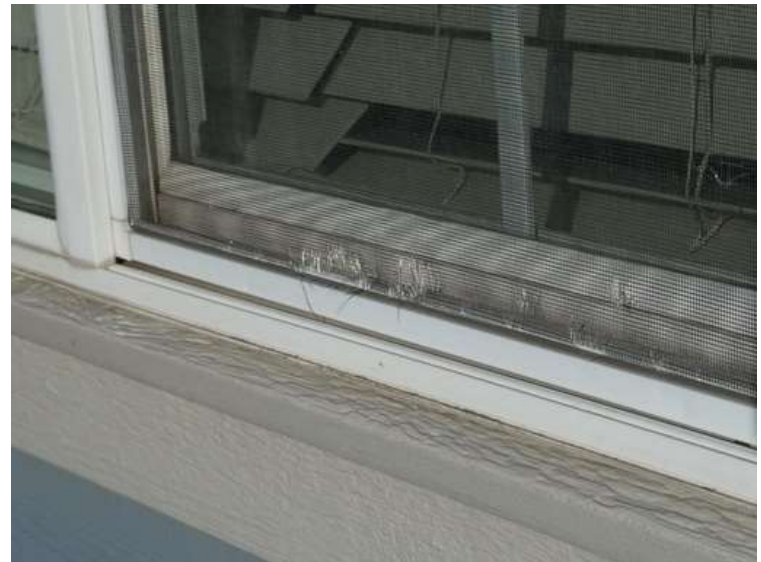
188. Building 07. Tears in a screen from hail.

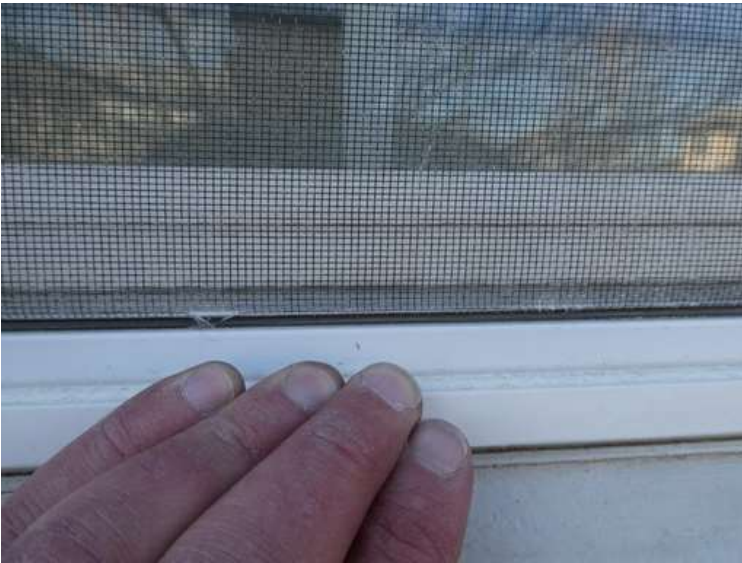
191. Building 08. Tears in a screen.

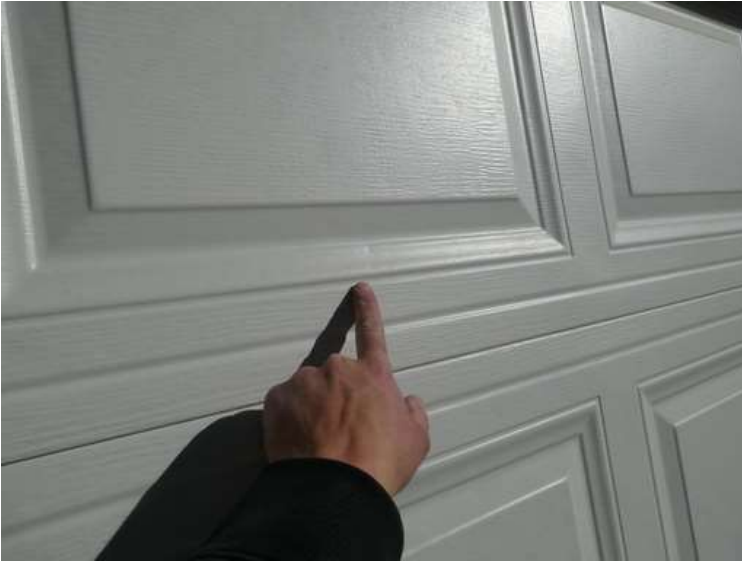
193. Building 08. Dent in a garage door from hail.

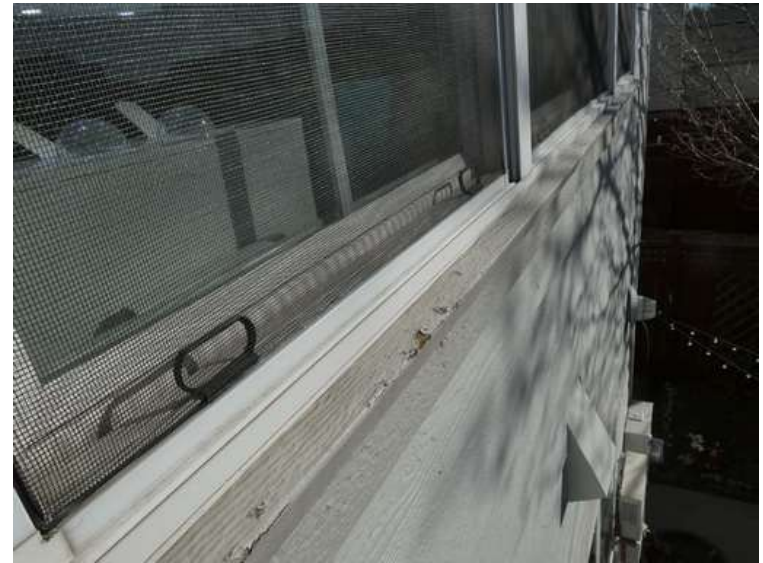
198. Building 08. Chips in paint.

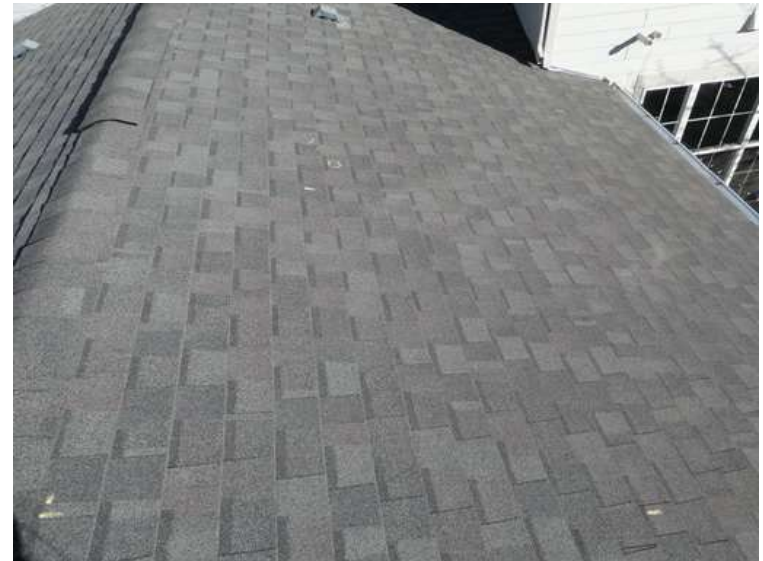
200. Building 08. South test area. One shingle within the test area was bruised by hail.

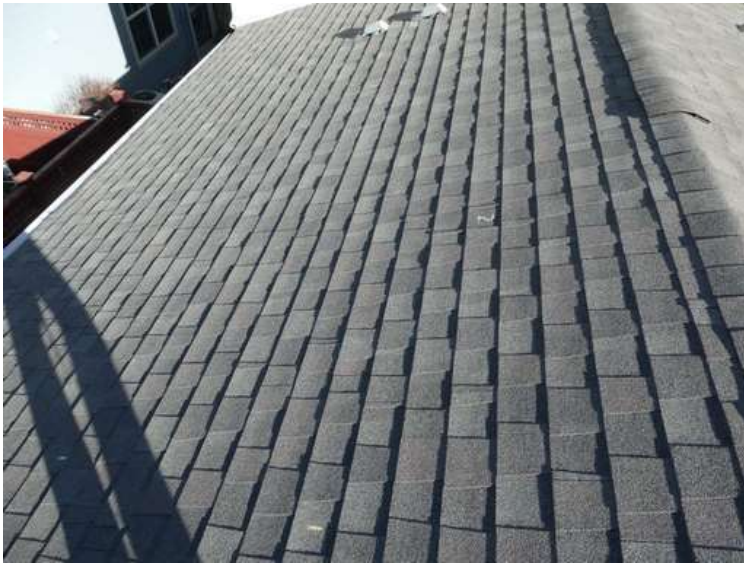
203. Building 08. North test area. No shingles within the test area were bruised by hail.

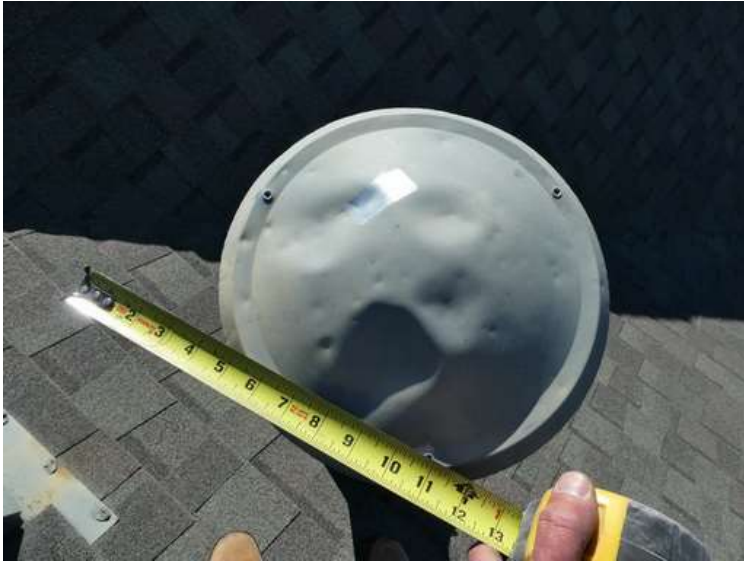
205. Building 08. Dents in a flue cap.

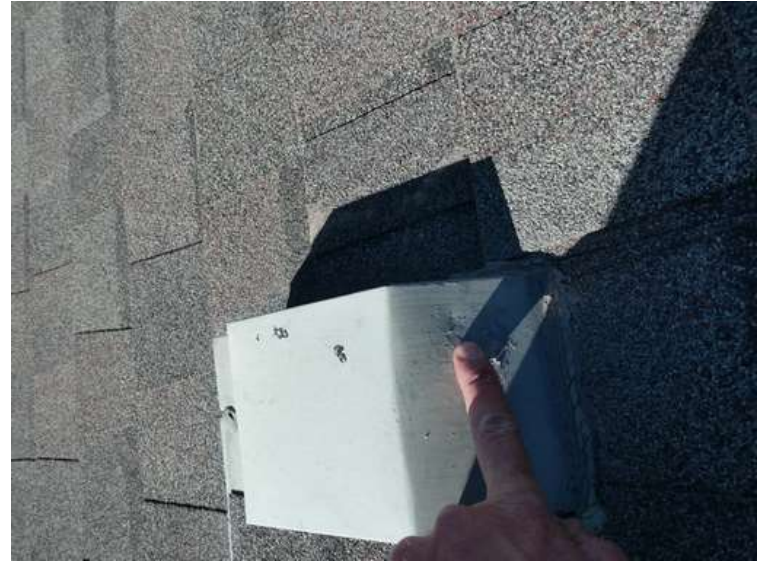
206. Building 08. Dent in an exhaust vent.
