Stapleton Rowhome Association
Hail Damage Evaluation
10045 Martin Luther King Boulevard
Denver, CO 80238
Farmers File: 5010168593
Haag File: 1121000002-128

Re: Stapleton Rowhome Association
Hail Damage Evaluation
10045 Martin Luther King Boulevard
Denver, CO 80238
Farmers File: 5010168593
Haag File: 1121000002-128

In accordance with your request, we inspected the Stapleton Rowhome Association buildings to determine the extent of hail-caused damage to the building exteriors and when the damage occurred. We inspected the sites on February 1, 2, and 3, 2021.

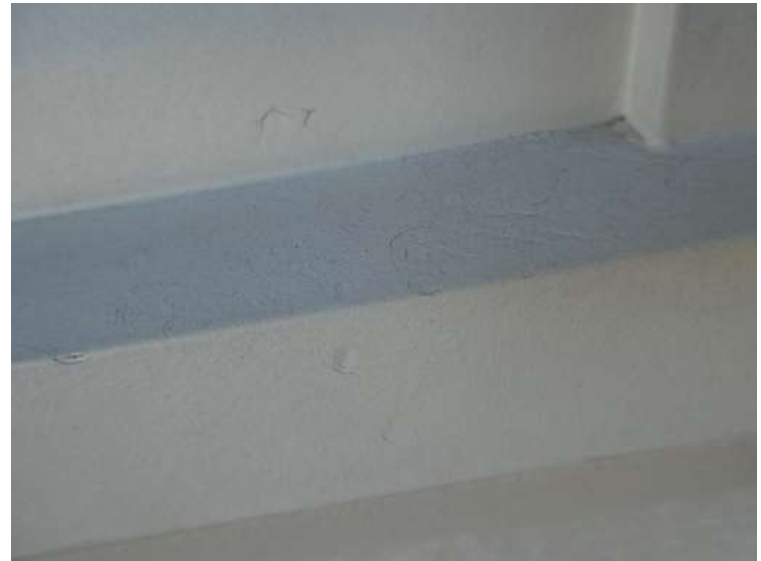
208. Building 08. Chip in paint from hail.

6. Hail chipped paint on top surfaces of protrusions such as windowsills, trim pieces, and railings. Paint finishes on vertical fiber cement siding were not fractured by hail. Hail scuffed stain finishes on wood fences around backyards. The sills, trim pieces, railings, and fences can be repainted.

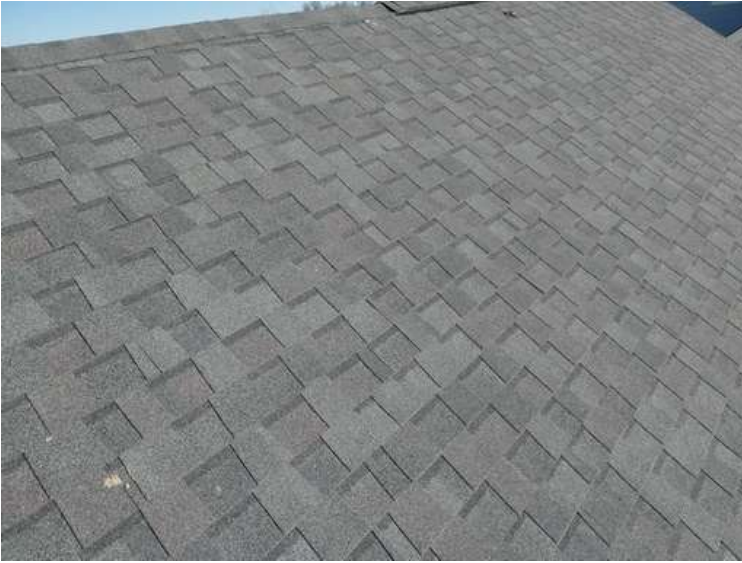
209. Building 08. West test area. No shingles within the test area were bruised by hail.

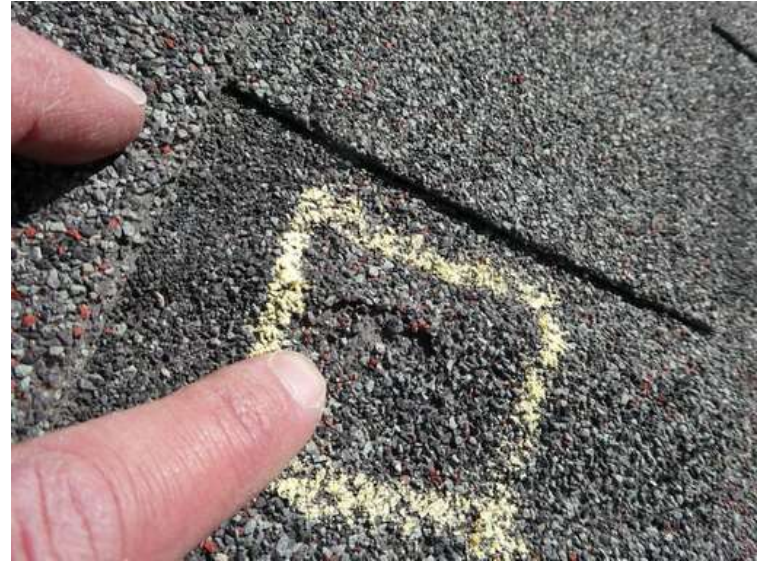
210. Building 08. Bruise in a wrinkle outside the test area.

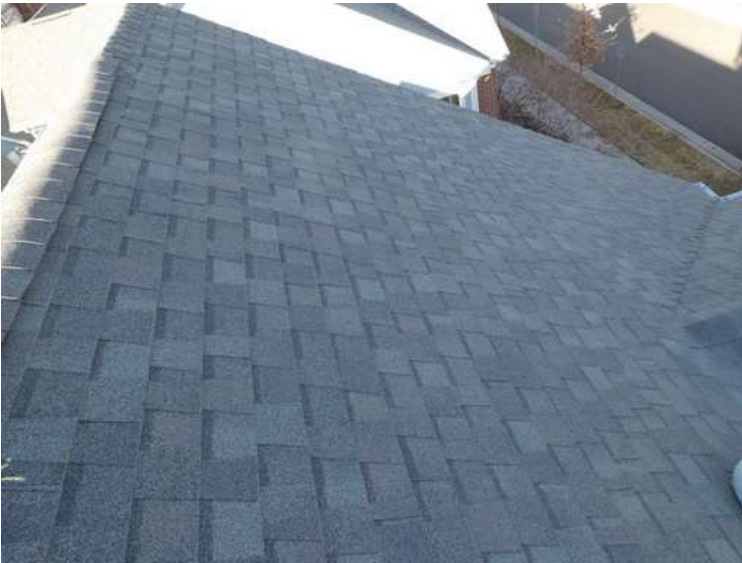
211. Building 08. East test area. No shingles within the test area were bruised by hail.

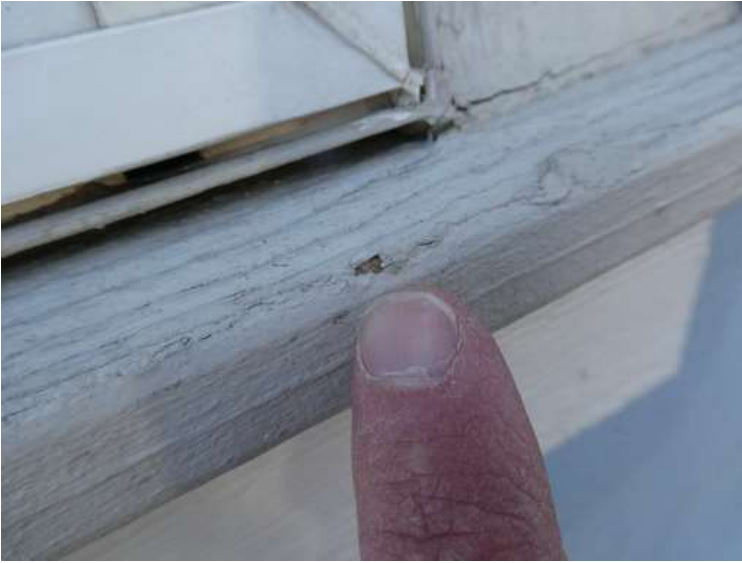
213. Building 09. Chip in paint on a sill.

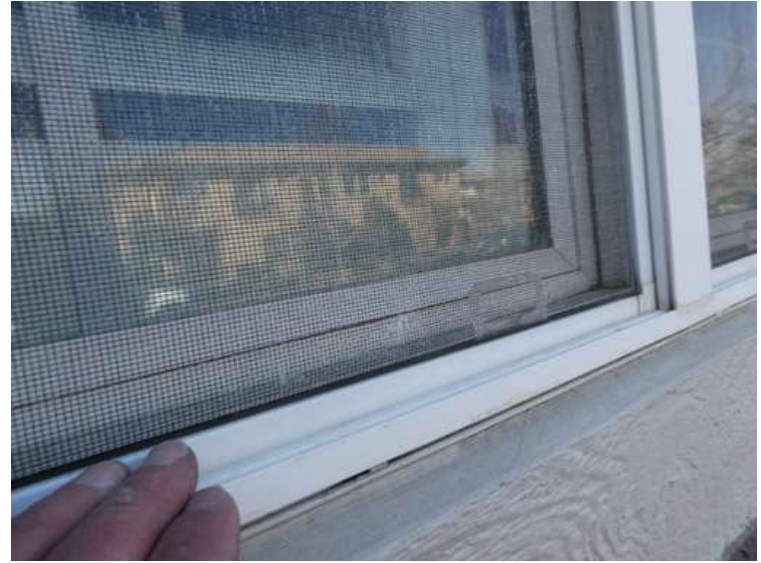
214. Building 09. Tears in a screen.

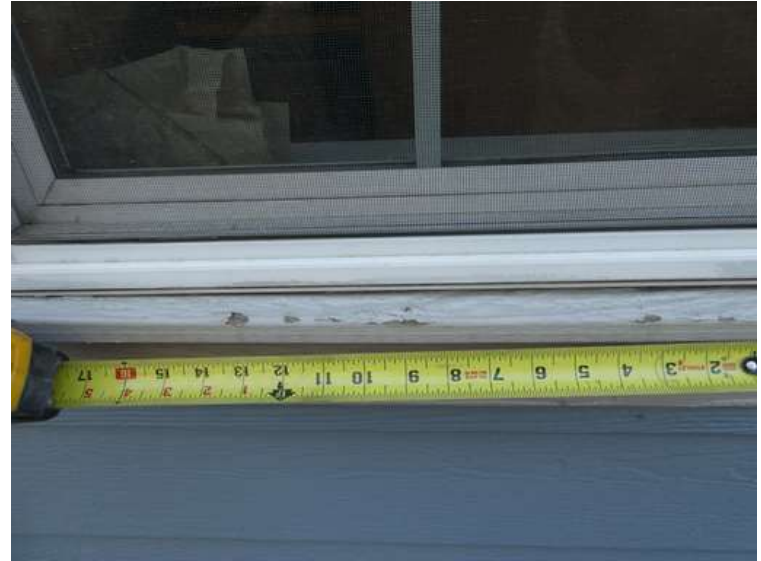
216. Building 09. Chips in paint on a sill.

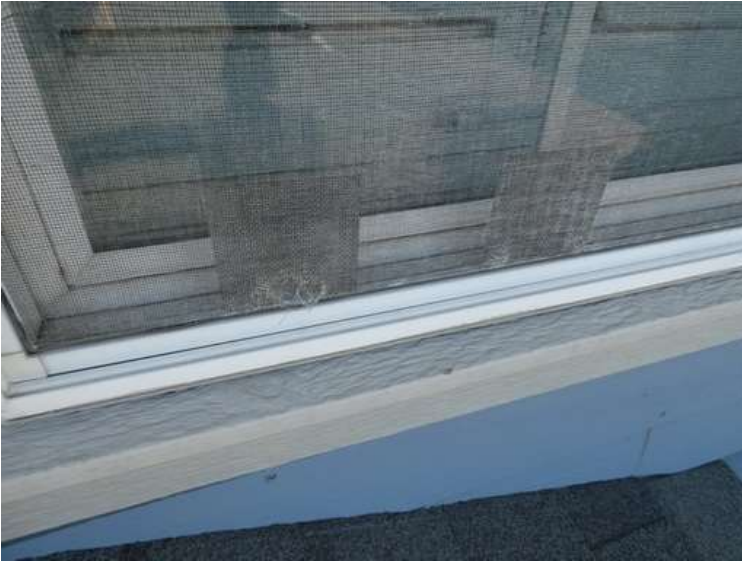
221. Building 09. Tears in a screen.

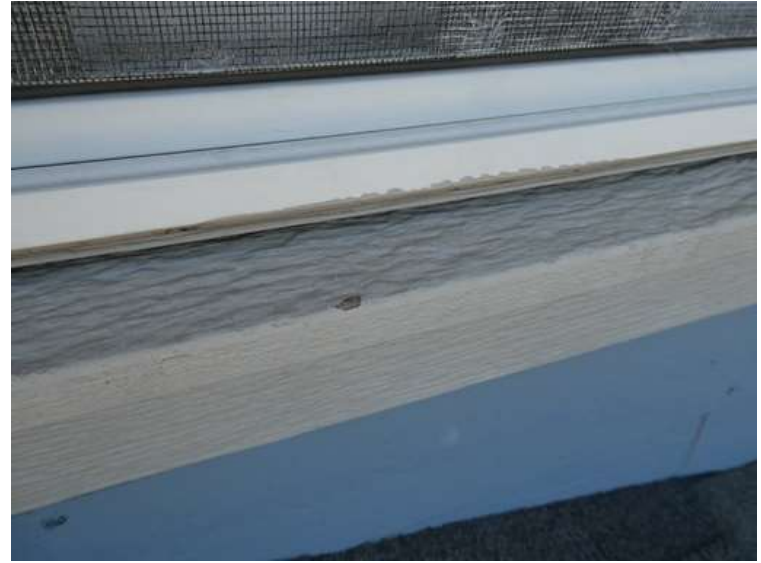
222. Building 09. Chip in paint on a sill.

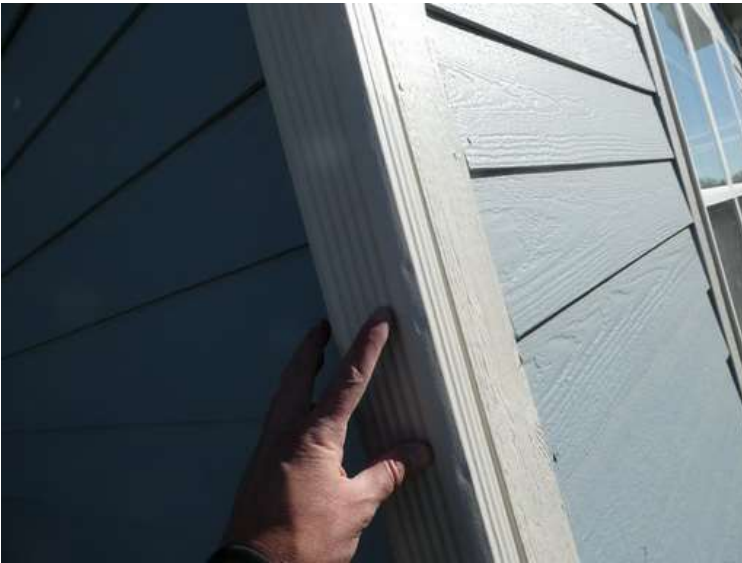
223. Building 09. Dents in a downspout.

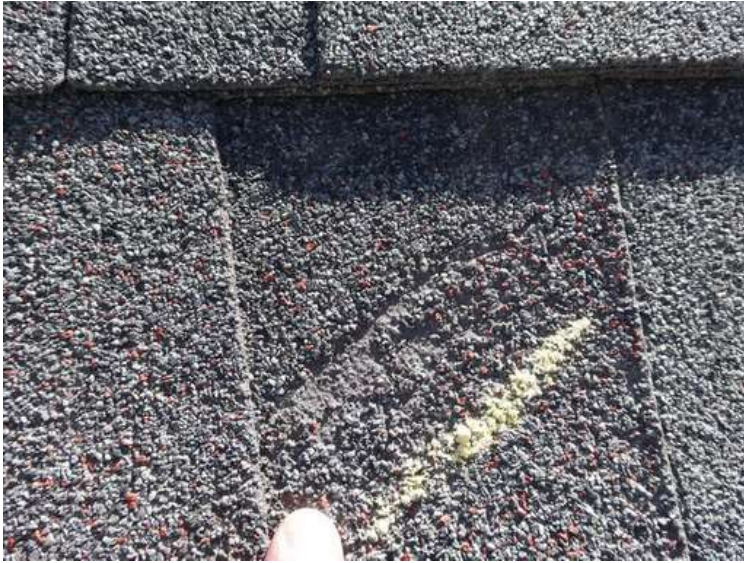
225. Building 09. Mechanical scuff.

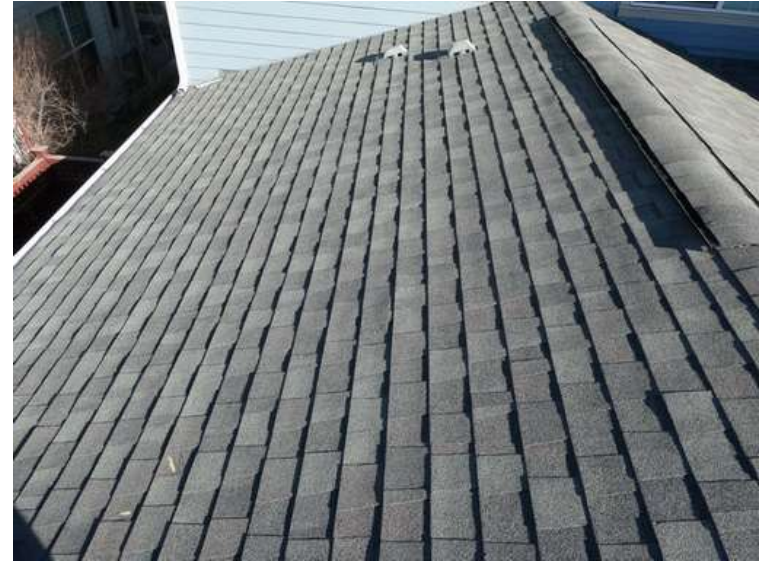
226. Building 09. North test area. No shingles within the test area were bruised by hail.

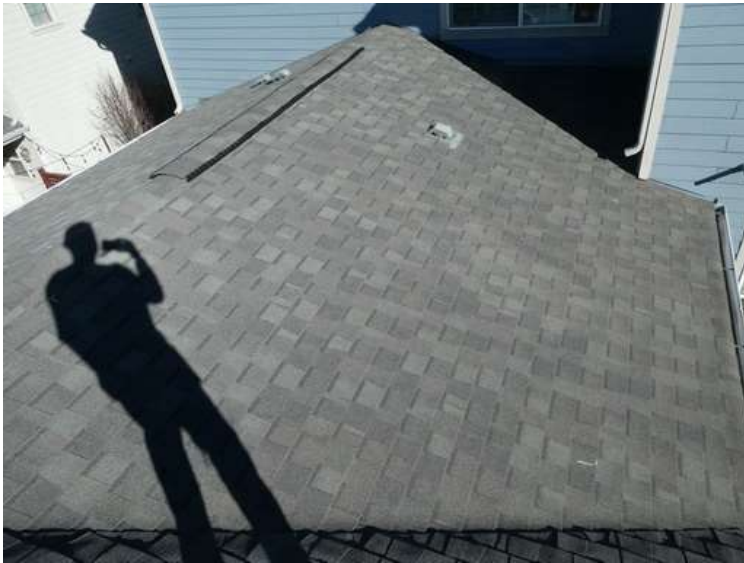
227. Building 09. South test area. No shingles within the test area were bruised by hail.

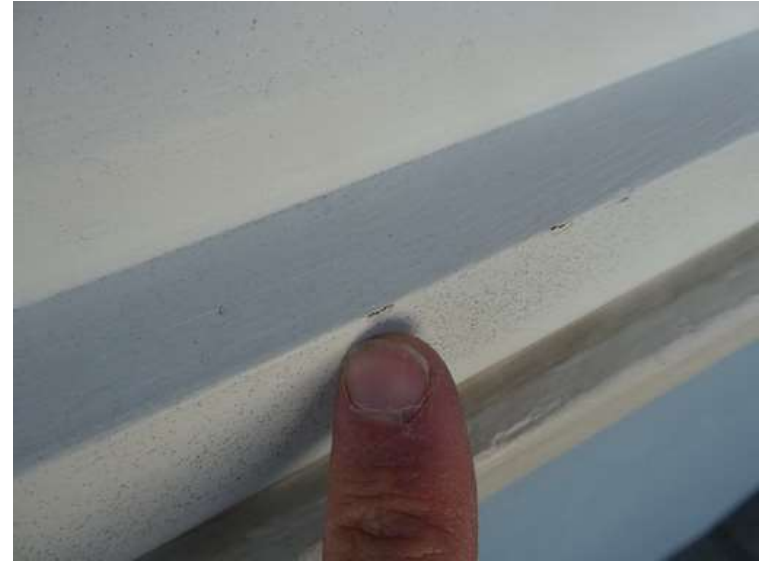
230. Building 09. Chips in paint on a north elevation sill.

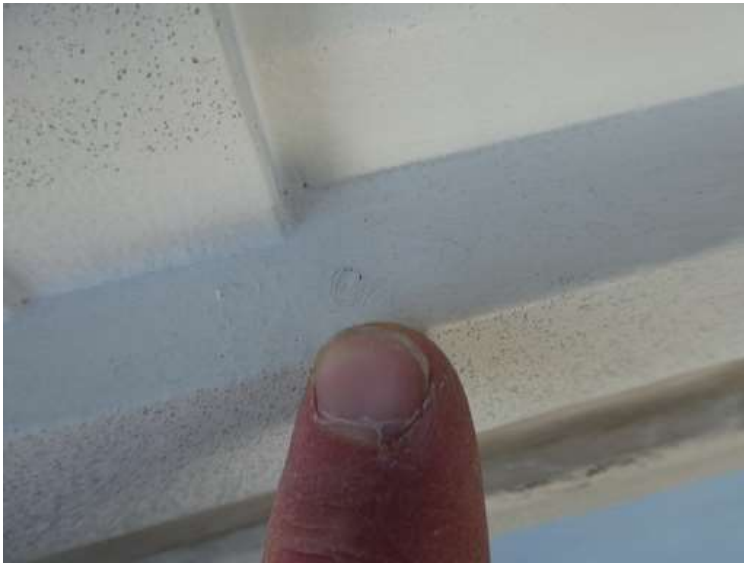
231. Building 09. Chips in paint.

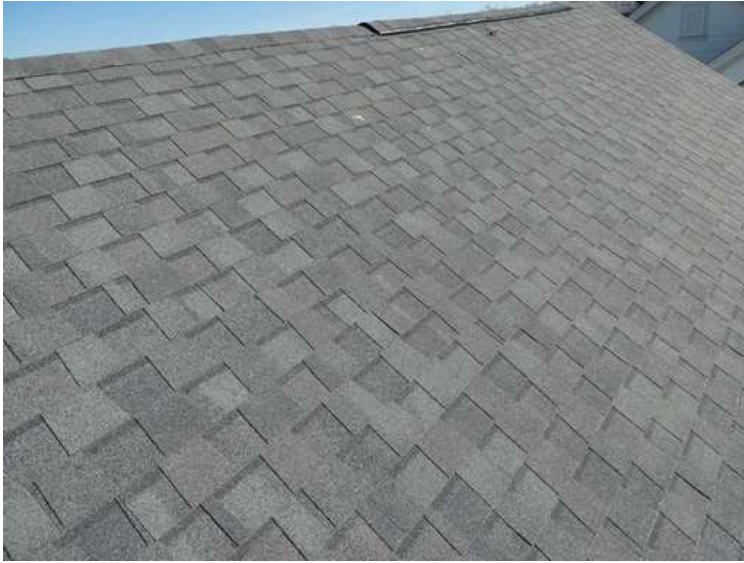
233. Building 09. West test area. No shingles within the test area were bruised by hail.

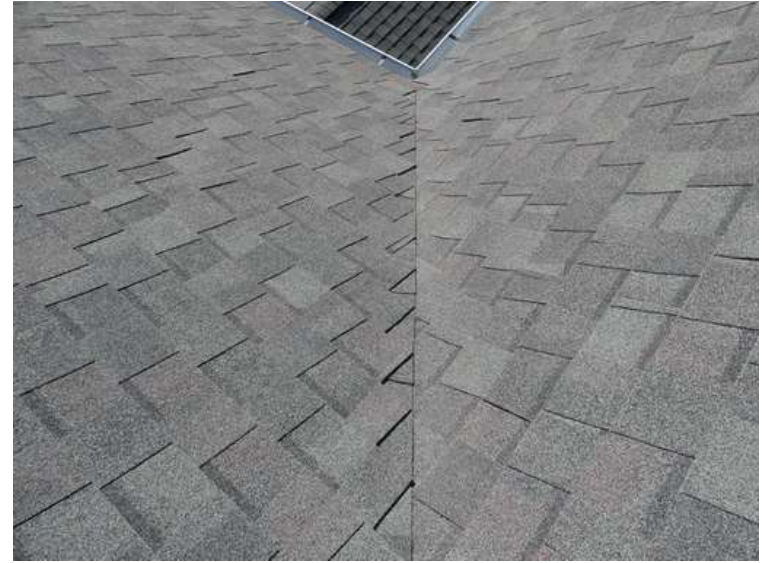
234. Building 09. Shingles draped over valleys were not bruised by hail.

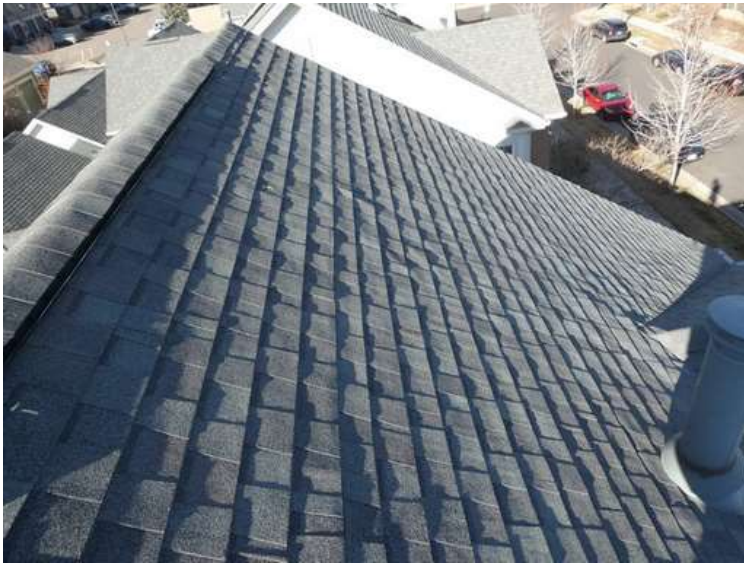
235. Building 09. East test area. No shingles within the test area were bruised by hail.

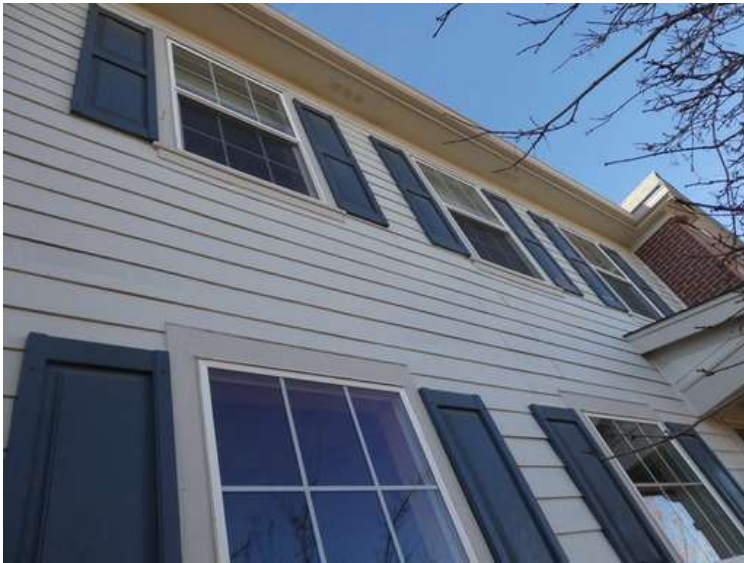
237. Building 10. Paint finishes on fiber cement siding was not chipped by hail.

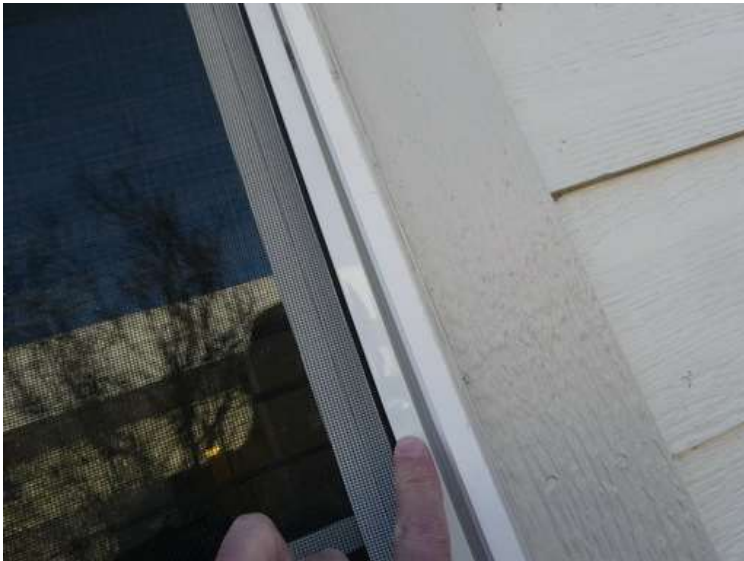
239. Building 10. Dent in a screen frame.

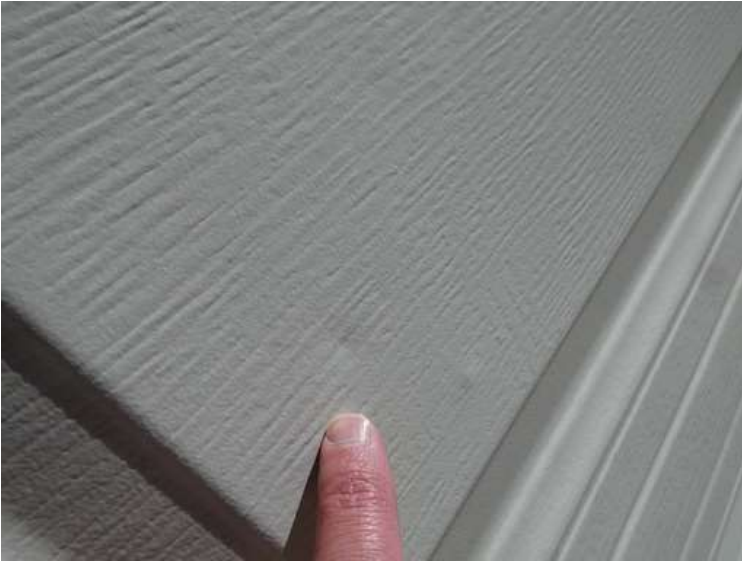
241. Building 10. Dent in a garage door from hail.

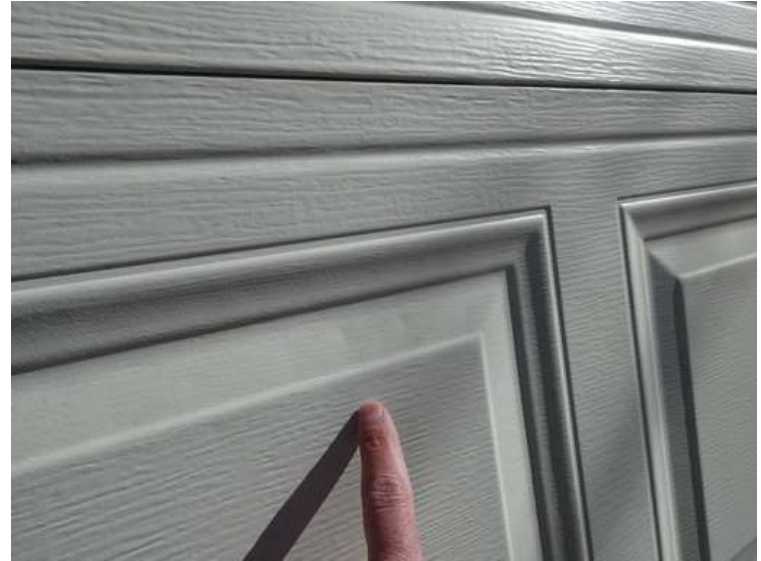
242. Building 10. Dents in a garage door.

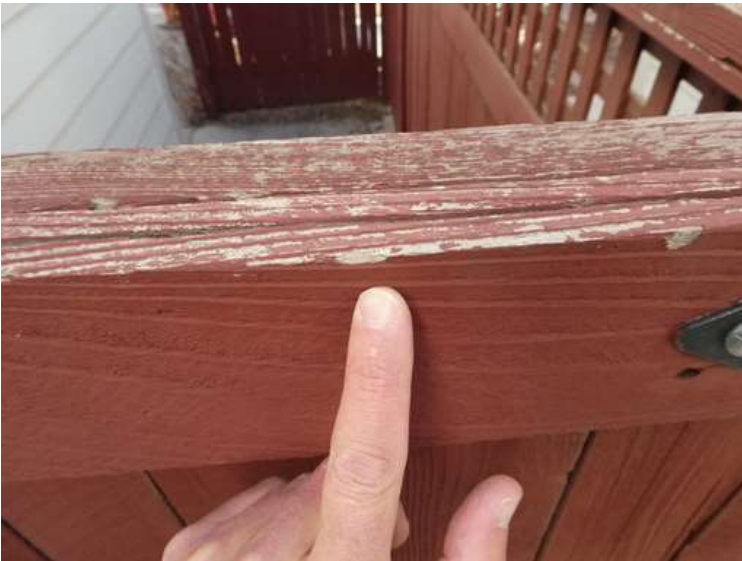
243. Building 10. Stain scuffed by hail.

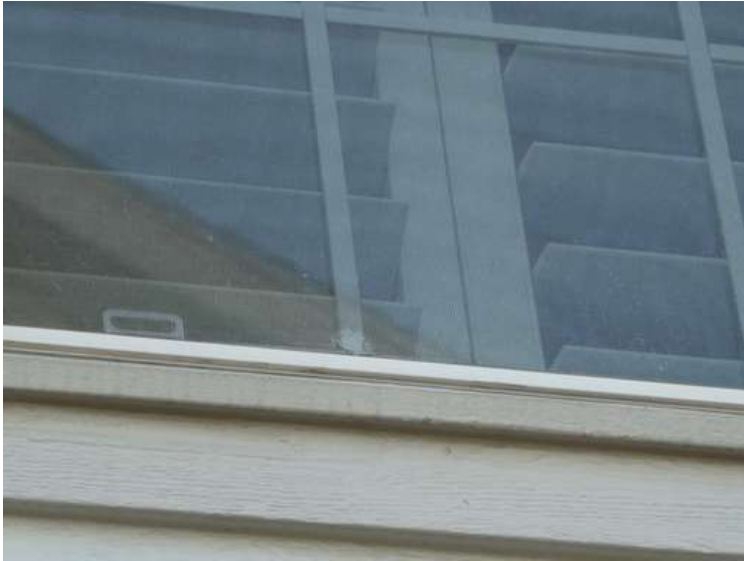
245. Building 10. Tear in a screen from hail.

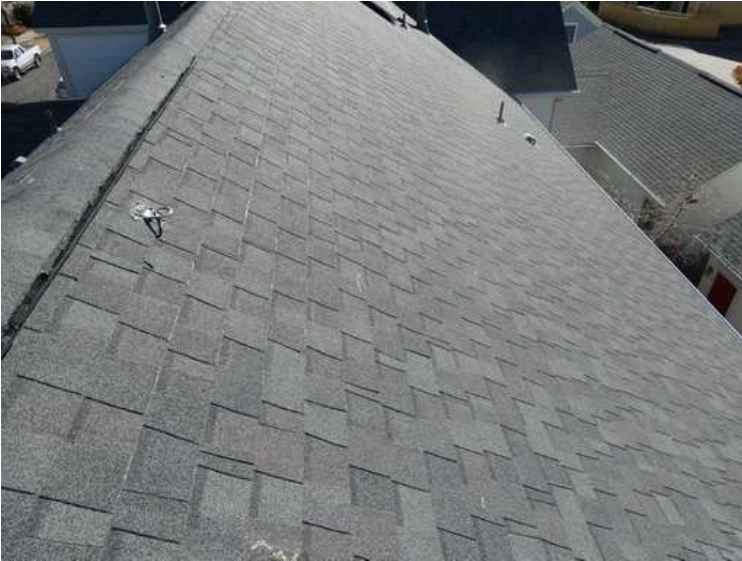
251. Building 10. West test area. No shingles within the test area were bruised by hail.

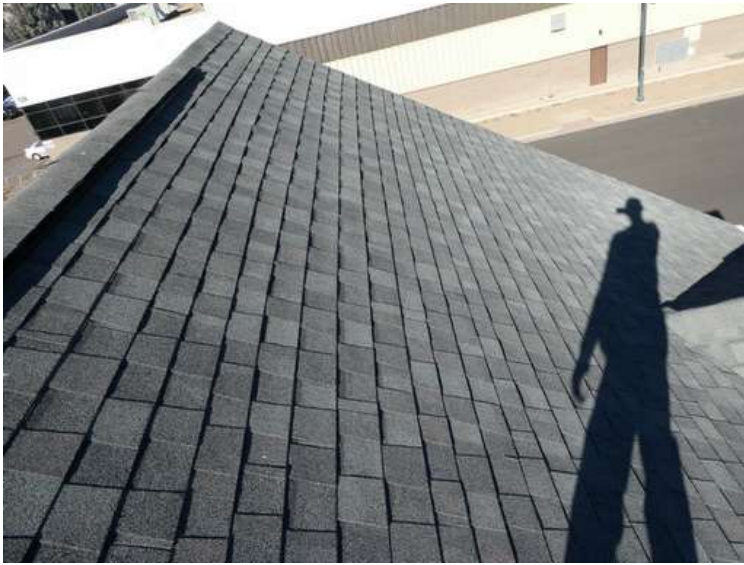
253. Building 10. East test area. No shingles within the test area were bruised by hail.

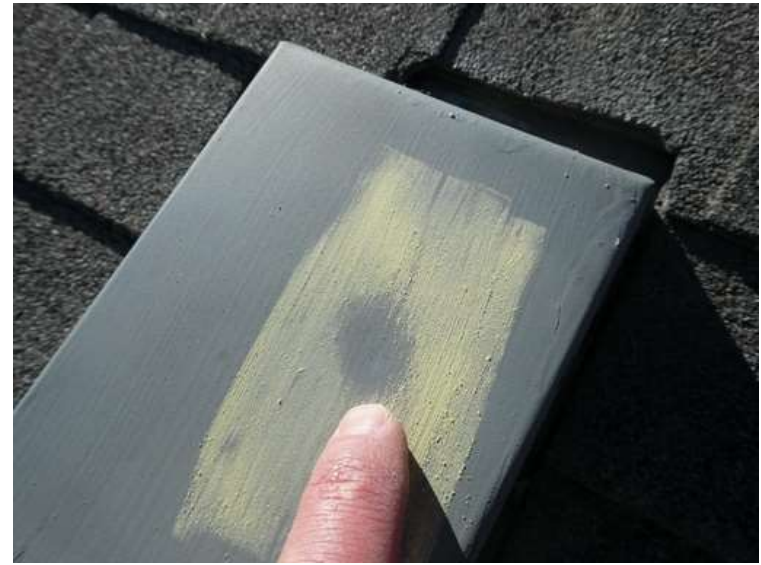
254. Building 10. Dent in an exhaust vent cap from hail.

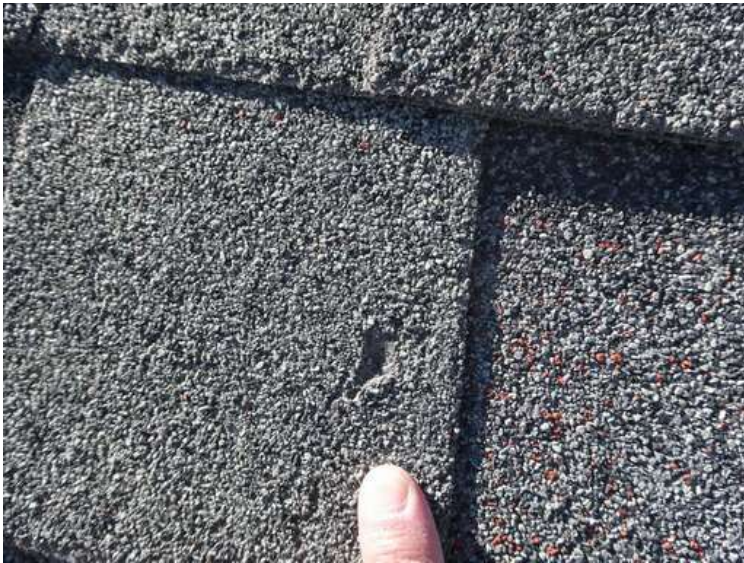
255. Building 10. Mechanical gouge.

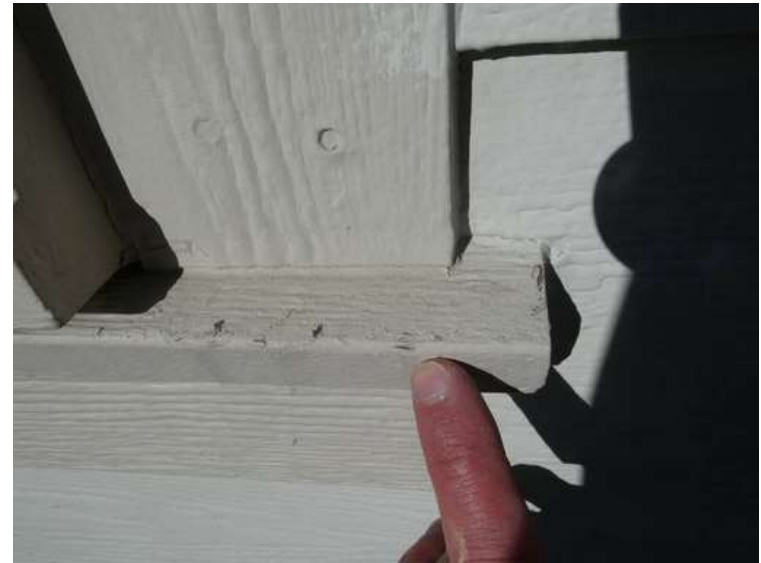
258. Building 10. Paint chips on a sill.

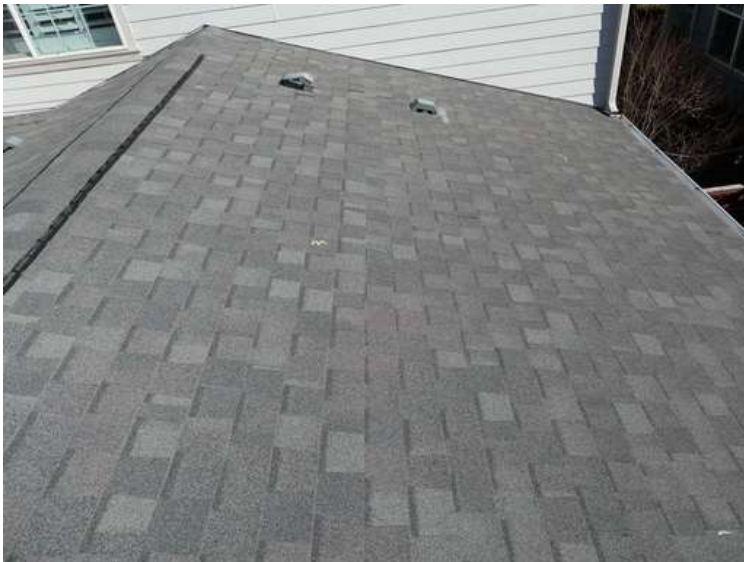
259. Building 10. South test area. No shingles within the test area were bruised by hail.

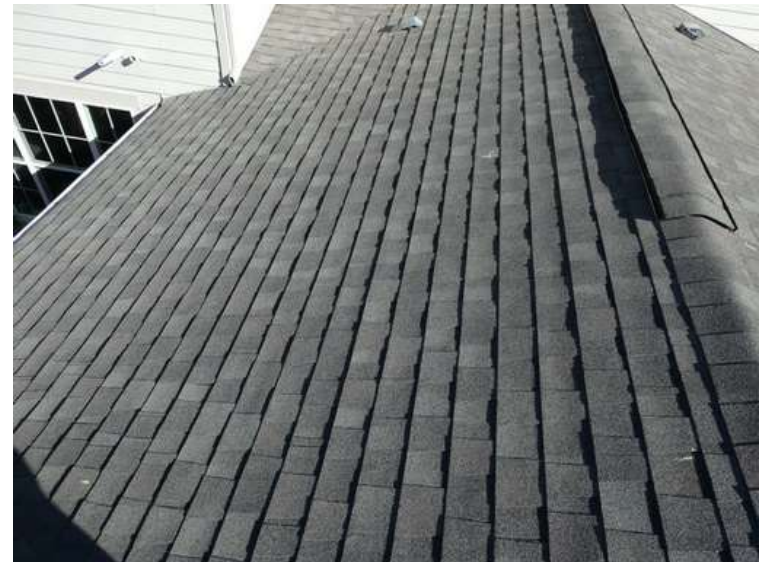
260. Building 10. North test area. No shingles within the test area were bruised by hail.

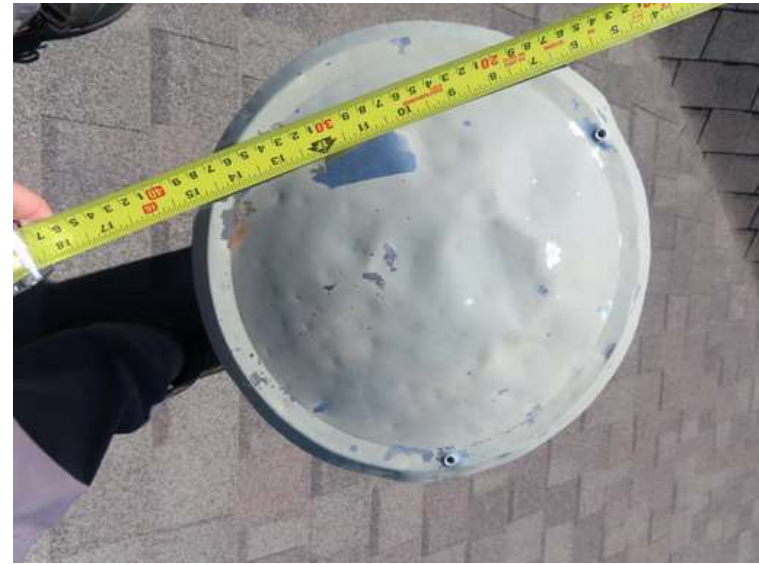
270. Building 11. Dents in a flue cap from hail.

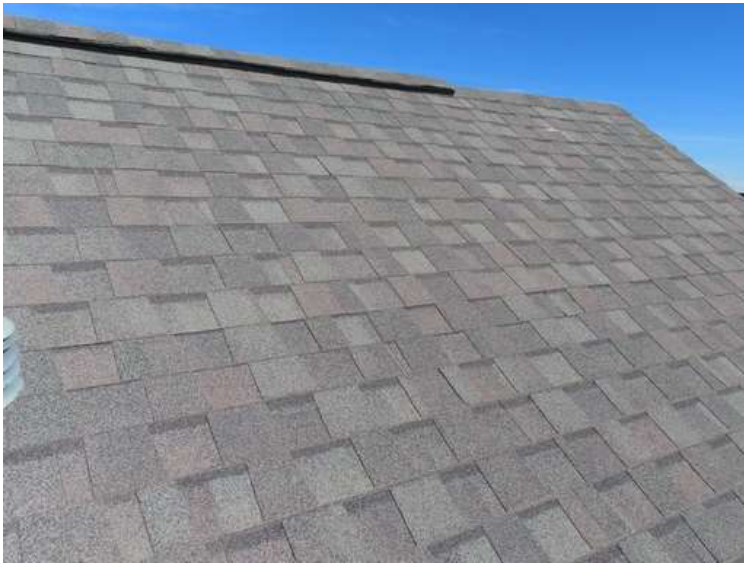
271. Building 11. South test area. No shingles within the test area were bruised by hail.

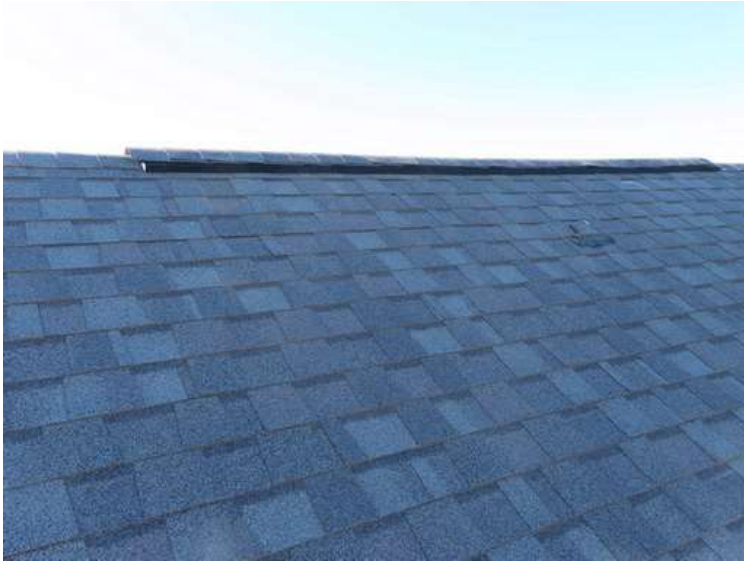
273. Building 11. North test area. No shingles within the test area were bruised by hail.

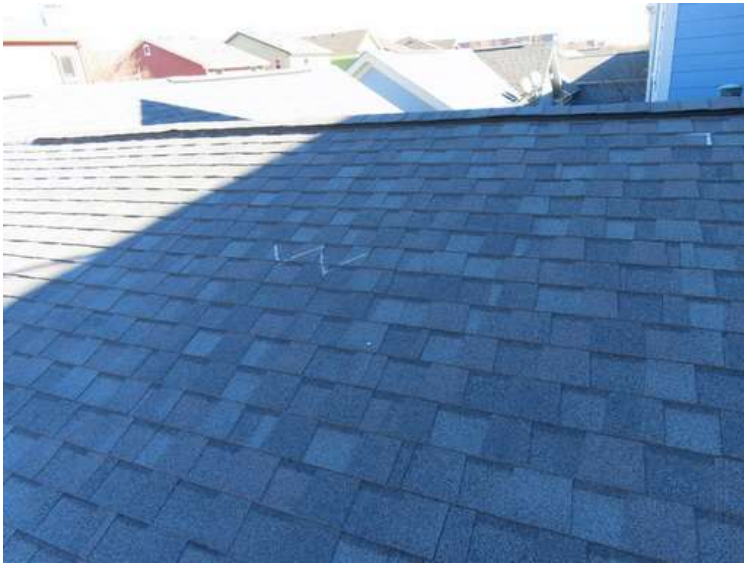
275. Building 11. West test area. No shingles within the test area were bruised by hail.

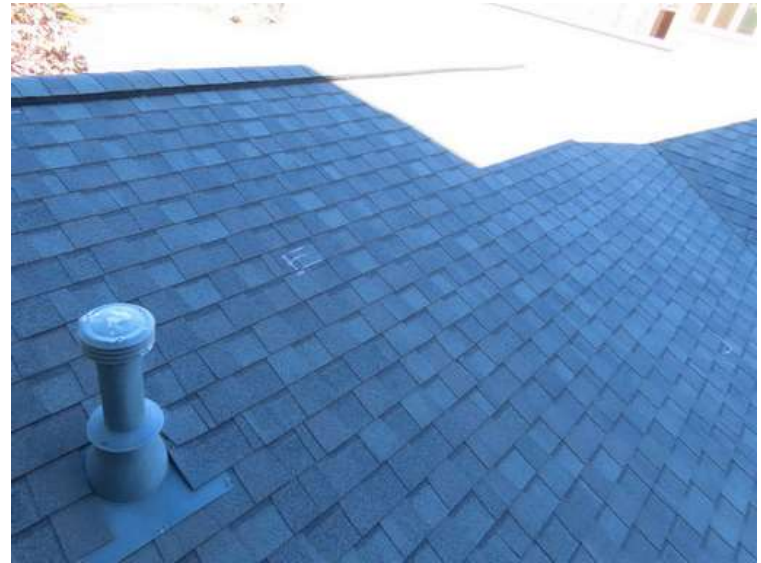
276. Building 11. East test area. No shingles within the test area were bruised by hail.

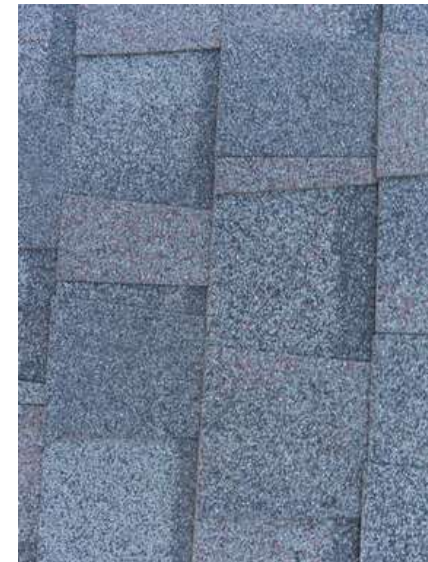
283. Building 12. West test area. No shingles within the test area were bruised by hail.

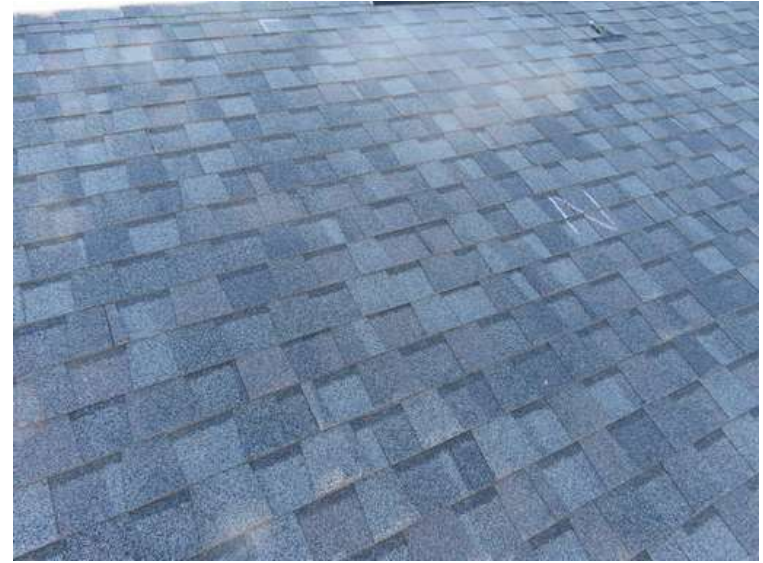
285. Building 12. Wrinkled roofing from decking movement.

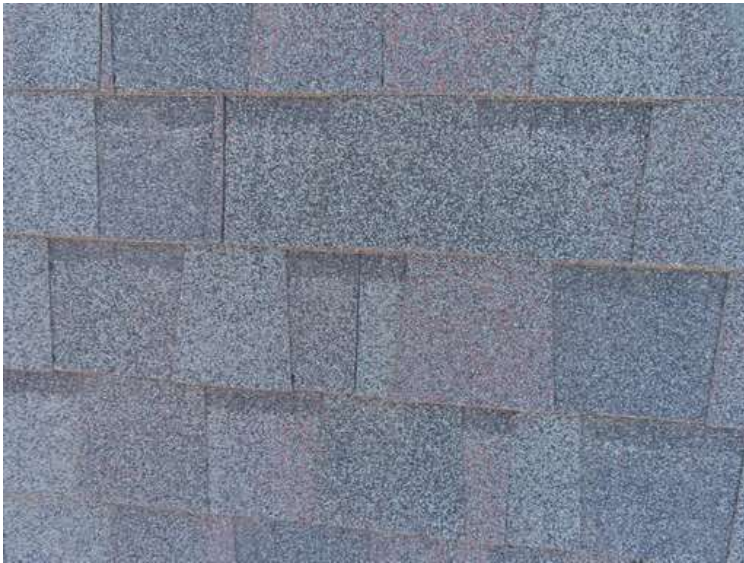
286. Building 12. North test area. No shingles within the test area were bruised by hail.

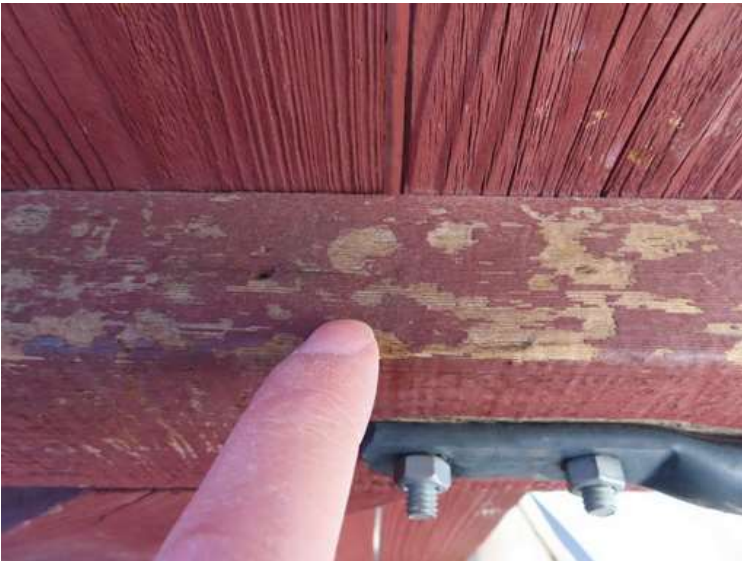
294. Building 13. Paint on a windowsill chipped by hail.

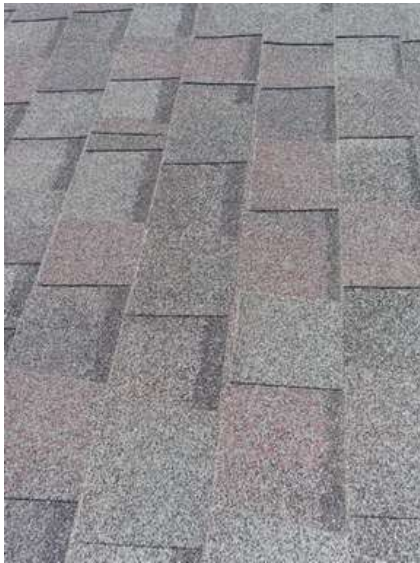
299. Building 13. Typical shingles.

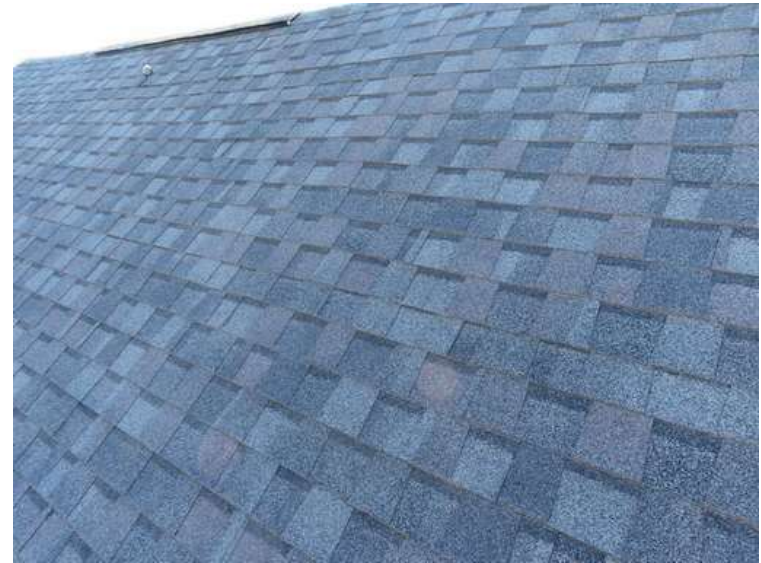
300. Building 13. North test area. No shingles within the test area were bruised by hail.

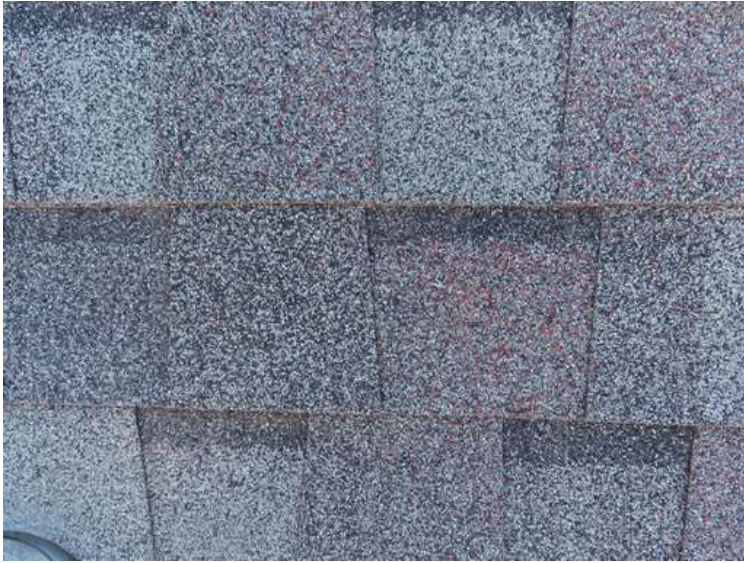
301. Building 13. Typical shingles.

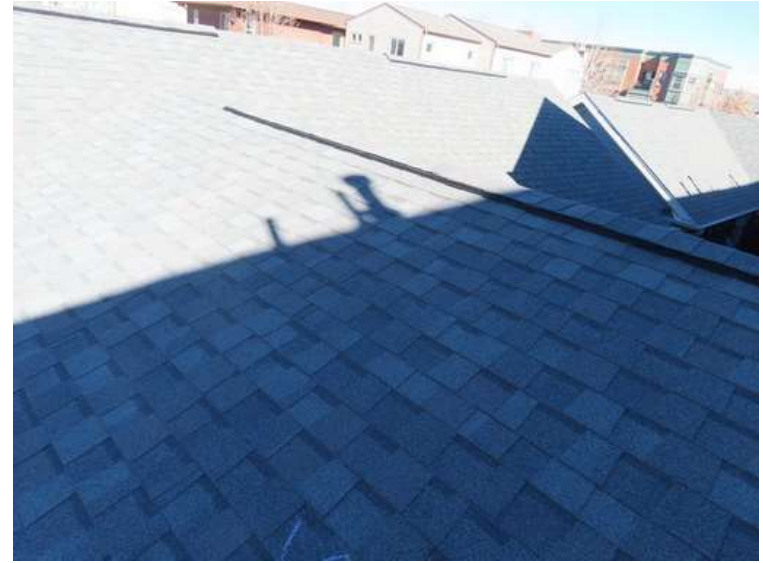
302. Building 13. West test area. No shingles within the test area were bruised by hail.

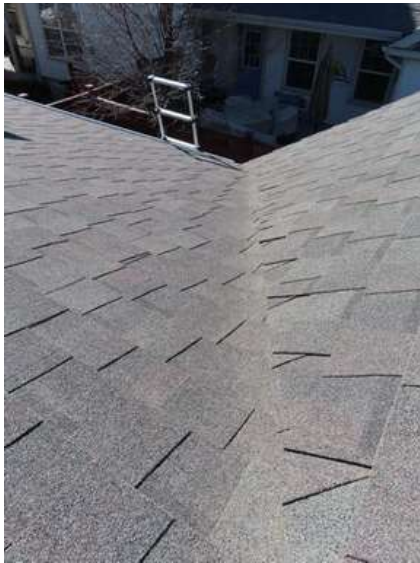
303. Building 13. Shingles draped over a valley were not bruised by hail.

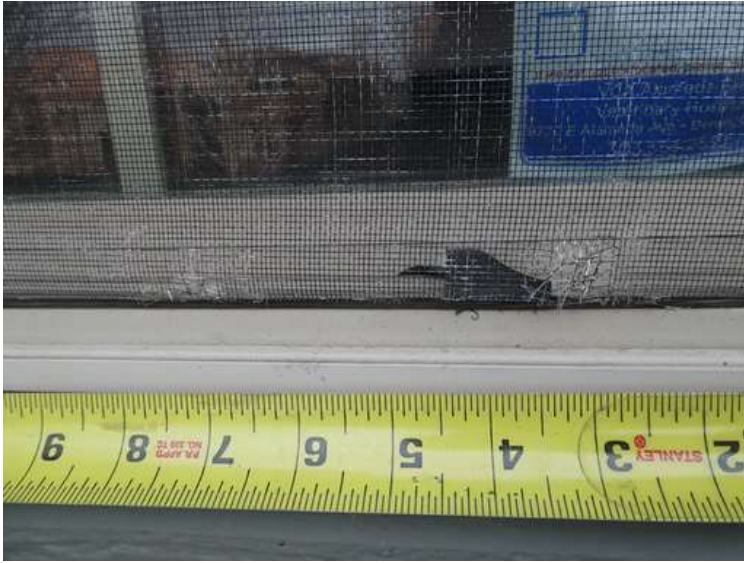
305. Building 14. Tears in a window screen from hail.

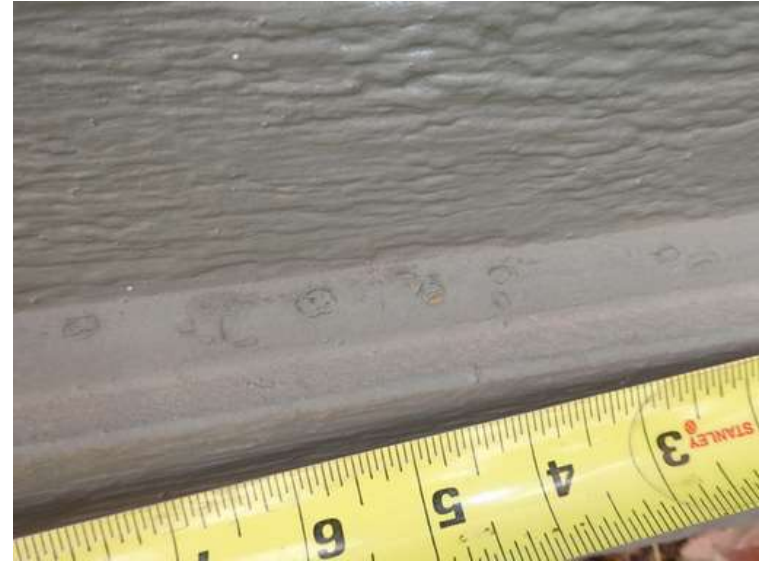
306. Building 14. Chips in paint from hail.

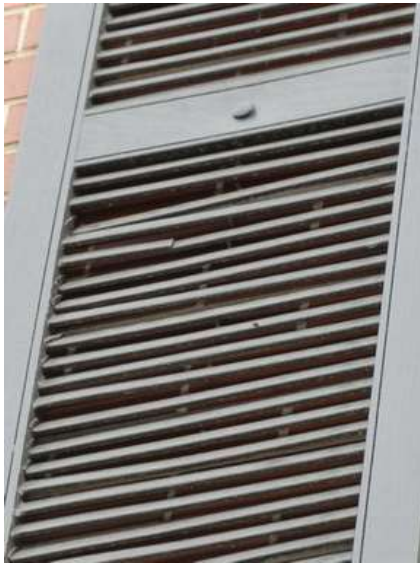
307. Building 14. Fractures in a plastic shutter from hail.

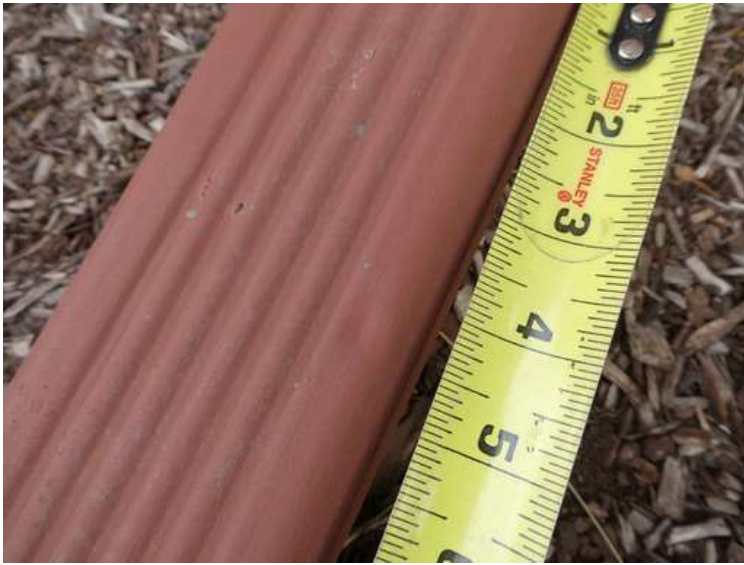
309. Building 14. Dent in a downspout extension from hail.

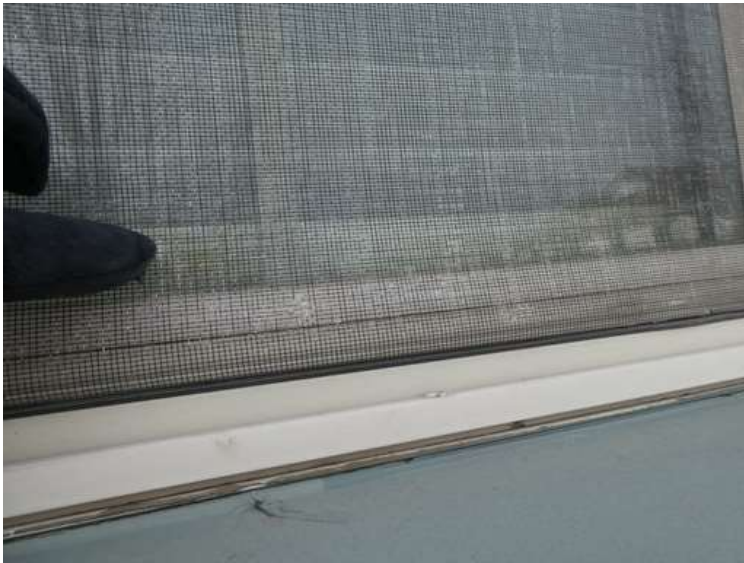
311. Building 14. Tears in a screen from hail.

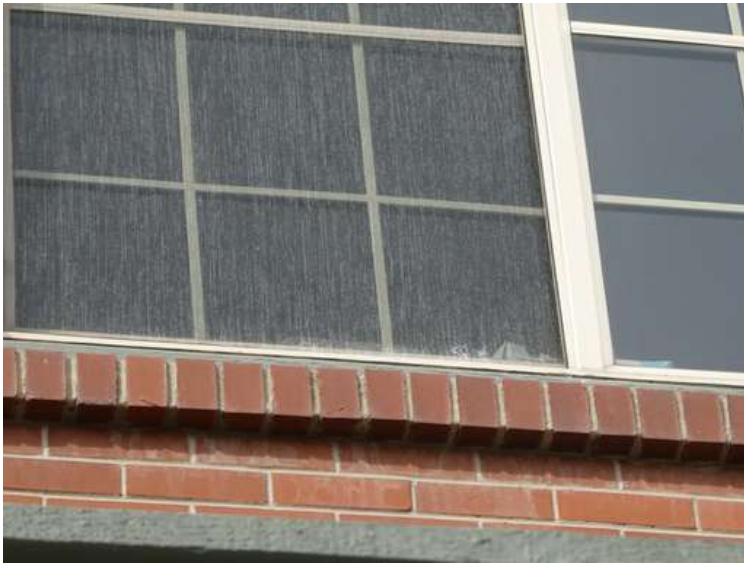
313. Building 14. Tears in a screen from hail.

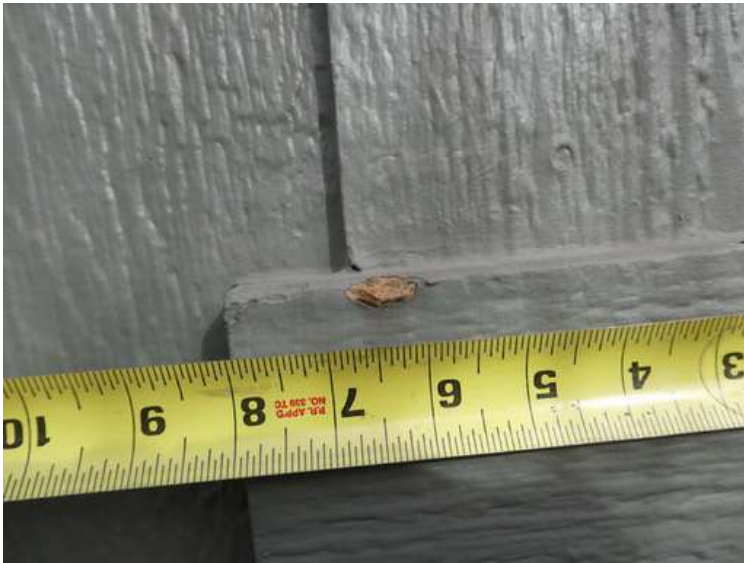
317. Building 14. Chip in paint from hail.

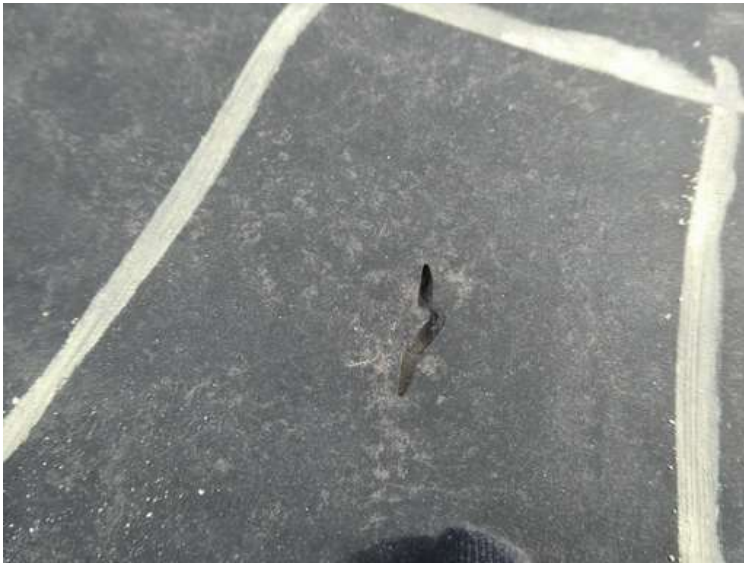
321. Building 14. Mechanical tear in the membrane.

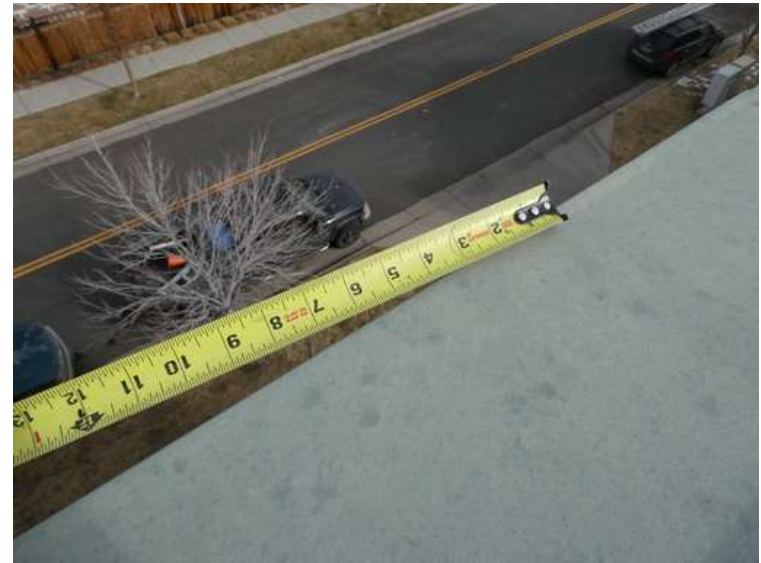
322. Building 14. Spatter marks on coping from recent hail.
