Stapleton Rowhome Association
Hail Damage Evaluation
10045 Martin Luther King Boulevard
Denver, CO 80238
Farmers File: 5010168593
Haag File: 1121000002-128

Re: Stapleton Rowhome Association
Hail Damage Evaluation
10045 Martin Luther King Boulevard
Denver, CO 80238
Farmers File: 5010168593
Haag File: 1121000002-128

In accordance with your request, we inspected the Stapleton Rowhome Association buildings to determine the extent of hail-caused damage to the building exteriors and when the damage occurred. We inspected the sites on February 1, 2, and 3, 2021.

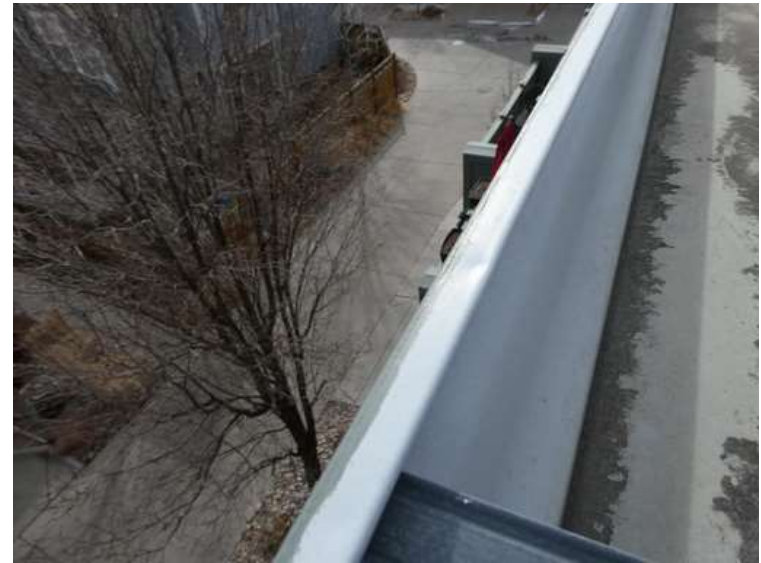
324. Building 14. Dent in a gutter from hail.

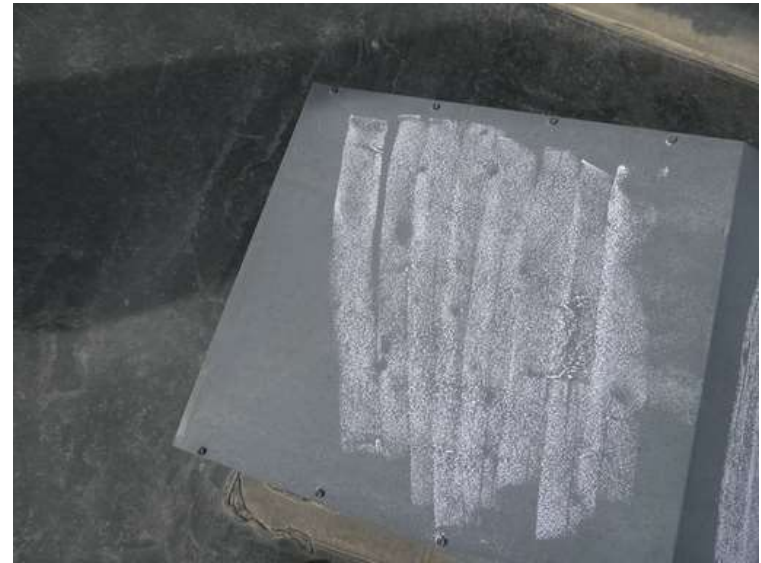
326. Building 14. Dents in a vent hood from hail.

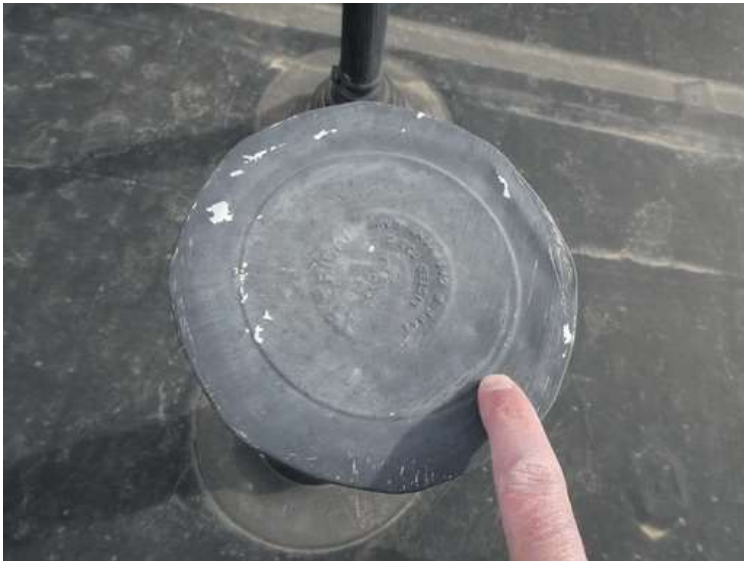
327. Building 14. Dents in a flue cap from hail.

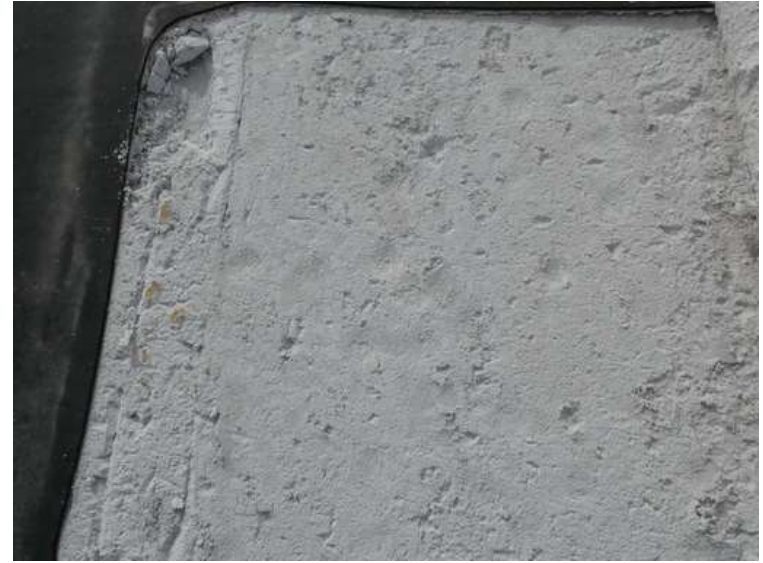
330. Building 14. Dents in the gypsum from hail. The gypsum was powdery.

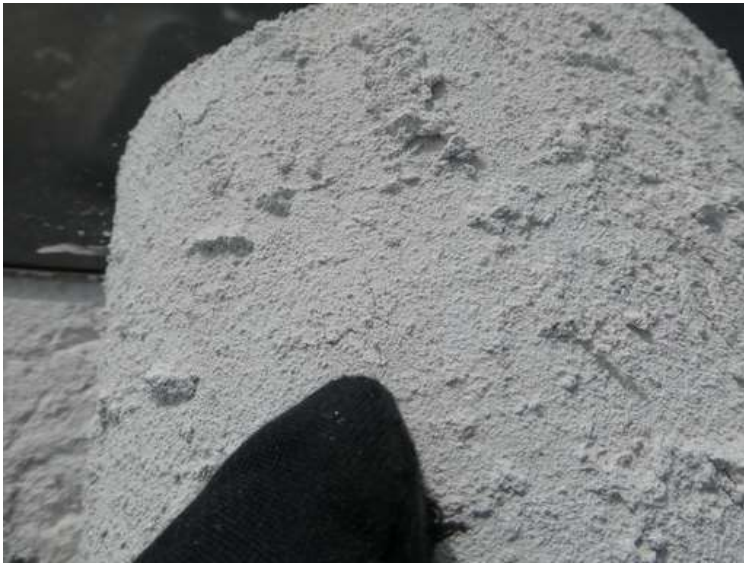
331. Building 14. Tear in the facer sheet adhered to the membrane from hail.

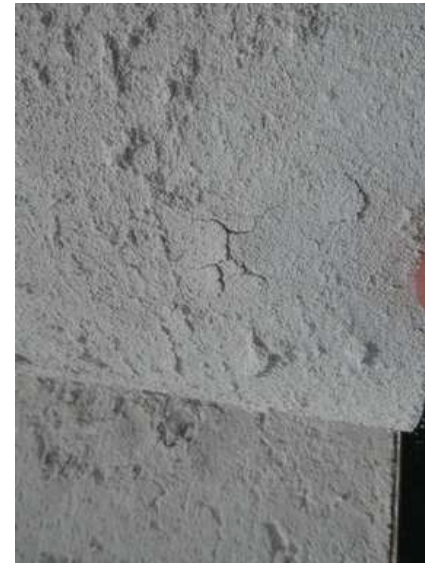
332. Building 14. Tear in the facer sheet adhered to the membrane from hail.

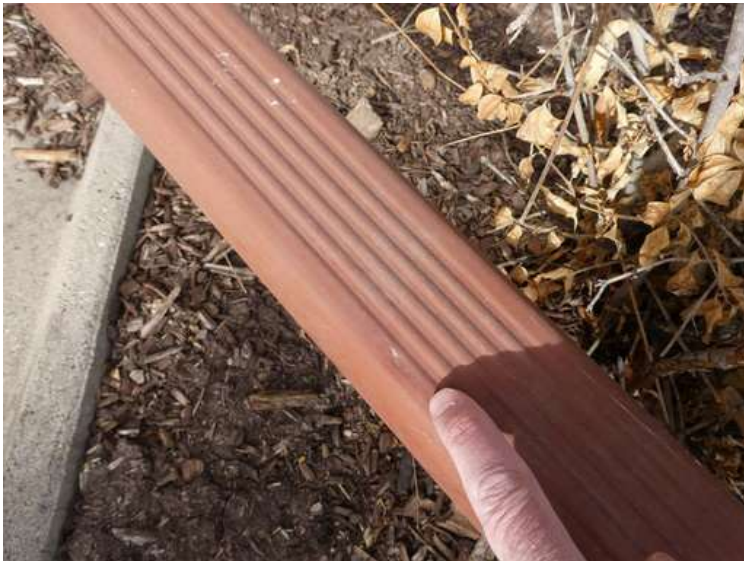
335. Building 15. Dent in a downspout extension from hail.

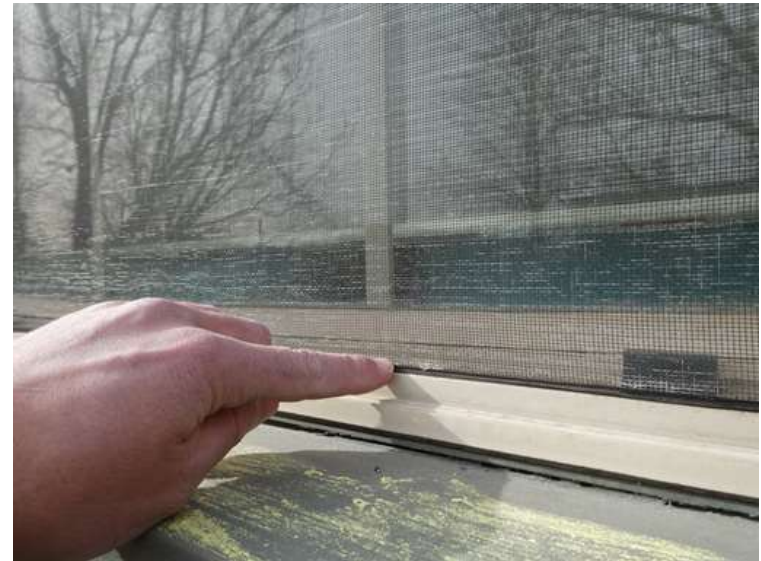
336. Building 15. Small tear in a screen.

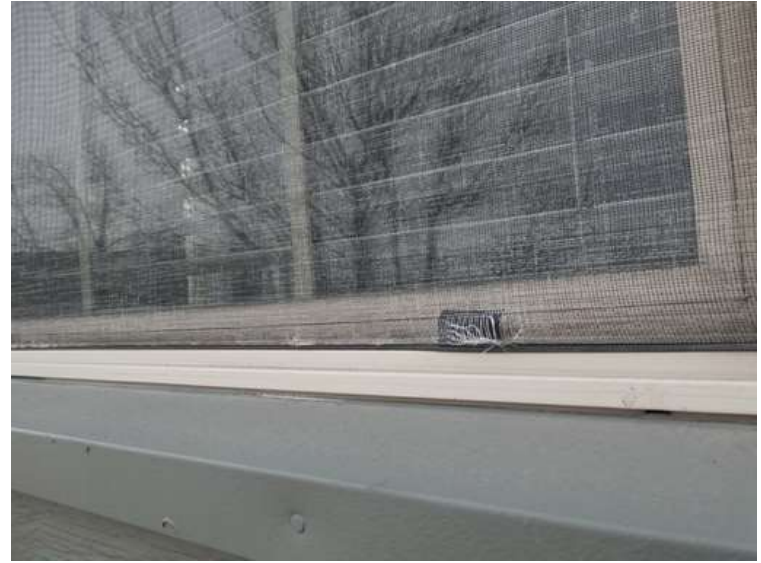
338. Building 15. Tears in a screen.

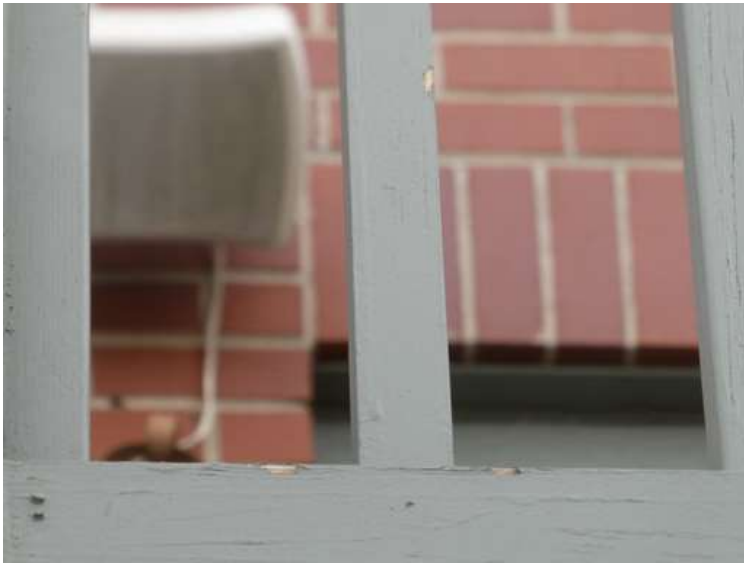
341. Building 15. Chips in paint on a railing.

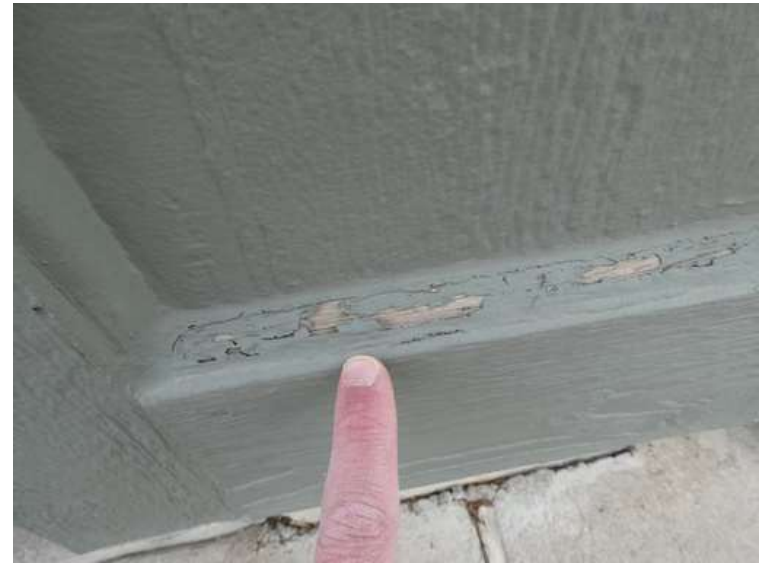
342. Building 15. Chips in weathered paint from hail.

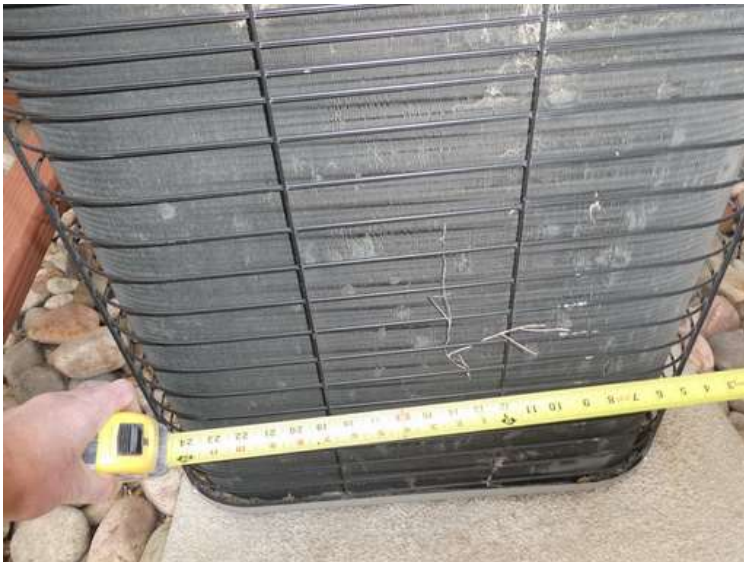
343. Building 15. Condenser fins dented by hail.

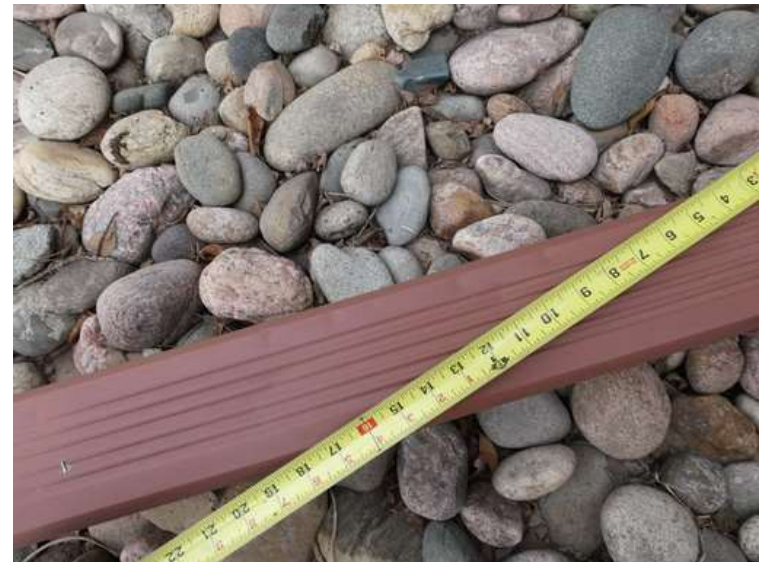
344. Building 15. Dents in a downspout extension from hail.

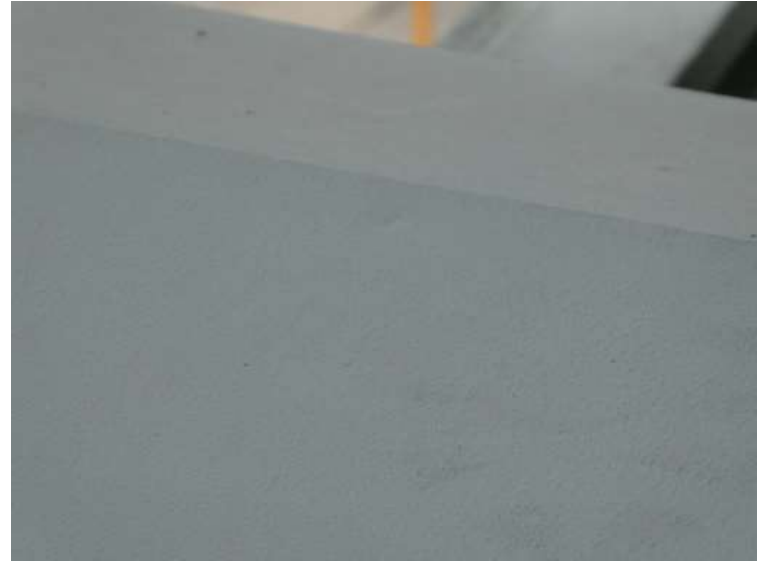
346. Building 15. Dents from hail.

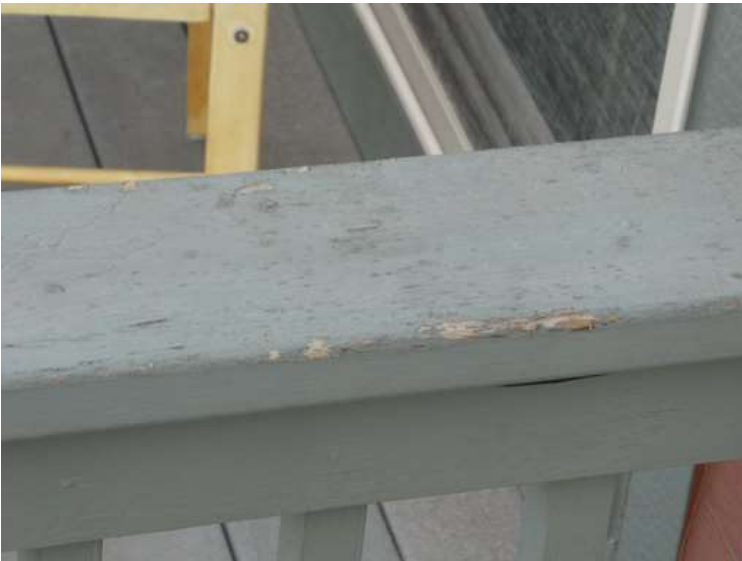
347. Building 15. Fractures in paint finishes on railings from hail.

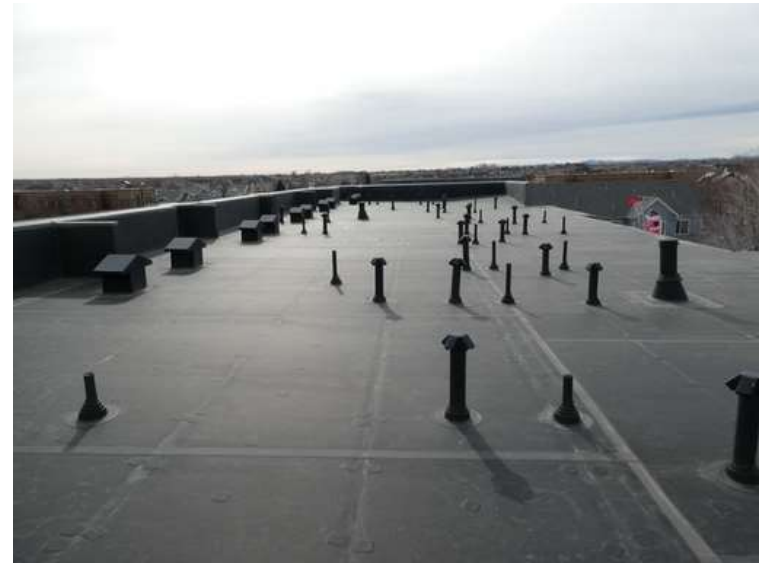
350. Building 15. View looking south. The roof was covered with an adhered EPDM membrane.

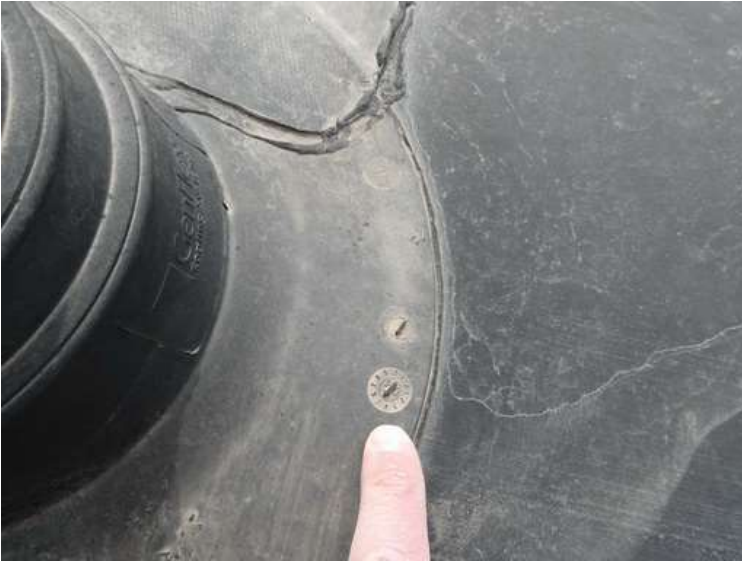
353. Building 15. Flashing boot dated, '04'.

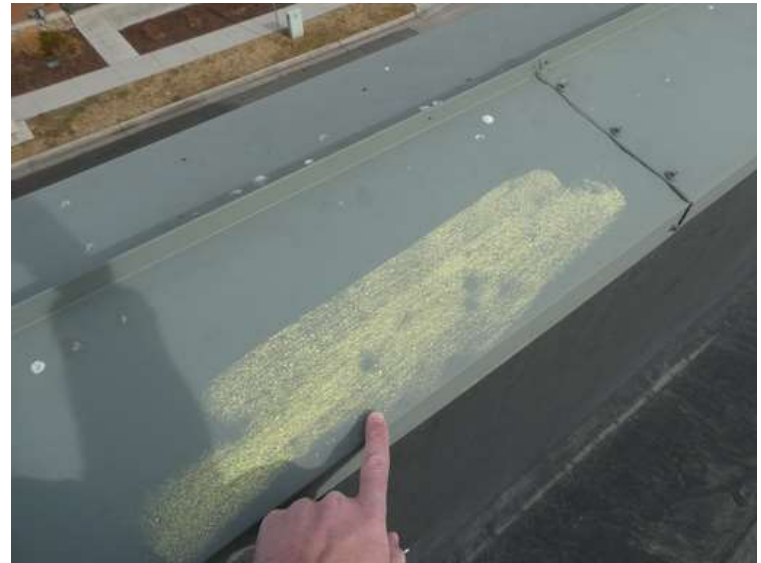
356. Building 15. Dents in coping from hail.

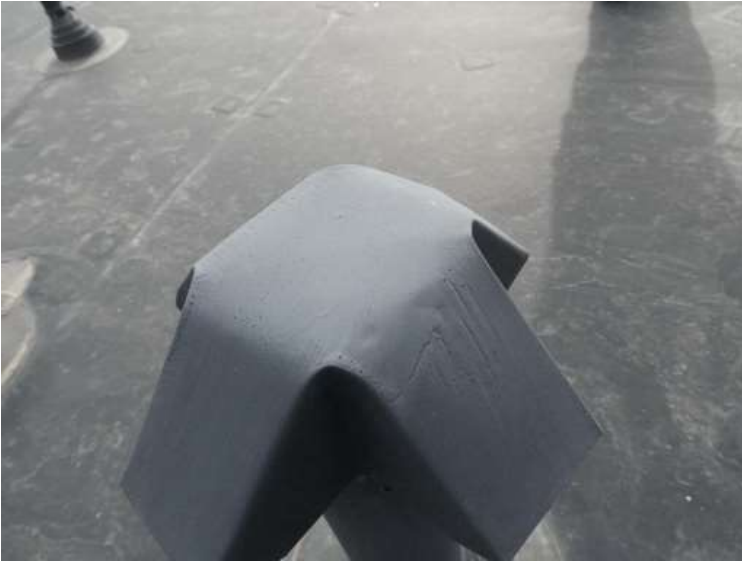
357. Building 15. Dent in a flue cap from hail.

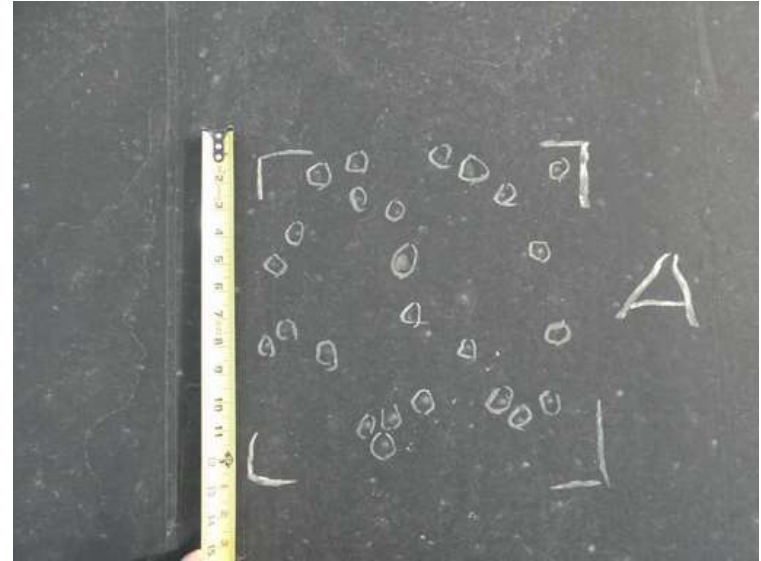
358. Building 15. Test area. Circular chalk marks denote dents in the substrate.

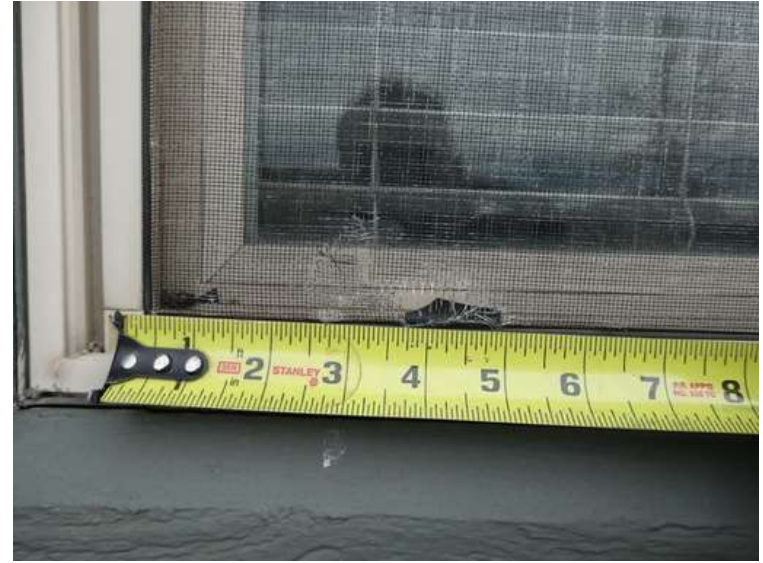
362. Building 16. Tears in a screen from hail.

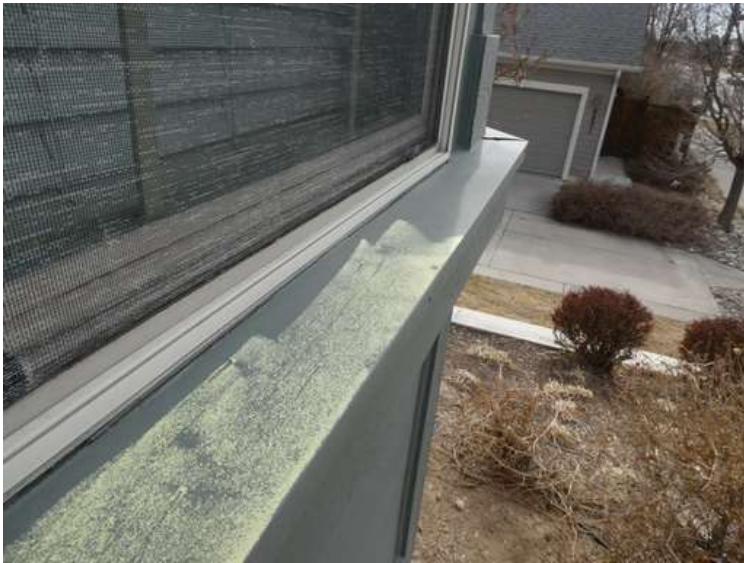
363. Building 16. Dents in steel flashing from hail.

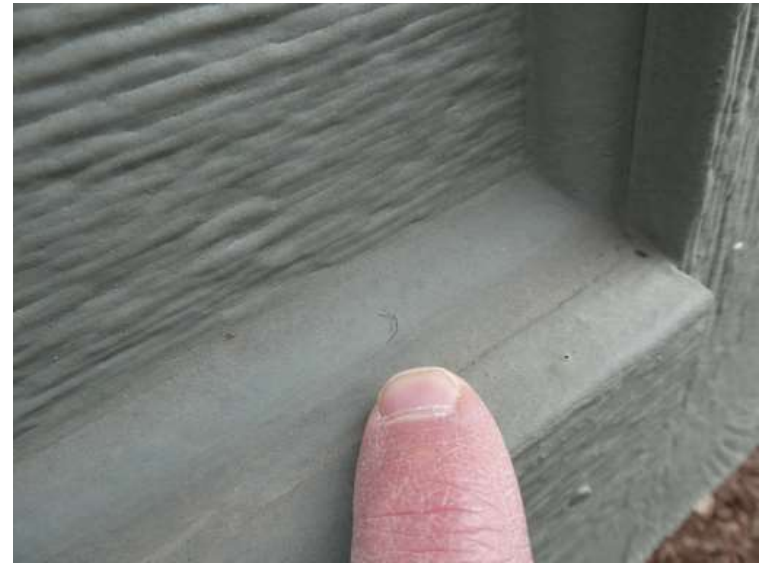
364. Building 16. Chip in paint from hail.

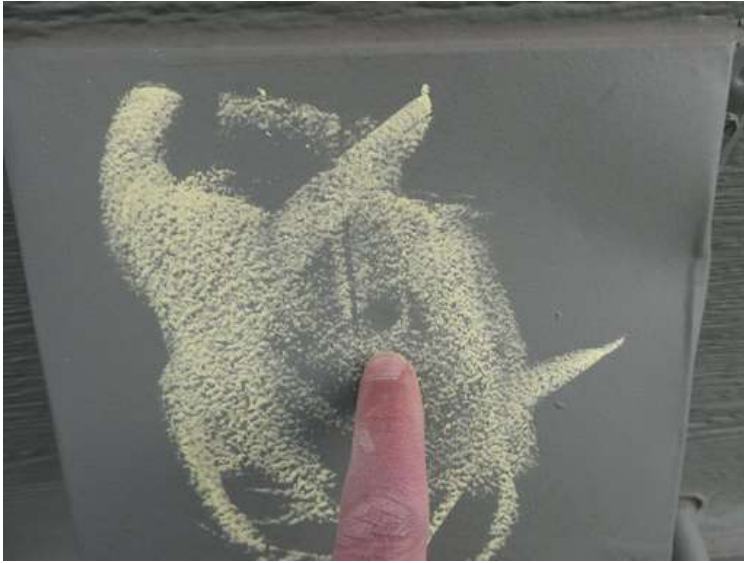
365. Building 16. Dent in a vent terminal from hail.

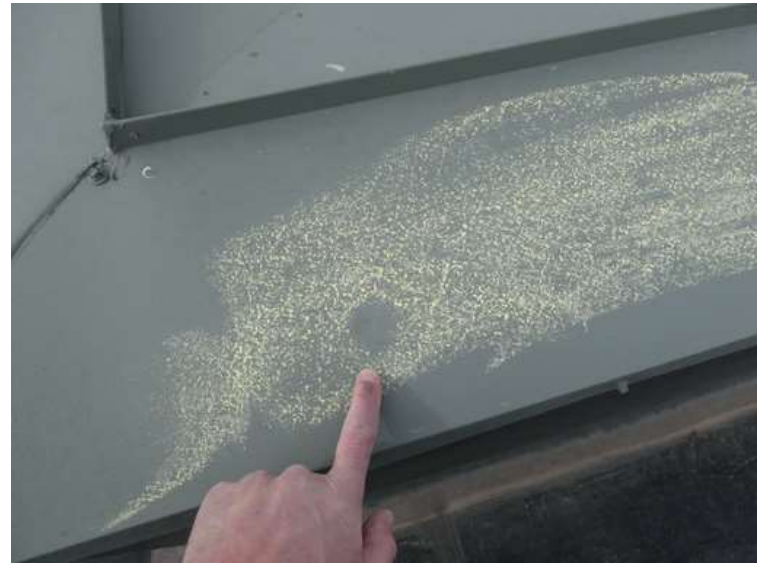
379. Building 16. Dent in an exhaust hood from hail.

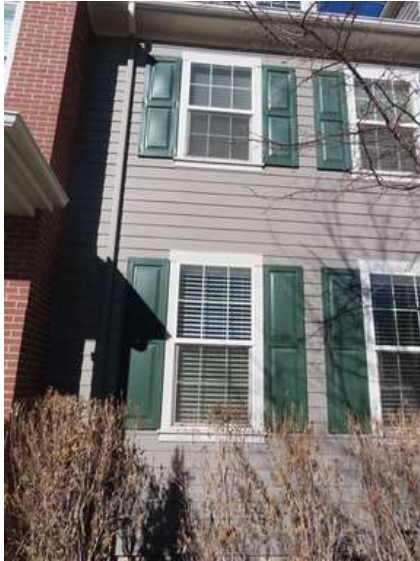
387. Building 17. Paint finishes on fiber cement siding were not chipped by hail.

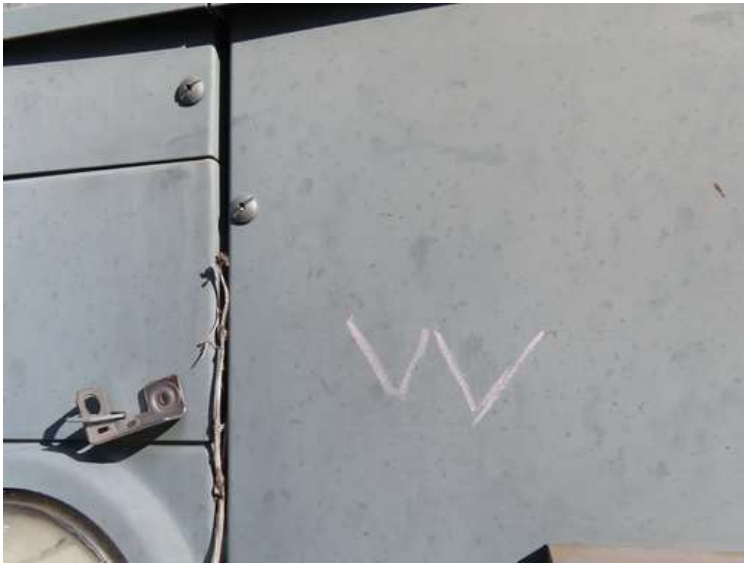
389. Building 17. Spatter marks on an electrical box.

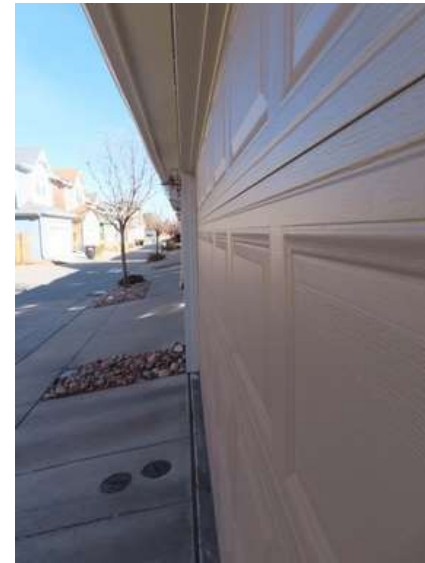
390. Building 17. Garage doors were not dented by hail.

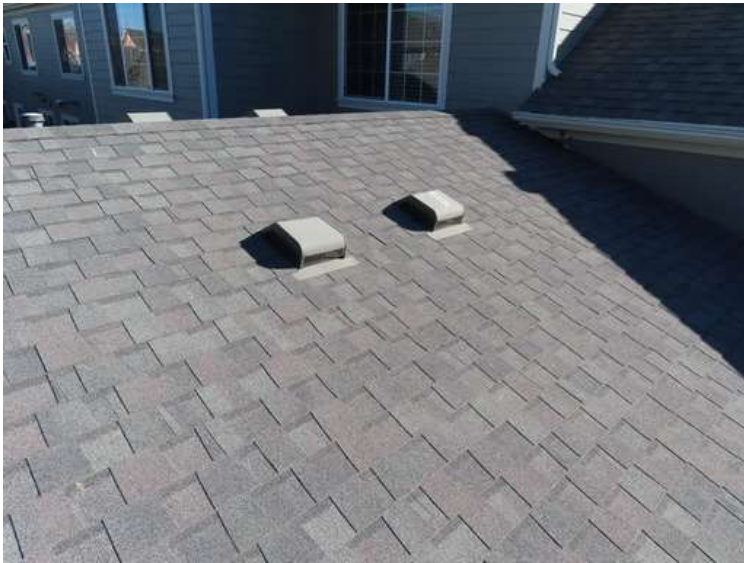
391. Building 17. West test area. No shingles within the test area were bruised by hail.

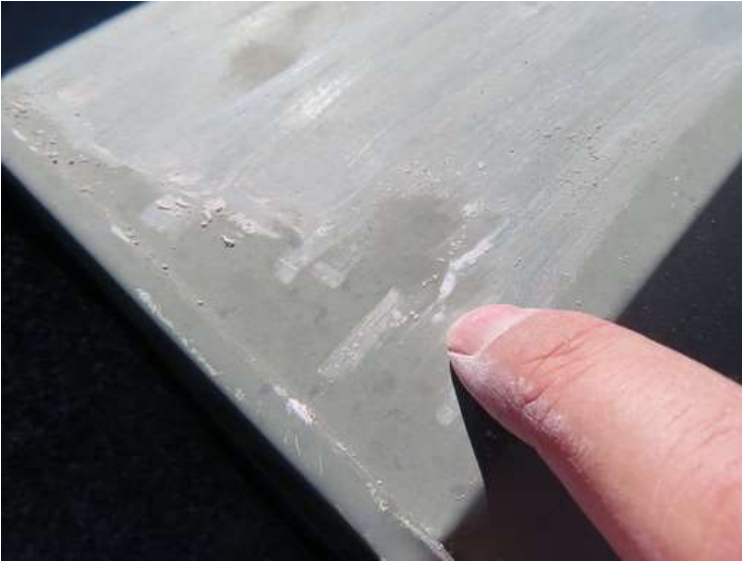
393. Building 17. Dent in an attic vent with a corresponding spatter mark.

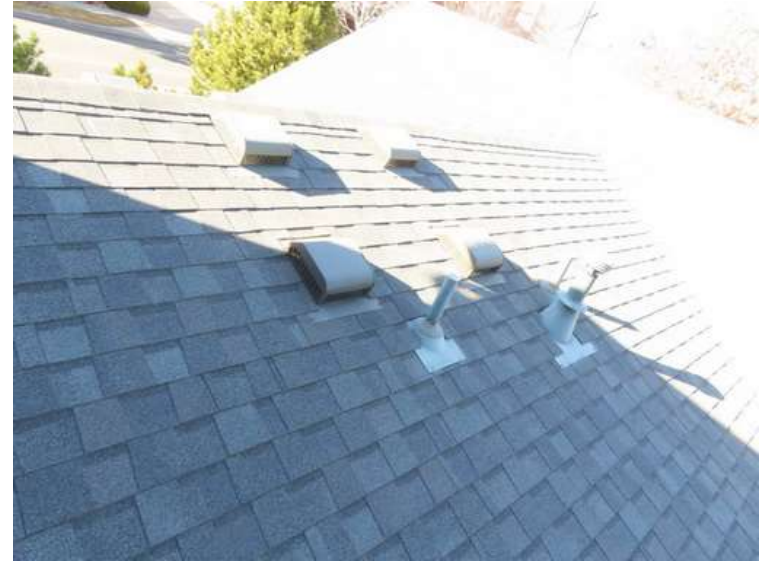
394. Building 17. East test area. No shingles within the test area were bruised by hail.

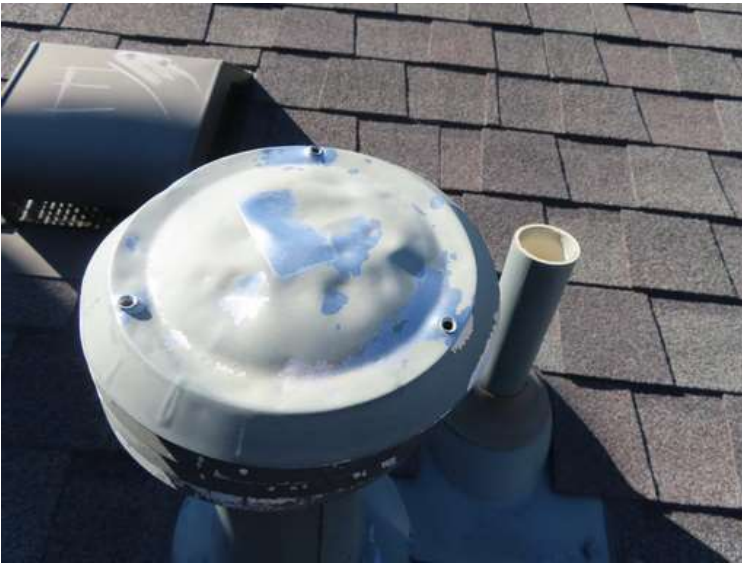
395. Building 17. Dents from hail.

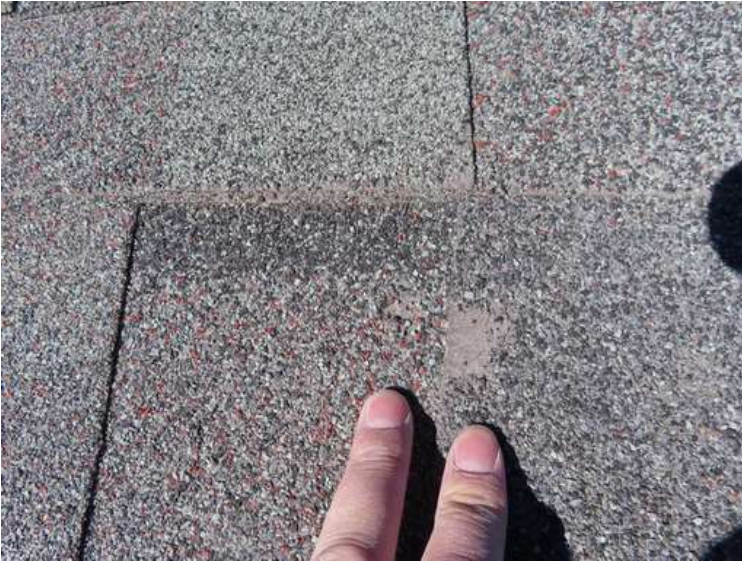
397. Building 17. Mar from installation.

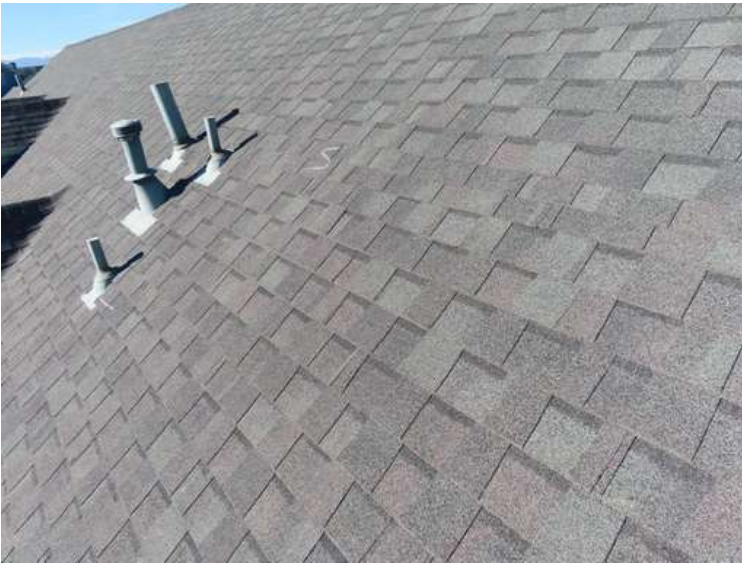
399. Building 17. South test area. No shingles within the test area were bruised by hail.

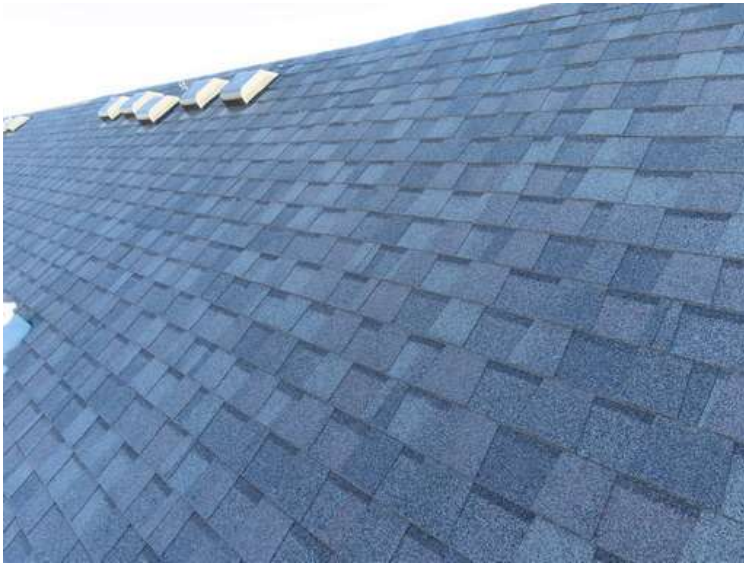
401. Building 17. North test area. No shingles within the test area were bruised by hail.

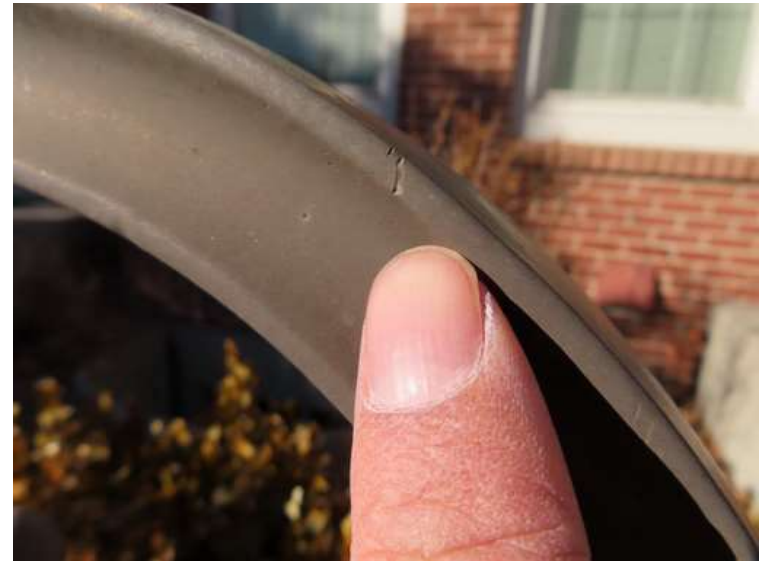
404. Building 18. Scrape in paint on an iron fence.

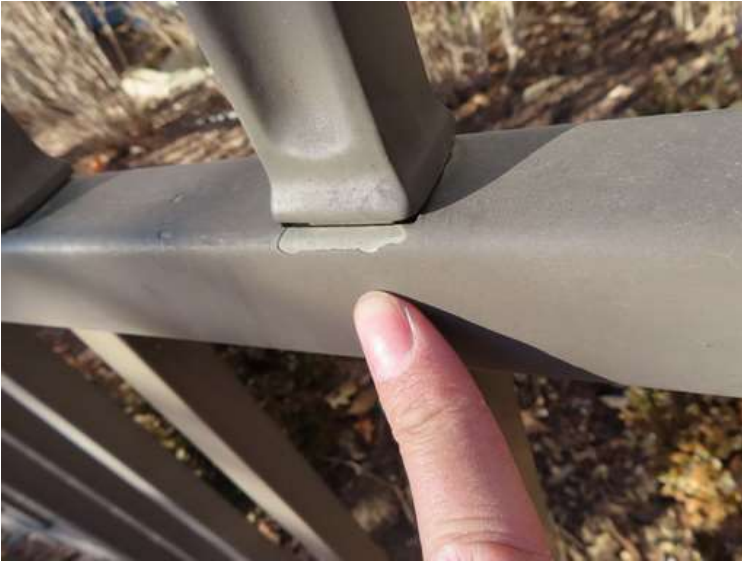
405. Building 18. Chip from thermal strains.

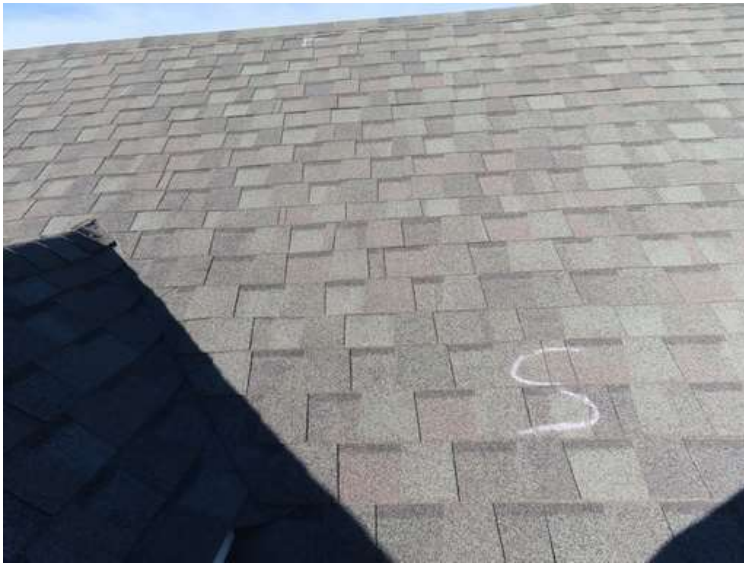
409. Building 18. South test area. No shingles within the test area were bruised by hail.

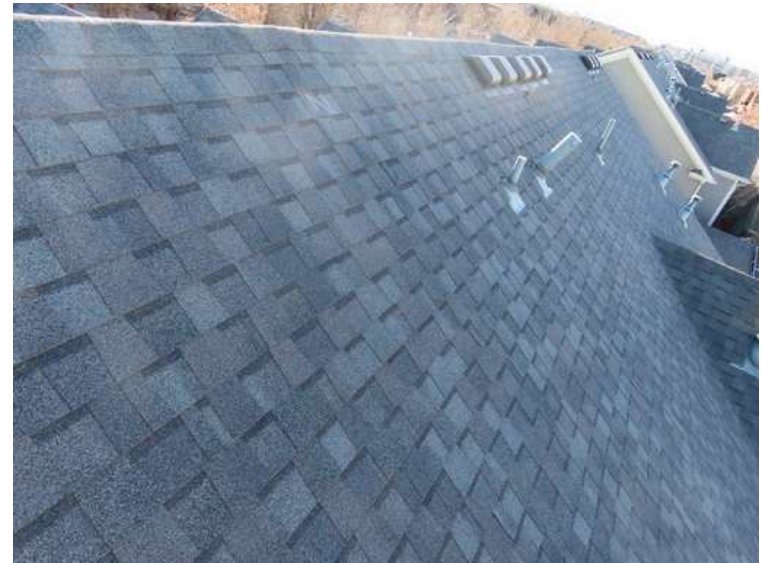
410. Building 18. North test area. No shingles within the test area were bruised by hail.

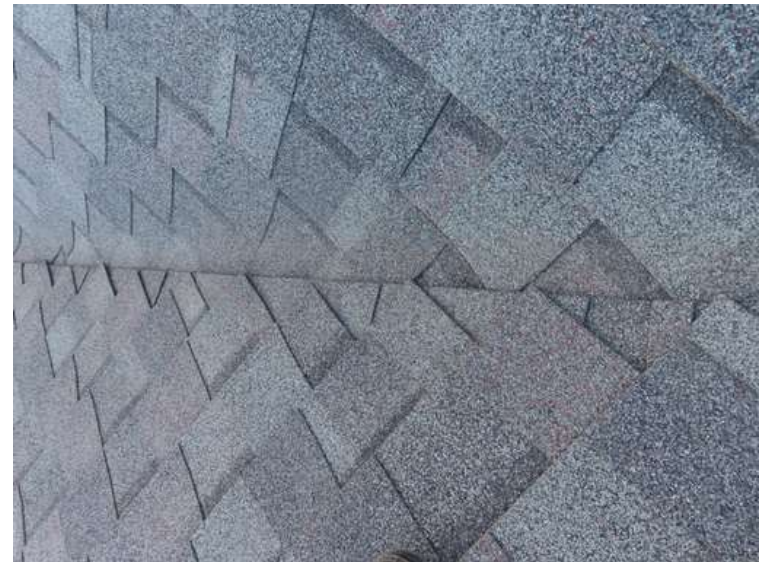
412. Building 18. Shingles draped over valleys were not bruised by hail.

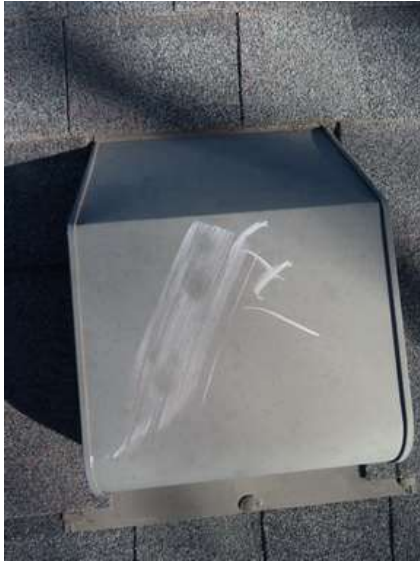
413. Building 18. Dents in an attic vent from hail.

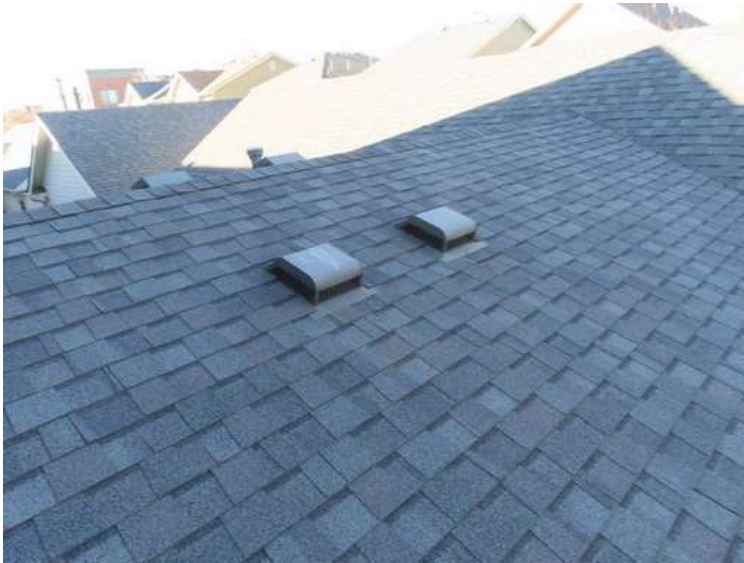
415. Building 18. East test area. No shingles within the test area were bruised by hail.

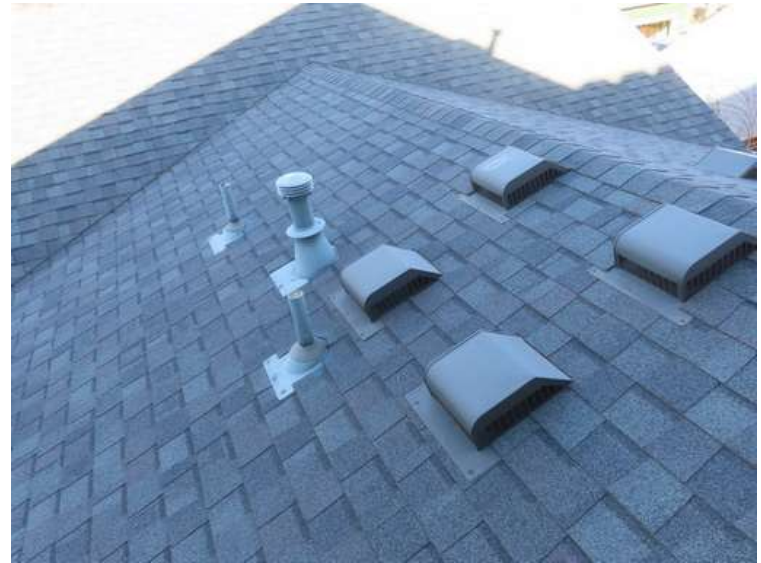
416. Building 18. West test area. No shingles within the test area were bruised by hail.

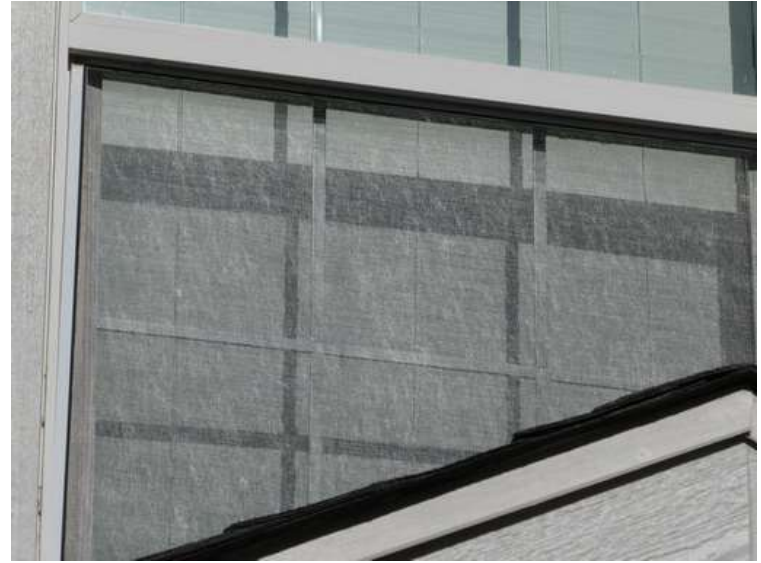
7. Hail fractured vinyl glazing bead on certain windows of a few buildings. Hail also fractured the frames of a few windows. Hail tore screens on windows on every building.

418. Building 19. Tears in a screen.

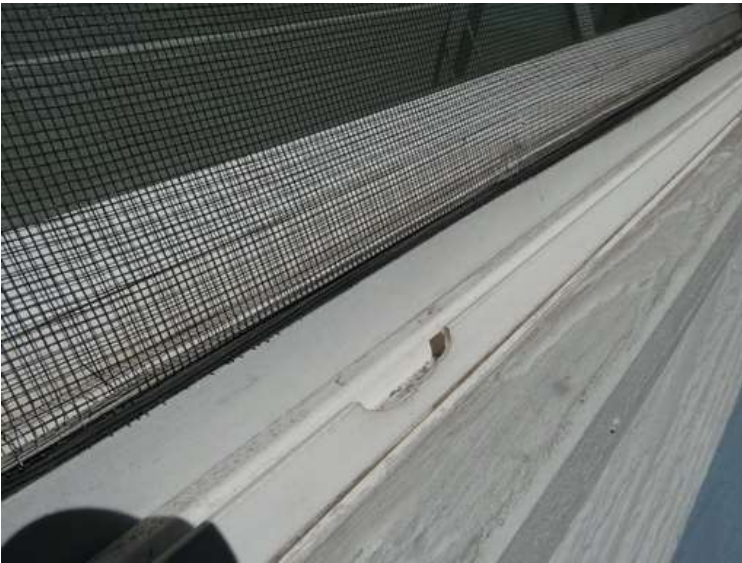
419. Building 19. Fractured frame.

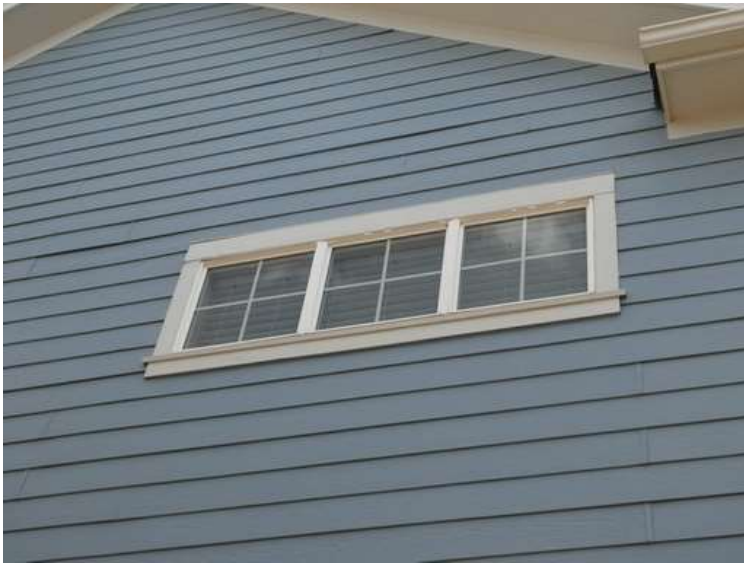
424. Building 19. Fractures in vinyl above the window.

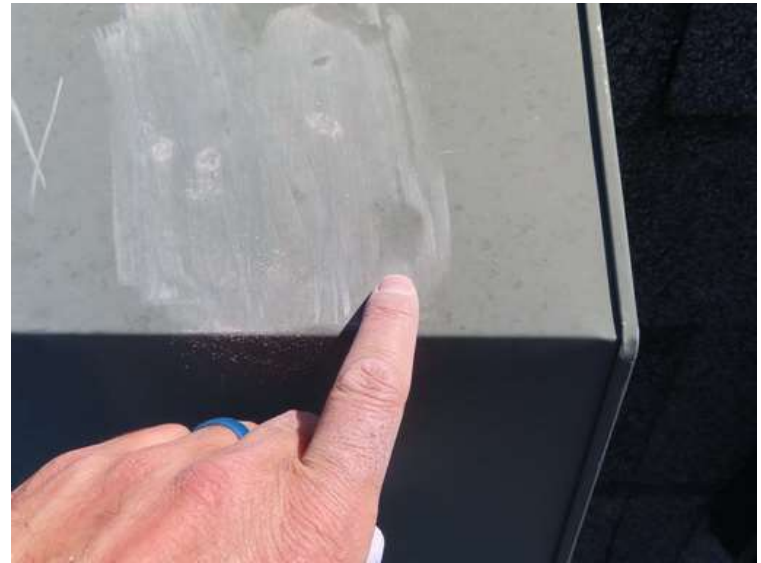
428. Building 19. Dents from hail.

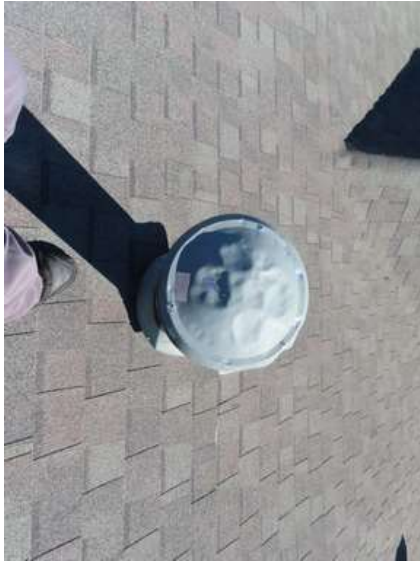
429. Building 19. Dents from hail.

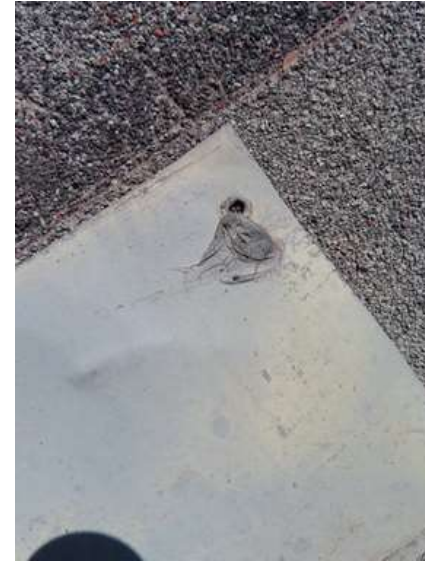
430. Building 19. Re-used flashing.

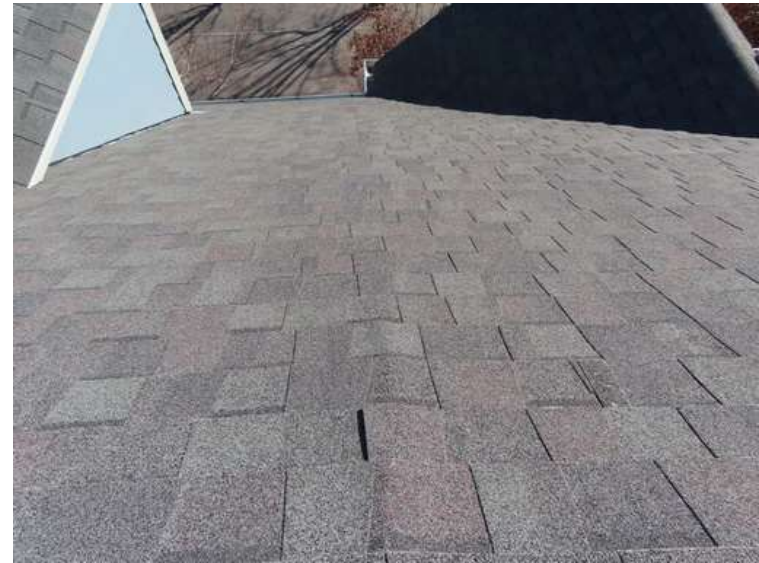
432. Building 19. Wrinkle from decking movement.

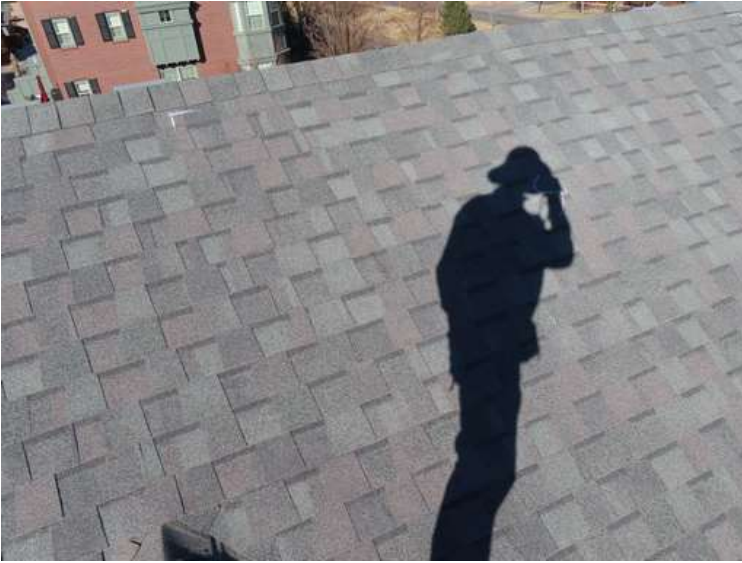
433. Building 19. South test area. No shingles within the test area were bruised by hail.

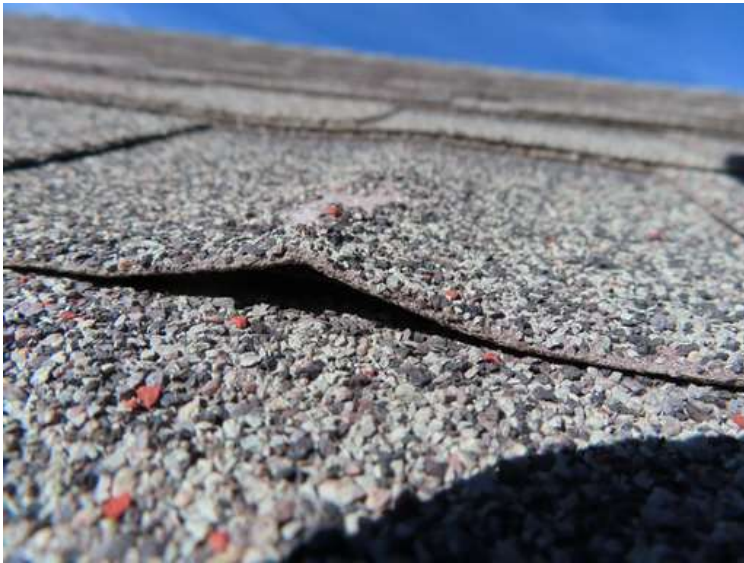
437. Building 19. Another view.

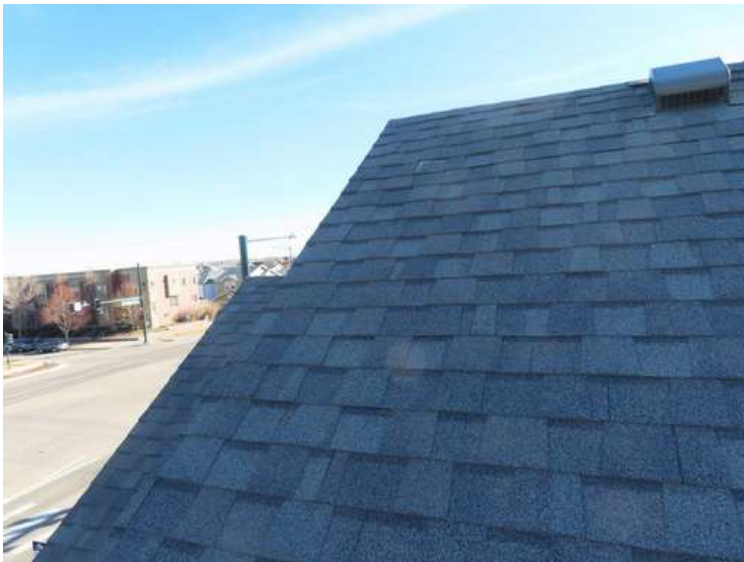
439. Building 19. North test area. No shingles within the test area were bruised by hail.

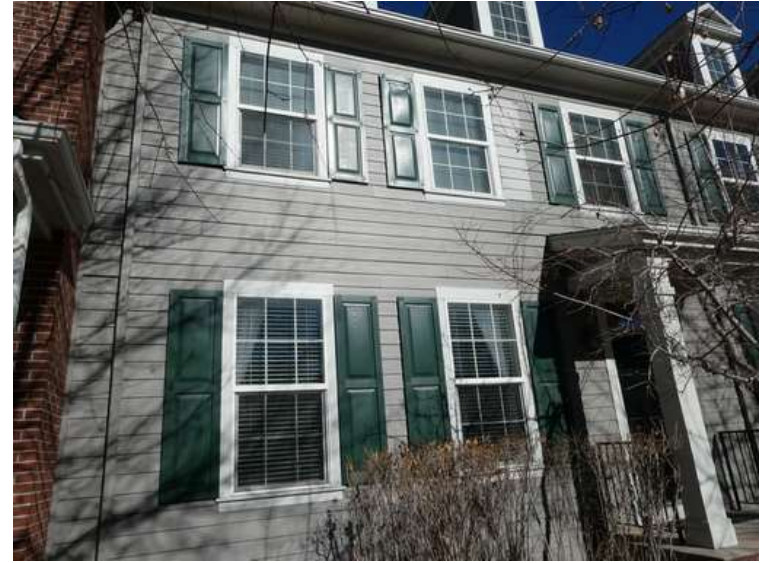
442. Building 20. Paint finishes on fiber cement siding were not chipped by hail.

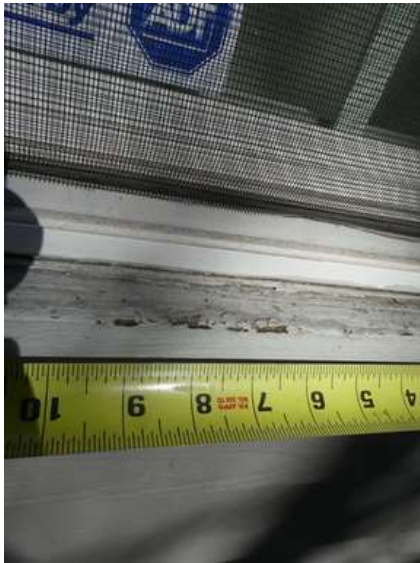
443. Building 20. Chips in paint on a fiberboard sill.
