Stapleton Rowhome Association
Hail Damage Evaluation
10045 Martin Luther King Boulevard
Denver, CO 80238
Farmers File: 5010168593
Haag File: 1121000002-128

Re: Stapleton Rowhome Association
Hail Damage Evaluation
10045 Martin Luther King Boulevard
Denver, CO 80238
Farmers File: 5010168593
Haag File: 1121000002-128

In accordance with your request, we inspected the Stapleton Rowhome Association buildings to determine the extent of hail-caused damage to the building exteriors and when the damage occurred. We inspected the sites on February 1, 2, and 3, 2021.

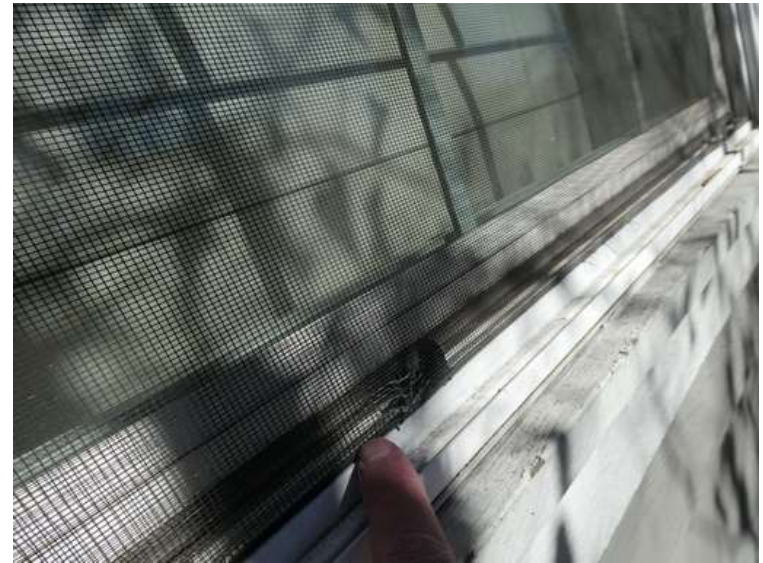
444. Building 20. Tear in a screen.

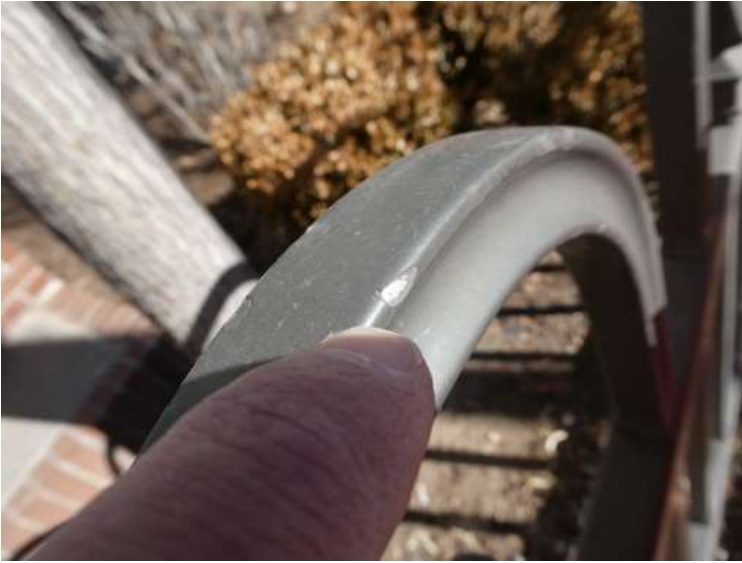
445. Building 20. Scrape in paint on an iron fence.

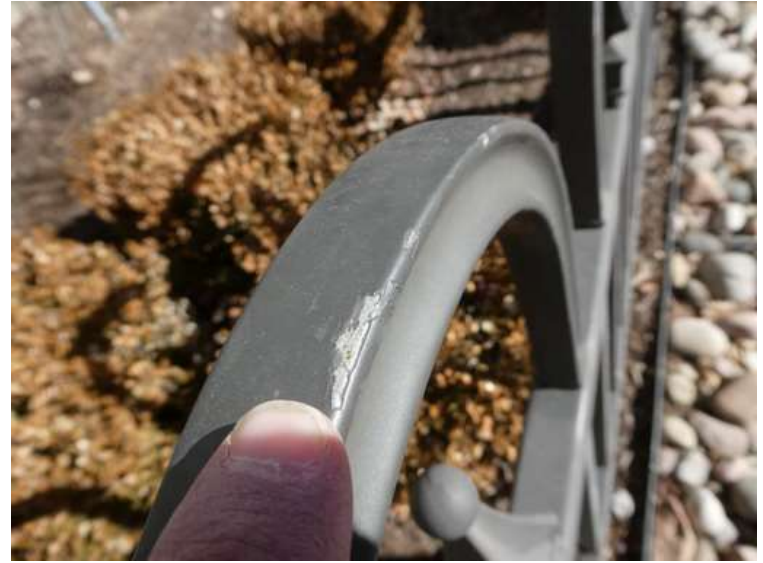
446. Building 20. Scrape in paint.

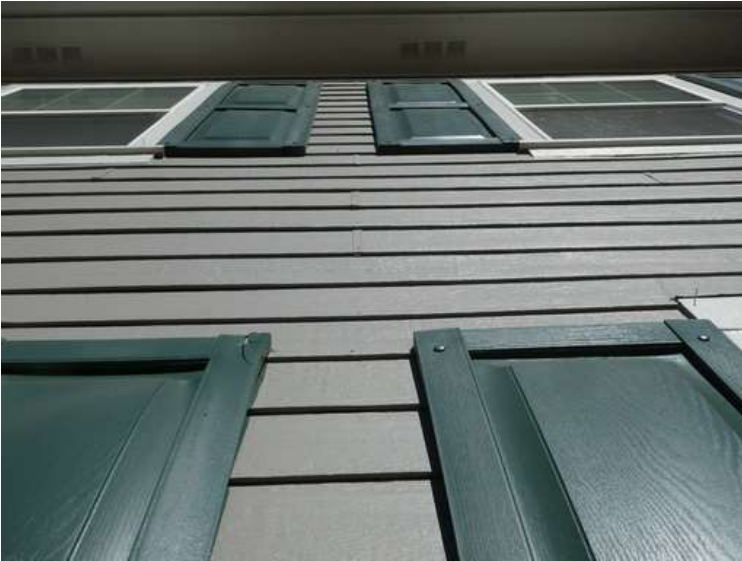
447. Building 20. Fracture in a shutter.

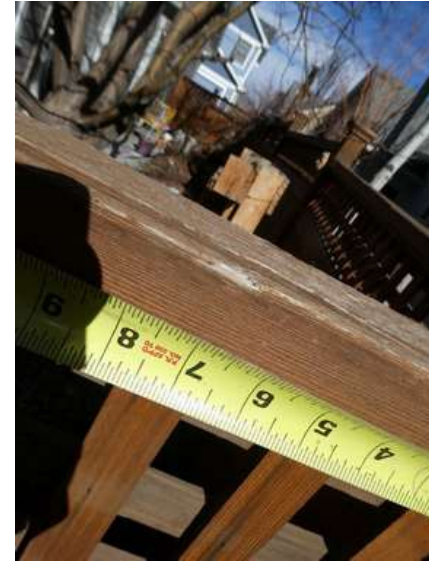
450. Building 20. Chip in a wood fence.

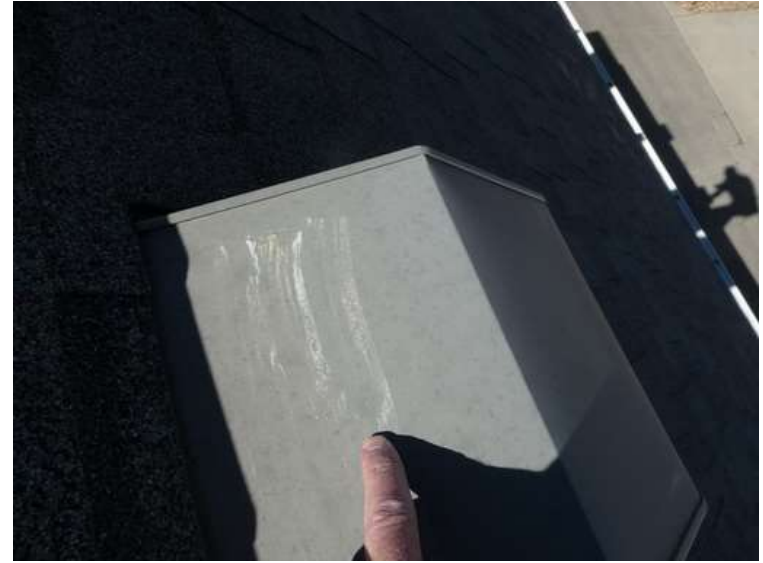
458. Building 20. Dents in an attic vent from hail.

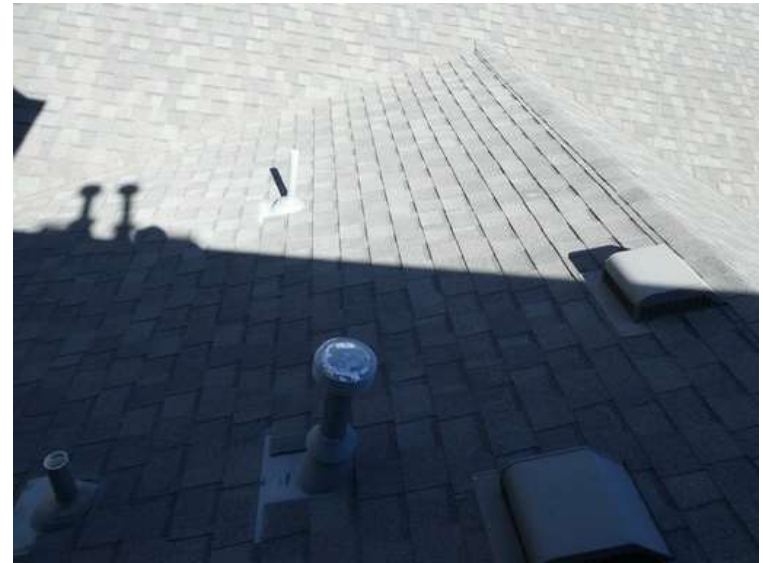
460. Building 20. West test area. No shingles within the test area were bruised by hail.

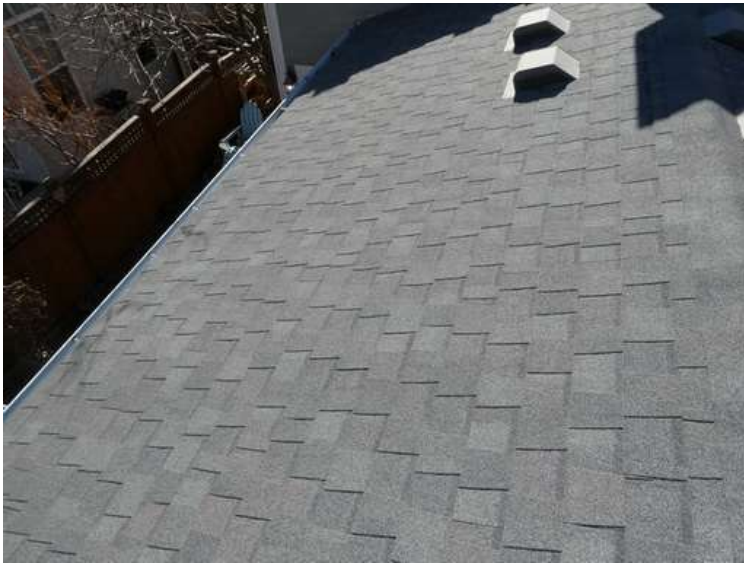
461. Building 20. East test area. No shingles within the test area were bruised by hail.

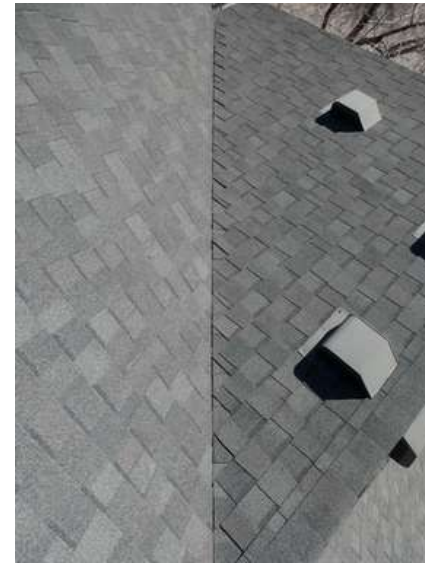
462. Building 20. Shingles draped over valleys were not bruised by hail.

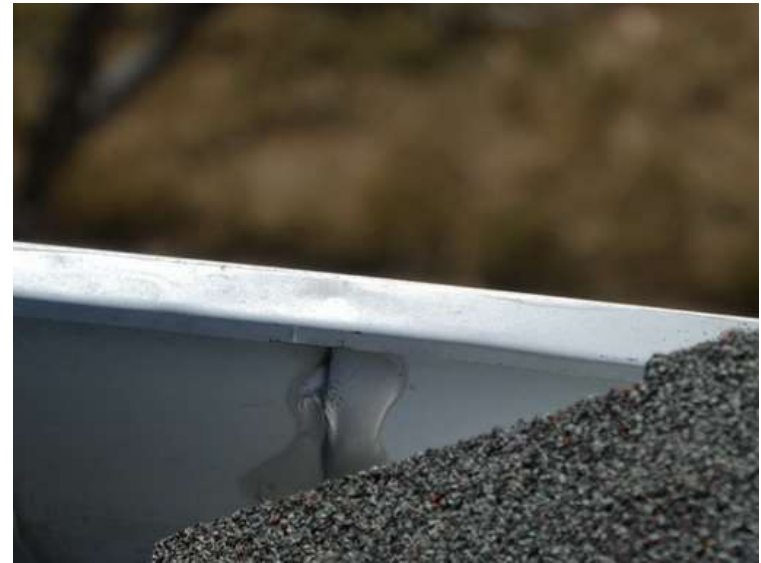
464. Building 20. Dent in a gutter.

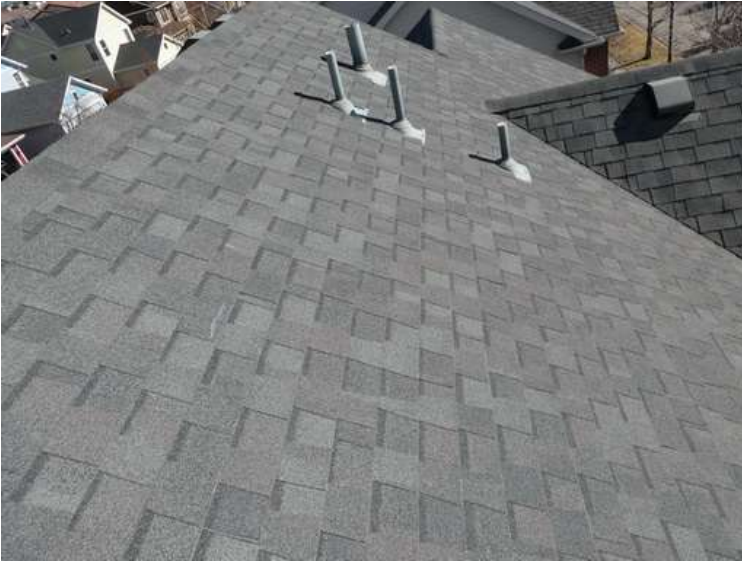
465. Building 20. South test area. No shingles within the test area were bruised by hail.

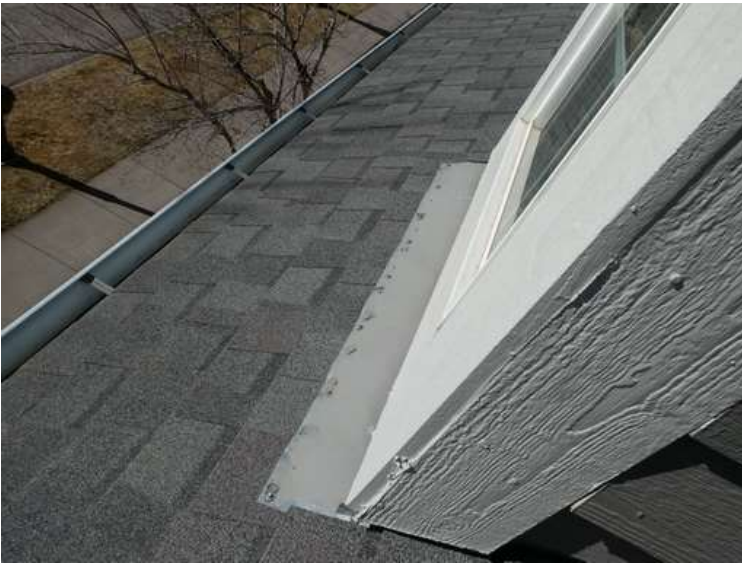
467. Building 20. Re-used headwall flashing.

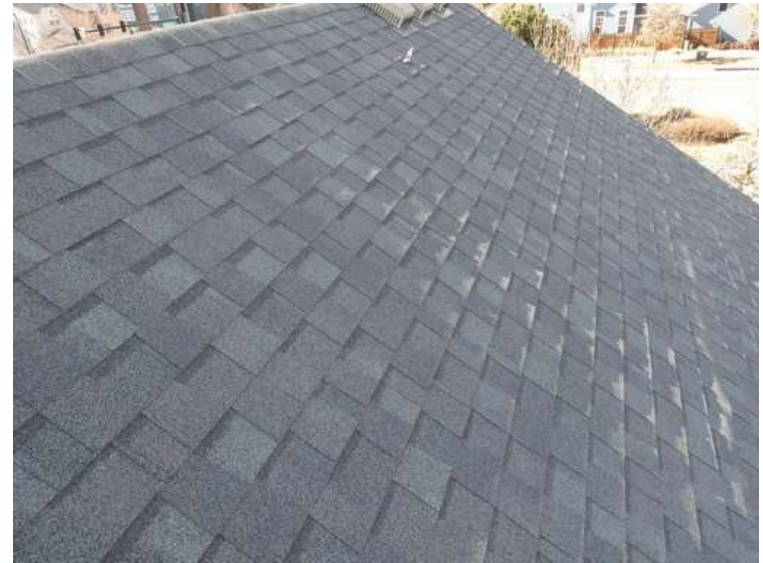
468. Building 20. North test area. No shingles within the test area were bruised by hail.

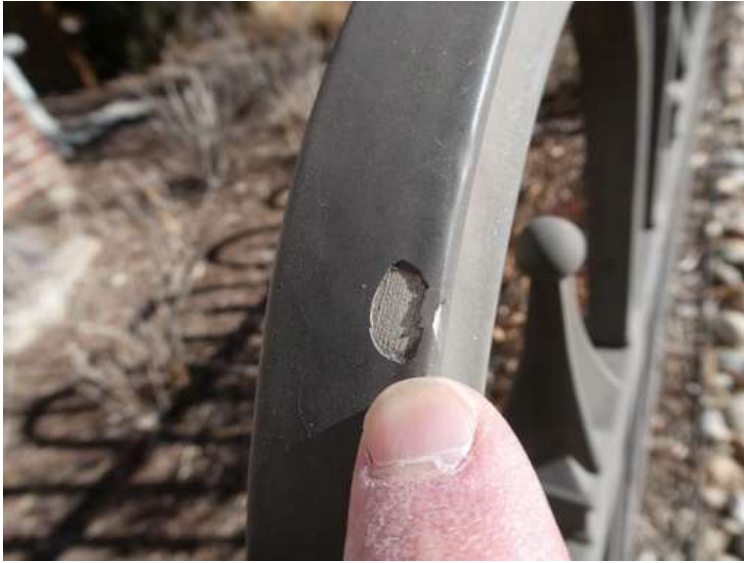
473. Building 21. Mechanical chip in paint.

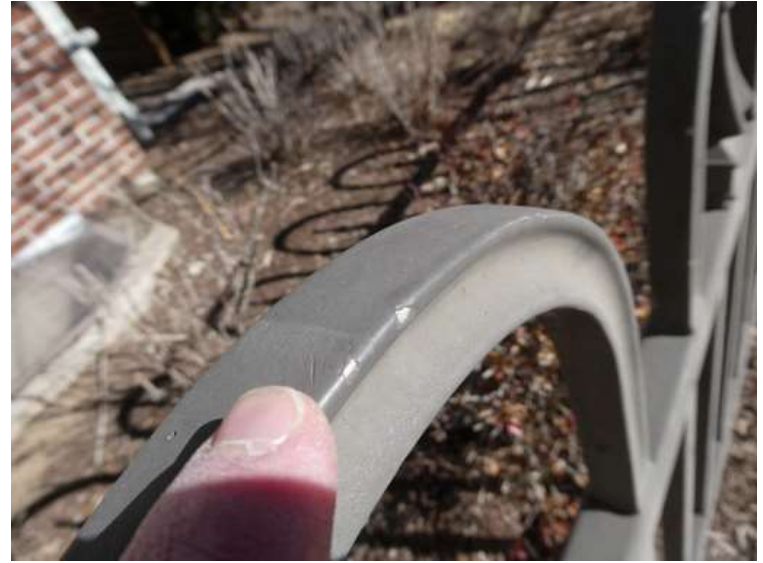
474. Building 21. Scuffs in paint.

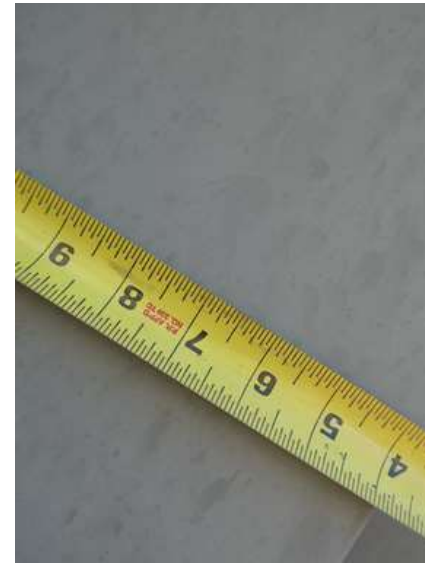
478. Building 21. Spatter marks on an electrical box from hail.

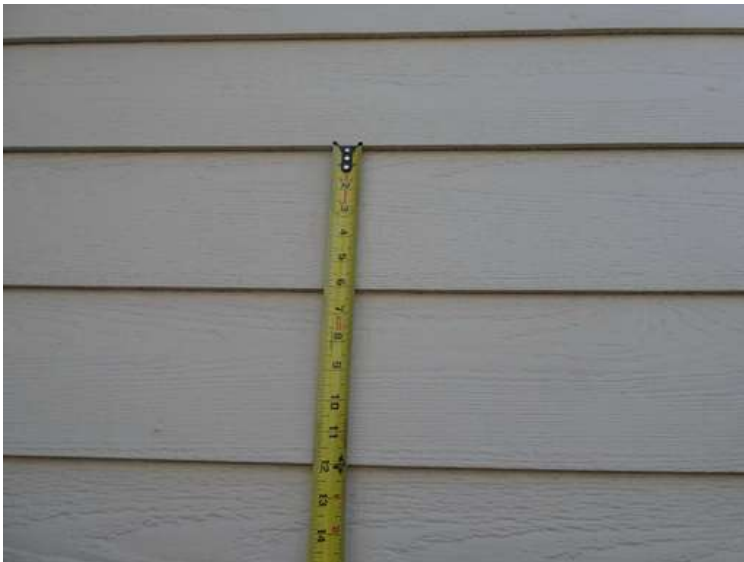
479. Building 21. Paint finish on fiber cement siding was not fractured by hail.

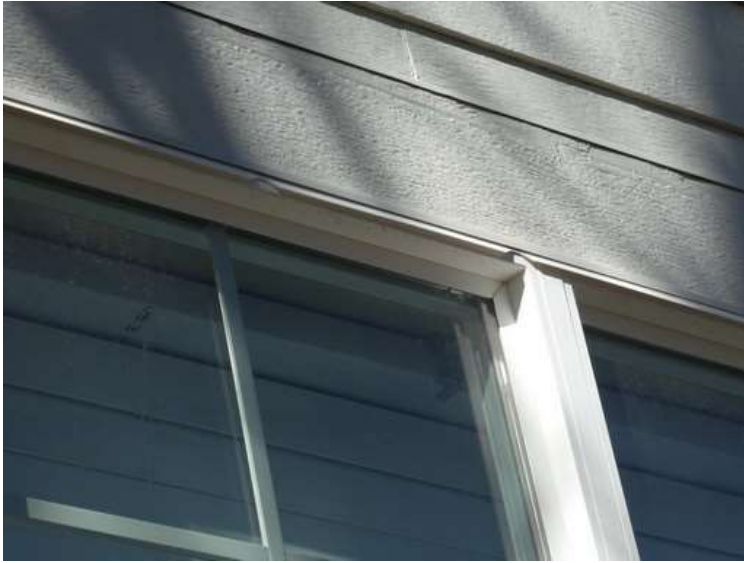
485. Building 21. Fractures in the vinyl frame from hail.

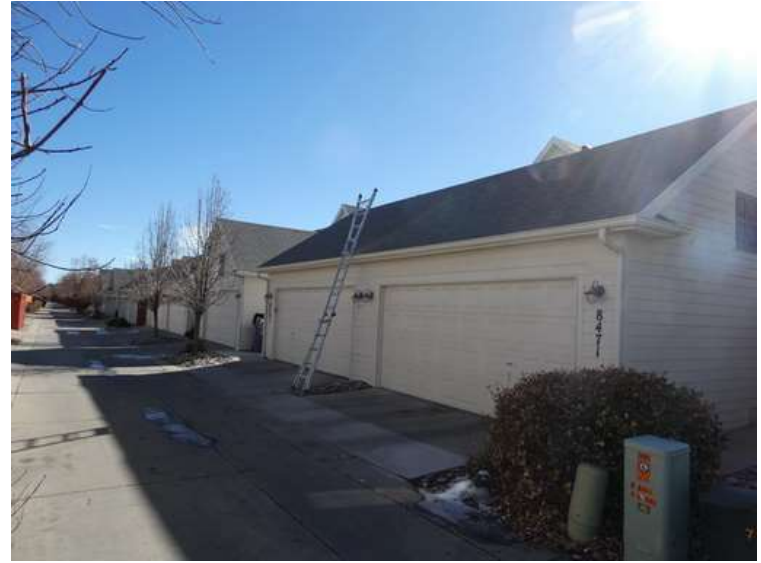
486. Building 21. North elevation. Garage doors were not dented by hail.

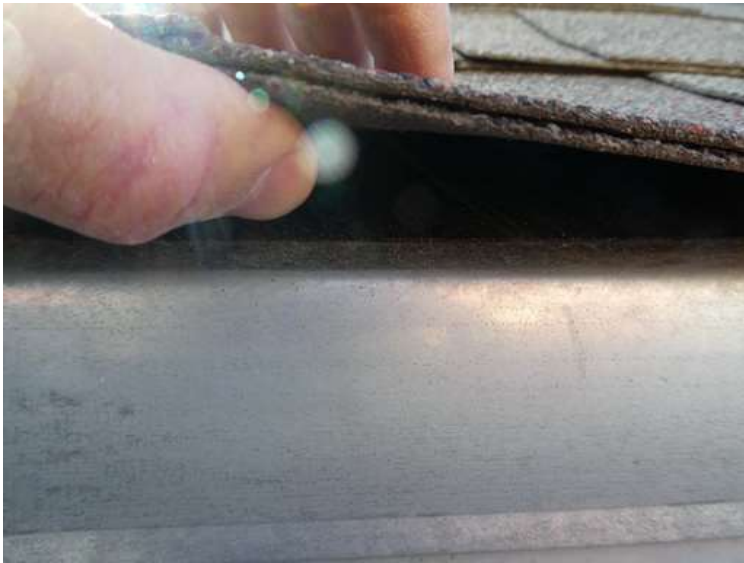
487. Building 21. Ice and water shield.

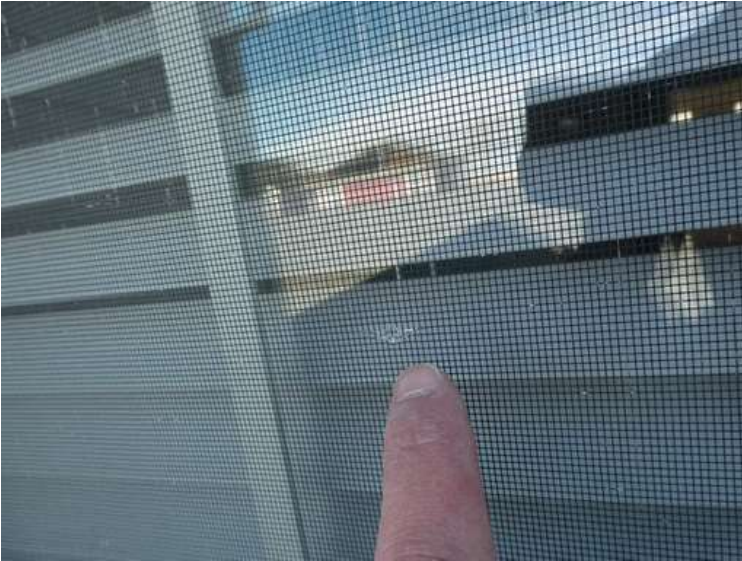
489. Building 21. Tear in a window screen.

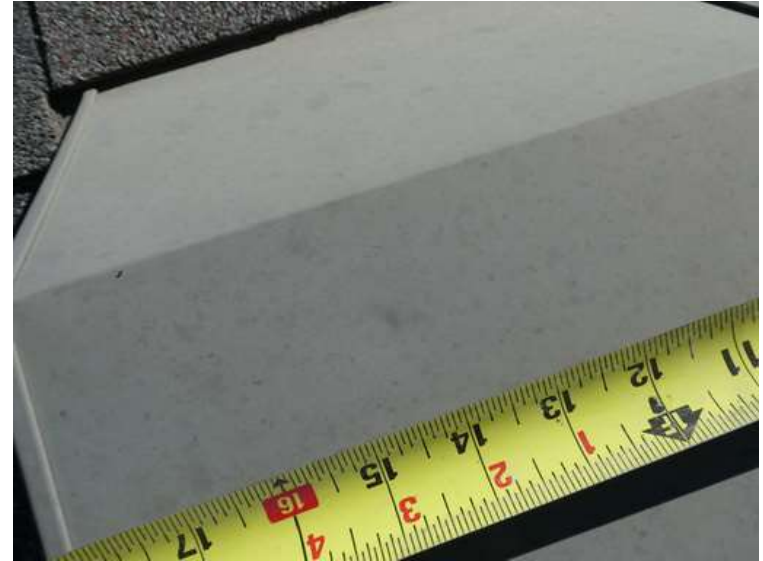
490. Building 21. Dent in an attic vent from hail.

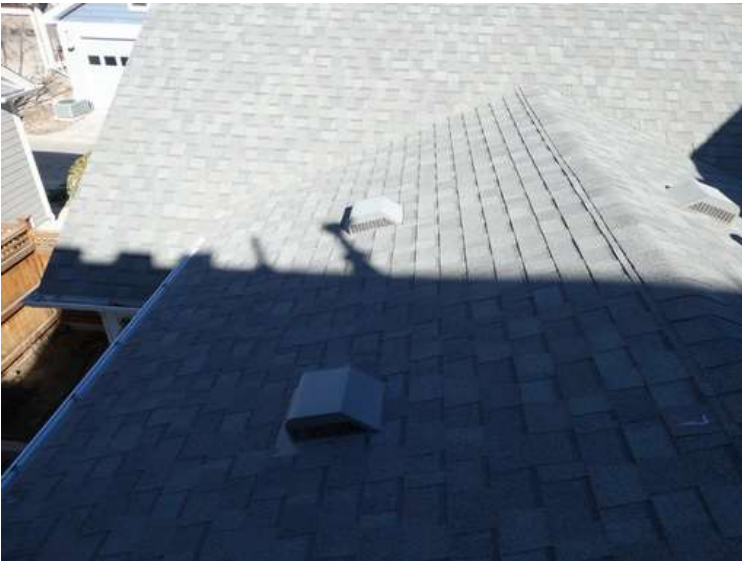
491. Building 21. West test area. No shingles within the test area were bruised by hail.

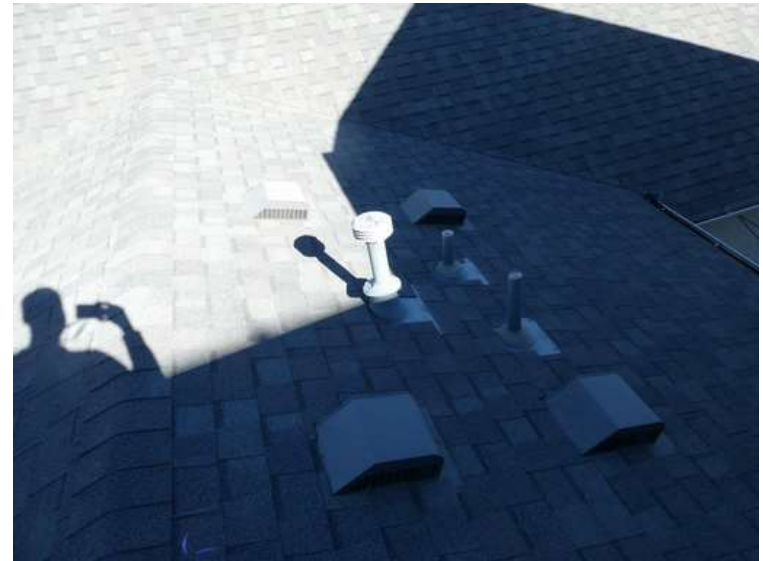
492. Building 21. East test area. No shingles within the test area were bruised by hail.

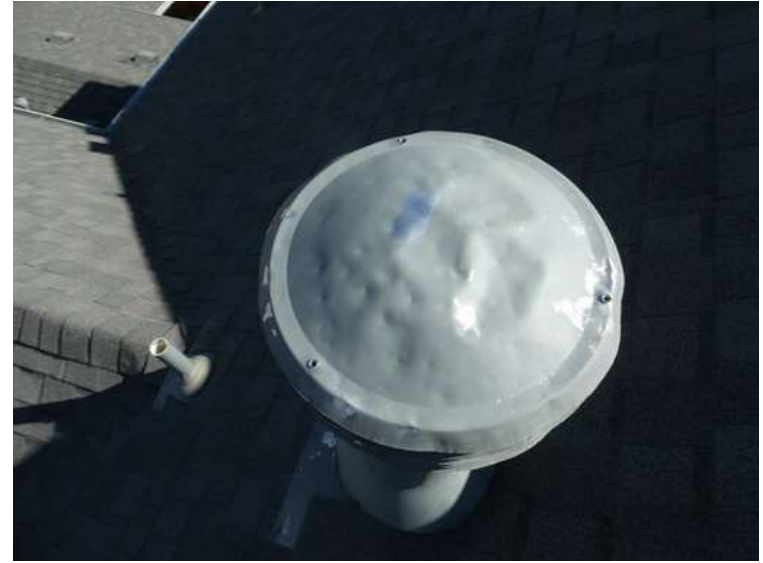
494. Building 21. Dents from hail.

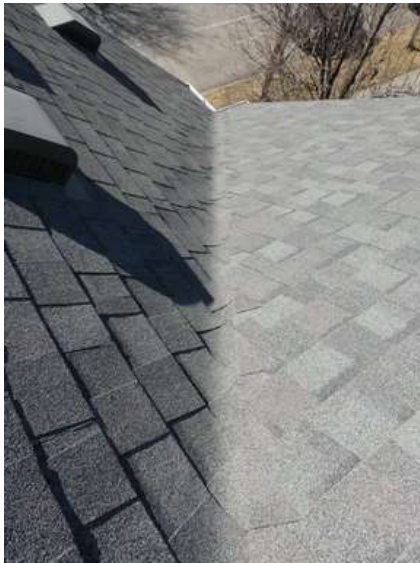
495. Building 21. Shingles draped over valleys were not bruised by hail.

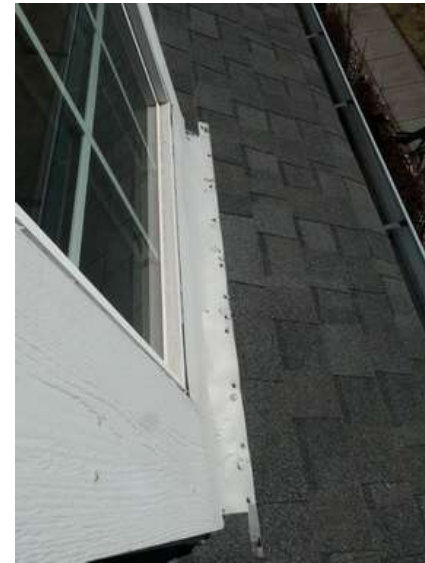
496. Building 21. Re-used headwall flashing.

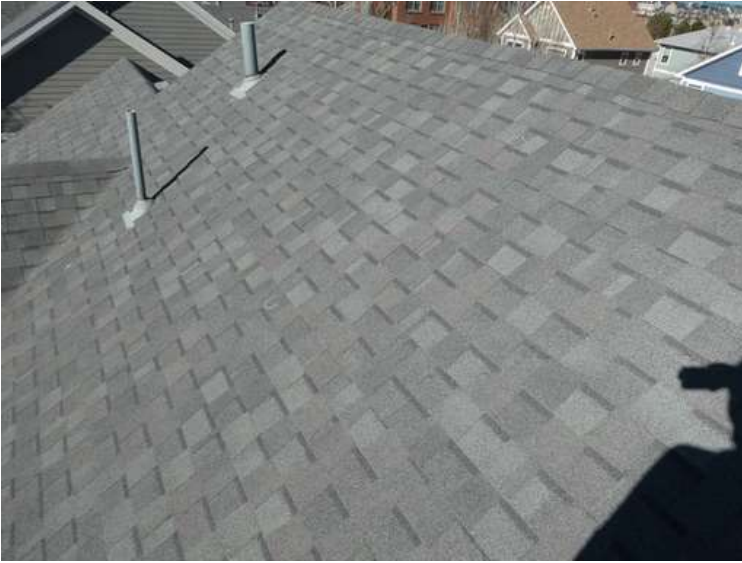
497. Building 21. South test area. Two shingles within the test area were bruised at wrinkles by hail.

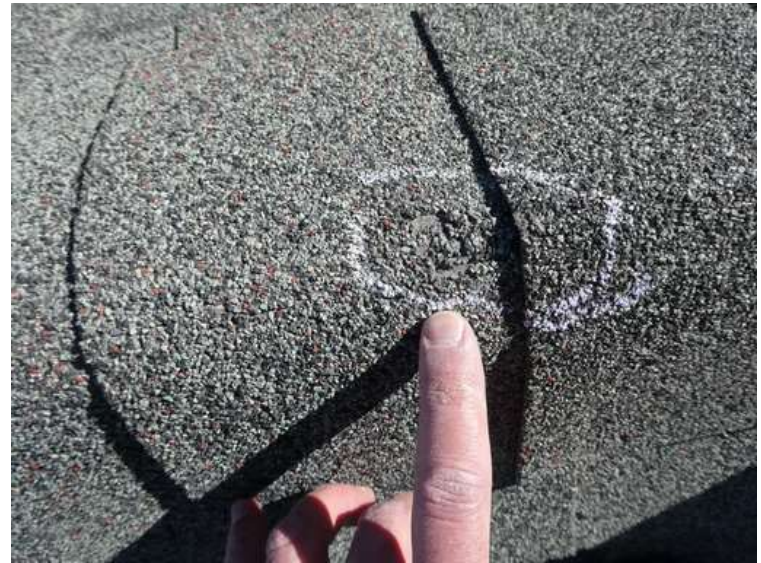
500. Building 21. Bruise in a ridge shingle.

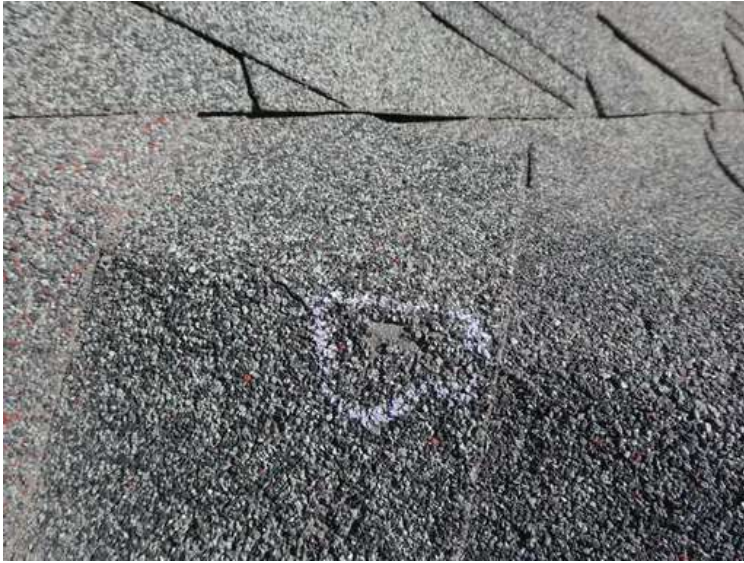
501. Building 21. Bruise in a ridge shingle.

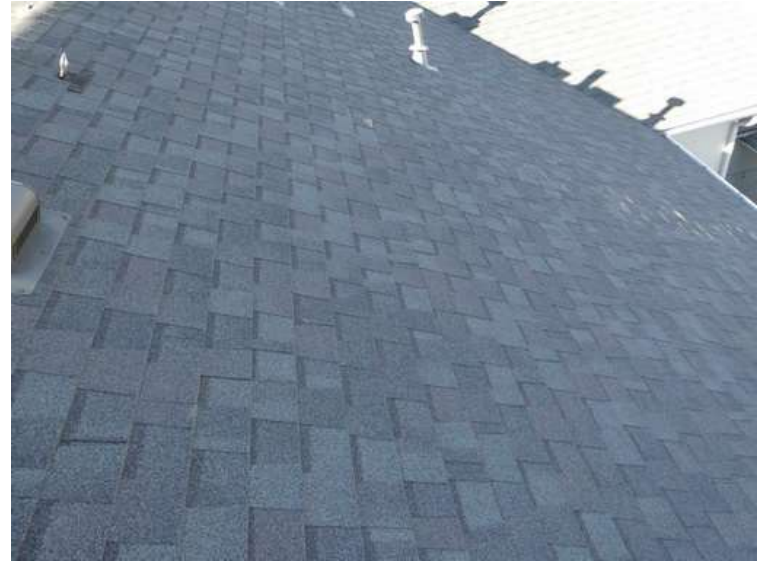
502. Building 21. North test area. No shingles within the test area were bruised by hail.

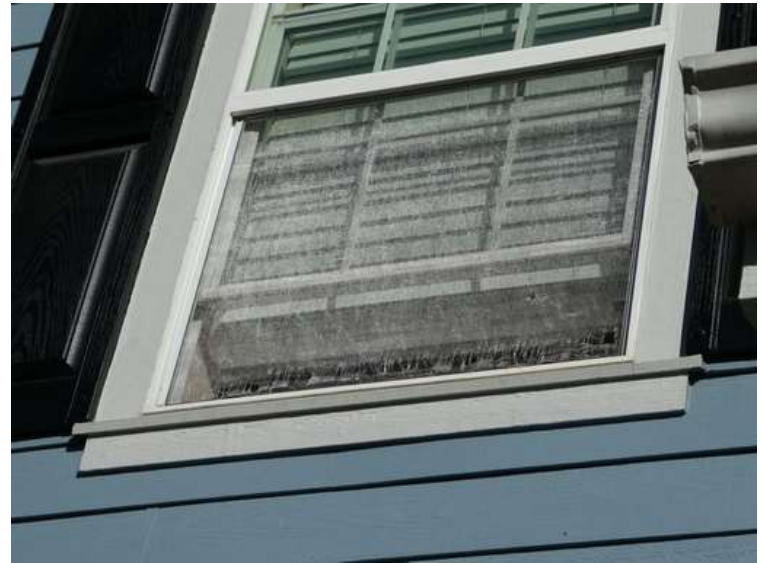
504. Building 22. Tears in a screen from hail.

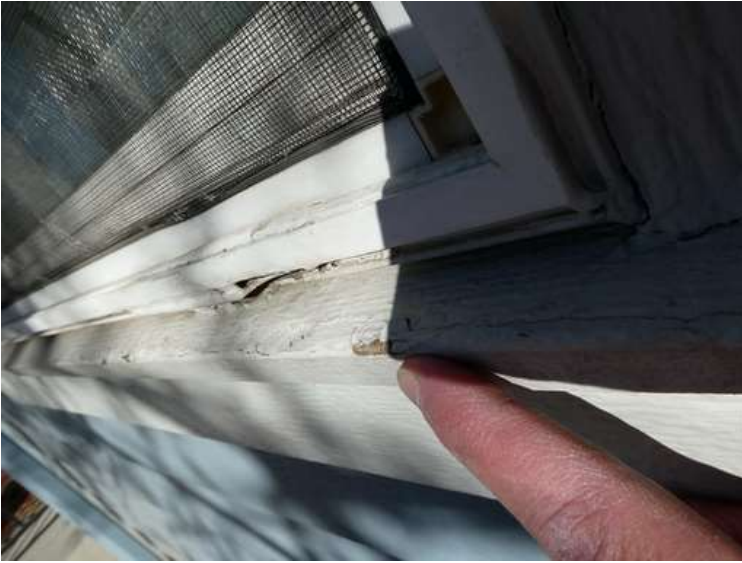
505. Building 22. Chip in paint from hail.

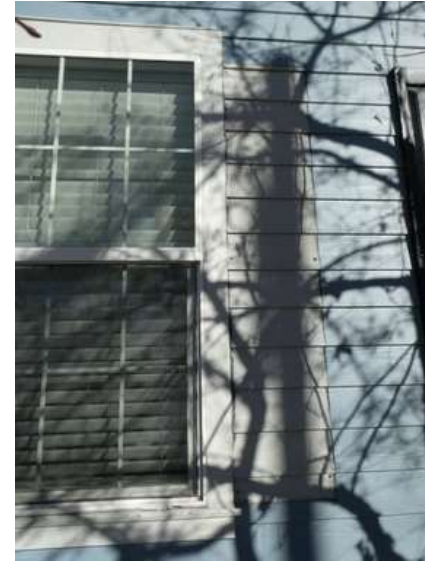
506. Building 22. Missing shutter.

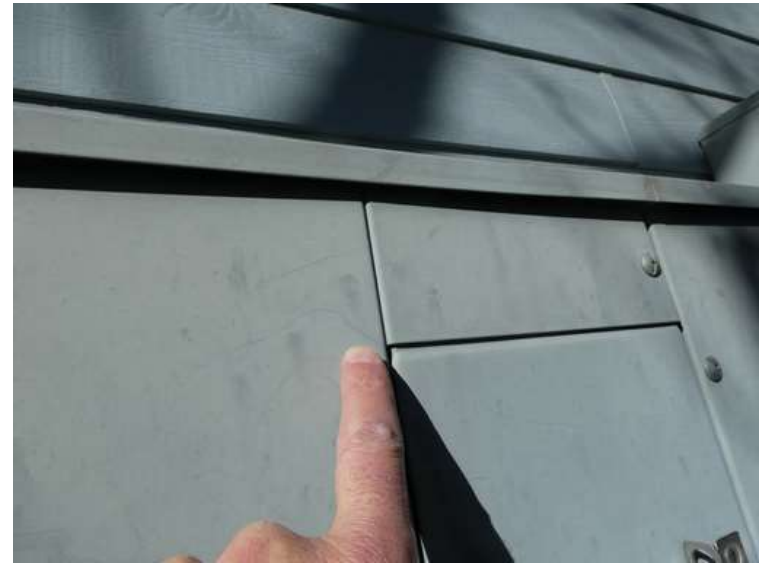
508. Building 22. Spatter marks on an electrical box from hail.

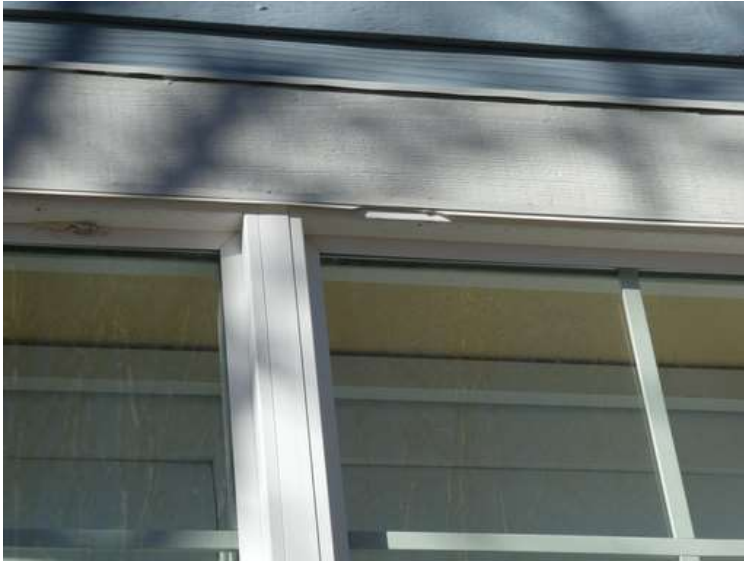
509. Building 22. Fracture in a plastic window frame from hail.

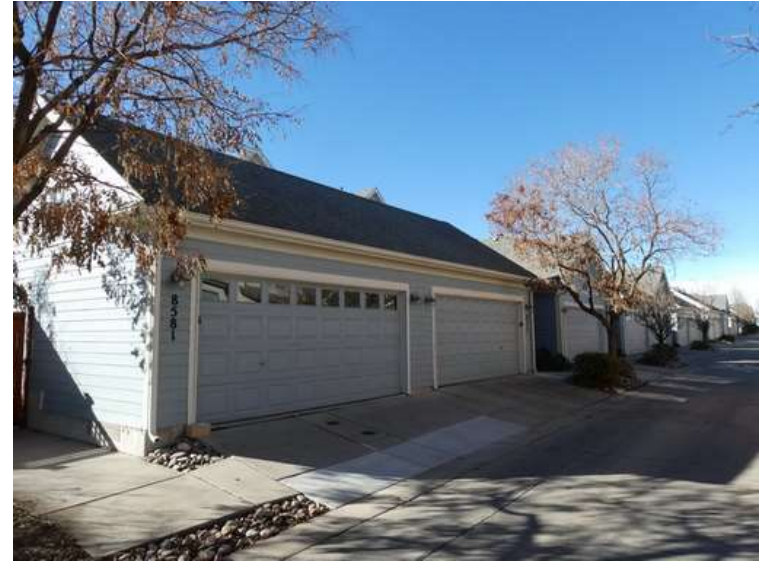
510. Building 22. North elevation. The garage doors were not dented by hail.

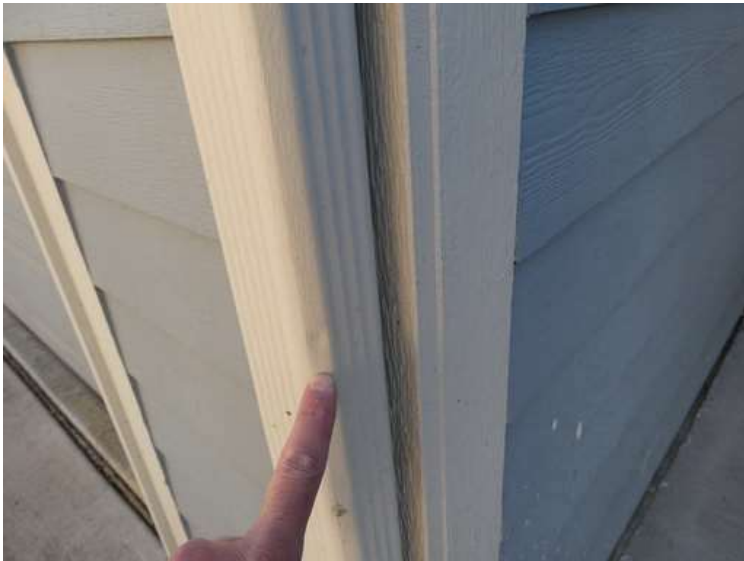
511. Building 22. Mechanical dent in a downspout.

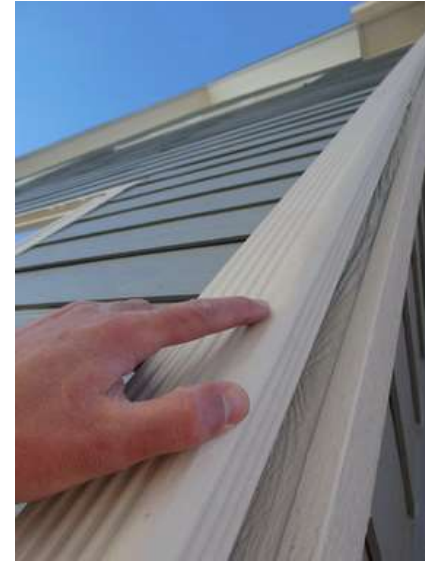
514. Building 22. Dent in a downspout.

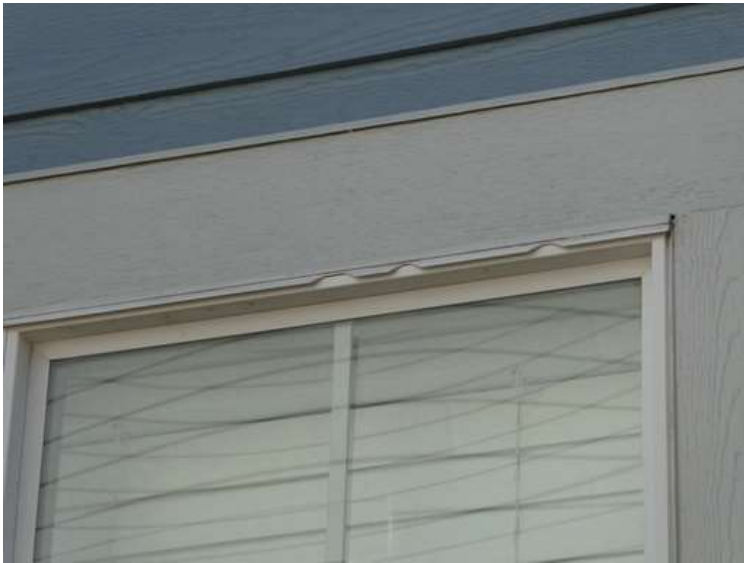
515. Building 22. Fractures in a plastic window frame from hail.

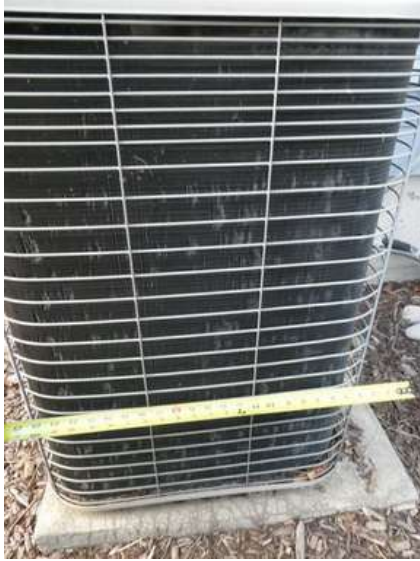
517. Building 22. Dents in condenser fins from hail.

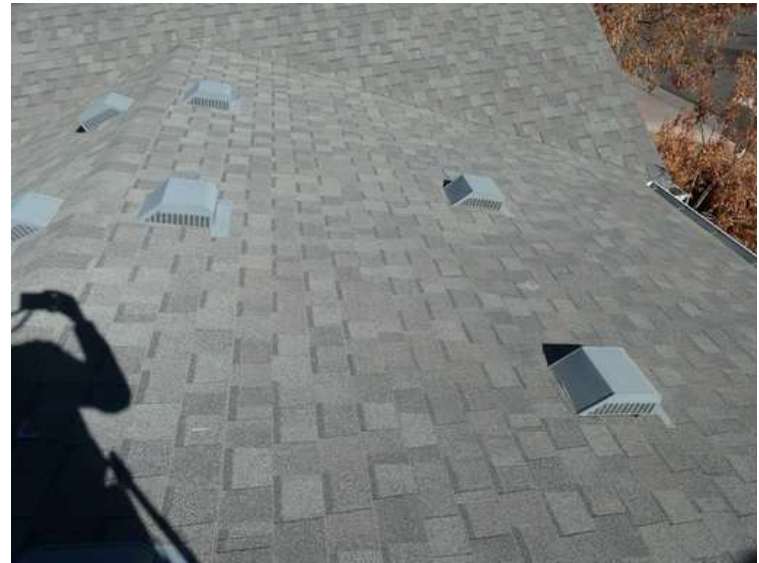
520. Building 22. East test area. Two shingles within the test area were bruised by hail at wrinkles.

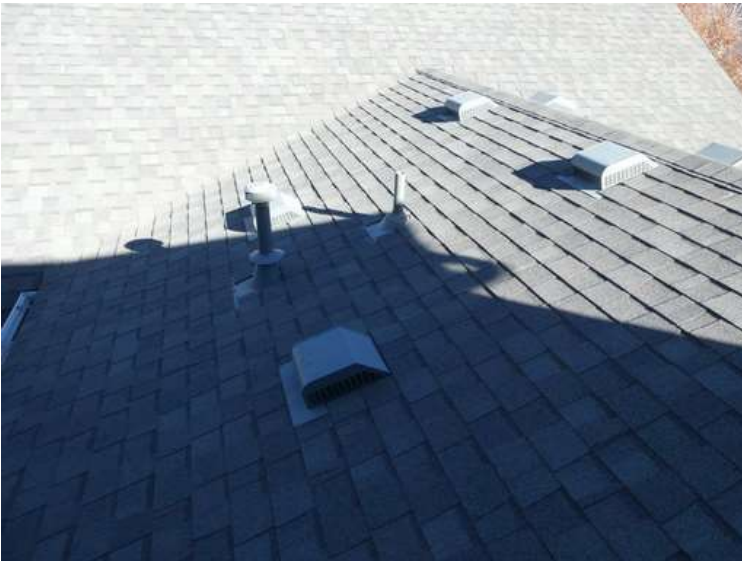
523. Building 22. West test area. No shingles within the test area were bruised by hail.

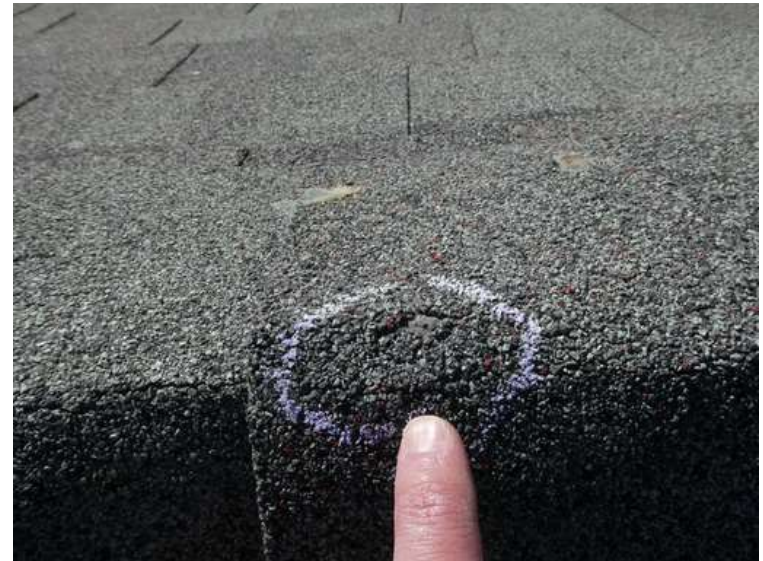
524. Building 22. Bruise in a ridge shingle.

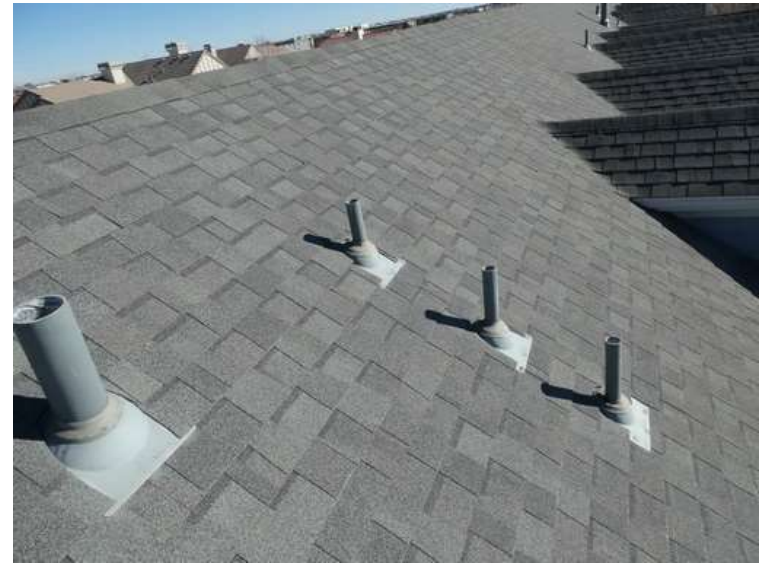
526. Building 22. South test area. No shingles within the test area were bruised by hail.

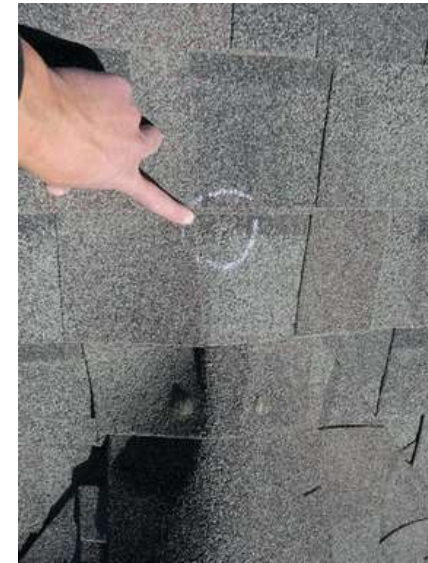
528. Building 22. Bruise in a ridge shingle.

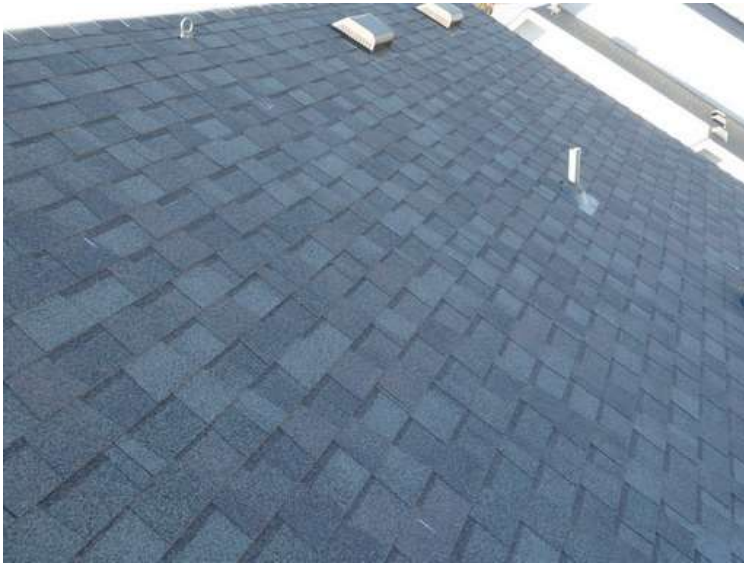
529. Building 22. North test area. No shingles within the test area were bruised by hail.

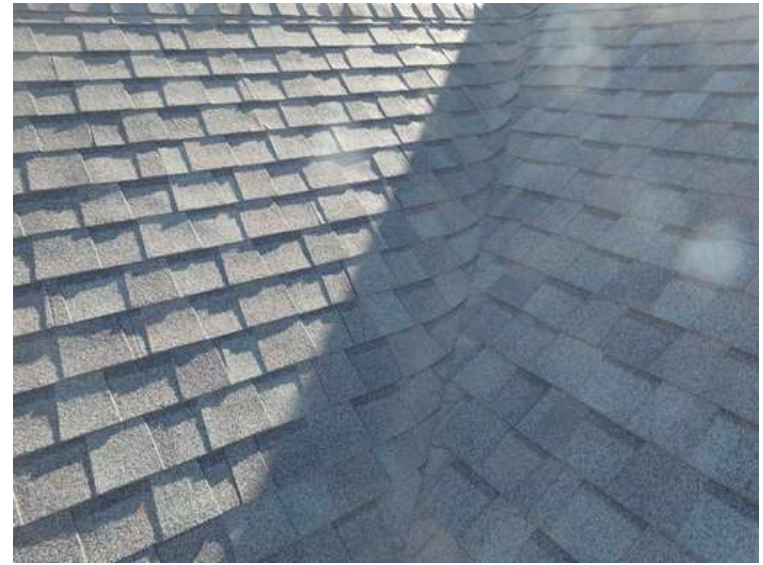
530. Building 22. Shingles draped over valleys were not bruised by hail.

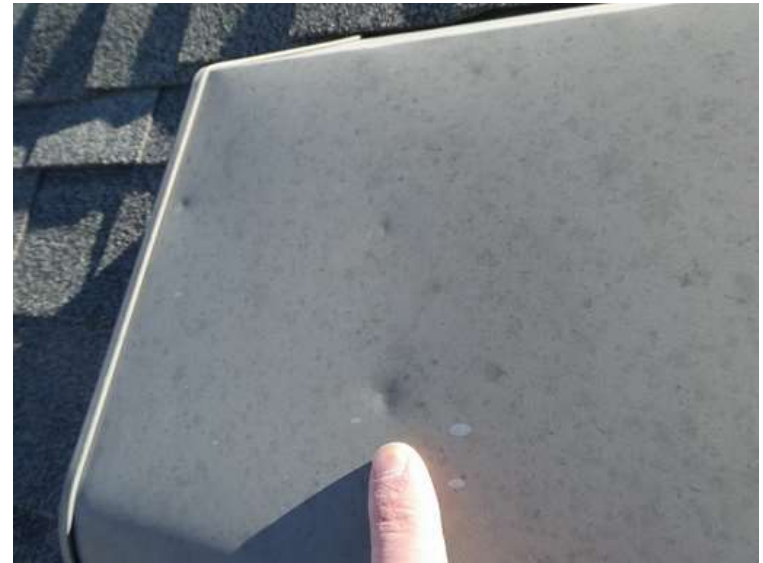
532. Building 22. Dent in an attic vent from hail.

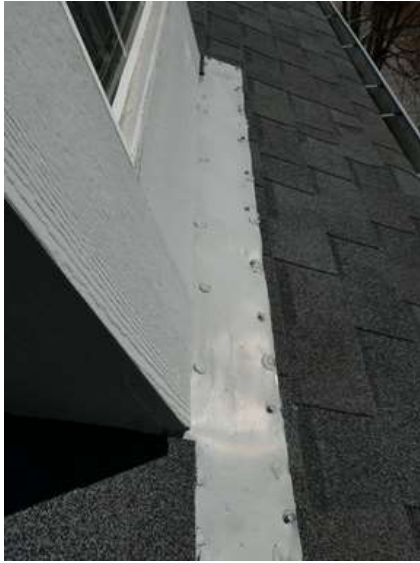
533. Building 22. Re-used flashing.

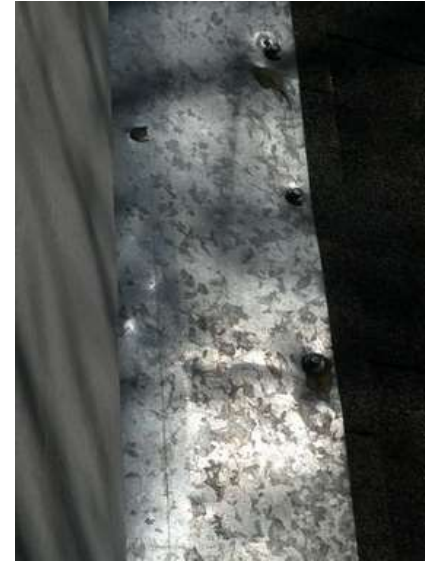
534. Building 22. Dent in headwall flashing.

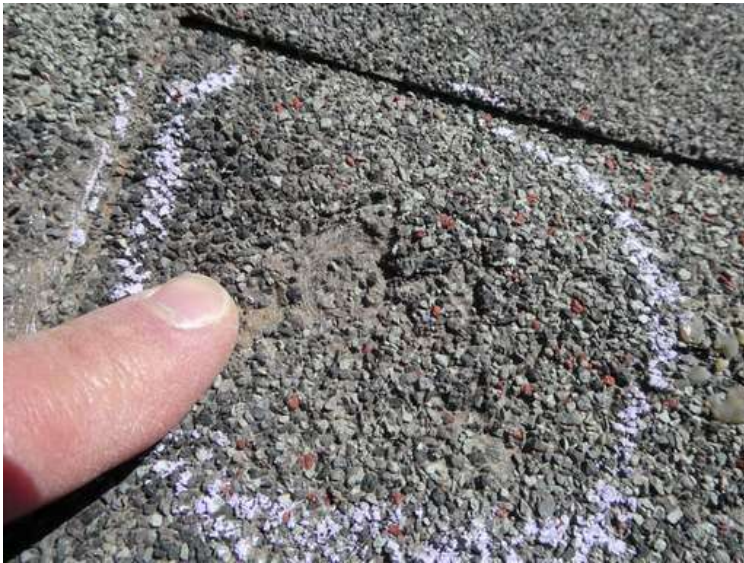
535. Building 22. Bruise in a ridge shingle.

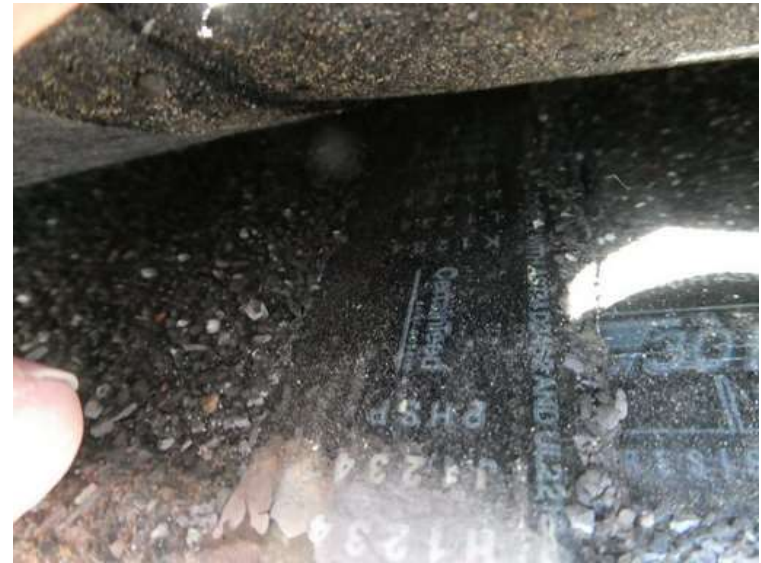
536. Building 22. Cellophane strip indicating impact resistant shingle.

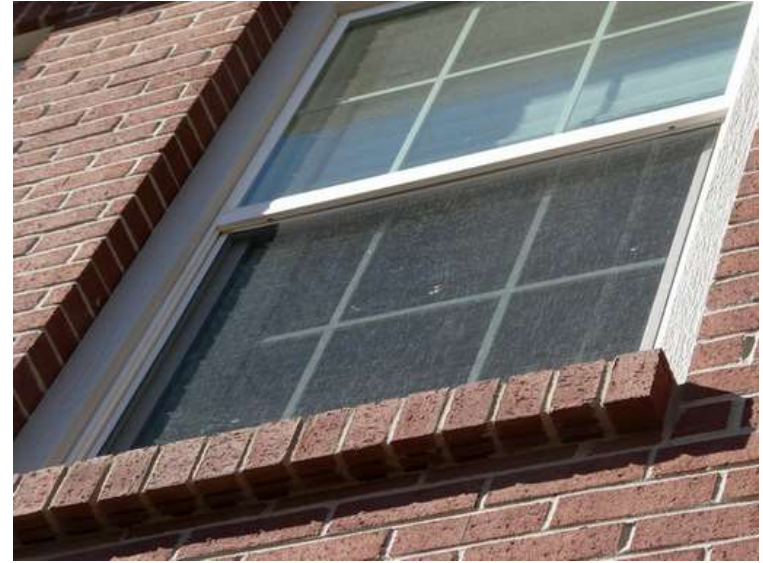
538. Building 23. Tears in a screen.

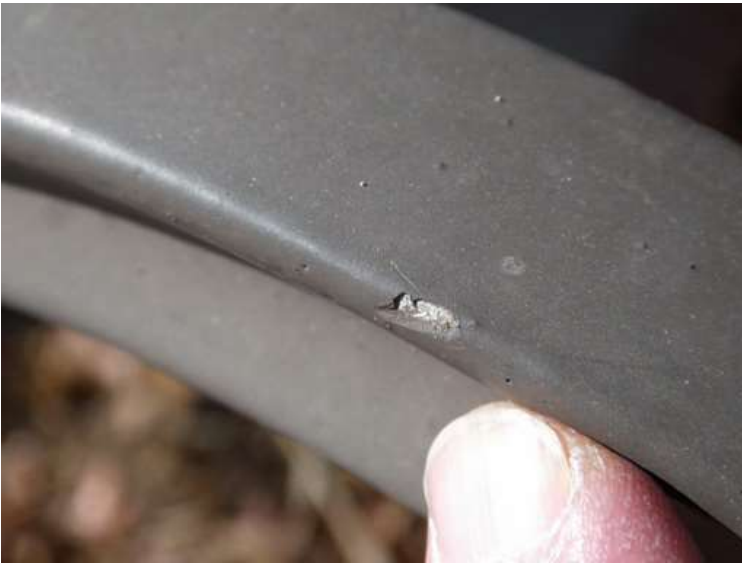
539. Building 23. Mechanical chip in paint on an iron fence.

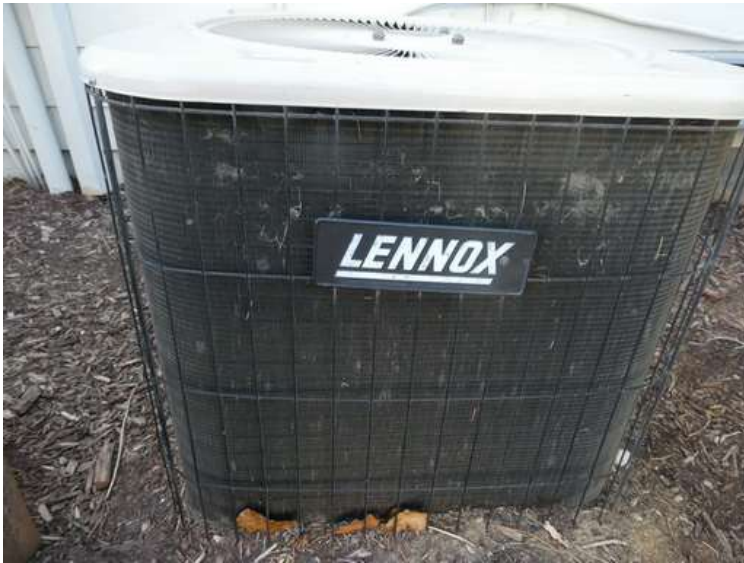
541. Building 23. Small dents in condenser fins from hail.

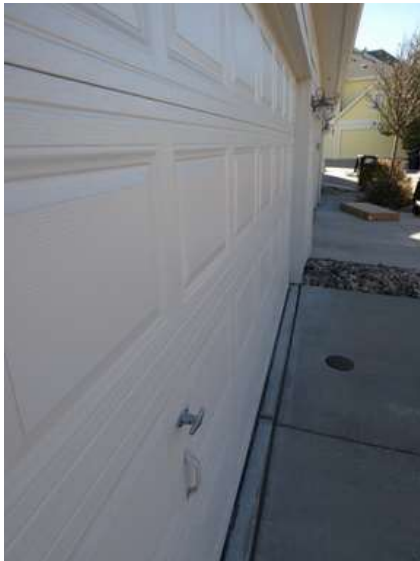
543. Building 23. Garage doors were not dented by hail.
