Stapleton Rowhome Association
Hail Damage Evaluation
10045 Martin Luther King Boulevard
Denver, CO 80238
Farmers File: 5010168593
Haag File: 1121000002-128

Re: Stapleton Rowhome Association
Hail Damage Evaluation
10045 Martin Luther King Boulevard
Denver, CO 80238
Farmers File: 5010168593
Haag File: 1121000002-128

In accordance with your request, we inspected the Stapleton Rowhome Association buildings to determine the extent of hail-caused damage to the building exteriors and when the damage occurred. We inspected the sites on February 1, 2, and 3, 2021.

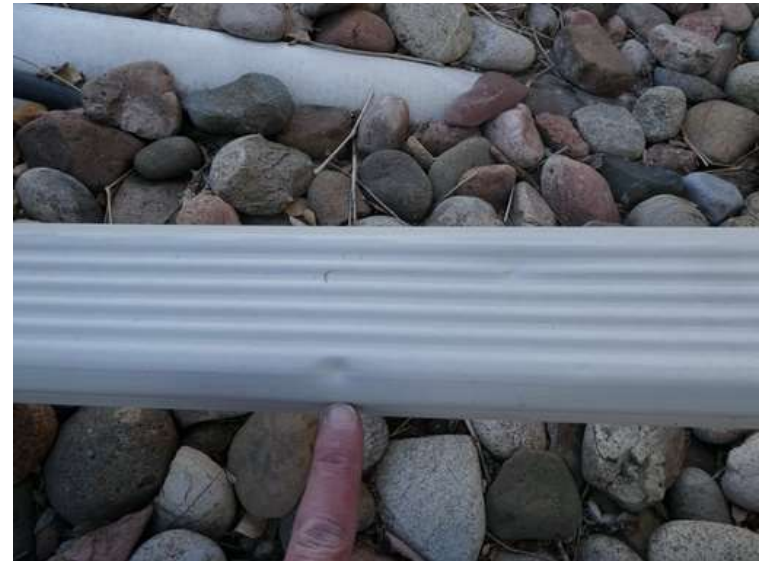
544. Building 23. Dent in a downspout extension from hail.

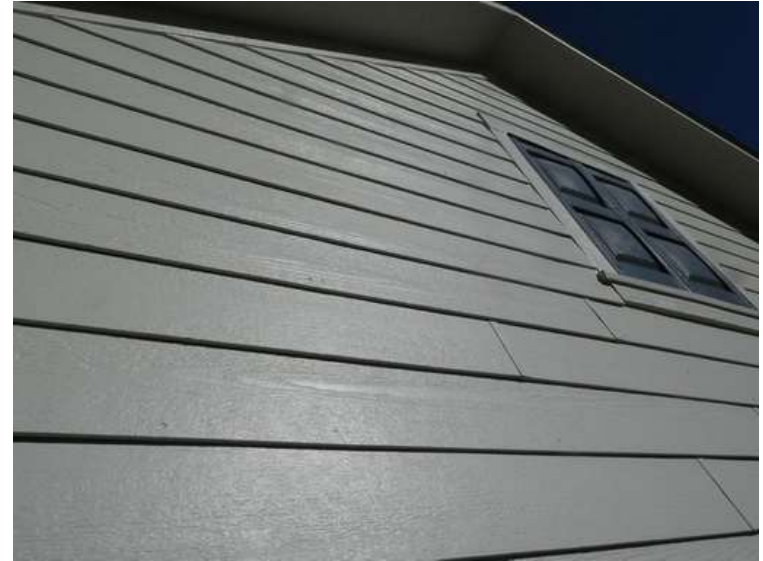
546. Building 23. Paint finishes on fiber cement siding were not chipped by hail.

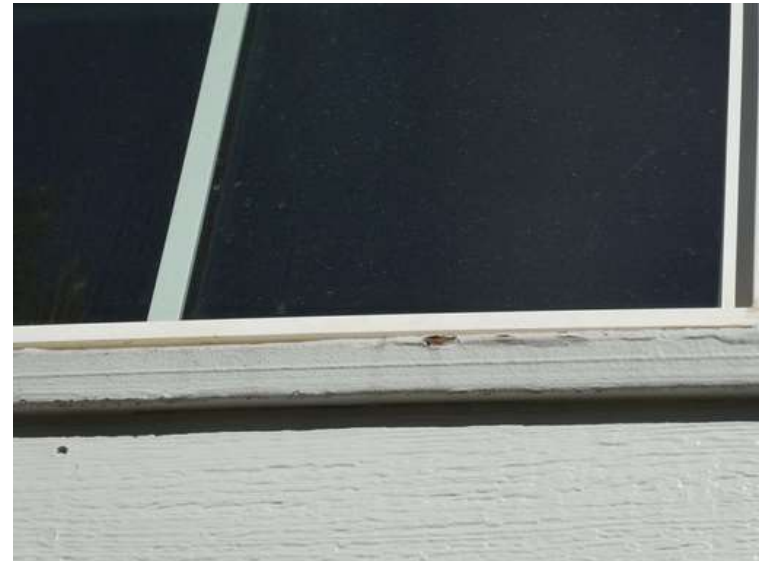
548. Building 23. Chip in paint from hail.

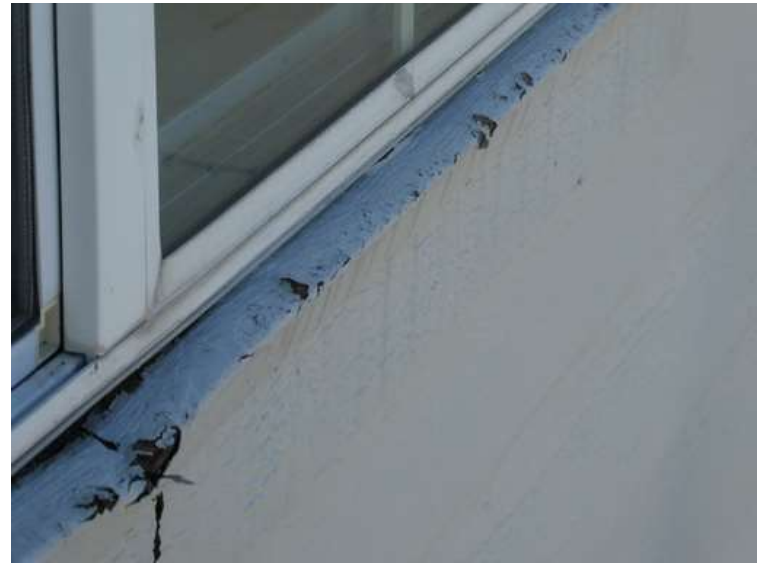
550. Building 23. Chips in paint on a fiberboard windowsill.

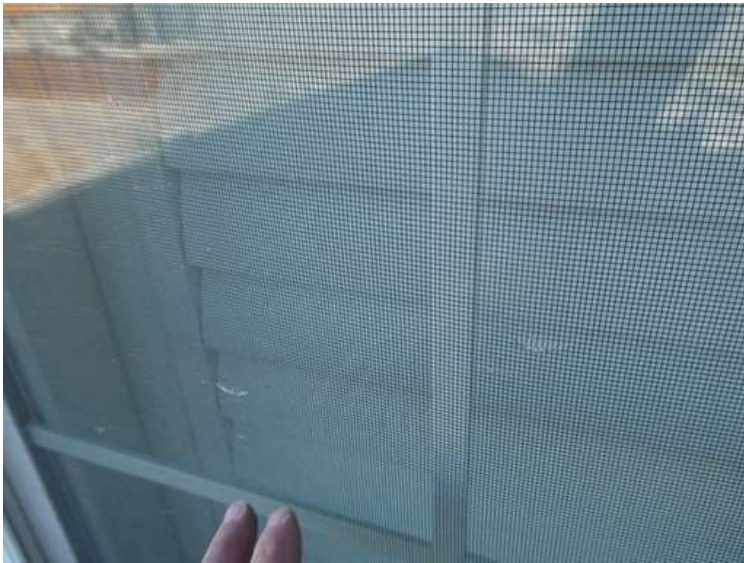
551. Building 23. Tears in a screen.

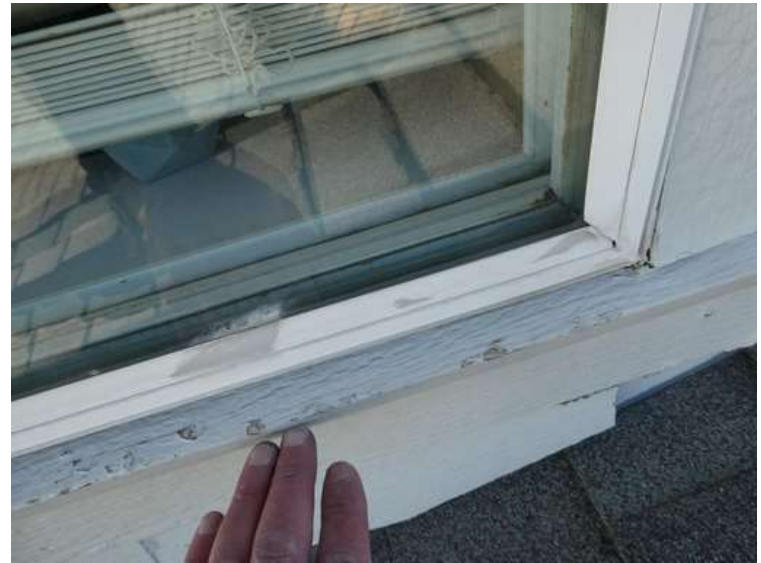
552. Building 23. Chips in paint from hail.

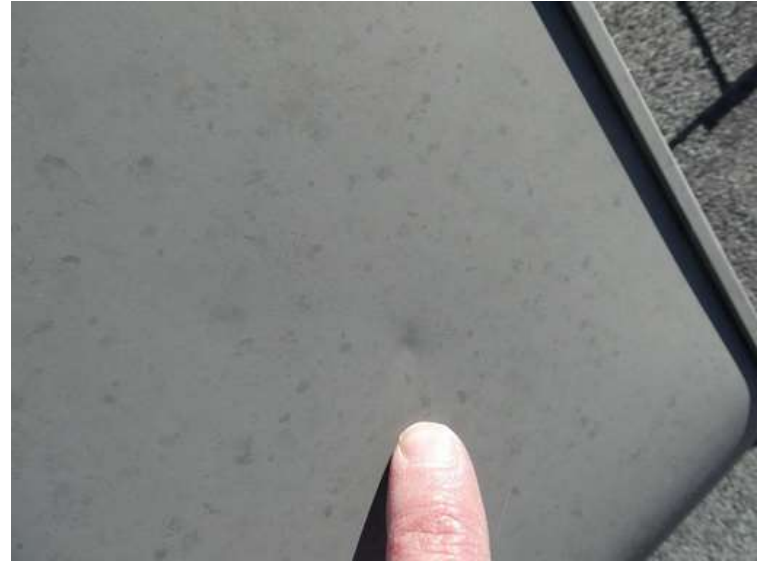
554. Building 23. Dent in a steel attic vent from hail.

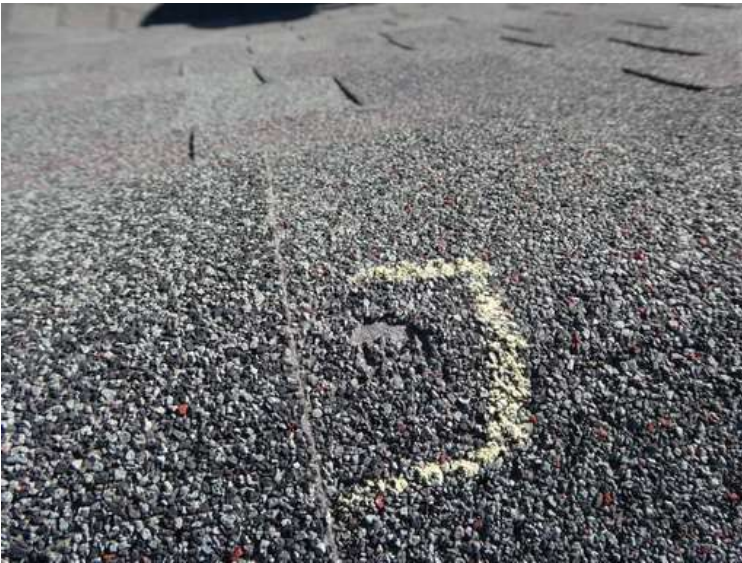
555. Building 23. Bruise in a ridge shingle from hail.

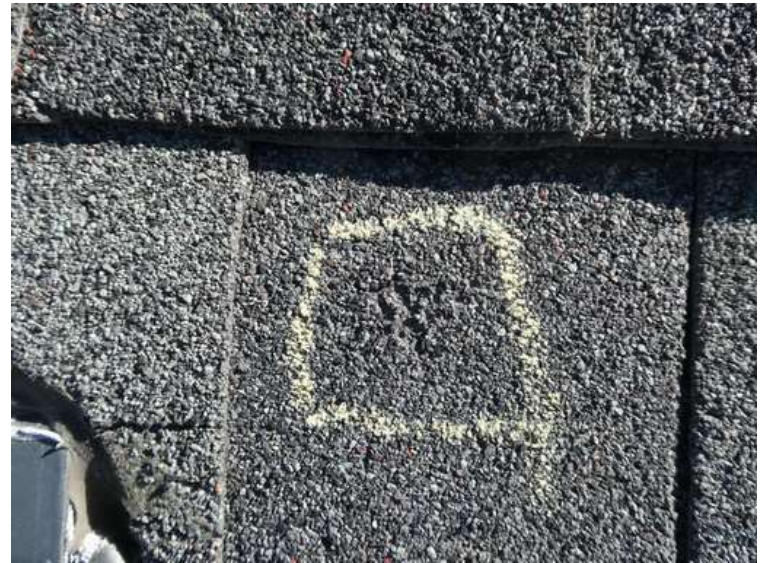
556. Building 23. Bruise in a shingle draped over flashing from hail.

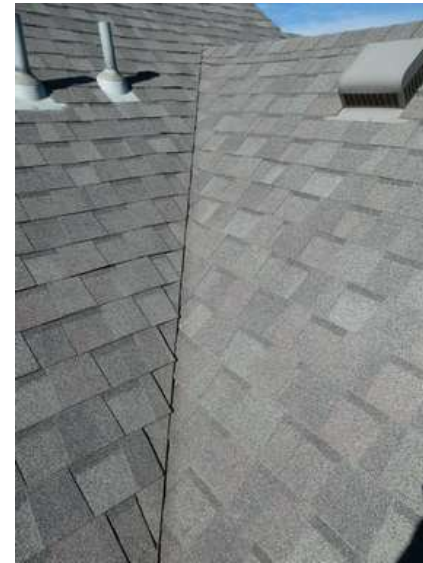
562. Building 23. Shingles draped over valleys were not bruised by hail.

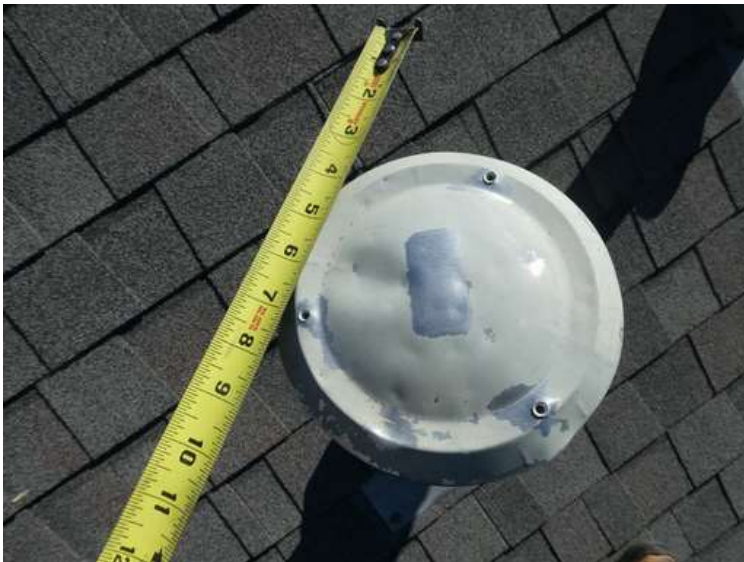
563. Building 23. Dents in a flue cap from hail.

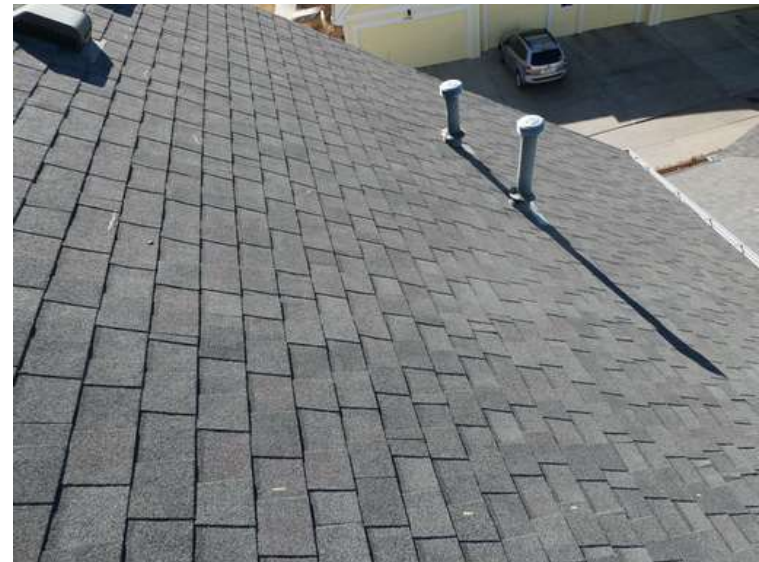
564. Building 23. West test area. No shingles within the test area were bruised by hail.

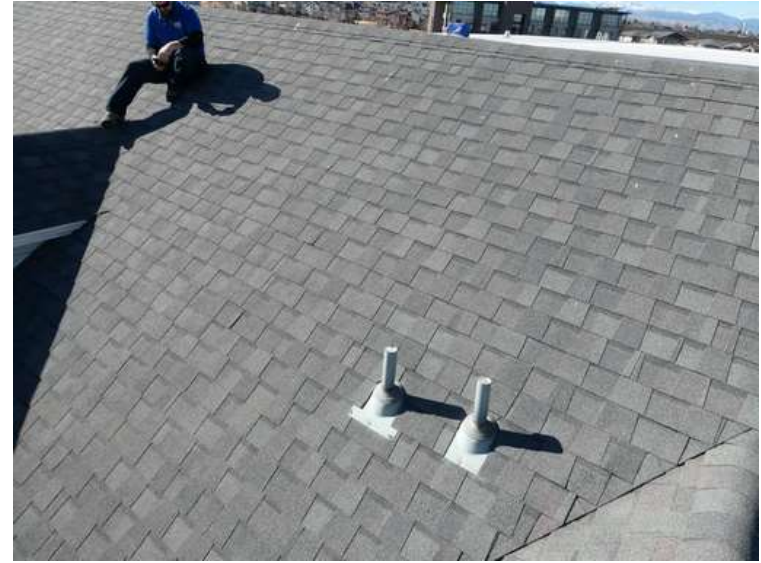
566. Building 23. East test area. No shingles within the test area were bruised by hail.

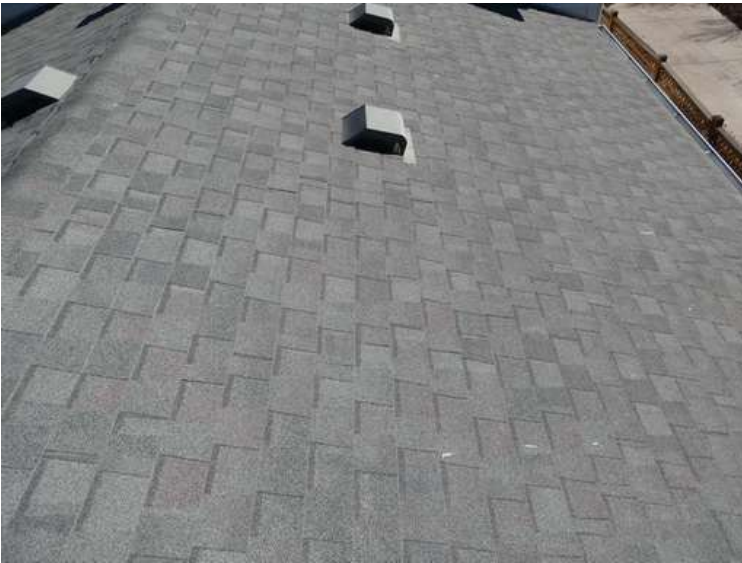
567. Building 23. South test area. No shingles within the test area were bruised by hail.

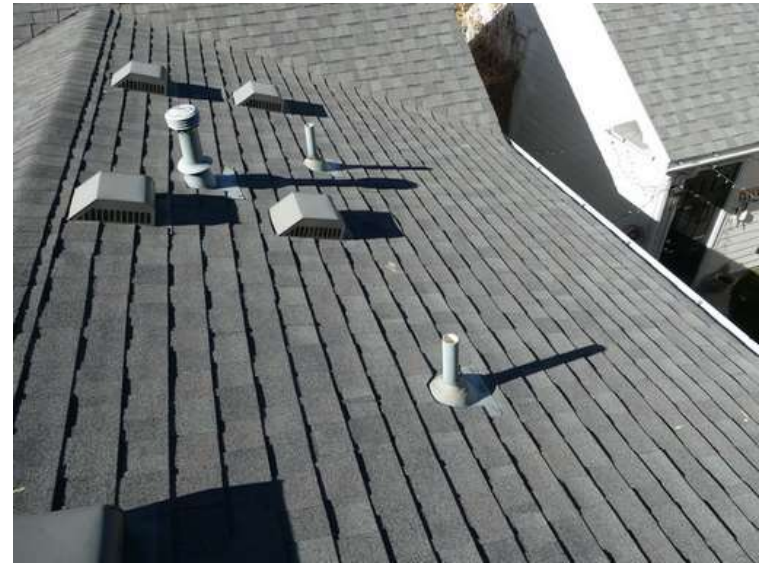
568. Building 23. North test area. No shingles within the test area were bruised by hail.

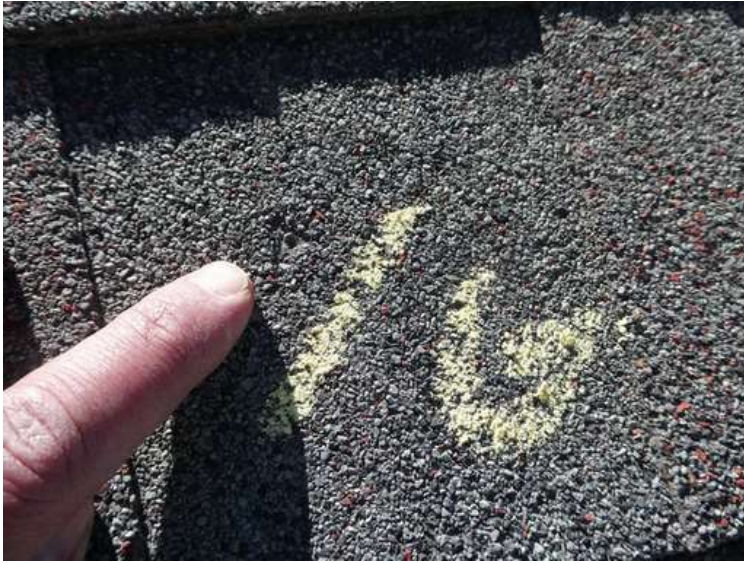
569. Building 23. Mechanical gouge.

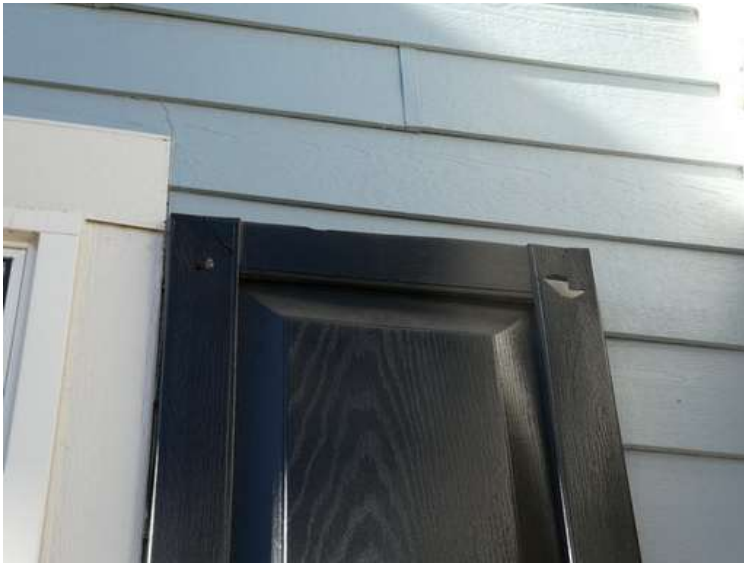
571. Building 24. Fractures in a shutter from wind.

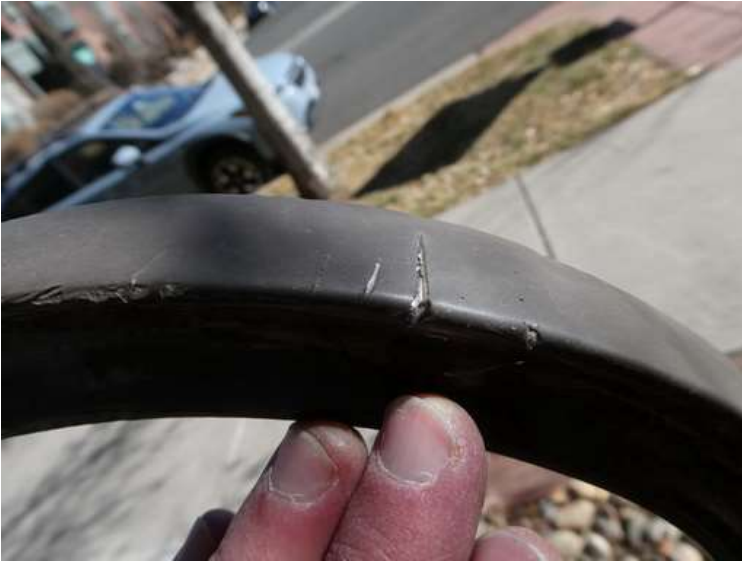
573. Building 24. Mechanical scuffs.

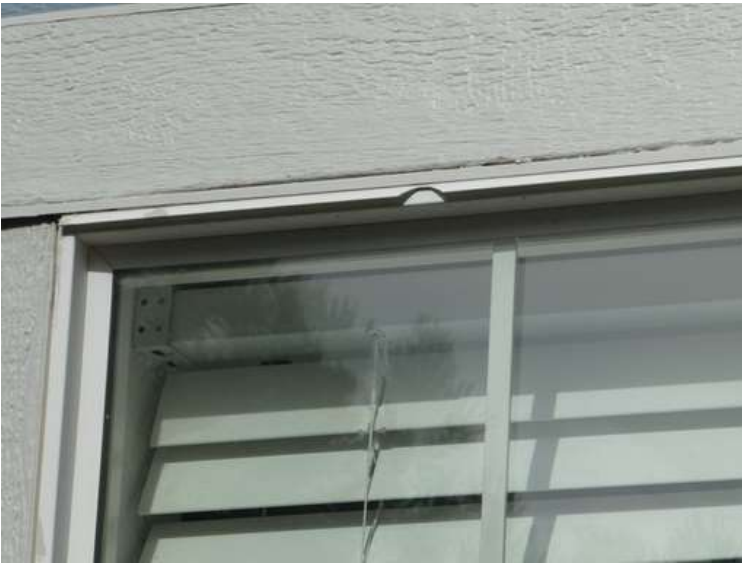
575. Building 24. Fracture in a vinyl window frame from hail.

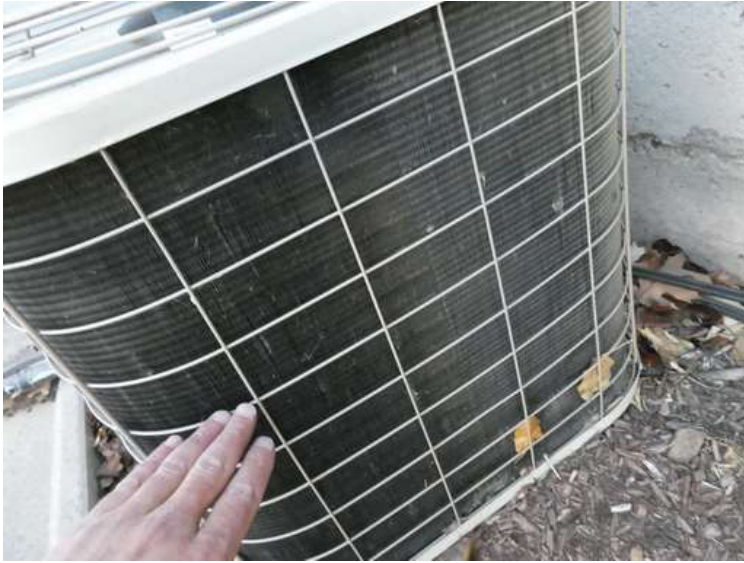
577. Building 24. Small dents in condenser fins from hail.

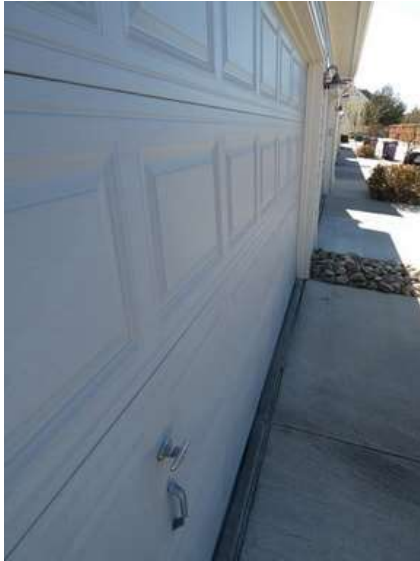
579. Building 24. Garage doors were not dented by hail.

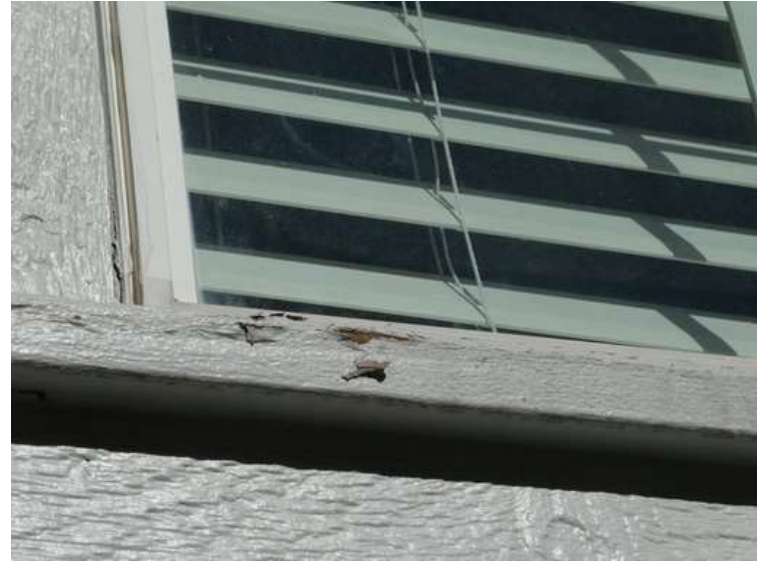
582. Building 24. Chip in paint from hail.

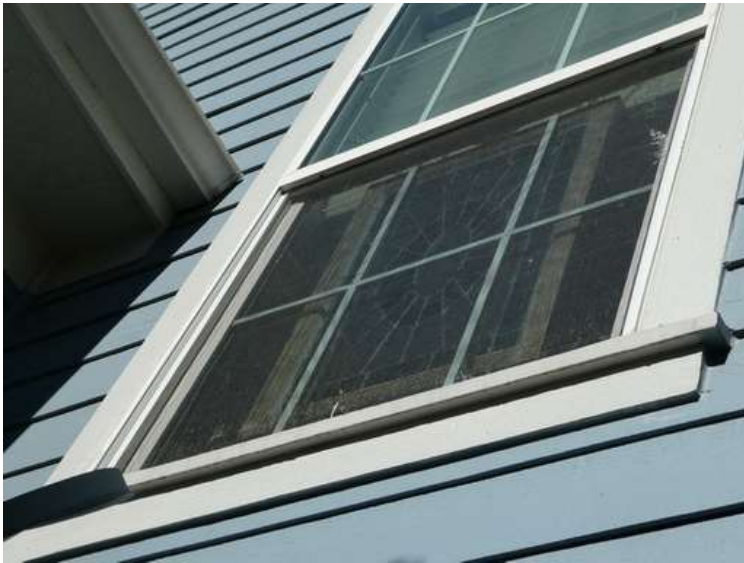
583. Building 24. Tears in a screen from hail.

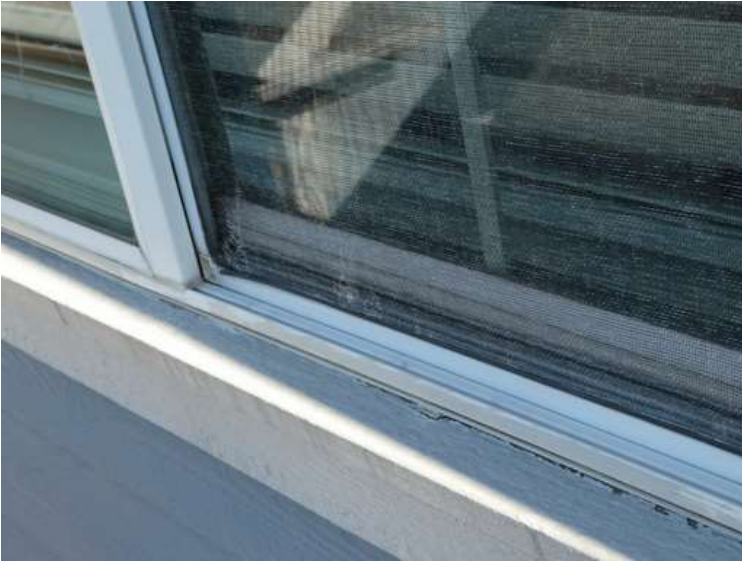
585. Building 24. Tears from hail.

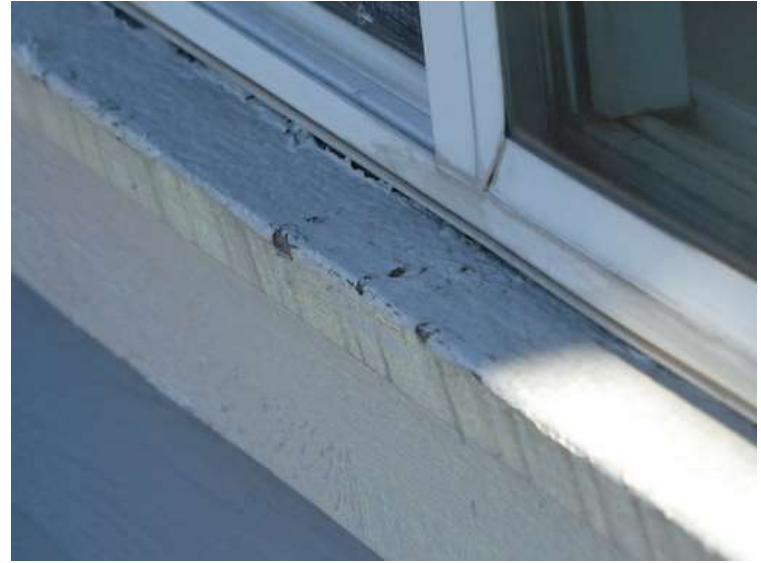
586. Building 24. Chips in paint from hail.

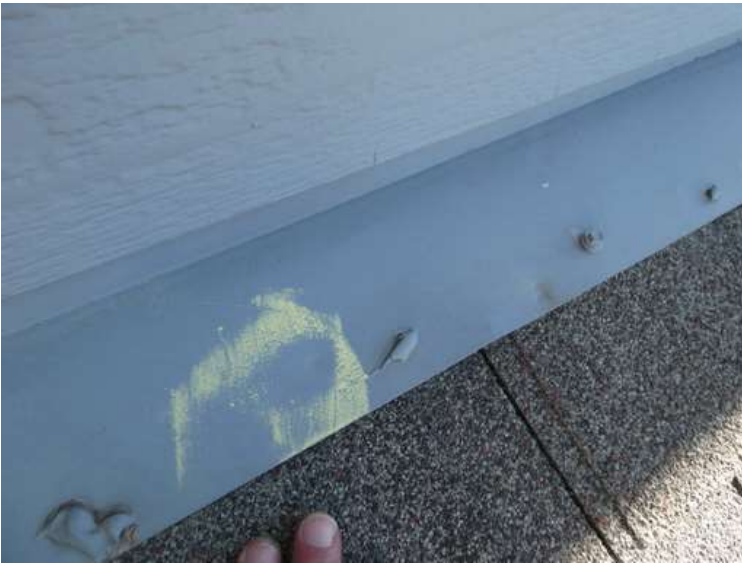
587. Building 24. Dent in headwall flashing.

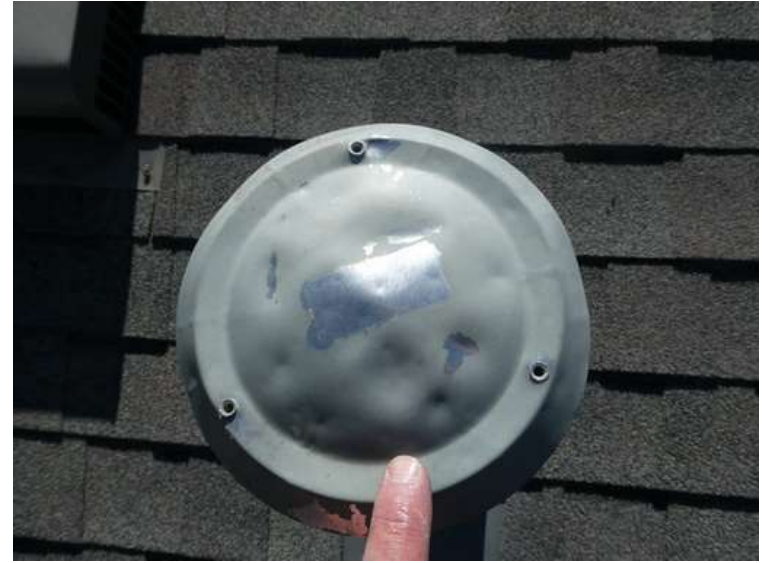
590. Building 24. Dents from hail.

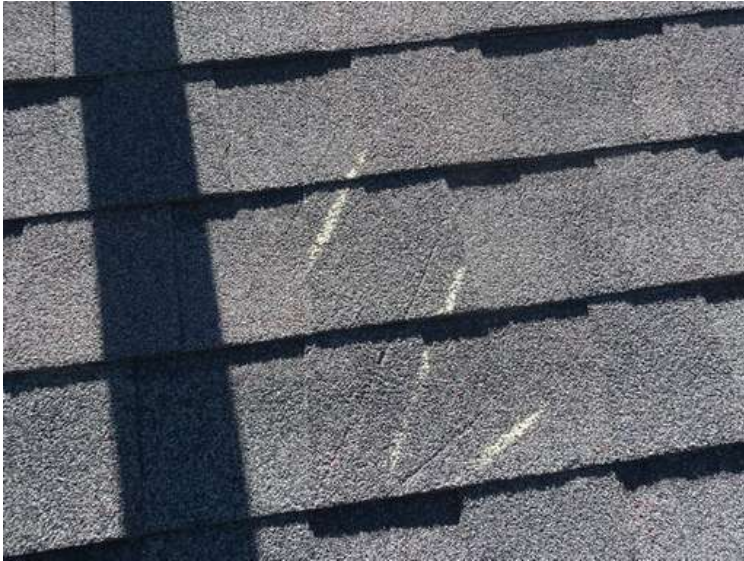
593. Building 24. Knife cuts.

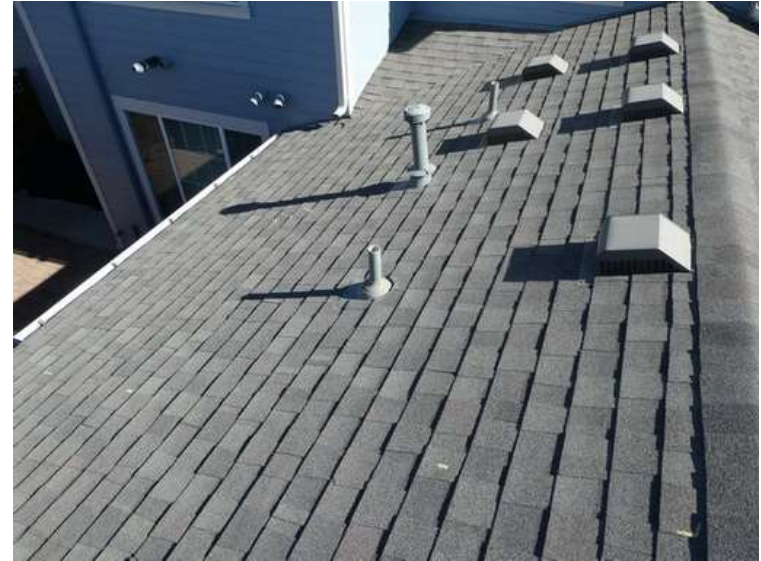
594. Building 24. North test area. No shingles within the test area were bruised by hail.

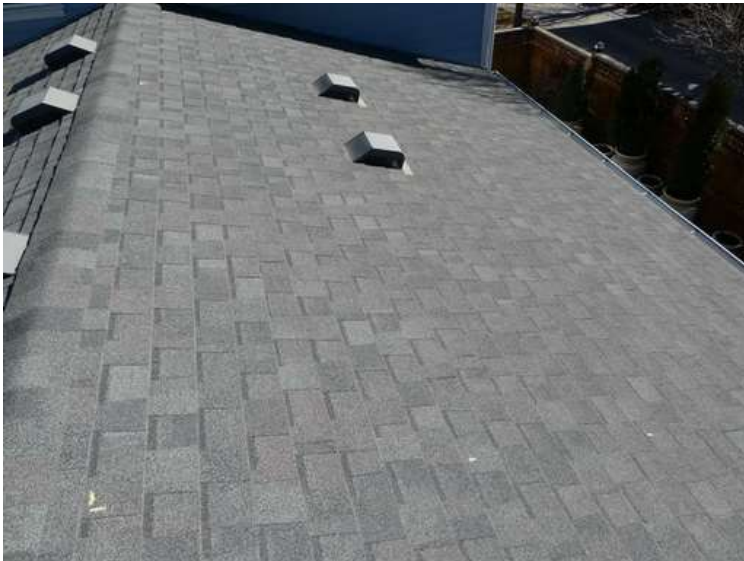
595. Building 24. South test area. No shingles within the test area were bruised by hail.

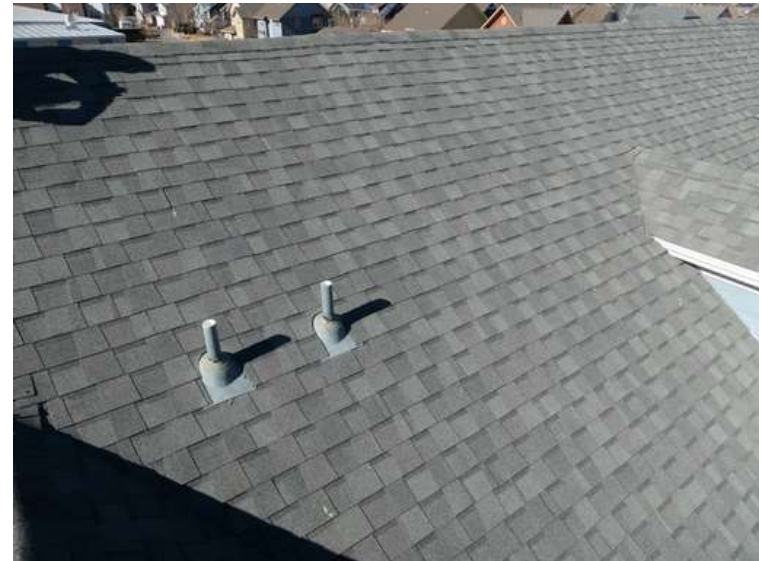
596. Building 24. East test area. No shingles within the test area were bruised by hail.

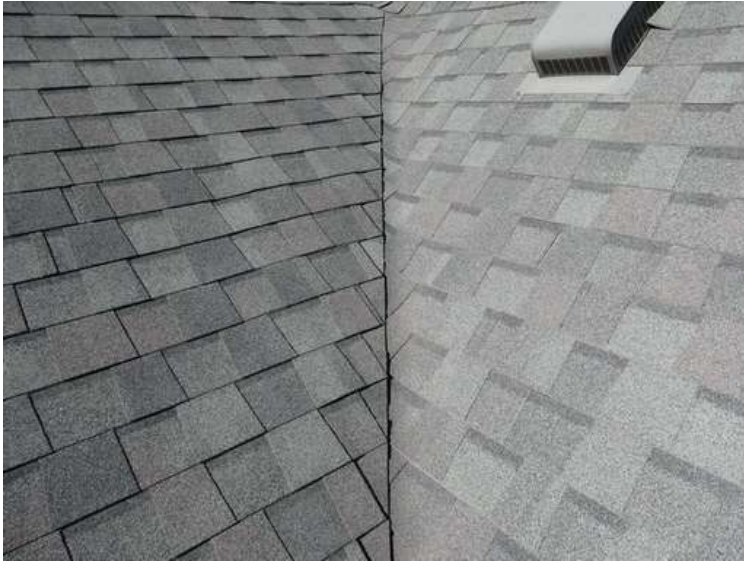
597. Building 24. Shingles draped over valleys were not bruised by hail.

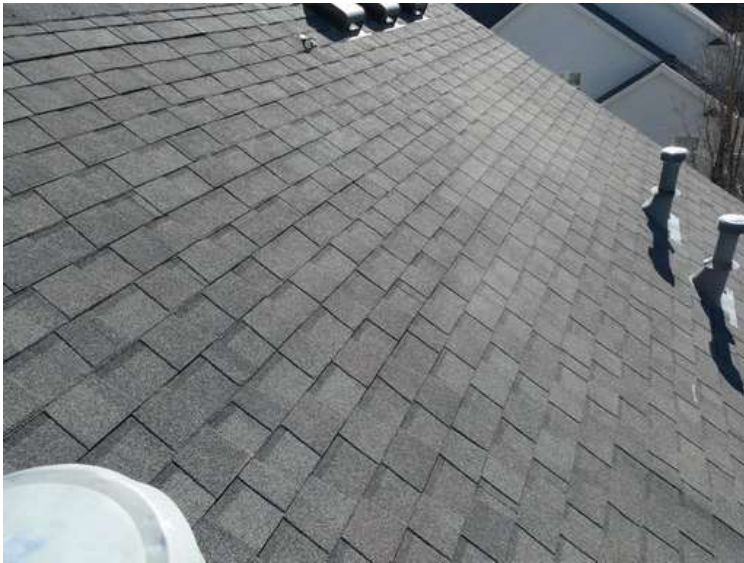
599. Building 24. West test area. No shingles within the test area were bruised by hail.

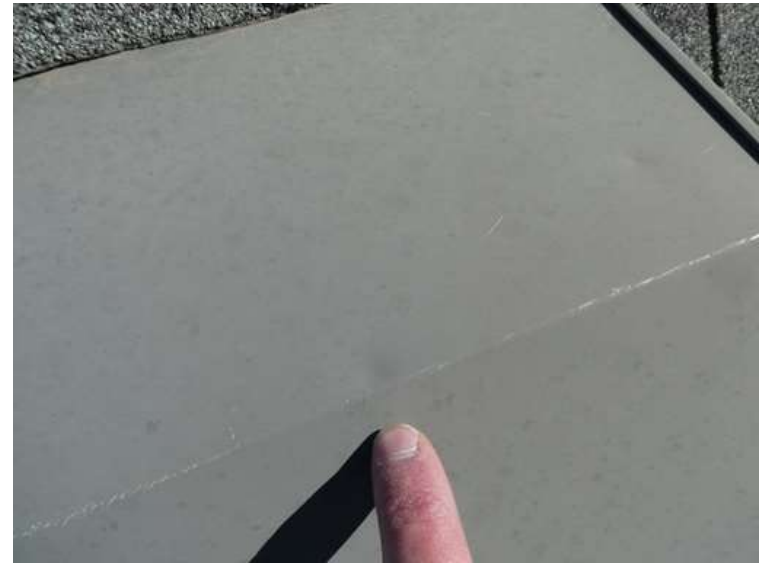
600. Building 24. Dent from hail.

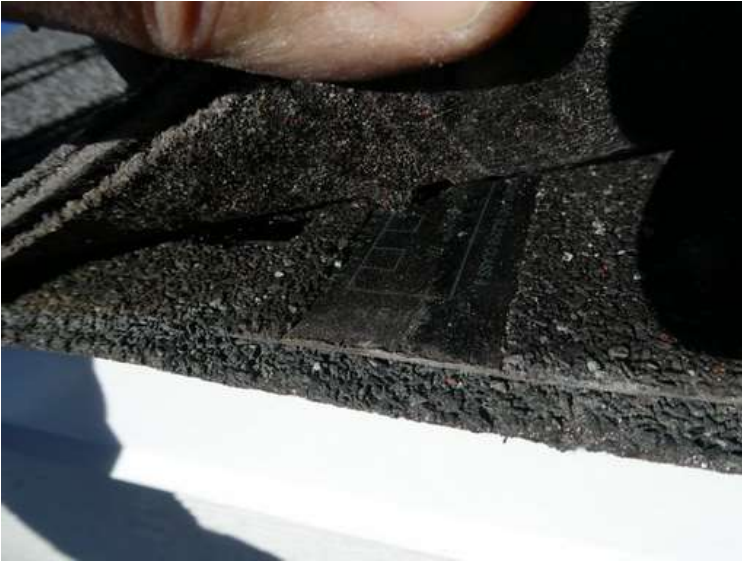
601. Building 24. Cellophane strip indicating Class 4 impact resistant shingle.

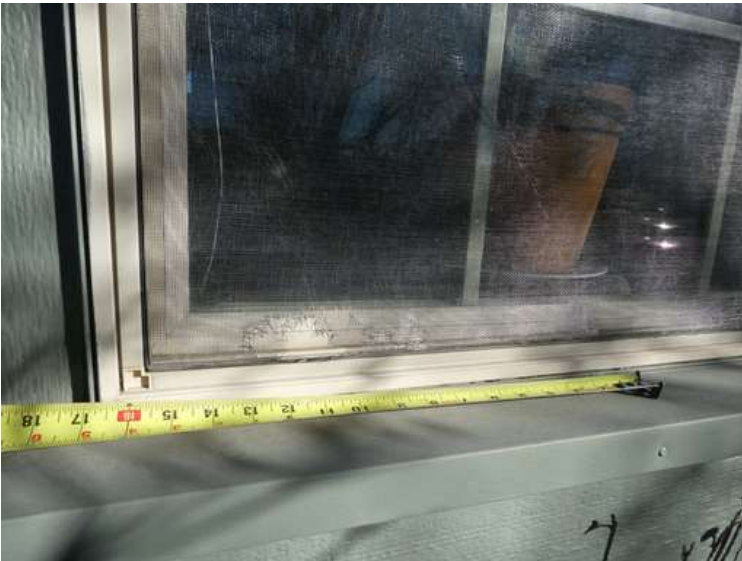
603. Building 25. Tears in a screen.

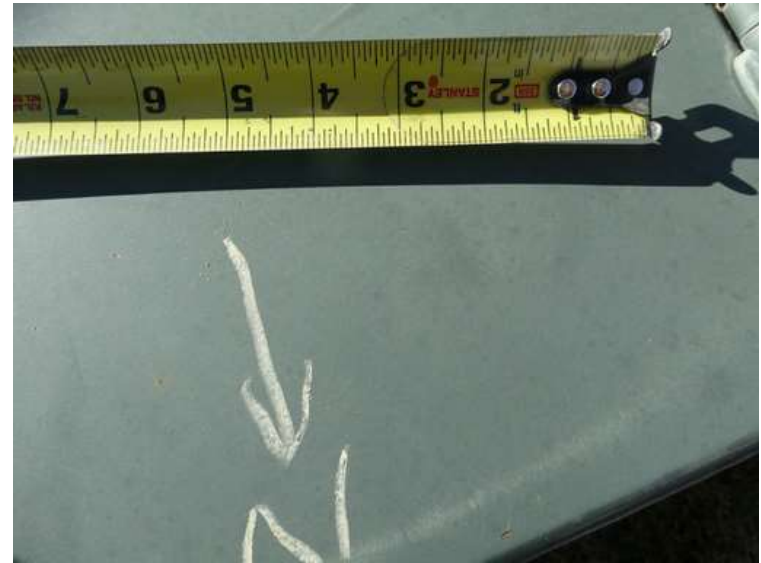
606. Building 25. Spatter marks on the top of a transformer cabinet.

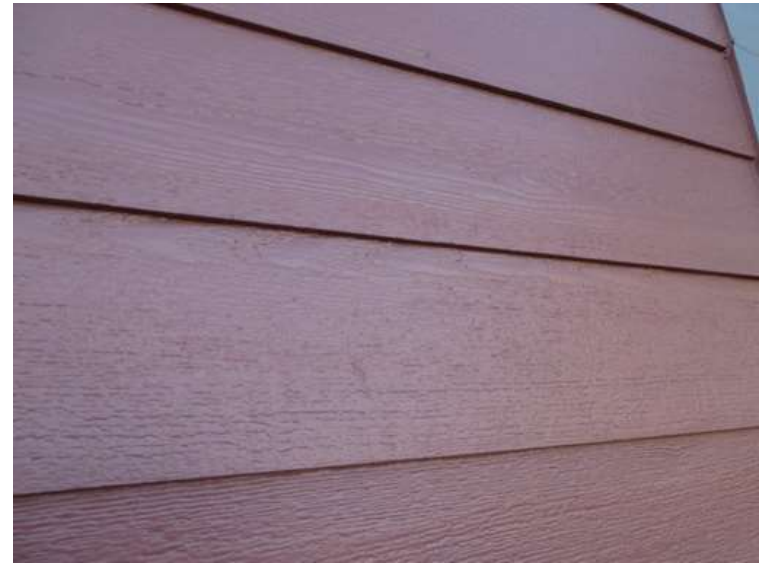
608. Building 25. Paint finishes on fiber cement siding were not chipped by hail.

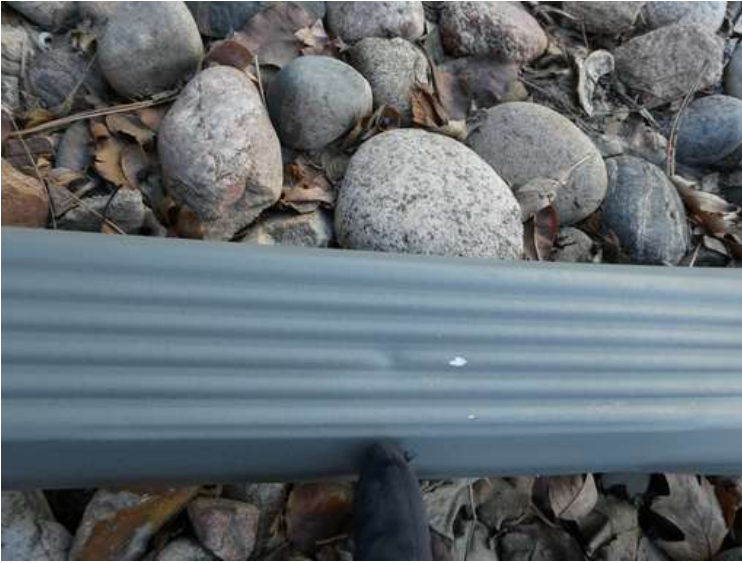
609. Building 25. Dent in a downspout extension from hail.

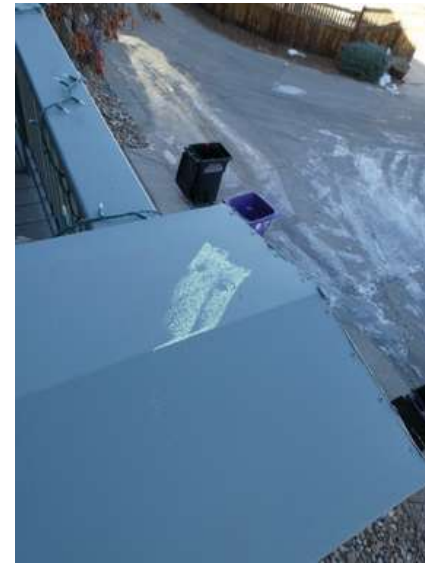
614. Building 25. Dents in a steel cap from hail.

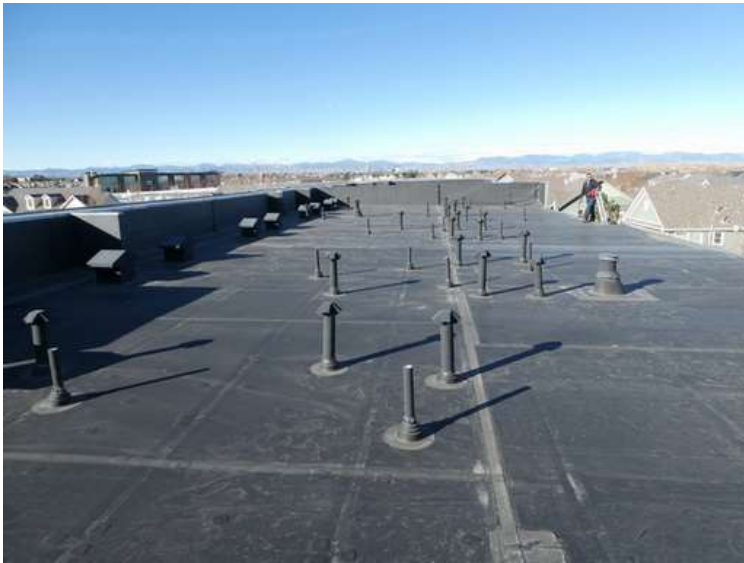
615. Building 25. View looking west. The roof was covered with an adhered EPDM membrane.

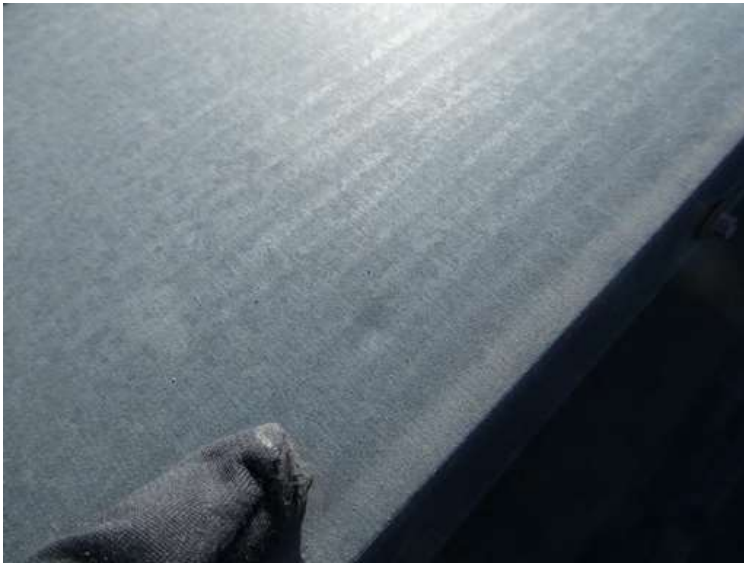
620. Building 25. Dents in an exhaust hood from hail.

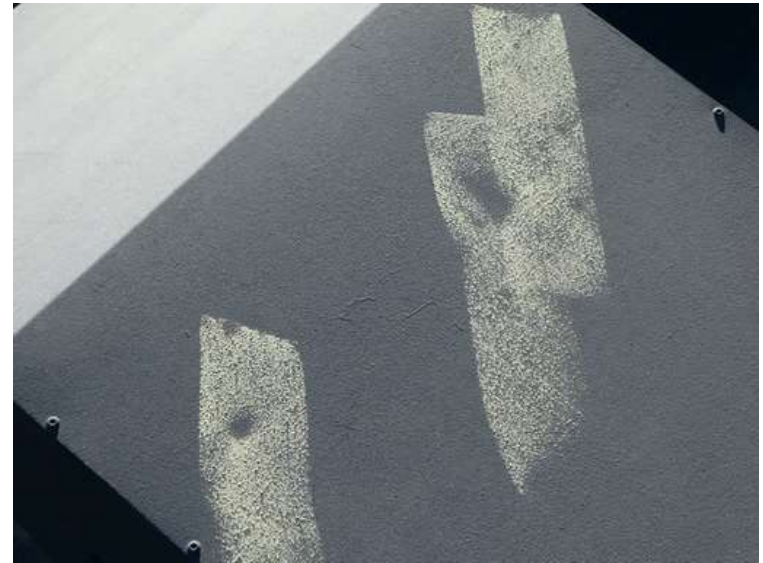
621. Building 25. Dent in the roof surface.

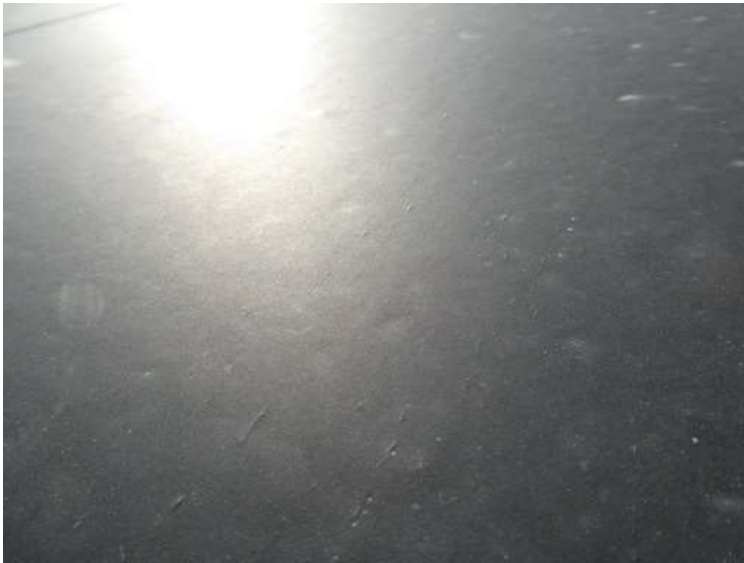
622. Building 25. Straight edge over a dent.

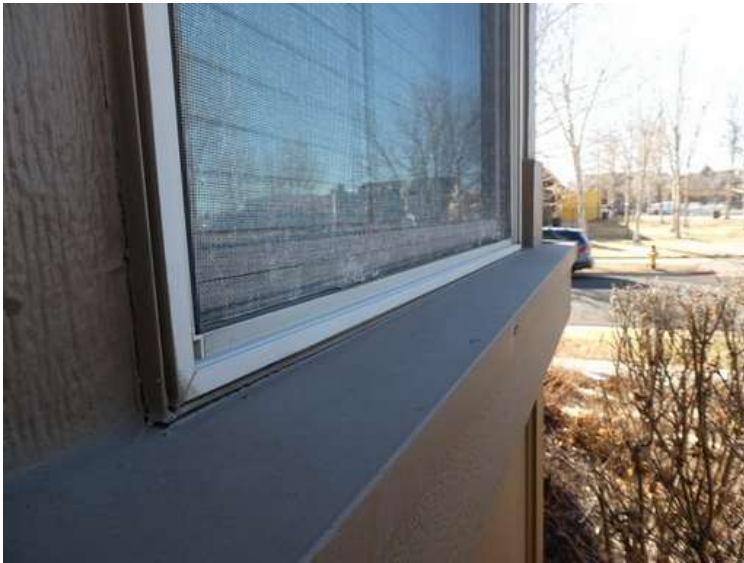
636. Building 26. Dent in a steel ledge.

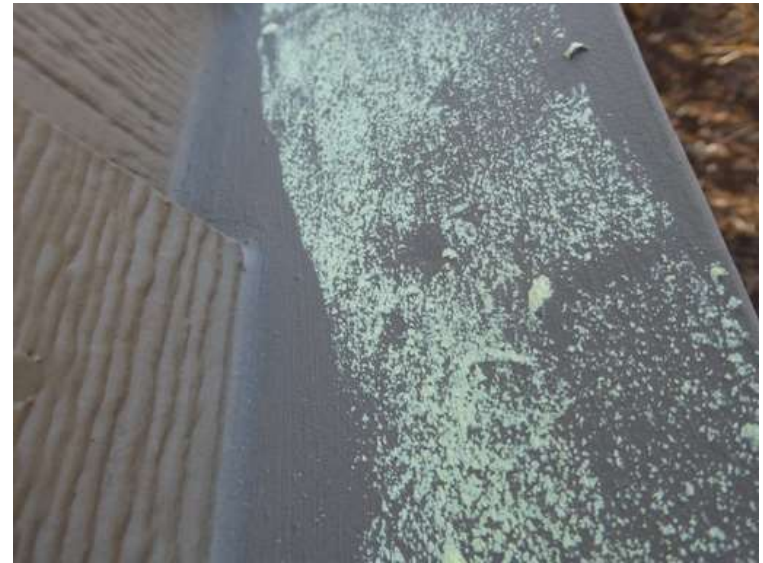
637. Building 26. Chips in paint from hail.

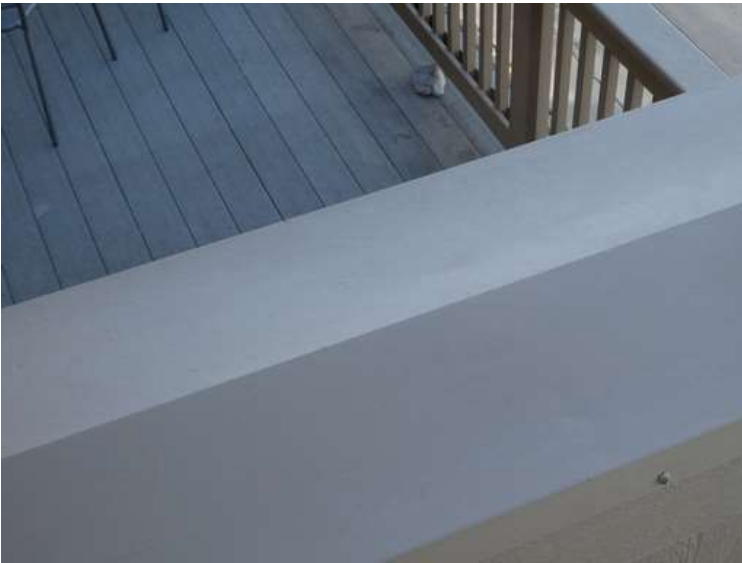
640. Building 26. Dent in a gutter.

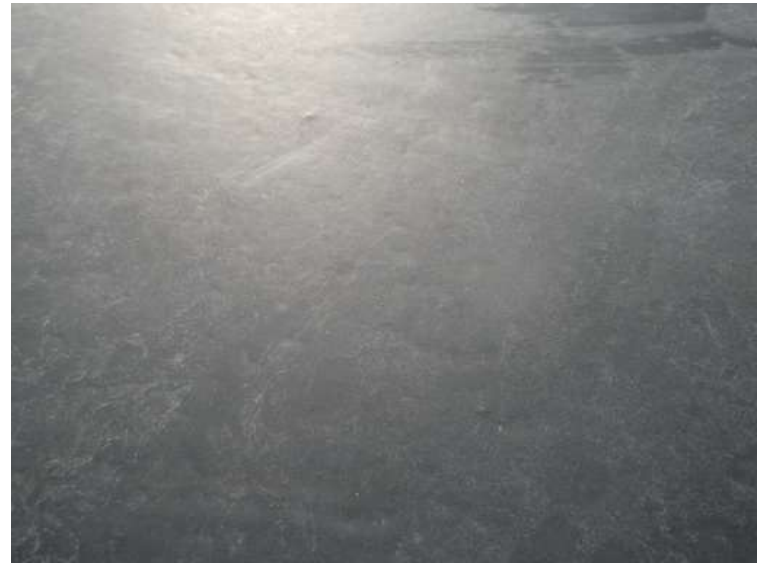
648. Building 26. Dents in the roof surface.

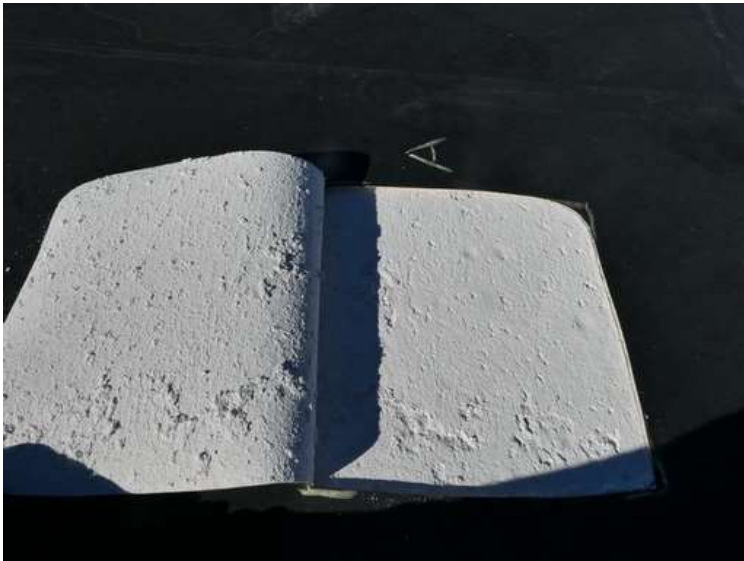
655. Building 26. Sample folded back. The gypsum substrate was dented.

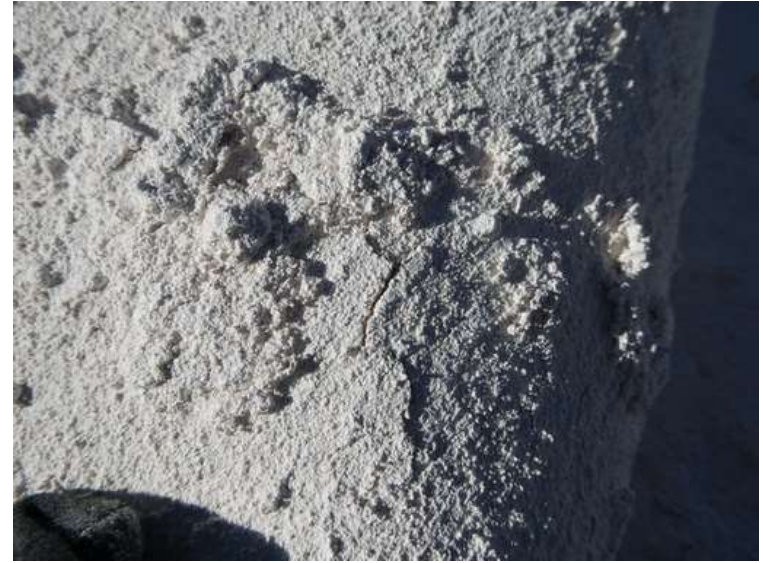
658. Building 26. Tear in the facer sheet from hail.
