# Illinois River and Tributaries: Streambank Erosion Sites and Analysis 2020 Report

Prepared by Natural State Streams LLC for The Illinois River Watershed Partnership, September 2021

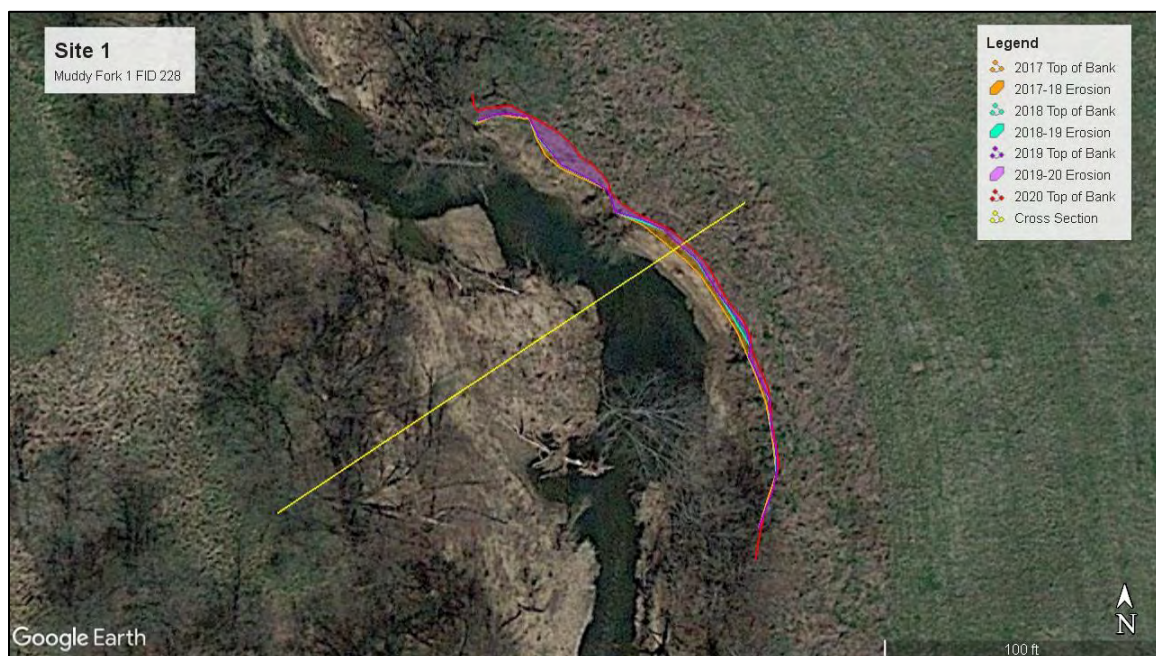
**Figure 5.** Planform view of the Muddy Fork 1 FID 228 annual survey site. The Creek flows generally South to North at this location. The small orange shaded area represents the bank lost to erosion from 2017-2018, while the light blue shaded area represents bank lost from 2018-2019, and the purple shaded area depicts land that washed downriver from 2019-2020. Google Earth Imagery Date: 3/4/2020.

Based on the 2017, 2018, 2019, & 2020 cross-section surveys, the stream bank at this location moved an average of 1.72 feet laterally across the bank profile annually, which is ranked 8<sup>th</sup> out of the 15 annual survey sites for highest annual bank erosion rate. In total, we measured 5.17 ft of lateral erosion from 6/13/2017 to 5/7/2020. (Figures 6 & 7). Annual GPS top of bank measurements corroborate these results (Figure 5). The total average measured volume of soil/sediment loss due to erosion for this stream bank segment from 2017-2020 is 4,367ft<sup>3</sup>/year (162 yd<sup>3</sup>/year).

A small logjam just upstream from the survey site has been contributing to mid-channel and transverse bar development for years and creating a condition of elevated Near-Bank Shear Stress (NBSS). After all of the data analysis, a more thorough BEHI and NBSS investigation (2020), and utilizing the erosion prediction curves developed for the Illinois River Watershed, we have estimated that this bank will continue to erode at a rate of around 3.75 feet per year on average.

We are seeing evidence of the greatest amount of erosion migrating gradually downstream as this is a natural process described as down valley meander migration. As the area of greatest stress erodes a bit with each flood, the eroding bank slowly moves in an upstream to downstream direction. We observed areas on the most upstream portion of this cut bank to be fairly stable and starting to recolonize with vegetation, while the most active areas of erosion are on the downstream 1/3 of the study bank.

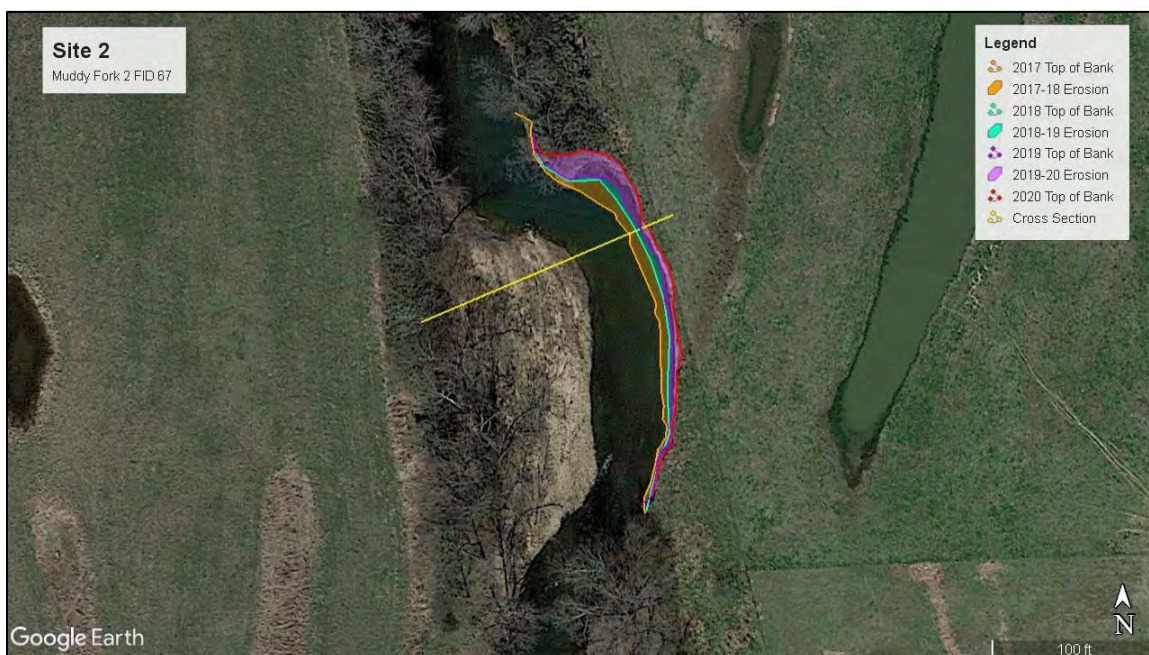
**Figure 8.** Planform view of Muddy Fork 2 FID 67 annual survey site. The creek flows generally South to North at this location. The orange shaded area represents the bank lost to erosion from 2017-2018, while the small light blue shaded area represents bank lost from 2018-2019, and the purple shaded area depicts land eroded from 2019-2020. Google Earth Imagery Date: 3/4/2020.

Based on the 2017, 2018, 2019, & 2020 cross-section surveys, the stream bank at this location moved an average of 3.92 feet laterally across the bank profile each year from 2017 to 2020 (Figures 9 & 10). Annual top of bank measurements corroborate these results. Immediately downstream of the cross section however, erosion rates are closer to 10 feet per year according to the annual top of bank measurements (Figure 8). The calculated average annual volume of soil/sediment loss due to erosion for this stream bank segment from 2017-2020 is 10,862 ft<sup>3</sup> (402 yd<sup>3</sup>).

Firstly, a streambank stabilization would remove a large polluter of sediment and nutrients into the Illinois River. Out of the 15 banks in our study, this site is eroding at the 5<sup>th</sup> highest rate. Additionally, this site has excellent potential to provide a large ecological uplift to this reach of stream. A large, deep pool exists at this location that could be stabilized with submerged woody debris or large rock, providing instream habitat for fish as well as mussels, including the endangered Neosho Mucket which historically inhabited this stretch of creek. Finally, a riparian corridor could be established that surrounds the two remnant channel scars up on the high floodplain. These channel scars do not often flood from the creek, but do hold water most of the year. Riparian wetlands like this are seemingly becoming more and more rare each year as development encroaches upon and impacts our streams and rivers.

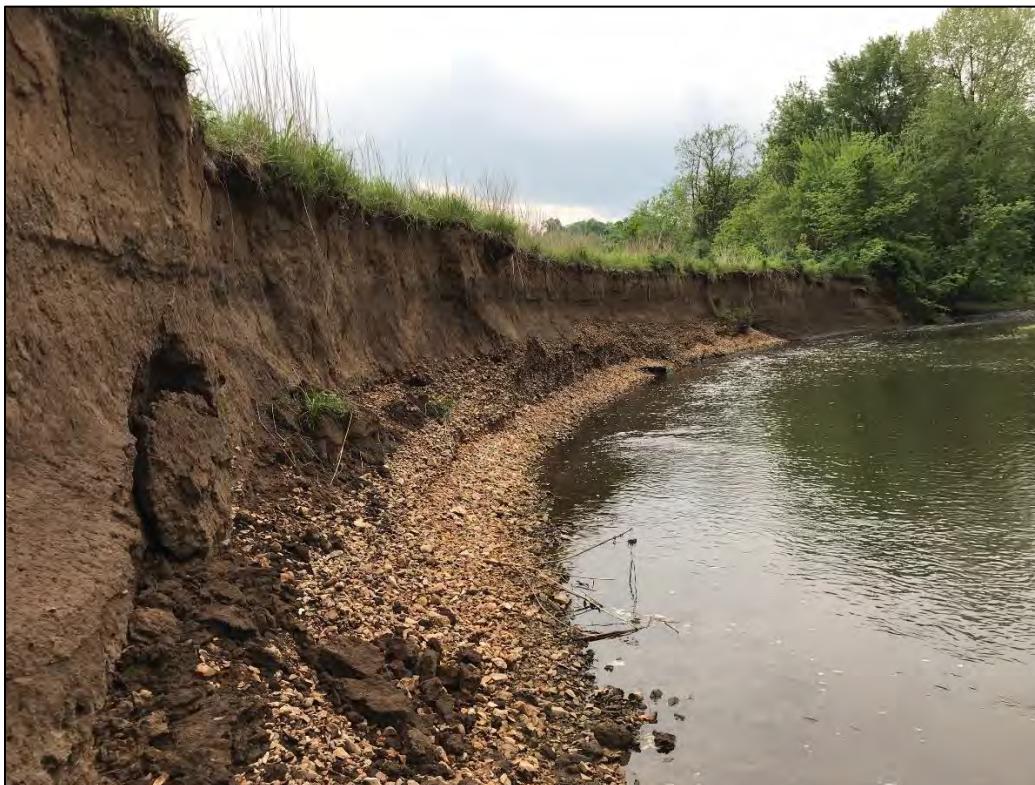
*Muddy Fork 2, FID 67 (2019) Actively eroding bank*

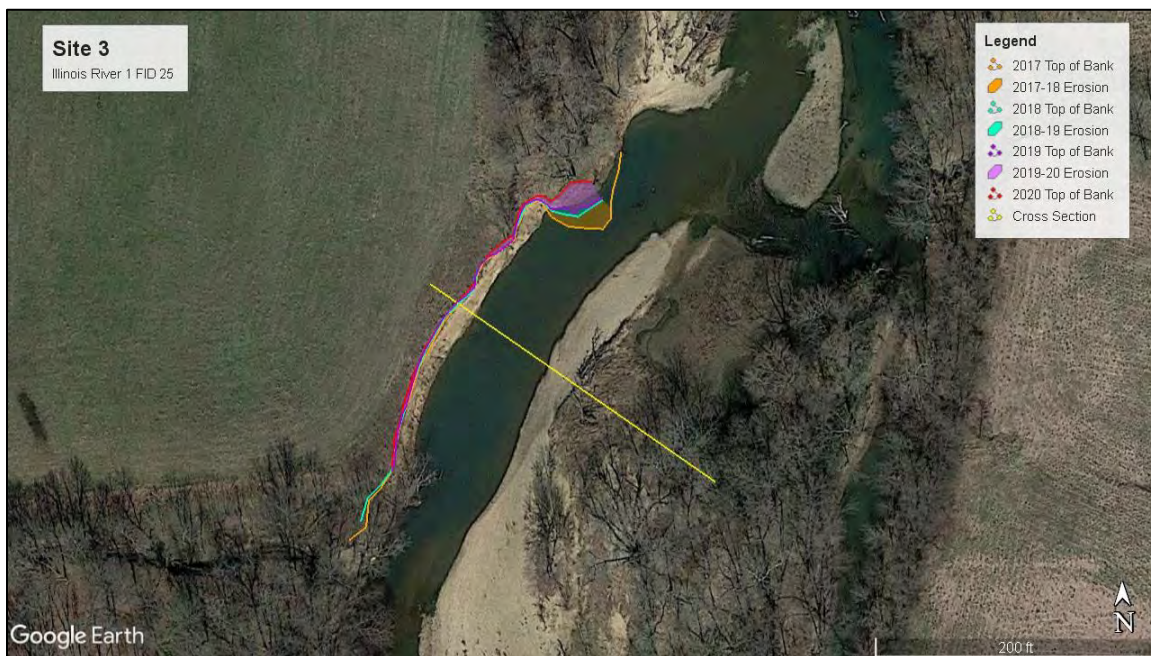
**Figure 11.** Planform view of Illinois River 1 FID 25 Permanent Survey Site. The orange shaded area represents bank lost to erosion from 2017-2018. The small light blue shaded area represents bank erosion from 2018-2019, and the purple shaded area depicts land lost to erosion from 2019-2020. Google Earth Imagery Date 3/4/2020).

Based on the 2017, 2018, 2019, & 2020 cross-section surveys, the stream bank at this location moved an average of 0.99 feet laterally across the bank profile annually (Figures 12 & 13). Annual top of bank measurements corroborate these results (Figure 11), although there is an area downstream of the cross section that has been experiencing much higher rates. The river has quickly been washing away a vegetated point that, until very recently, used to abruptly jut out into the river. It appears that much of the erosion relating to this flow obstruction may be complete, as the river now has developed a more natural flowpath along the bank. The average measured annual volume of soil/sediment loss due to erosion for this stream bank segment from 2017-2020 is 4,080 ft<sup>3</sup> (151 yd<sup>3</sup>).

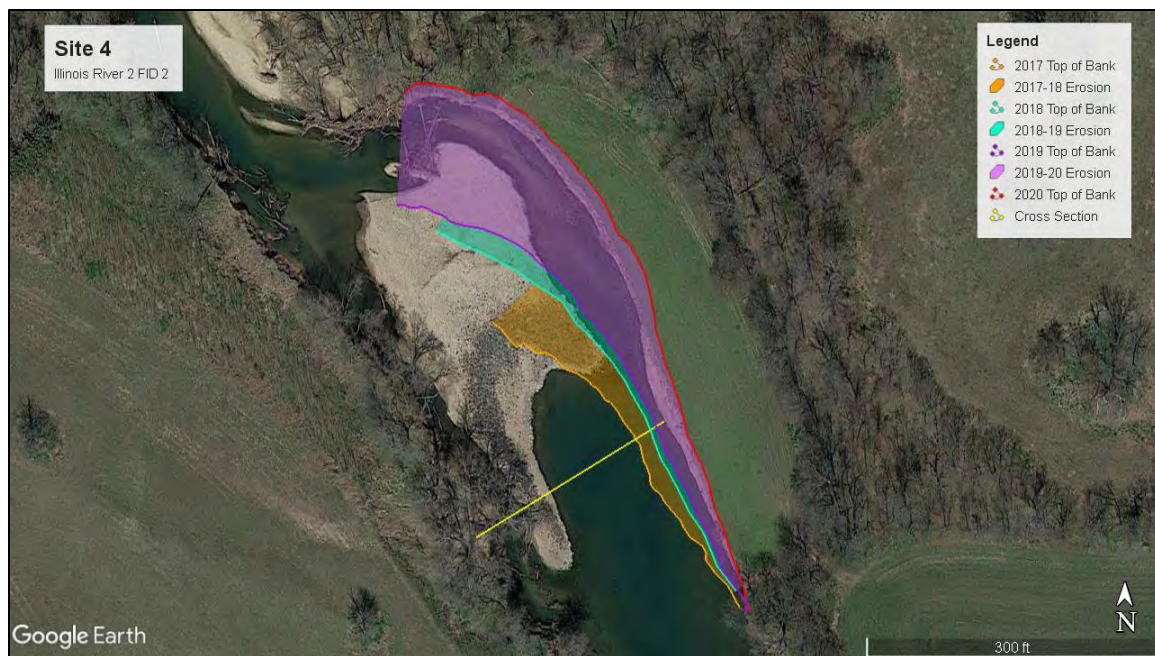
**Figure 14.** Planform view of Illinois River 2 FID 2 annual survey site. The river flows generally South to North at this location. The orange shaded area represents the bank/pasture lost to erosion from 2017-2018. The light blue shaded area represents widening of the river channel and land washed away from 2018-2019, while the purple shaded area depicts the river channel continuing to widen and a large area of eroded soil and grass that washed downstream from 2019-2020. Google Earth Imagery Date: 3/4/2020.

Based on the 2017, 2018, 2019, & 2020 cross-section surveys, the stream bank at this location moved an average of 18.06 feet laterally across the bank profile each year from 2017 to 2020 (Figures 15 & 16). Annual top of bank measurements corroborate these results (Figure 14), although the primary erosive force is continuing to migrate downstream of the cross section location. Annual top of bank measurements as well as

Google Earth aerial photography confirm that the river bank shaded in purple on Figure 12 above has eroded a staggering 135 ft laterally in just the last year alone (5/2019-5/2020). The average measured volume of soil loss due to bank erosion for the stream bank segment annually from 2017-2020 is 297,589 ft<sup>3</sup> (11,022 yd<sup>3</sup>). The total volume over the last year alone from May 2019-May 2020 is 621,262 ft<sup>3</sup> (23,010 yd<sup>3</sup>). To put that in perspective, **the volume of bank loss from this one site alone is nearly double of all of the other 14 study sites combined!**

Through natural erosive and depositional processes, a large quantity of loose shale once accumulated in the bed of the river at this location, just downstream of a large natural bedrock outcropping of relatively flaky shale in the Illinois River. Over some period of time, this shale had been transported some 200 feet downstream of the outcropping and had built up in layers and formed an unusual but relatively stable riffle that spanned the riverbed approximately 60 feet upstream of the current cross section location. This shale layering can be observed as a stable channel feature on Google Earth from the earliest aerial in 1994 all the way up to around 2009 when it appears that a mid-channel gravel bar had begun to form on top of the riffle, extending downstream for some ways directly in the center of the river channel.

Mid-channel bars are notorious for altering flows, and this bar can be witnessed splitting flow in two separate directions, directly towards either side of the channel causing elevated Near Bank Shear Stress (NBSS) on both the left and right bank. By interpreting the Google Earth aeriels it is apparent that, sometime after 2009 and before 2012, bank erosion started occurring immediately upstream and downstream of where the shale riffle met the right bank. This erosion is associated with very high NBSS caused by the formation of the small mid-channel bar that had begun to form around 2009. Only a very narrow riparian corridor was present at this location, as most of the land here was and still is maintained primarily as a hay field. By 2014 the shale riffle had become destabilized. It had migrated downstream approximately 30 feet from its previous location, and an extensive mid-channel gravel bar had formed extending for some ways downstream.

Regardless of the outcome of any further discussions regarding bats, we recommend immediate action. It is truly unknown how great and long-term of an effect this large-scale disturbance could have without professional intervention. A plan should be developed as soon as possible to restore this reach of river to a state of stability and equilibrium. This will not be an easy fix, but there really are countless benefits to undertaking an endeavor like this. We could spend the next 5 years restoring every eroding bank in this study and still not come close to realizing the potential sediment and nutrient reduction impact of this one project.

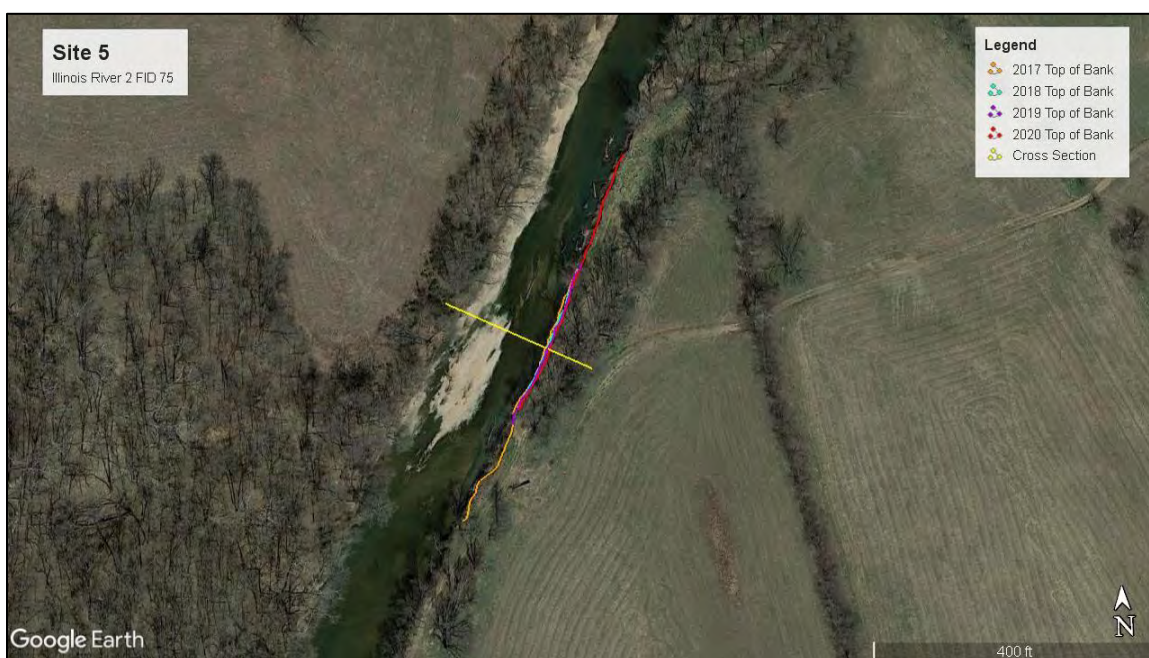
**Figure 17.** Planform view of Illinois River 2 FID 75 annual survey site. The river flows generally South to North at this location. The orange line represents the location of the study bank in 2017. 2018 is represented as a light blue line. The purple line depicts the top of bank location on the survey date in 2019, and the red line represents top of bank in 2020. All of the lines overlap slightly, indicating that the location of the top of bank has not moved tremendously through the 3-year study period. Google Earth Imagery Date: 3/4/2020.

Based on the 2017, 2018, 2019, & 2020 cross-section surveys, the stream bank at this location laterally moved an average of 1.88 feet annually (Figures 18 & 19). Annual top of bank measurements corroborate these results (Figure 17). The average measured volume of soil/sediment loss due to erosion for this stream bank segment from 2017-2020 is 4,713 ft<sup>3</sup> (175 yd<sup>3</sup>).

Based on the latest data and modeling, predict that the bank at this site will continue to erode at an average rate of 1.78 feet laterally per year. That estimate would put this site in the top half of study sites in regards to predicted erosion potential (ft/year). Our recommendation is to keep an eye on this site over the coming years and be aware that any significant growth or migration of the mid-channel gravel bar would indicate a corresponding increase in NBSS. Any efforts to maintain and enhance the riparian corridor onsite would also be helpful. There are several small riverside hay fields that could be taken out of hay production and a now-mow regimen introduced (while maintaining river access) to encourage forest re-growth and help ensure the long-term sustainability of this beautiful spot.

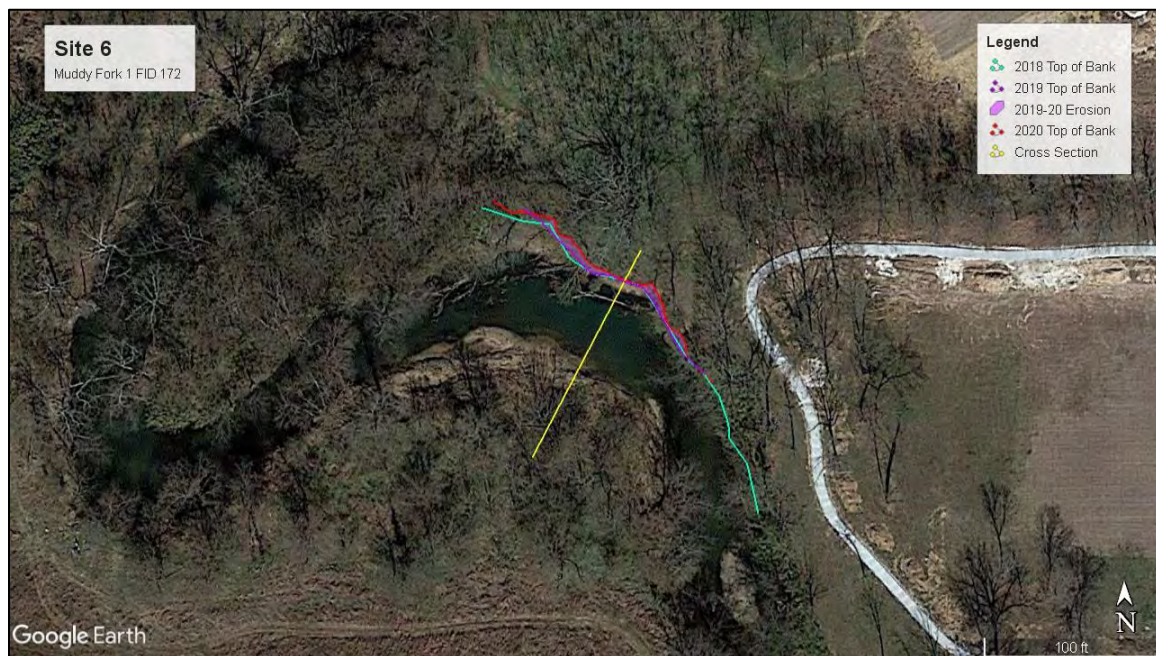
**Figure 20.** Planform view of Muddy Fork 1 FID 172 annual survey site. The light blue line indicates the target top of bank location in 2018. The purple line indicates the bank location in 2019, and the red line indicate the location of the top of bank during the most recent survey in 2020. Of note is that this area is experiencing rapid development in or very close to the active floodplain and riparian corridor of Muddy Fork. A paved trail that was not here in 2019 is clearly visible on this aerial as well as new building pads directly to the north of that trail. Google Earth Imagery Date: 3/4/2020.

Based on the 2018, 2019, & 2020 cross-section surveys, the stream bank at this location moved an average of 0.43 feet laterally across the bank profile each year (Figures 21 & 22). Annual top of bank measurements were inconclusive due to heavy canopy cover but generally corroborate these results. (Figure 20). The average measured volume of soil/sediment loss due to erosion for this stream bank segment annually from 2018-2020 is 5,060 ft<sup>3</sup> (187 yd<sup>3</sup>).

Based on modeling completed in 2020, it is estimated that the cut bank at this site will continue to erode at an average rate of only 0.33 feet laterally per year. This is one of the lowest measured and predicted erosion rates for any of the 15 sites in the study. Initially it may appear that there would be more erosion occurring at this site, given that the bank is nearly vertical, quite tall and has relatively little direct protection from roots and other vegetation. It is really the bank material here that is the key to those low observed and predicted erosion rates that we are reporting. This bank is comprised almost entirely of clay. Clay is generally resistant to erosion, and therefore a bank comprised of clay (unless it has layers of sand or gravel) will generally experience low rates of erosion.

The only recommendation that we have for this site is to potentially engage with Prairie Grove Parks staff to ensure that the riparian corridor along Muddy Fork is preserved as this place continues to develop into a popular park. In addition, developers appear to be encroaching very close to the floodplain from the East of this location. There is a large tract of relatively wild land on the West side of the creek that appears to be active floodplain. From the historical aerial photos, you can see that this area was once maybe a hay or sod farm, but it appears to have laid fallow for some time now. Ensuring that low-lying properties like this do not get filled or unsustainably developed is important for preventing long-term channel instability and is also great for natural flood retention and mitigation downstream.

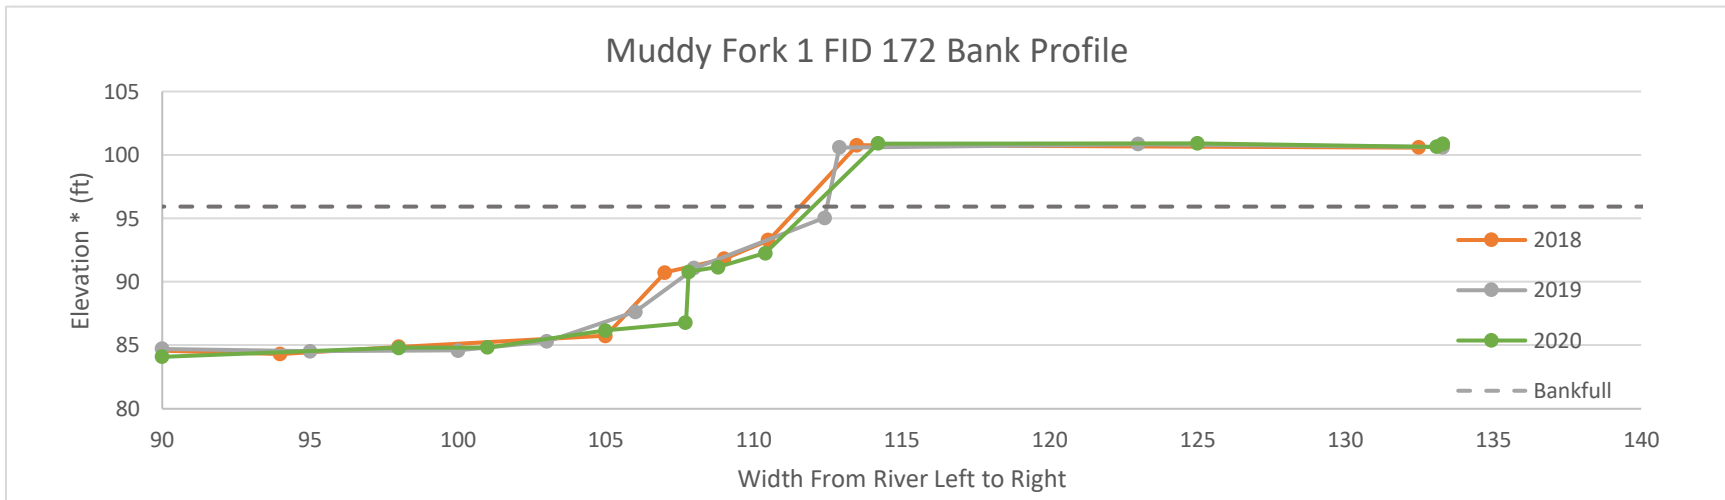
**Figure 22.** Site 6 Bank Profile. Measurements taken 5/15/2018, 5/15/2019, & 5/6/2020. (Bankfull height: 95.93 ft) \*Elevations not georeferenced

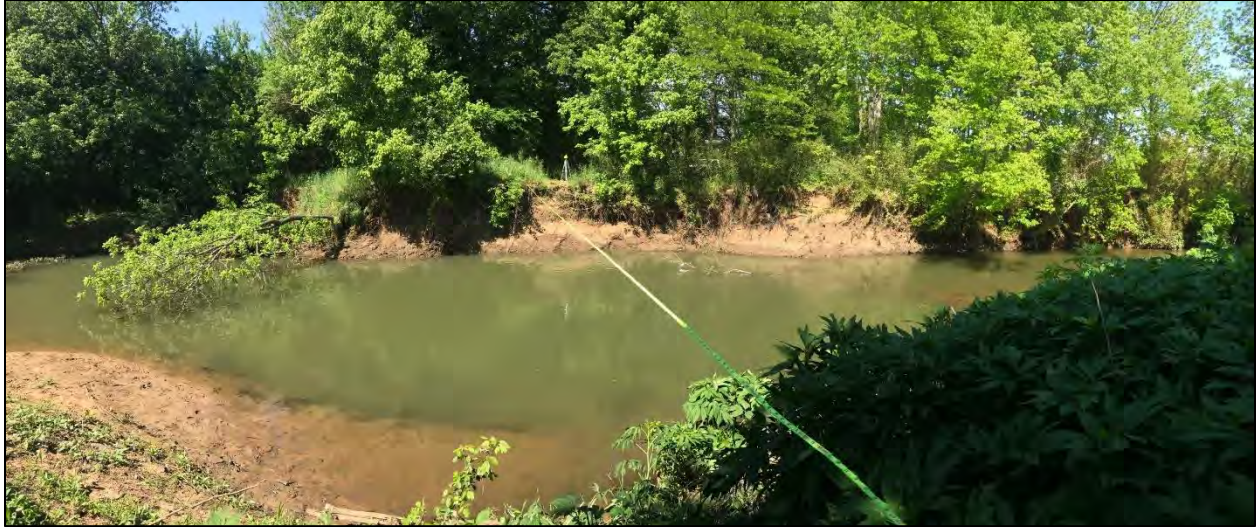
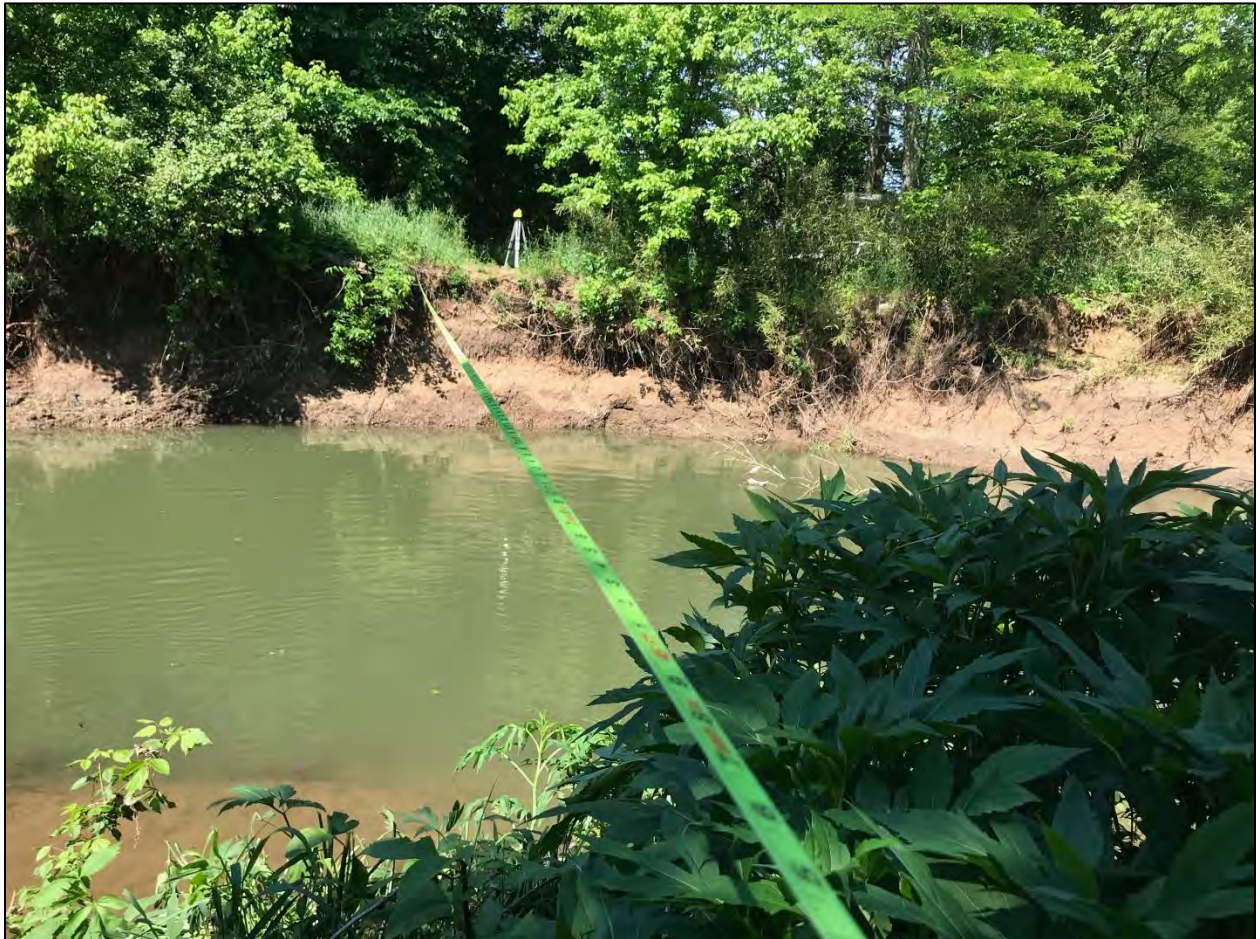
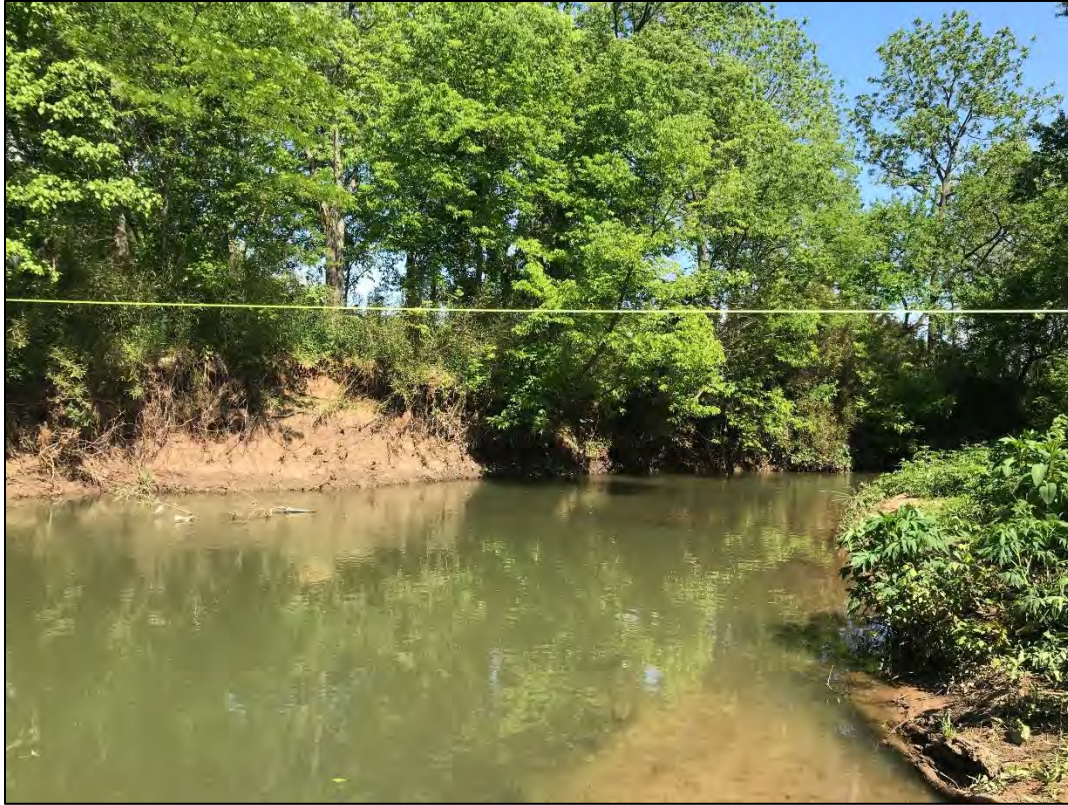
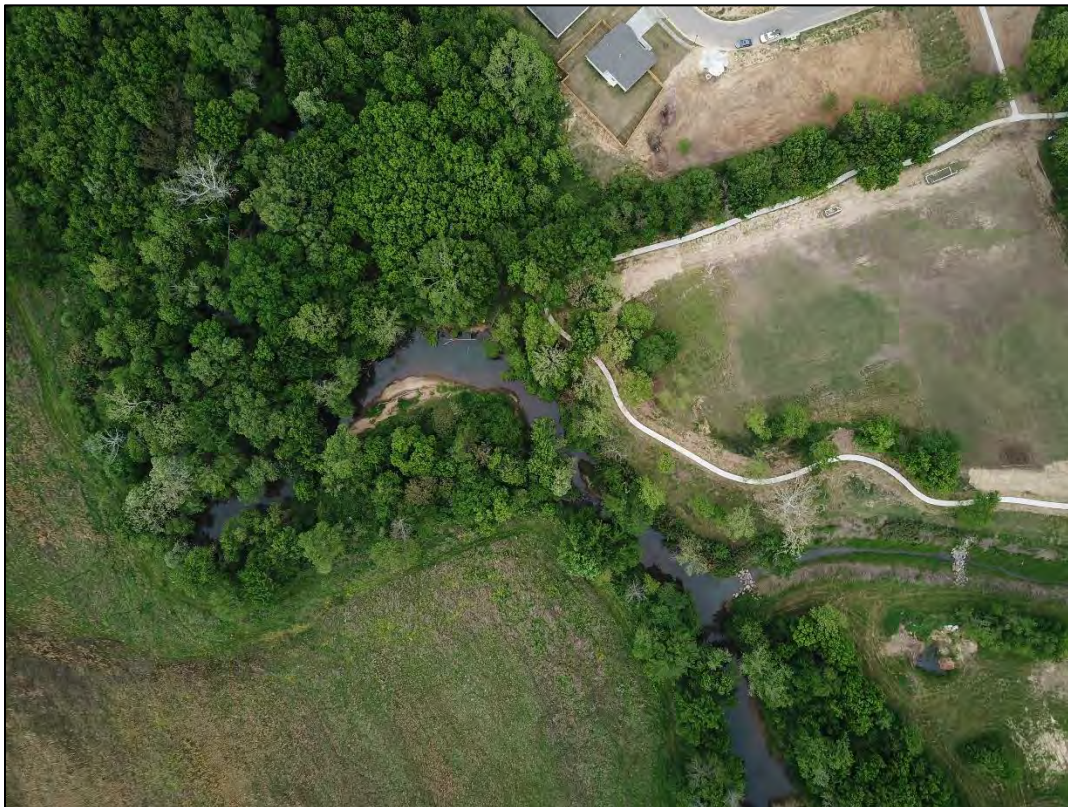
Site 6 Photos

*Muddy Fork 1 FID 172 (2019) Critical Bank View*

*Muddy Fork 1 FID 172 (2019) Cross Section View*

*Muddy Fork 1 FID 172 (2019) Upstream View*

*Muddy Fork 1, FID 172 Aerial View (2020)*

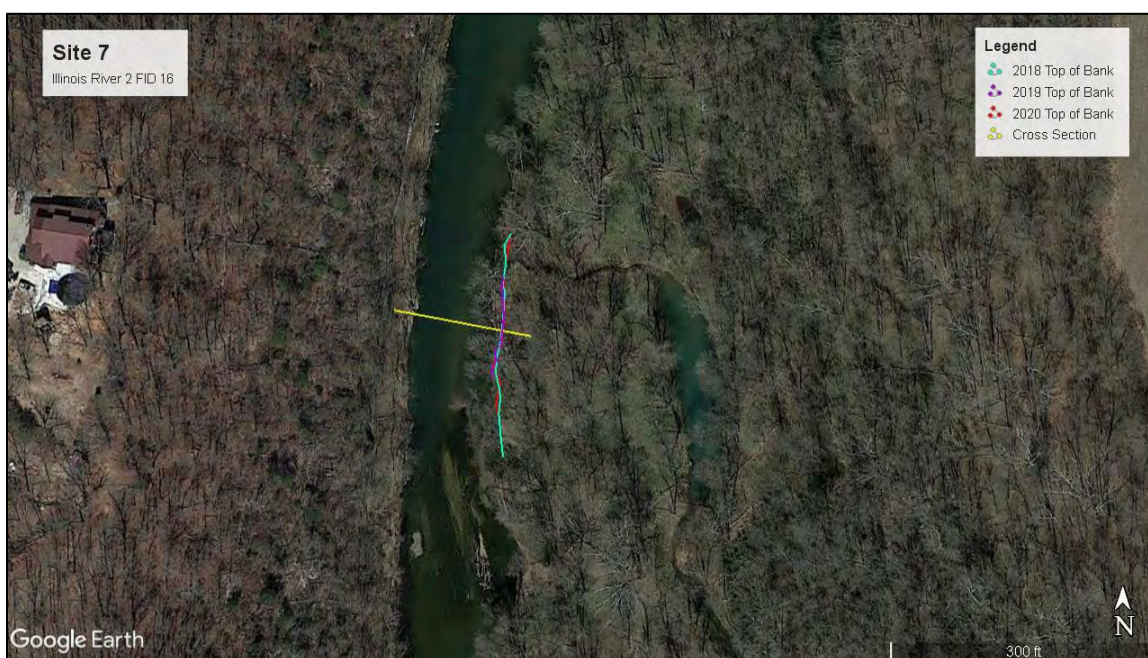
**Figure 23.** Planform view of Illinois River 2 FID 16 annual survey site. The light blue line represents the location of the study bank in 2018. The purple line depicts the top of bank location on the survey date in 2019, and the red line represents top of bank in 2020. The annual top of bank lines appear to overlap at this scale, indicating that the bank has not moved tremendously through the 2-year study period. Also of note is the mature and healthy riparian corridor and unique oxbow wetland/lake few by a small tributary within the floodplain adjacent to the river. Google Earth Imagery Date: 3/4/2020.

Based on the 2018, 2019, & 2020 cross-section surveys, the stream bank at this location moved an average of 0.23 feet laterally per year from 2018-2020 (Figures 24 & 25). Annual top of bank measurements were inconclusive due to the heavy canopy cover but generally corroborate these results (Figure 23). The average annual measured volume of soil/sediment loss due to erosion for this stream bank segment from 2018-2020 is 893 ft<sup>3</sup> (33.1 yd<sup>3</sup>).

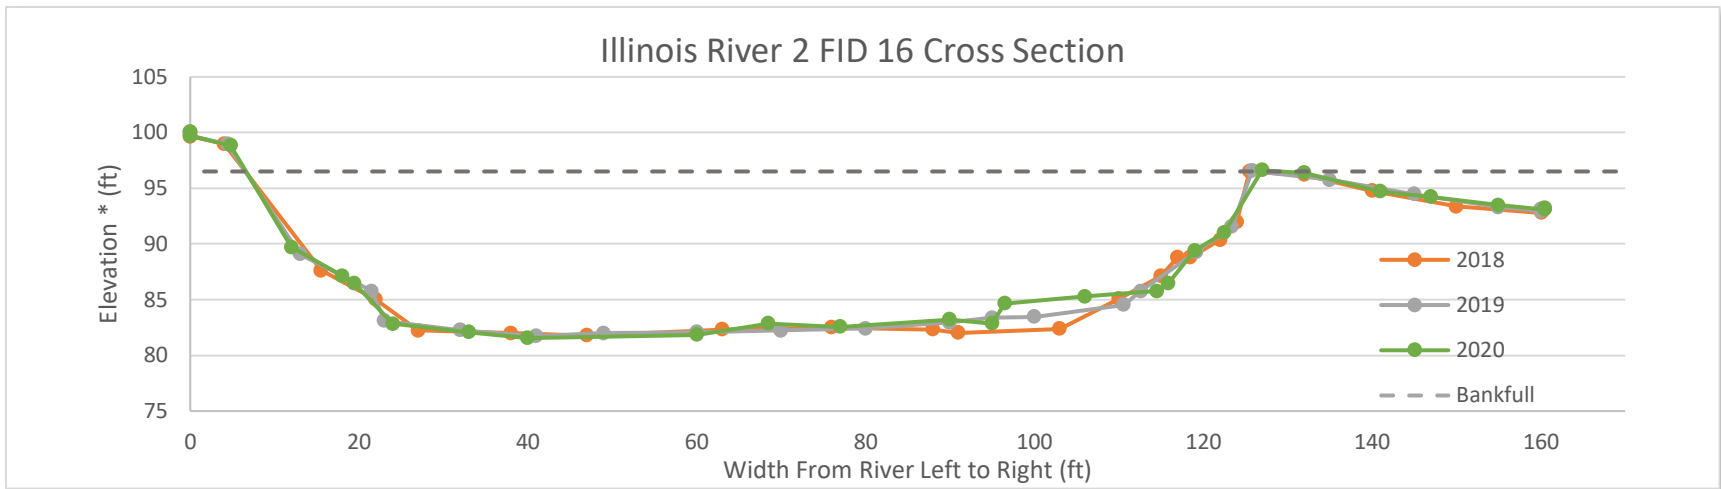
**Figure 24.** Site 7 Cross Section. Measurements taken 6/5/2018, 5/16/2019, & 5/13/2020. (Bankfull height: 96.51 ft) \*Elevations not georeferenced

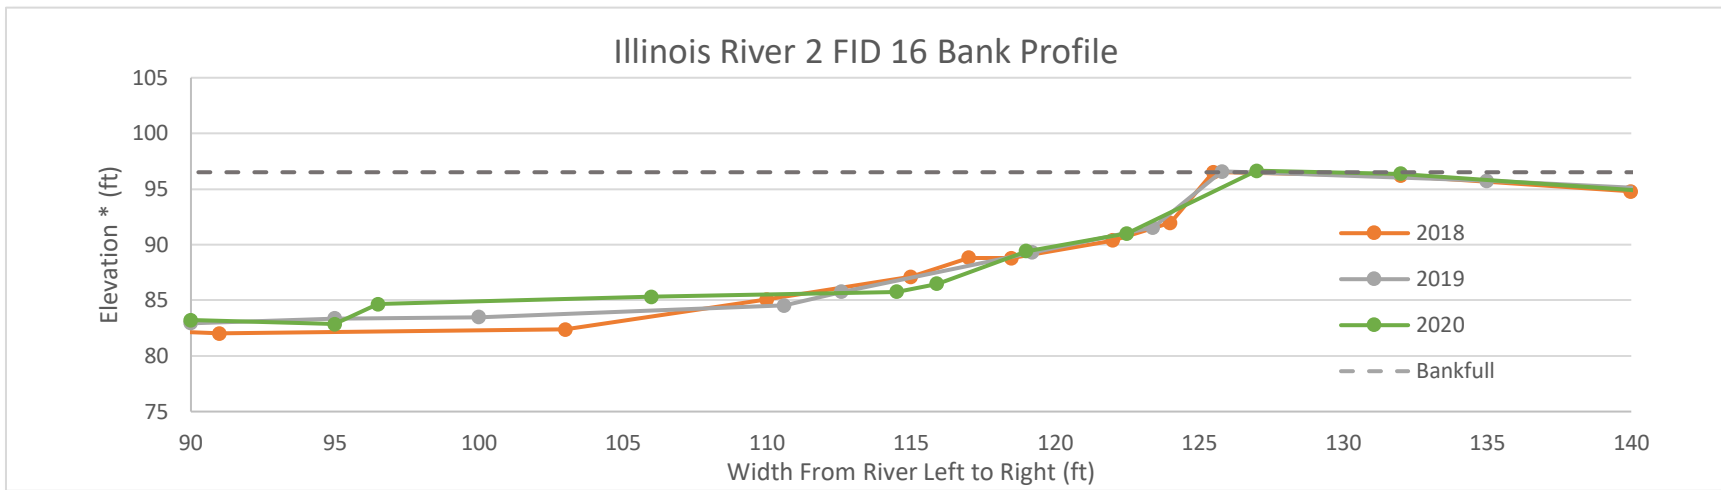
**Figure 25.** Site 7 Bank Profile. Measurements taken 6/5/2018, 5/16/2019, & 5/13/2020. (Bankfull height: 96.51 ft) \*Elevations not georeferenced

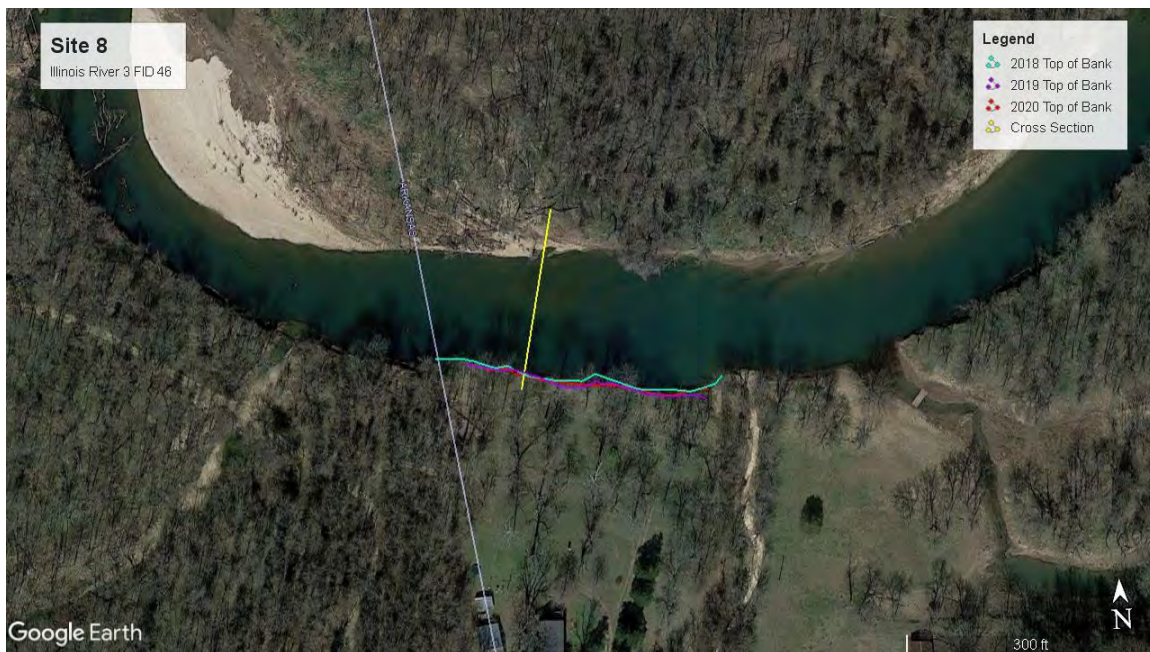
**Figure 26.** Planform view of Illinois River 3 FID 46 annual survey site. Illinois River flows generally East to West at this location. The light blue line represents the location of the study bank in 2018, while the purple line and red lines depict the top of bank location on the survey dates in 2019 and 2020 respectively. Google Earth Imagery Date: 3/4/2020.

Based on the analysis of 2018, 2019, & 2020 cross-section surveys, it has been determined that the stream bank at this location moved an average of 1.83 feet laterally across the bank profile each year from 2018 to 2020 (Figures 27 & 28). Annual top of bank measurements were inconclusive due to heavy canopy cover but generally corroborate these results. (Figure 26). The average annual measured volume of soil/sediment loss due to erosion for this stream bank segment from 2018-2020 is 11,422 ft<sup>3</sup> (423 yd<sup>3</sup>).

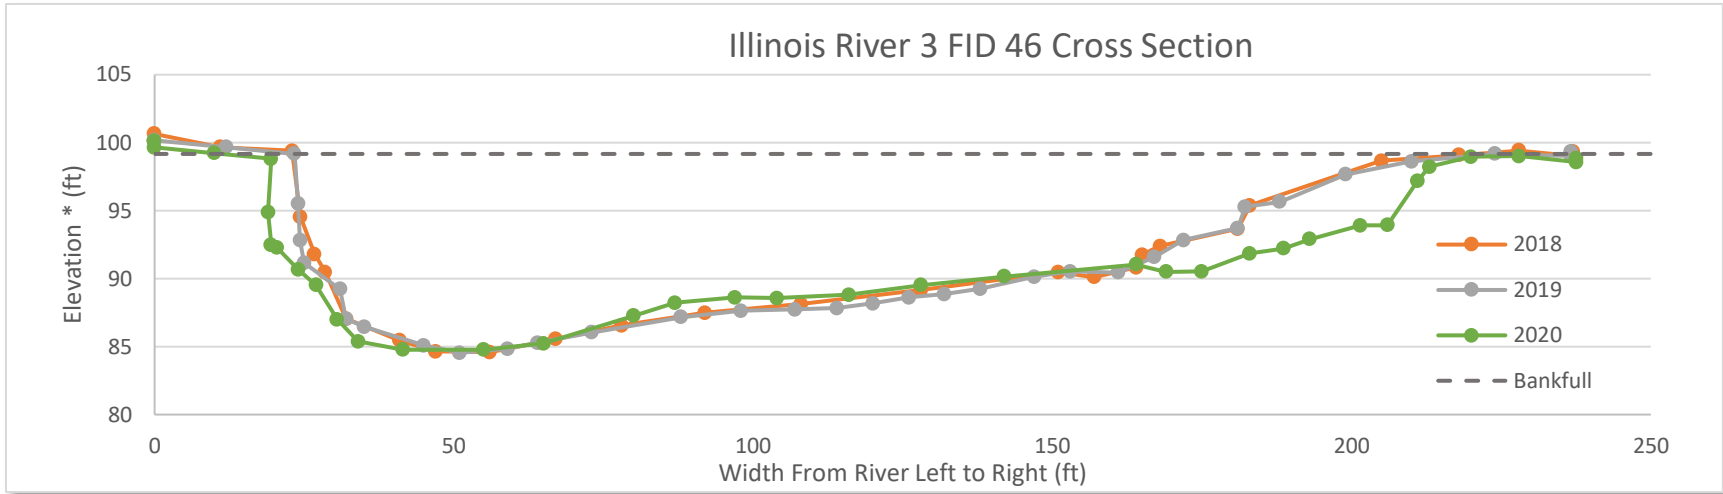
Updated modeling based on analysis of 2017-2020 Illinois River field data yields a predicted estimate of 1.65 feet of annual lateral bank erosion for this site. Both the observed rates and predicted rates are about middle of the pack in relation to the other 14 study sites. Looking at the cross section graph (Figure 27), you can observe that both the left and right bank scoured during the 2019-2020 survey period. This is interesting, because generally there will be aggradation/deposition that occurs on the inside bend (point bar) while corresponding degradation/erosion occurs on the outside bank (cut bank).

It takes an especially large and more infrequent flood event to generate sufficient water velocity in the channel to remobilize this deposition and flush it downstream and through the backwater zone. This site experienced relatively low water and only one flood event (1.65 x BKF discharge) during the 2018-2019 study year whereas during the 2019 to 2020 study year this same site experienced ten flood events, one of which was quite large (5.16 x BKF discharge), a magnitude event that generally only happens once every 3-4 years. This was likely the flood event that washed away this the sandy depositional bar and caused degradation on the inside bend of the pool (Figure 27).

**Figure 27.** Site 8 Cross Section. Measurements taken 5/23/2018, 5/15/2019, & 5/14/2020. (Bankfull height: 99.17 ft) \*Elevations not georeferenced

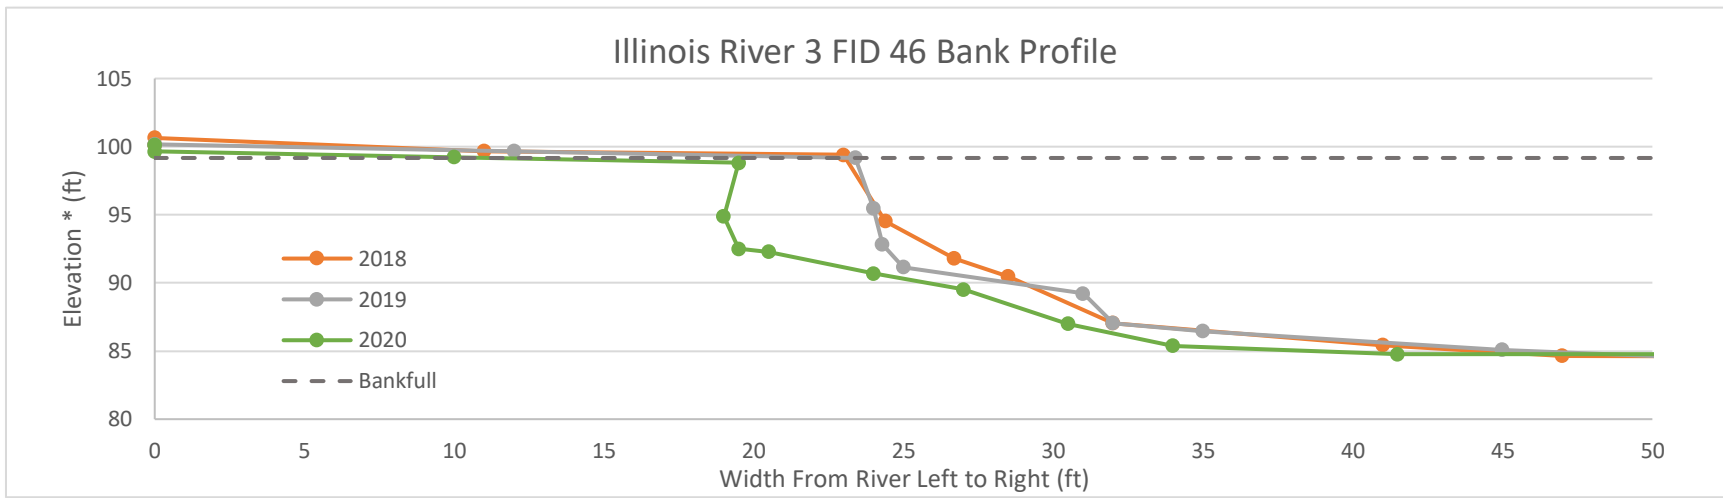
**Figure 28.** Site 8 Bank Profile. Measurements taken 5/23/2018, 5/15/2019, & 5/14/2020. (Bankfull height: 99.17 ft) \*Elevations not georeferenced

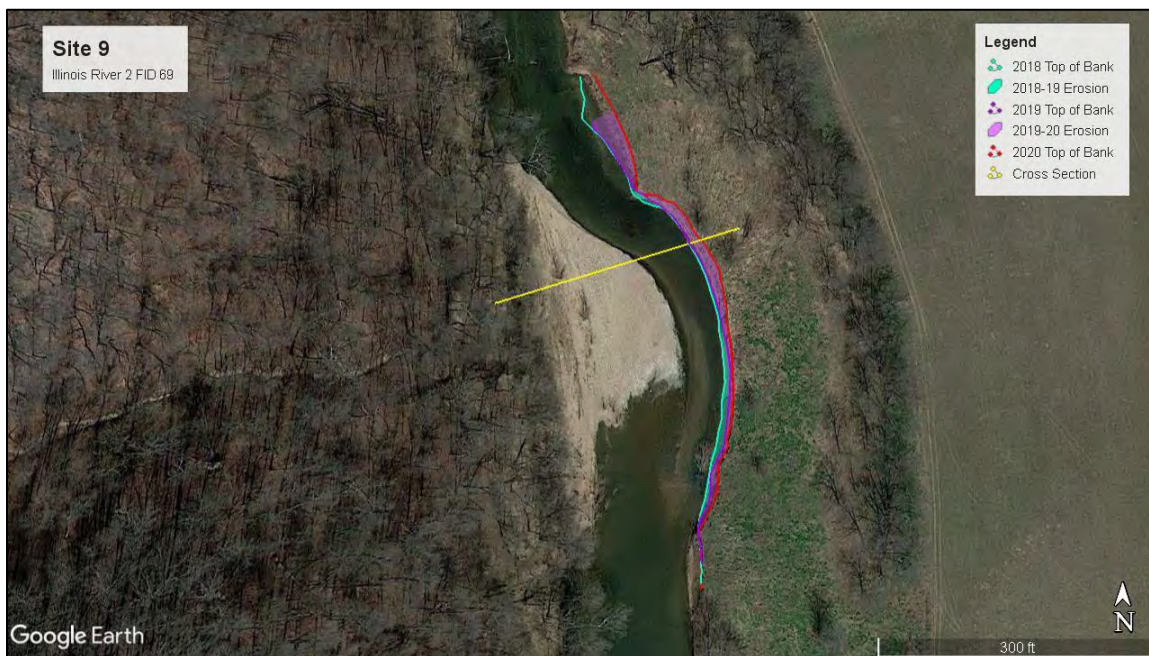
**Figure 29.** Planform view of Illinois River 2 FID 69 Permanent Survey Site. The small area shaded in light blue represents erosion that took place from 2018 to 2019, while the relatively larger area shaded in purple depicts bank erosion from 2019 to 2020. Google earth Imagery Date: 3/4/2020.

Based on the 2018, 2019, & 2020 cross-section surveys, the stream bank at this location is moving an average of 8.23 feet laterally across the bank profile per year (Figures 30 & 31). Annual top of bank measurements also support these results. (Figure 29). The average measured volume of soil/sediment loss due to erosion for this stream bank segment annually from 2018-2020 is 49,700 ft<sup>3</sup> (1,841 yd<sup>3</sup>).

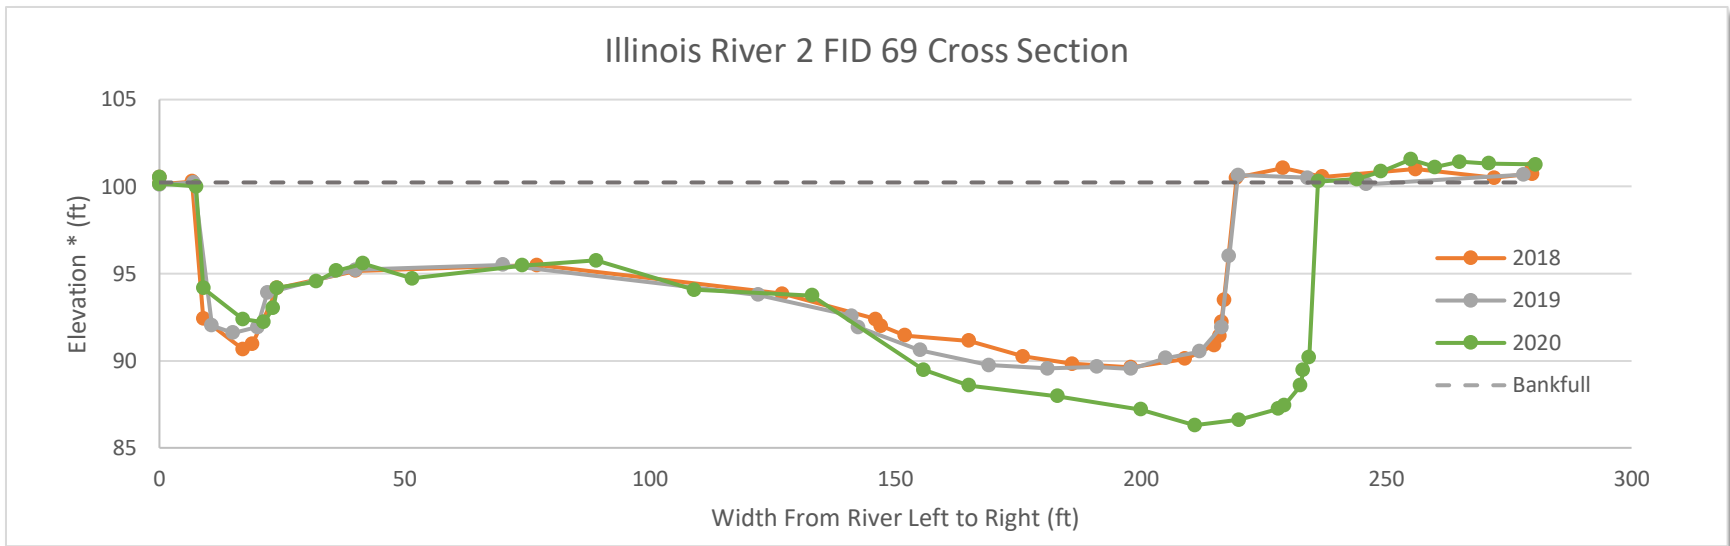
**Figure 30.** Site 9 Cross Section. Measurements taken 5/24/2018, 5/16/2019, & 5/13/2020. (Bankfull height: 100.24 ft) \*Elevations not georeferenced

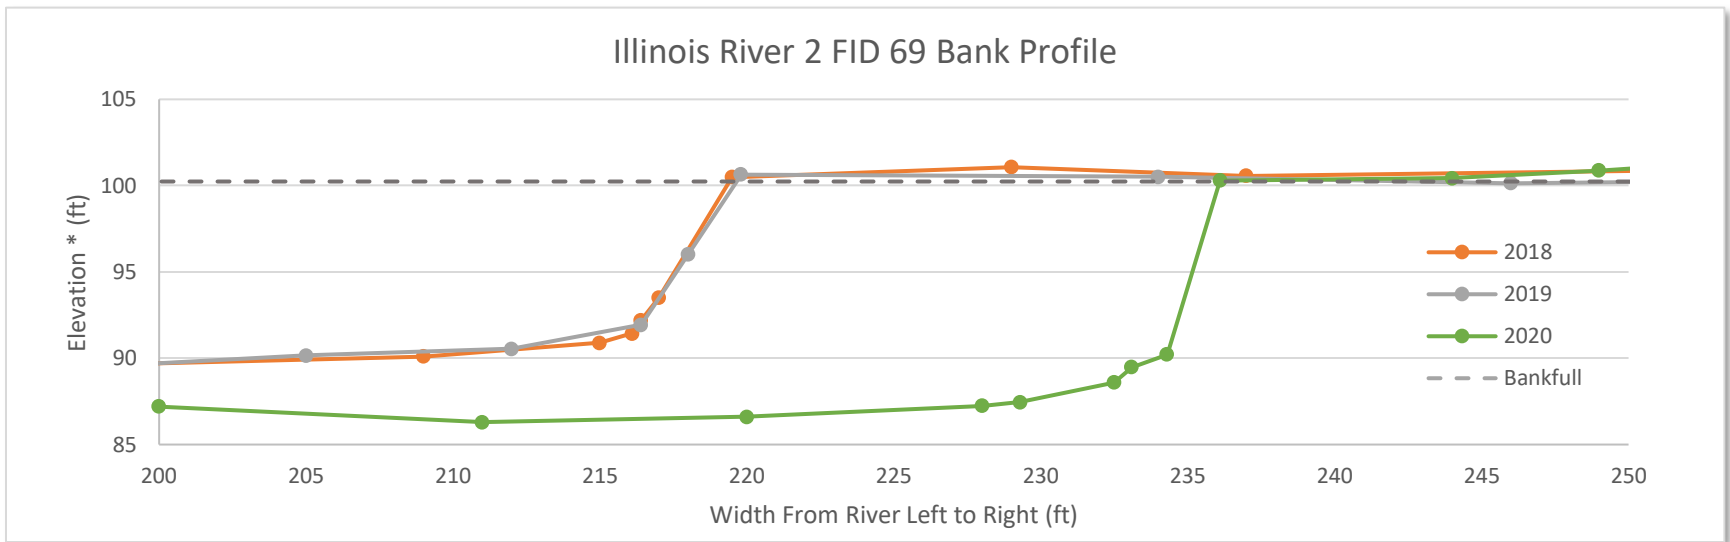
**Figure 31.** Site 9 Bank Profile. Measurements taken 5/24/2018, 5/16/2019, & 5/13/2020. (Bankfull height: 100.24 ft) \*Elevations not georeferenced
