# Illinois River and Tributaries: Streambank Erosion Sites and Analysis 2020 Report

Prepared by Natural State Streams LLC for The Illinois River Watershed Partnership, September 2021

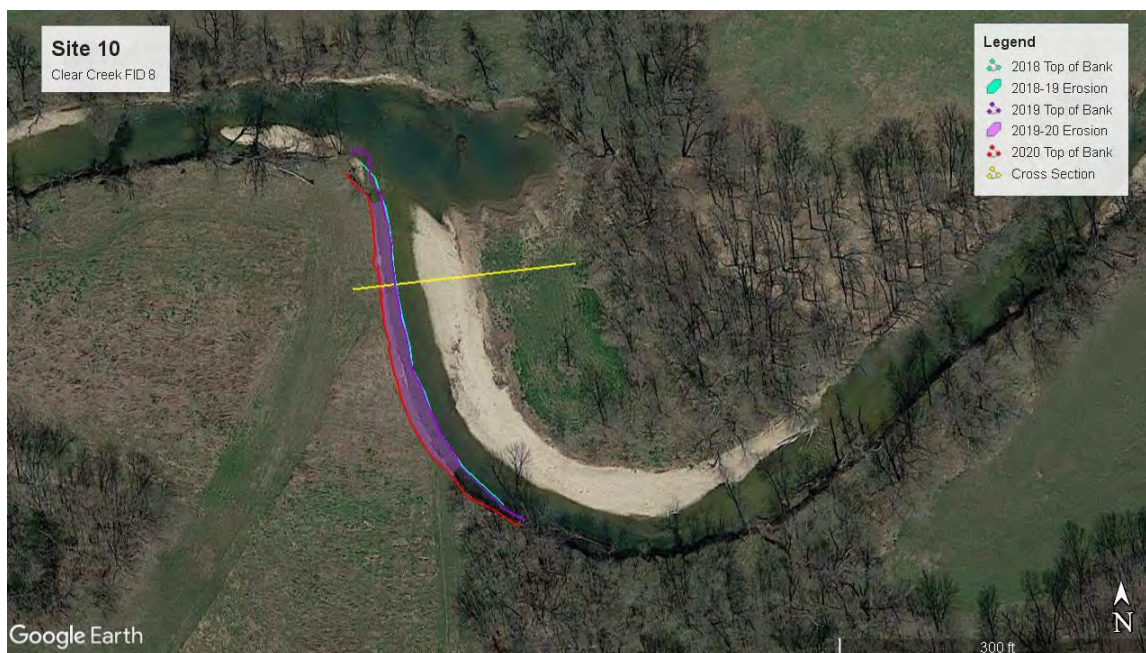
**Figure 32.** Planform view of Clear Creek FID 8 annual survey site. The area shaded in light blue the location of bank erosion that occurred between the 2018 and 2019 survey dates. The area shaded in purple is bank lost during the time period between 2019 and 2020. Google Earth Imagery Date: 3/4/2020.

Based on the 2018, 2019, & 2020 cross-section surveys, the stream bank at this location moved an average of 7.27 feet laterally across the bank profile annually throughout the study period (Figures 33 & 34). Annual top of bank measurements also support these results. (Figure 32). The average annual measured volume of soil/sediment loss due to erosion for this stream bank segment from 2018-2020 is 25,069 ft<sup>3</sup> (928 yd<sup>3</sup>).

Any serious restoration plan for this site is going to recommend hardening the toe of the bank with a combination of wood and/or rock as well as sloping, matting and replanting the bank with native vegetation. This is a site that is going to continue to experience very high stresses, so the restoration approach needs to be very resilient to that. Changes in both the hydrologic regime due to the headwaters encompassing large parts of the city of Fayetteville as well as the sediment regime due to all of the extensive bank erosion occurring along the creek make this a unique challenge. This could be a great demonstration project, however, with a high likelihood of success. The approaches utilized here could be replicated elsewhere along Clear Creek, serving as a demonstration site which also addresses a bank that is known to have been contributing a very large volume of sediment and nutrients downstream and eventually into the Illinois River.

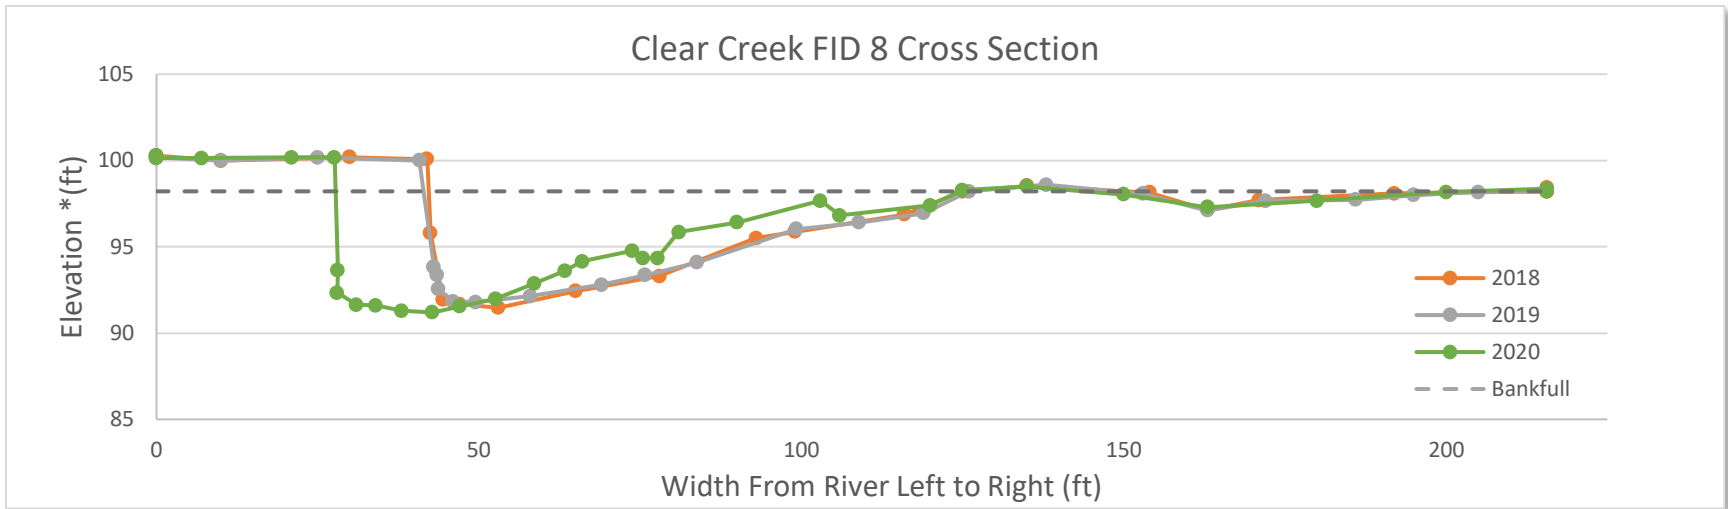
**Figure 33.** Site 10 Cross Section. Measurements taken 5/23/2018, 4/29/2019, & 5/11/2020. (Bankfull height: 98.21 ft) \*Elevations not georeferenced

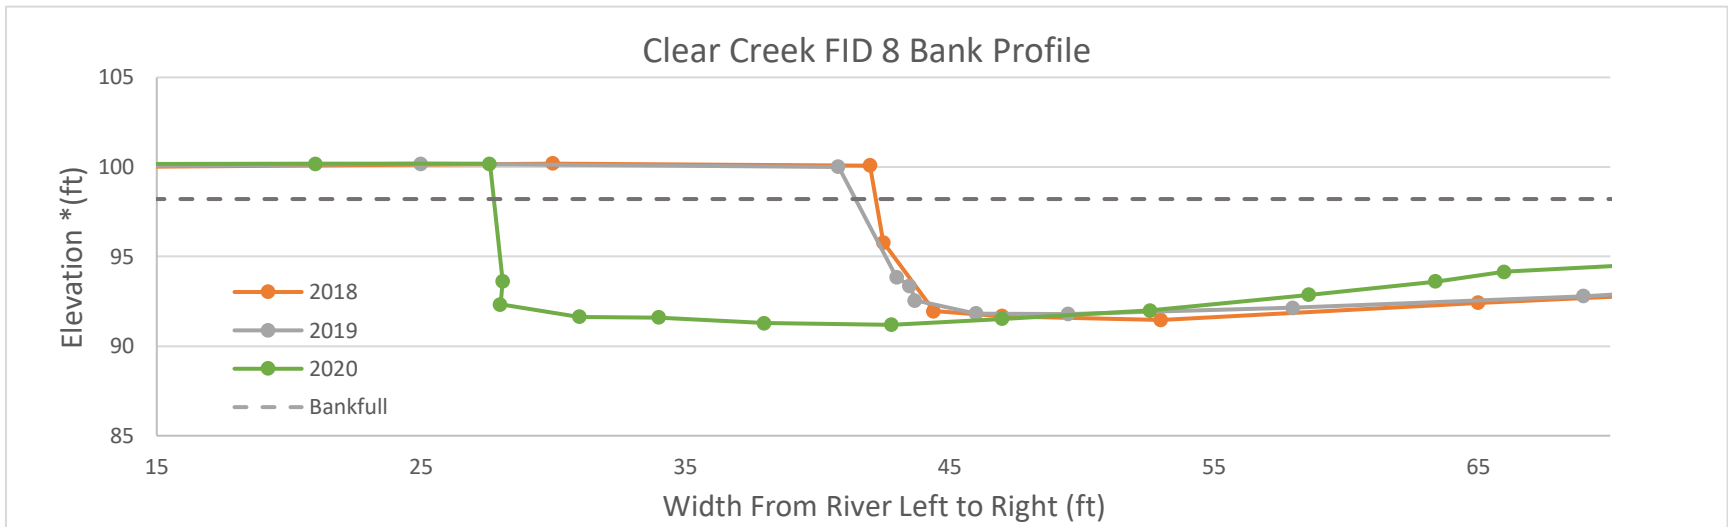
**Figure 34.** Site 10 Bank Profile. Measurements taken 5/23/2018, 4/29/2019, & 5/11/2020. (Bankfull height: 98.21 ft) \*Elevations not georeferenced

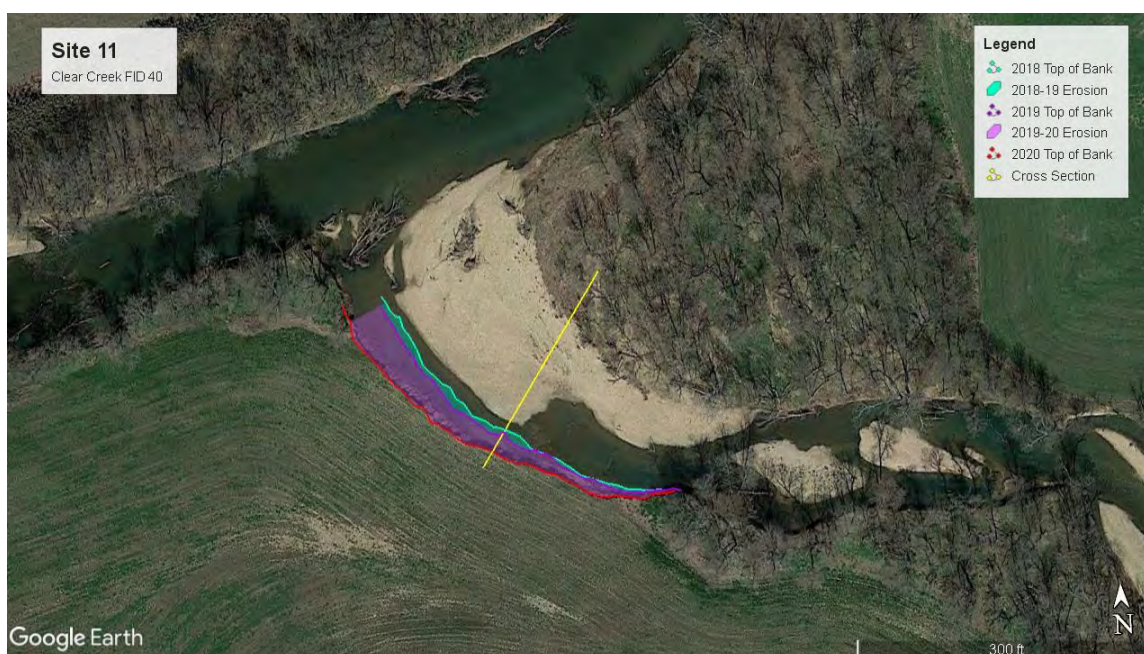
**Figure 35.** Planform view of Clear Creek FID 40 annual survey site. Clear Creek flows in from east to west and confluences with the Illinois River immediately downstream of the study bank. The area shaded in light blue represents stream bank erosion that took place on Clear Creek from 2018-2019, while the area shaded in purple depicts erosion that occurred from 2019-2020. Google Earth Imagery Date: 3/4/2020.

Based on detailed measurements collected in 2018, 2019, & 2020 at the cross section location, we have determined that the stream bank at this location moved each year an average of 11.51 feet laterally across the bank profile from 2018 to 2020 (Figures 36 & 37). Annual top of bank measurements corroborate these results. (Figure 35). The average measured volume of soil/sediment lost annually due to erosion for this stream bank segment from 2018-2020 is 45,879 ft<sup>3</sup> (1,699 yd<sup>3</sup>).

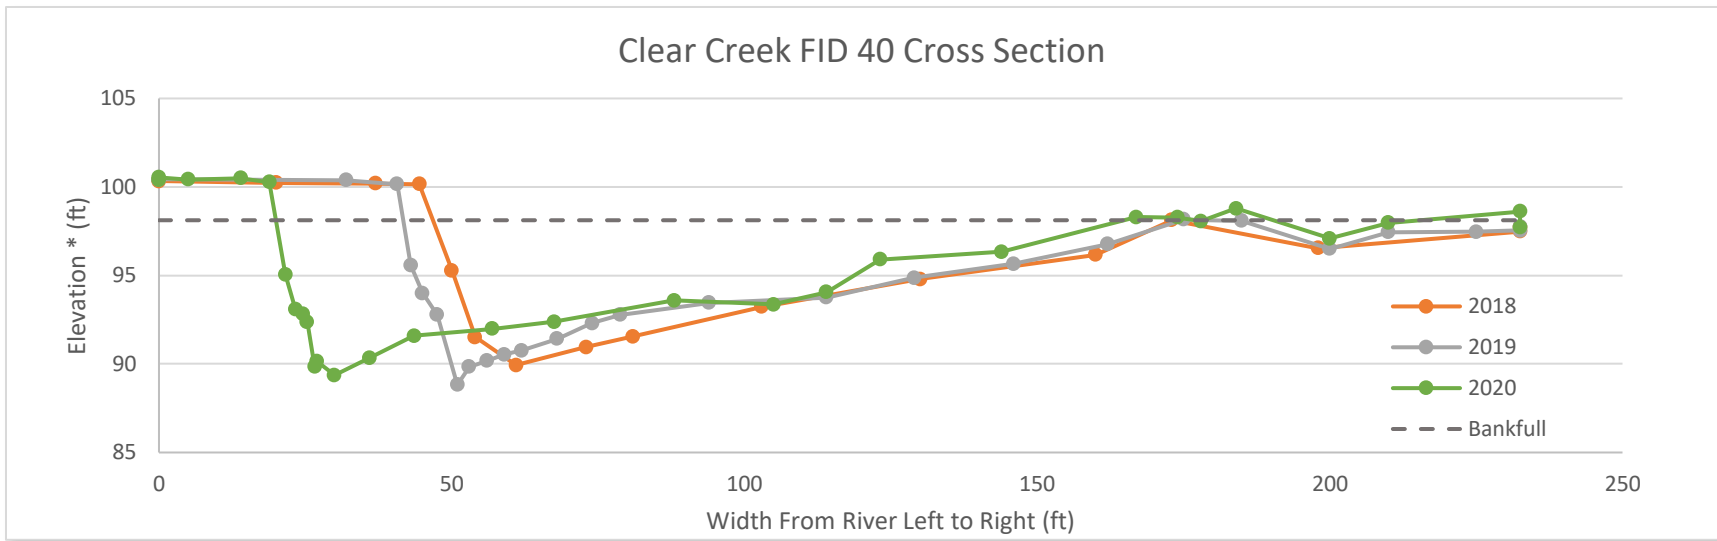
**Figure 36.** Site 11 Cross Section. Measurements taken 6/5/2018, 5/14/2019, & 5/11/2020. (Bankfull height: 98.12 ft) \*Elevations not georeferenced

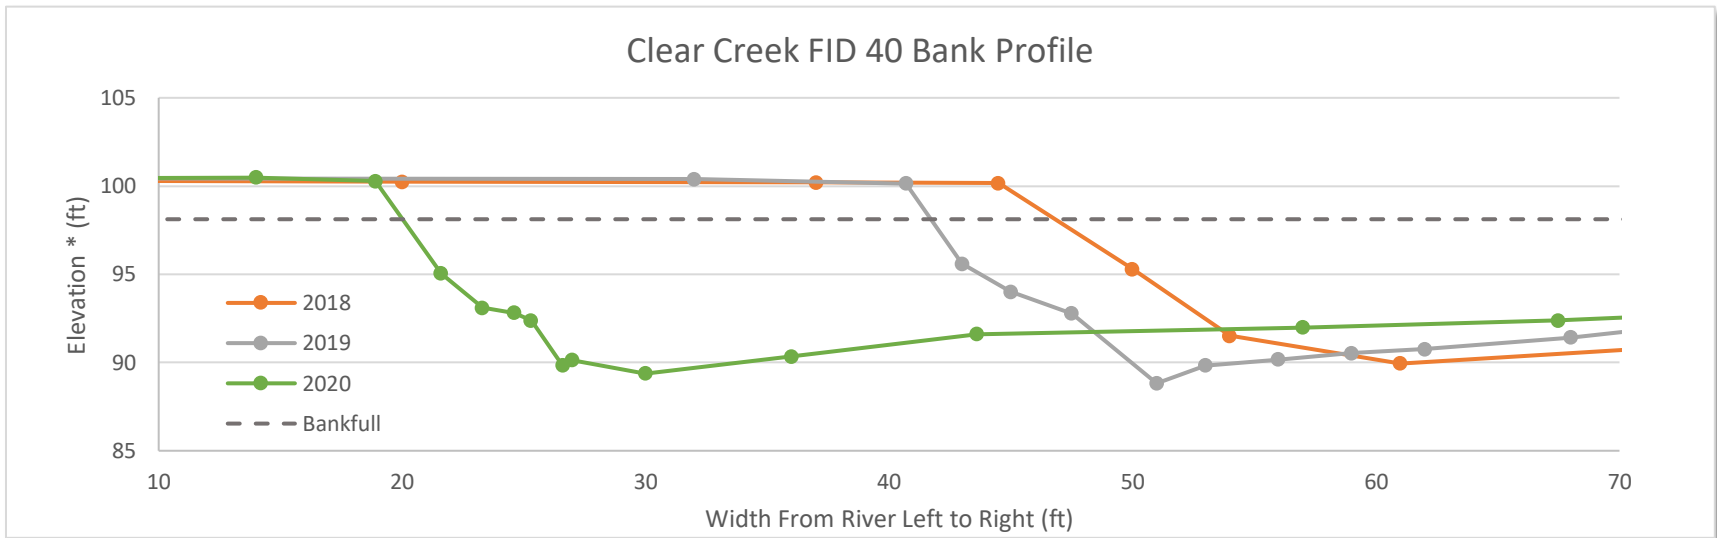
**Figure 37.** Site 11 Bank Profile. Measurements taken 6/5/2018, 5/14/2019, & 5/11/2020. (Bankfull height: 98.12 ft) \*Elevations not georeferenced

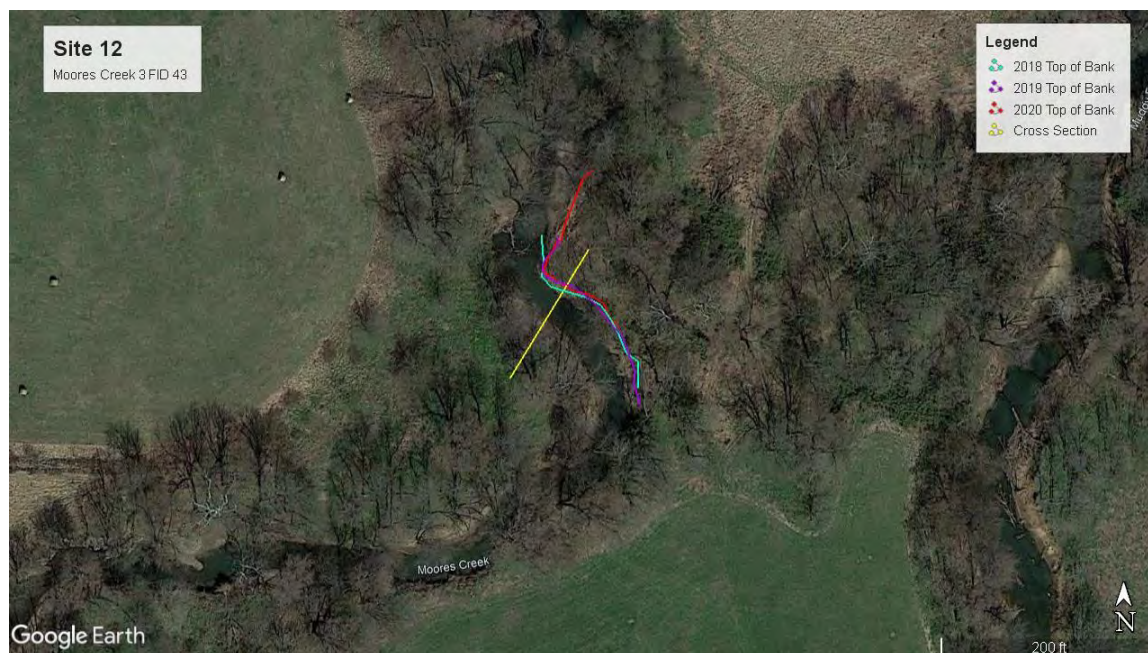
**Figure 38.** Planform view of Moores 3 Creek FID 43 annual survey site. The light blue line represents the location of the study bank in 2018. The purple line depicts the top of bank location on the survey date in 2019, and the red line represents top of bank in 2020. The annual top of bank lines appear to overlap at this scale, indicating that the bank has not moved tremendously through the 2-year study period. Google Earth Imagery Date: 3/4/2020.

Based on the 2018, 2019, & 2020 cross-section surveys, the stream bank at this location eroded an average of 0.27 feet laterally across the bank profile annually (Figures 39 & 40). Annual top of bank measurements were inconclusive due to heavy canopy cover but generally corroborate these results. (Figure 38). The average measured volume of soil/sediment loss due to erosion for this stream bank segment from 2018-2020 is 371 ft<sup>3</sup> (13.7 yd<sup>3</sup>).

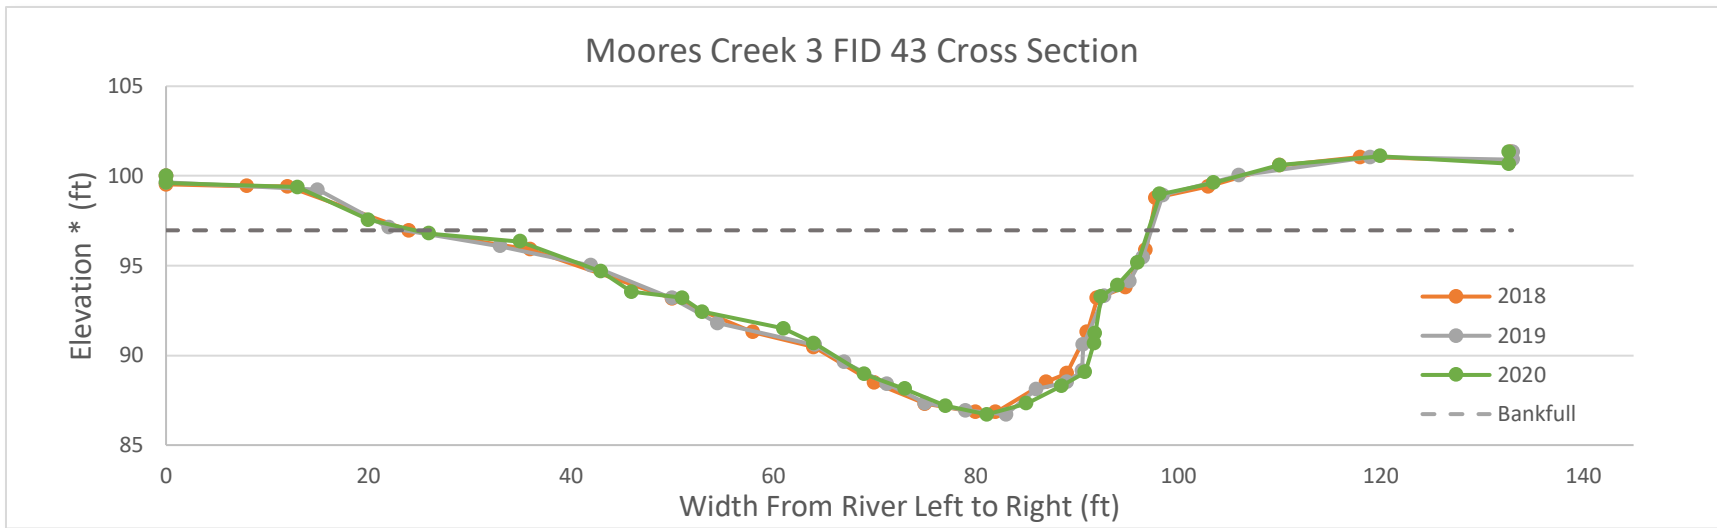
**Figure 39.** Site 12 Cross Section. Measurements taken 5/17/2018, 4/30/2019, & 5/7/2020. (Bankfull height: 96.97 ft) \*Elevations not georeferenced

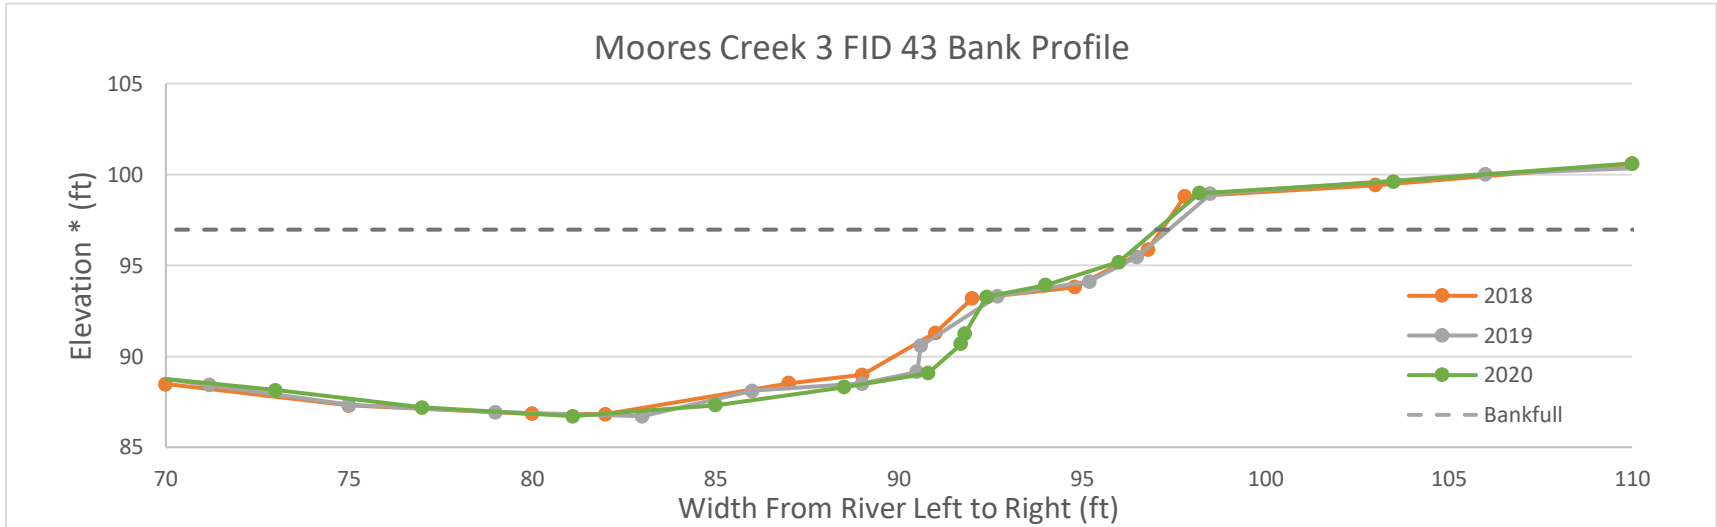
**Figure 40.** Site 12 Bank Profile. Measurements taken 5/17/2018, 4/30/2019, & 5/7/2020. (Bankfull height: 96.97 ft) \*Elevations not georeferenced

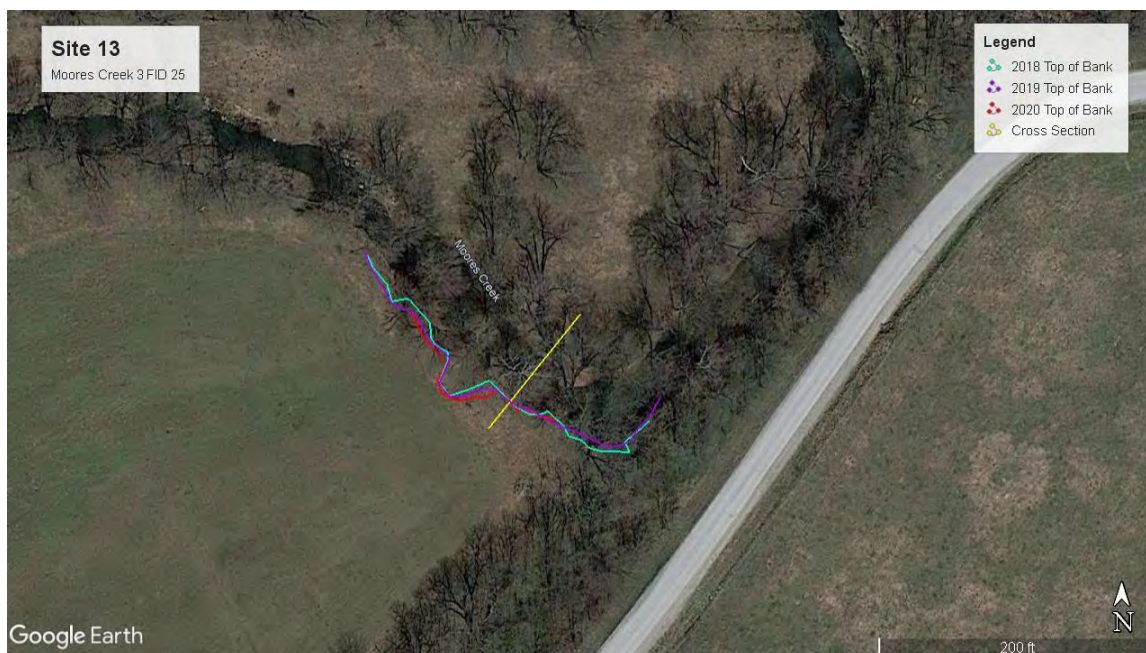
**Figure 41.** Planform view of Moores Creek 3 FID 25 annual survey site. The light blue line represents the location of the study bank in 2018. The purple line depicts the top of bank location on the survey date in 2019, and the red line represents top of bank in 2020. The annual top of bank lines appear to overlap at this scale, indicating that the bank has not moved tremendously through the 2-year study period. Google earth Imagery Date: 3/4/2020.

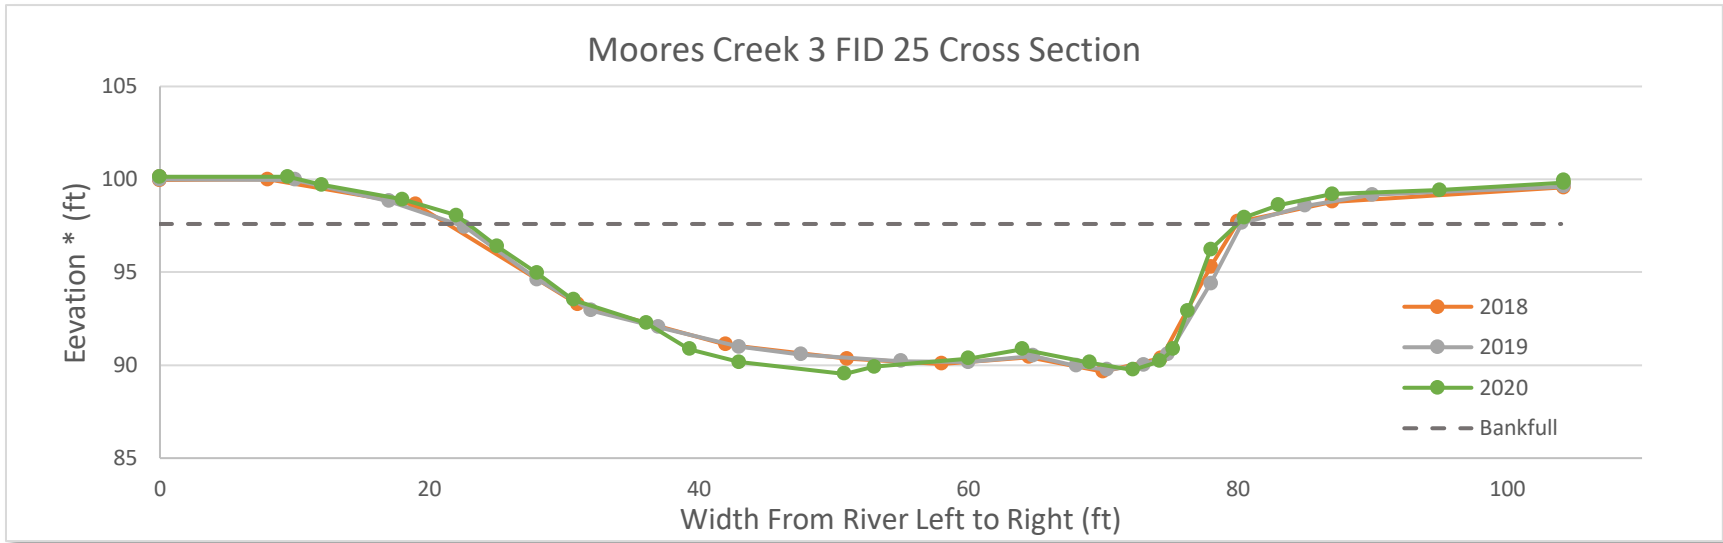
Based on the 2018, 2019 & 2020 cross-section surveys, the stream bank at this location moved an average of 0.26 feet laterally across the bank profile annually from 2018 to 2020 (Figures 42 & 43). Annual top of bank measurements were inconclusive because of relatively heavy canopy cover but generally corroborate these results. (Figure 41). The average measured volume of soil/sediment loss due to erosion for this stream bank segment from 2018-2020 is 21 ft<sup>3</sup> (0.8 yd<sup>3</sup>).

Figure 42. Site 13 Cross Section. Measurements taken 6/5/2018, 4/30/2019, & 5/11/2020. (Bankfull height: 97.6 ft) \*Elevations not georeferenced

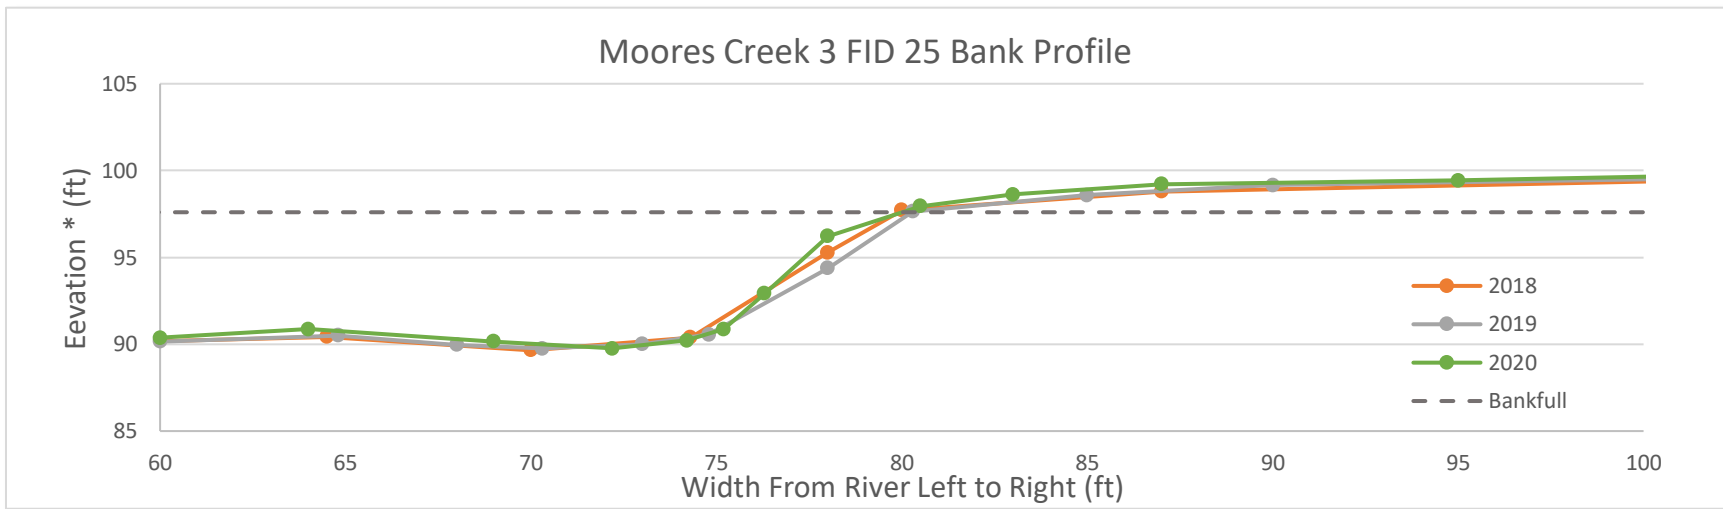
Figure 43. Site 13 Cross Section. Measurements taken 6/5/2018, 4/30/2019, & 5/11/2020. (Bankfull height: 97.6 ft) \*Elevations not georeferenced

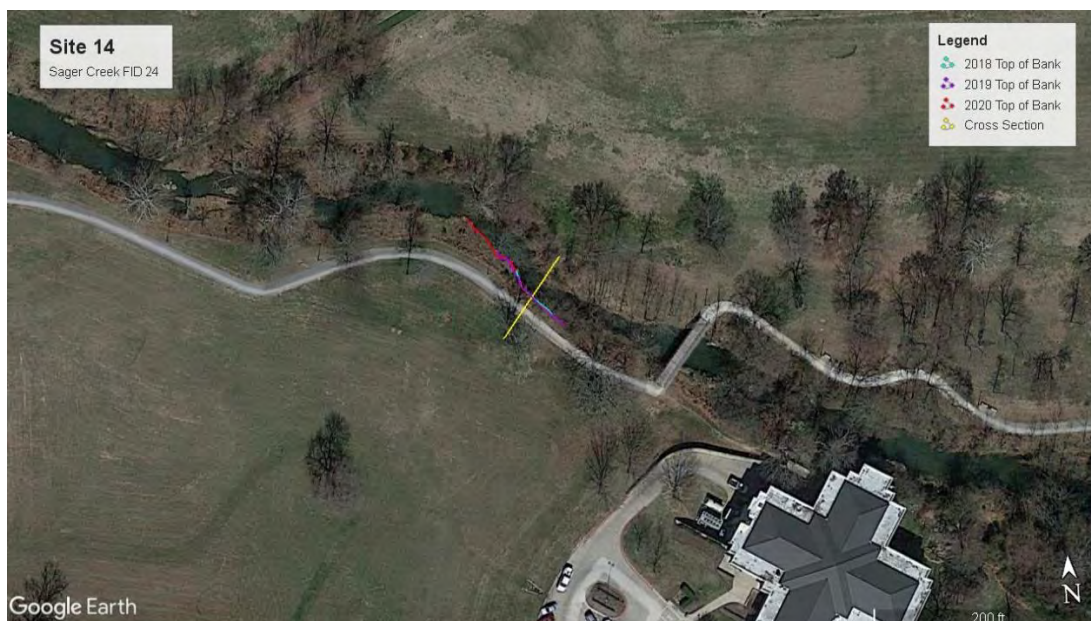
**Figure 44.** Planform view of Sager Creek FID 24 annual survey site. The light blue line represents the location of the top of study bank in 2018. The purple line depicts the top of bank location on the subsequent survey date one year later in 2019, and the red line represents top of bank in 2020. Google earth Imagery Date: 3/4/2020.

Based on the 2018, 2019 & 2020 cross-section surveys, the stream bank at this location moved an average of 0.43 feet laterally across the bank profile annually from 2018 to 2020 (Figures 45 & 46). Annual top of bank measurements corroborate these results. (Figure 44). The average measured volume of soil/sediment loss due to erosion for this stream bank segment from 2018-2020 is 139 ft<sup>3</sup> (5.1 yd<sup>3</sup>).

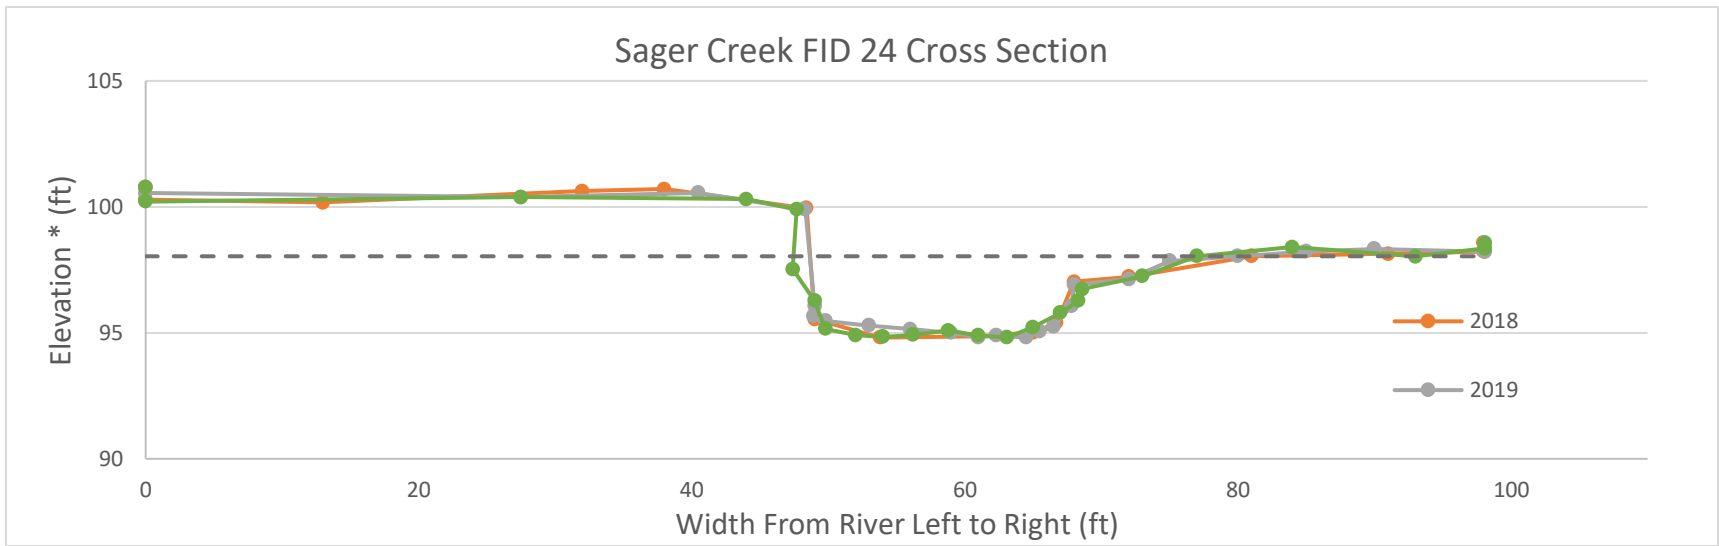
**Figure 45.** Site 14 Cross Section. Measurements taken 5/15/2018, 4/29/2019, & 5/6/2020. (Bankfull height: 98.04 ft) \*Elevations not georeferenced

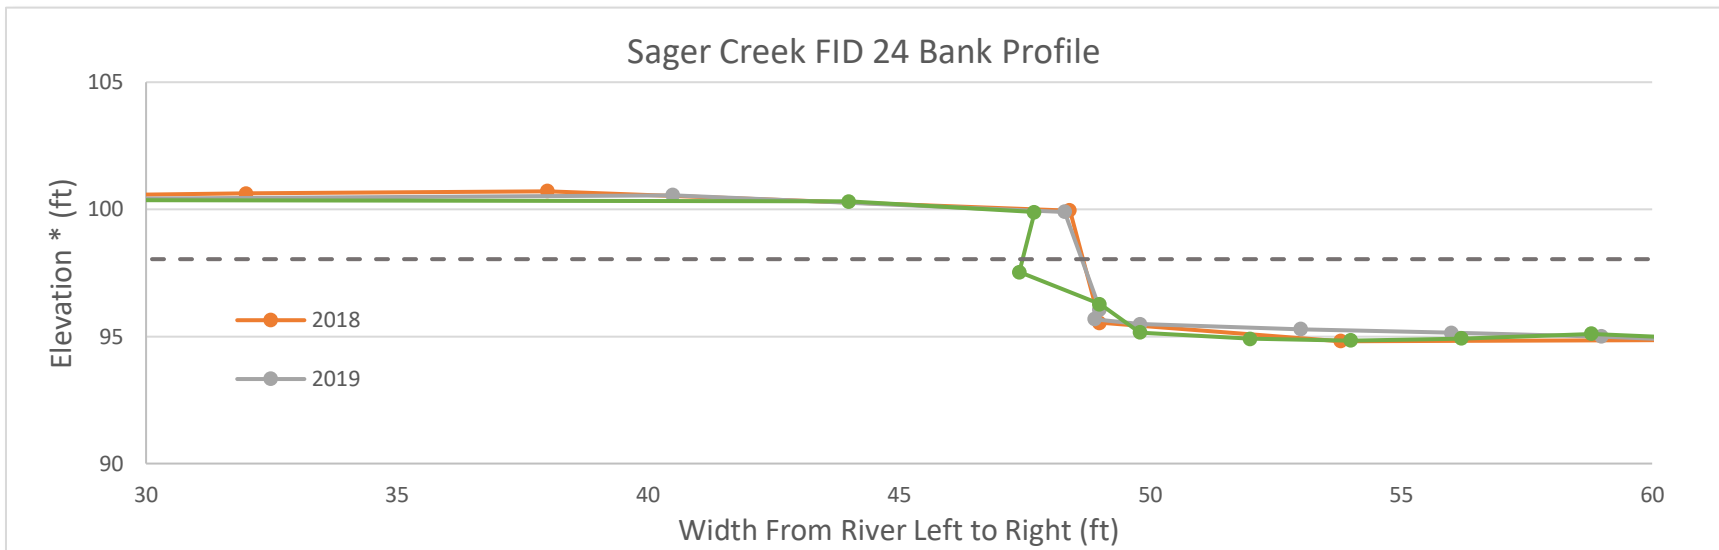
**Figure 46.** Site 14 Cross Section. Measurements taken 5/15/2018, 4/29/2019, & 5/6/2020. (Bankfull height: 98.04 ft) \*Elevations not georeferenced

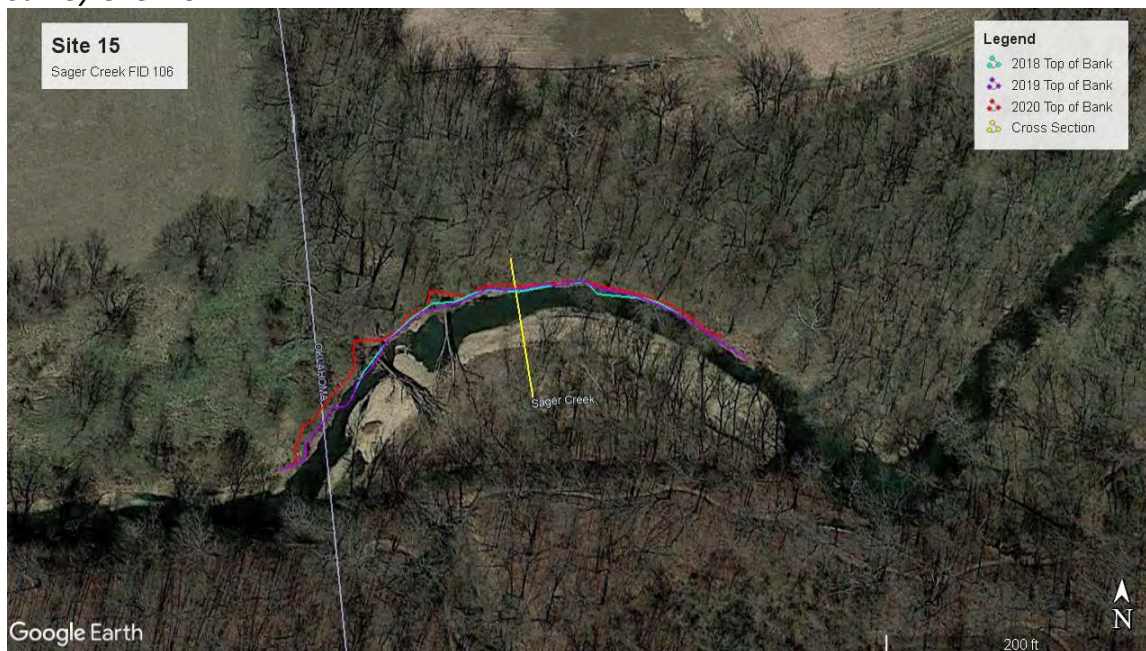
**Figure 47.** Planform view of Sager Creek FID 106 annual survey site. The light blue line indicates the top of bank location during the 2018 survey. The purple line illustrates the location of the bank in 2019, and the red line indicates the most recent top of bank location from the 2020 survey. Note that several large trees have recently fallen into the channel. More significant erosion is likely to occur here as a result of this disturbance. Google Earth Imagery Date 3/4/2020.

Based on the 2018, 2019, & 2020 cross-section surveys, the stream bank at this location moved an average of 1.18 feet laterally across the bank profile annually from 2018 to 2020 (Figures 48 & 49). Annual top of bank measurements corroborate these results. (Figure 47). The annual measured volume of soil/sediment loss due to erosion for this stream bank segment from 2018-2020 is 4,791 ft<sup>3</sup> (178 yd<sup>3</sup>).

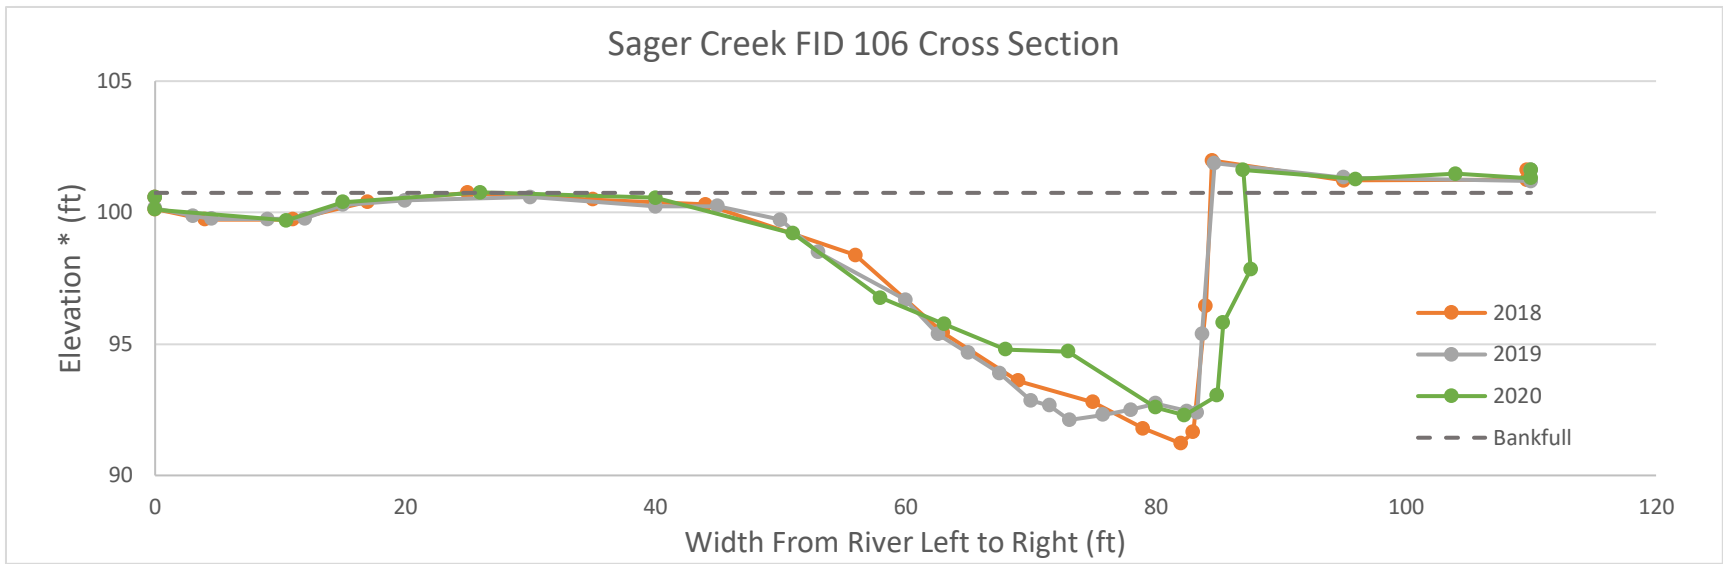
**Figure 48.** Site 15 Cross Section. Measurements taken 5/16/2018, 4/29/2019, & 5/12/2020. (Bankfull height: 100.75 ft) \*Elevations not georeferenced

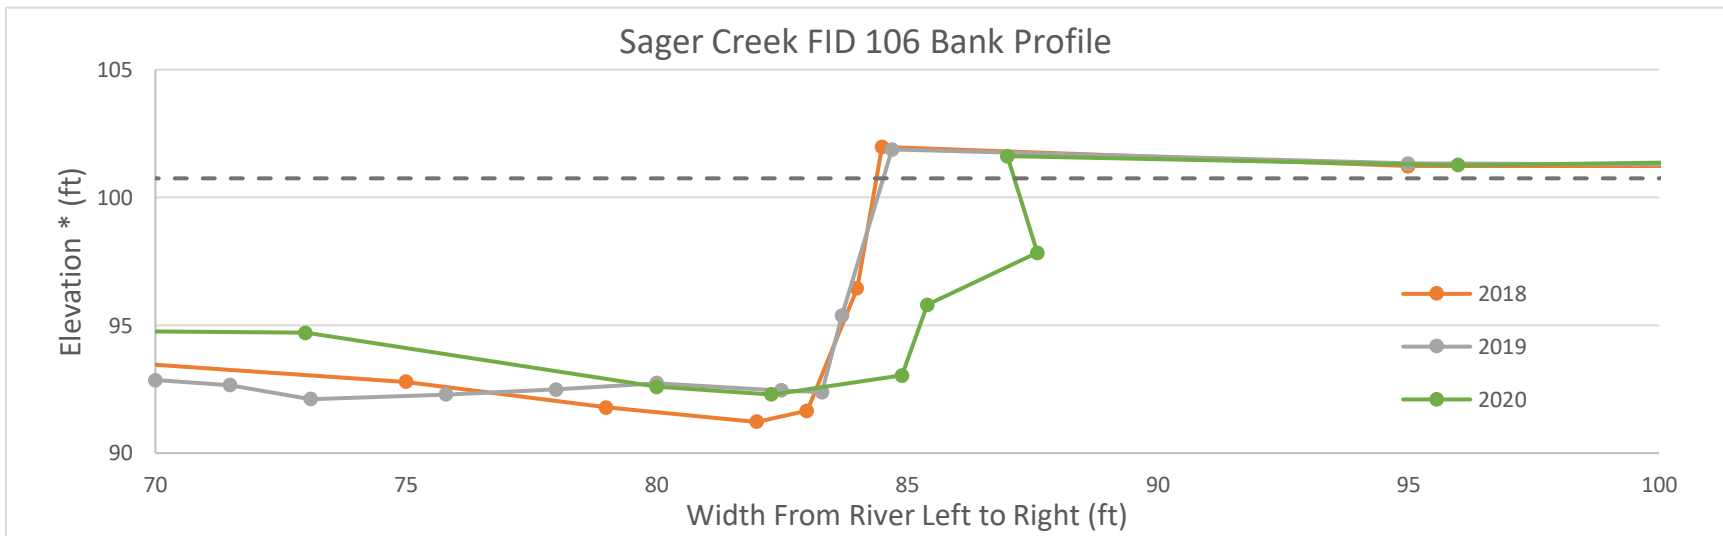
**Figure 49.** Site 15 Bank Profile. Measurements taken 5/16/2018, 4/29/2019, & 5/12/2020. (Bankfull height: 100.75 ft) \*Elevations not georeferenced

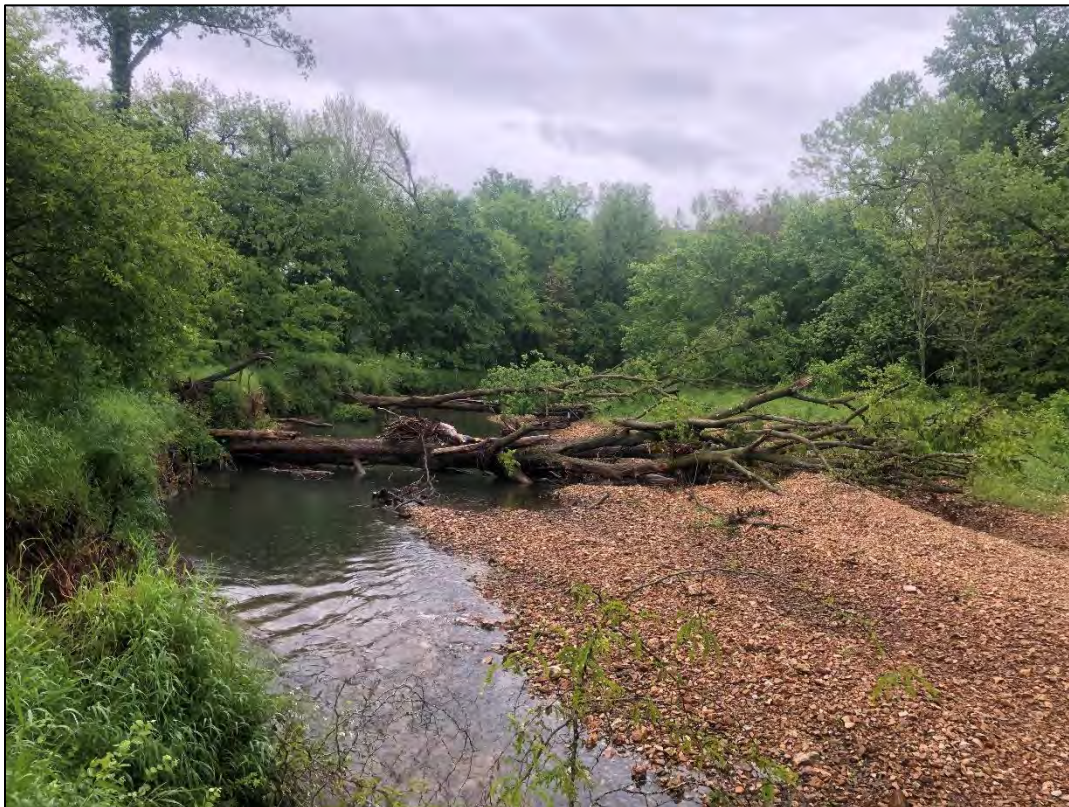
There are several large trees, however, that have recently fallen from a standing position along the top the bank and now lie in and across the stream channel downstream of the cross section location. We would not be surprised if these obstructions cause localized scour or even a debris jam, which could lead to greater than predicted actual erosion rates moving forward. The erosion rates here are relatively low, and this site has a largely intact riparian buffer, so we would not expect to have any specific restoration plans for this site. If anything, the trees lying in the channel could be removed to reduce scour potential and prevent a larger blockage from occurring.

*Sager Creek, FID 106 (2020) Looking Upstream at large trees in the channel that were standing in 2019.*
