# Fitzgerald Marine Reserve (FMR)

A Review of Infrastructure Projects and Natural Resource Protection Issues

MCC presentation February 13, 2013 by Lisa Ketcham

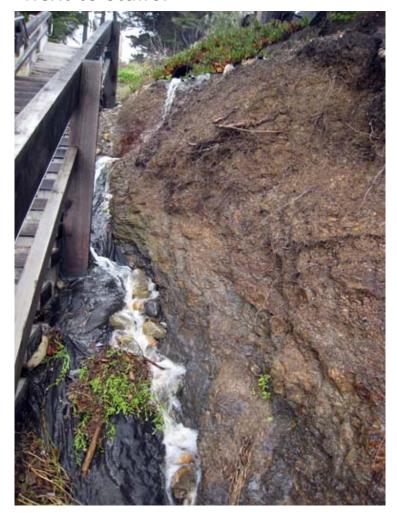
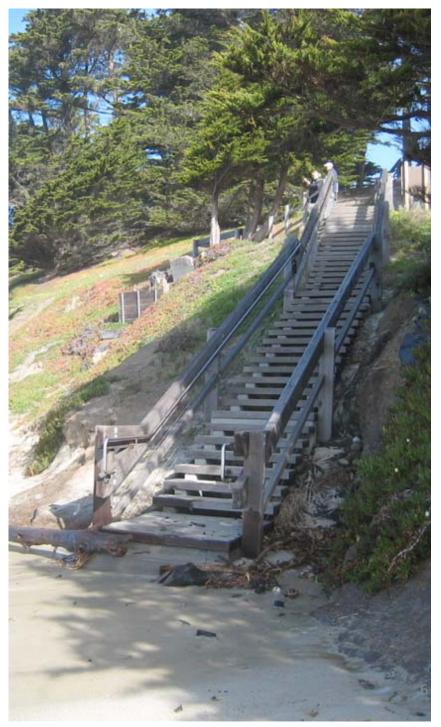
Seal Cove Staircase – lower section

Old culvert outfall is eroding cliff next to stairs.

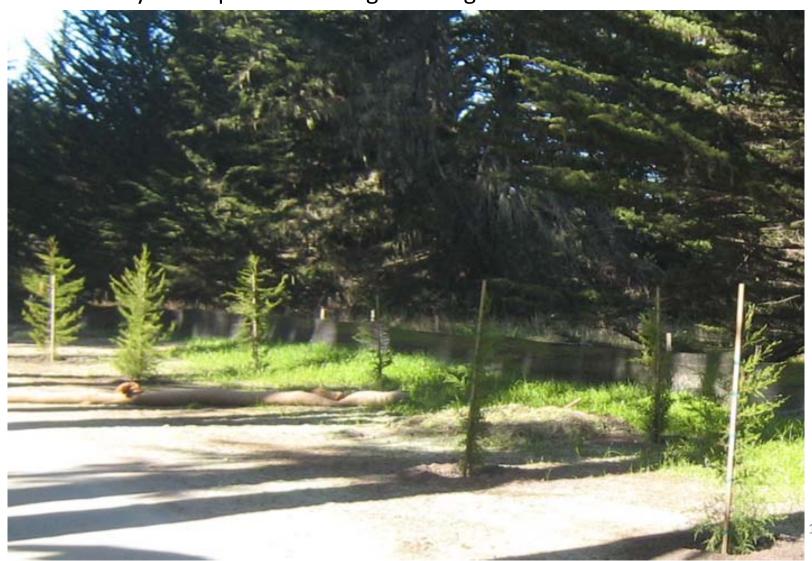
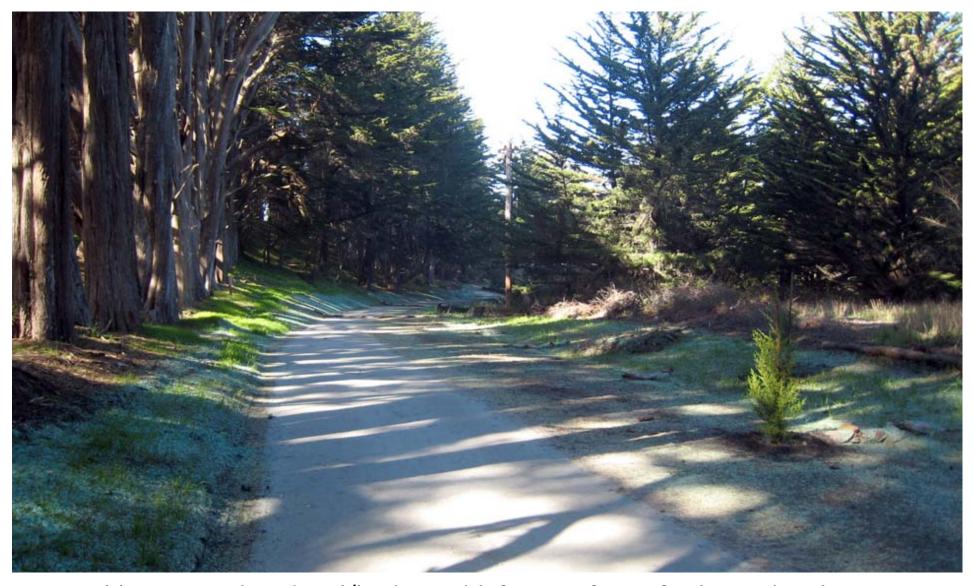
Sunny meadow by trail was planted with grove of cypress trees spaced only 12ft apart which will grow together in tangled mass without space to spread and develop picturesque lower branches which will be shaded out and die, as well as any other plants that might have grown here.

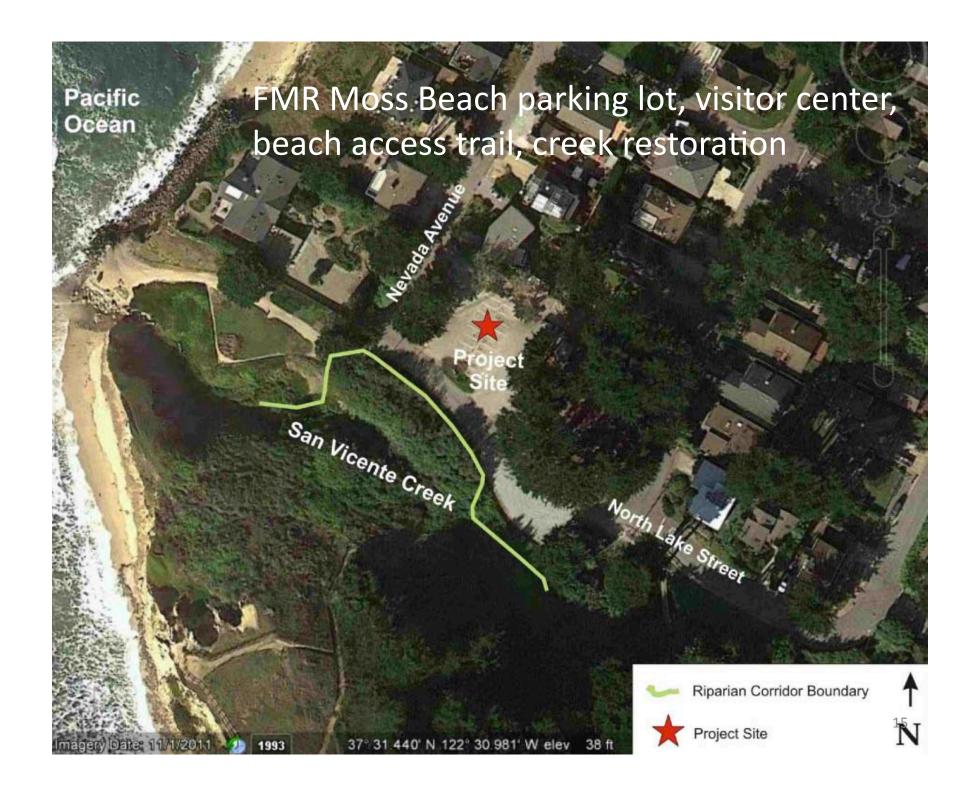
Public input reduced trail/bridge width from 12 ft to 8 ft; changed trail surface from asphalt to more natural/permeable decomposed granite fines; and kept the curves in the trail instead of the plan for a straight road.

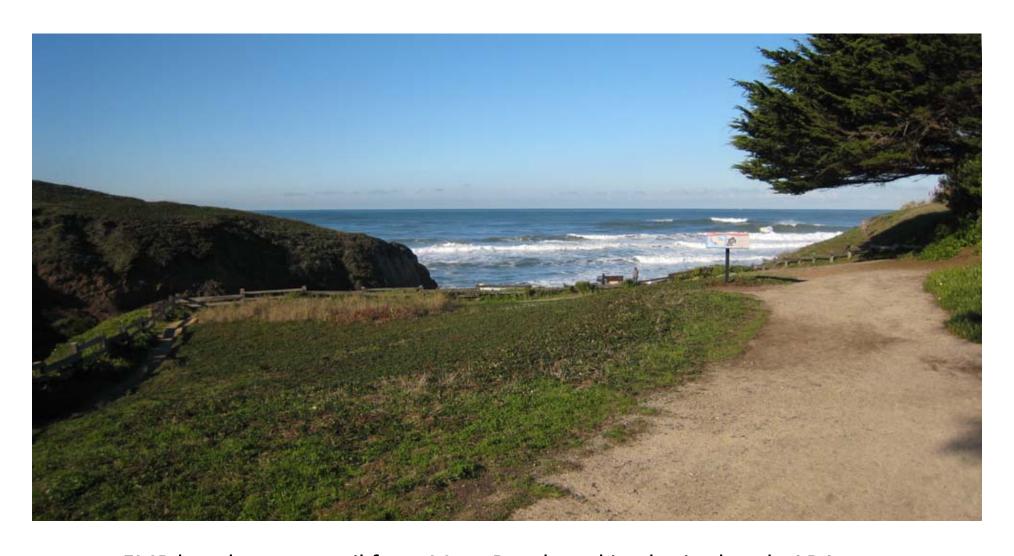
FMR beach access trail from Moss Beach parking lot is already ADA accessible to the overlook under cypress tree on the right, and has natural-looking DG trail surface.

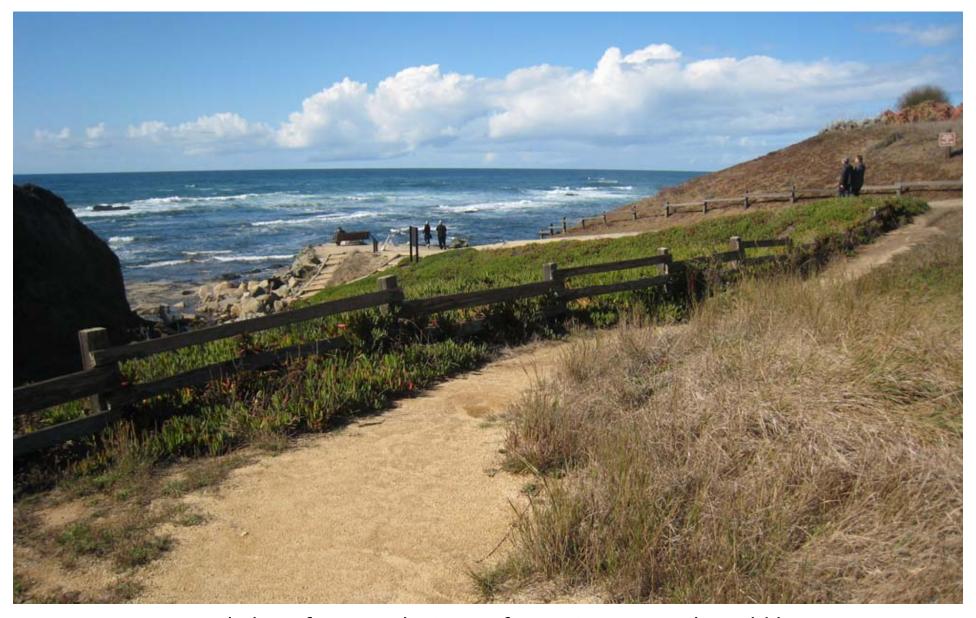
Loop trail along fence with views of San Vicente creek could be made ADA accessible with little disruption.
