# Deteriorating Riprap at Montara State Beach – Hazards, Scenic Views, and Public Access

Midcoast Community Council  
April 12, 2017

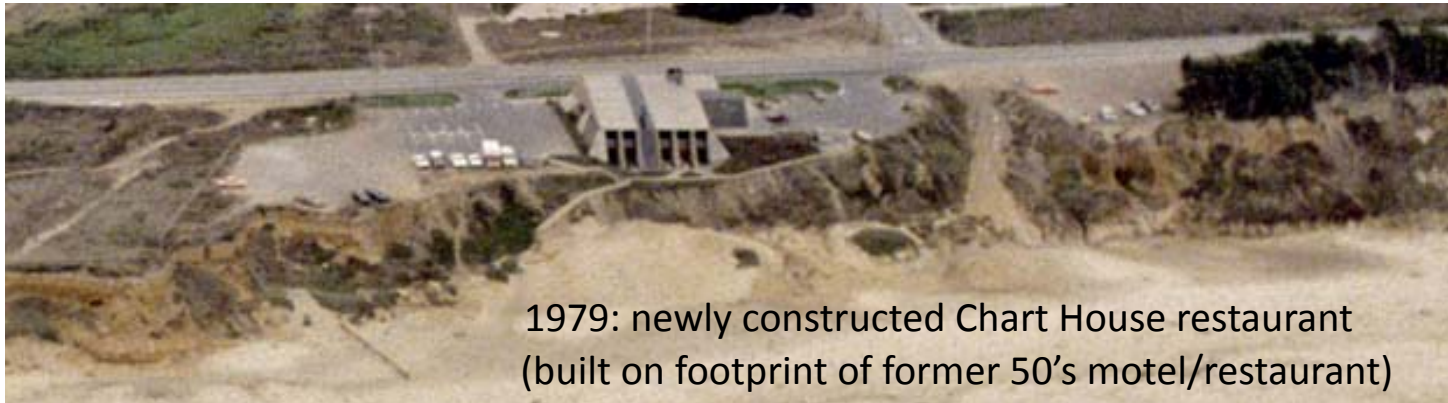
1979: newly constructed Chart House restaurant  
(built on footprint of former 50's motel/restaurant)

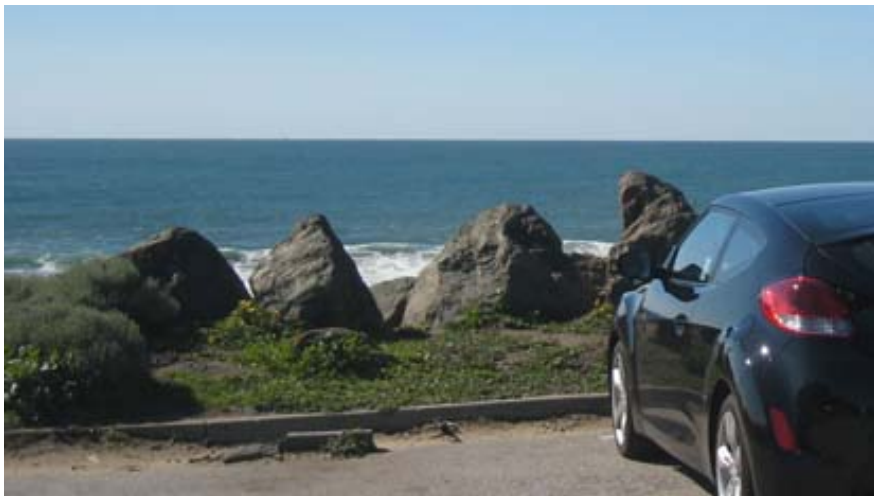
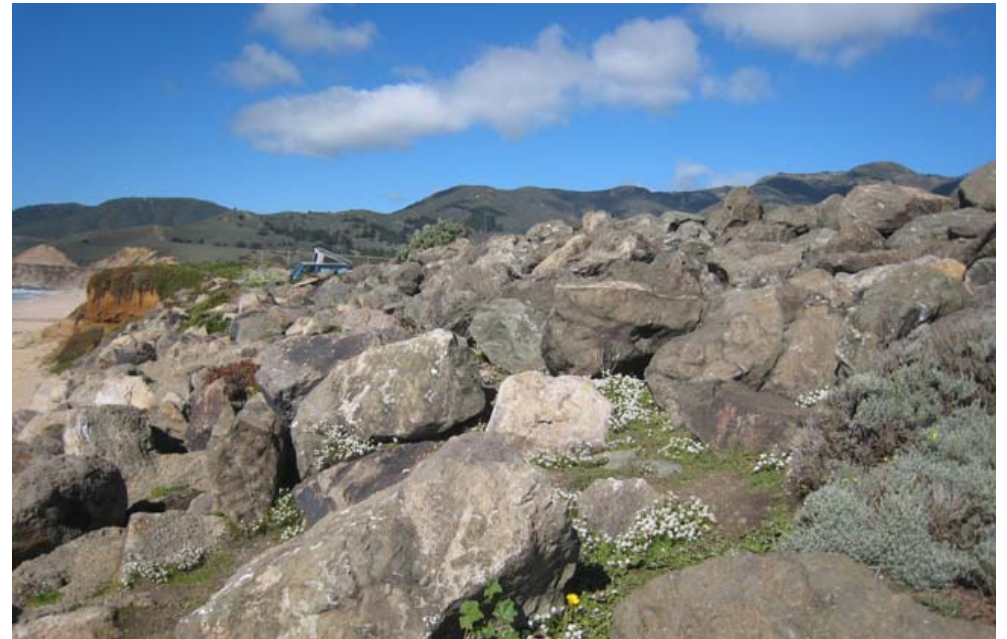
Riprap extends onto top of bluff, far beyond where needed for erosion protection, blocking blufftop access and views.

Removal of excess boulders that cover the upper slope and top of bluff above the red line on either side of the restaurant would restore public access and views and reduce the area of alien rocks that mar the otherwise pristine viewshed.
