Prepared For:

Prepared By:

**FINAL REPORT
FOR
N62470-14-D-3006
VALIDATE CORROSION INHIBITOR
AT
U.S. MILITARY INSTALLATIONS
OKINAWA, JAPAN**

(Corrpro Project No. – 340531156)

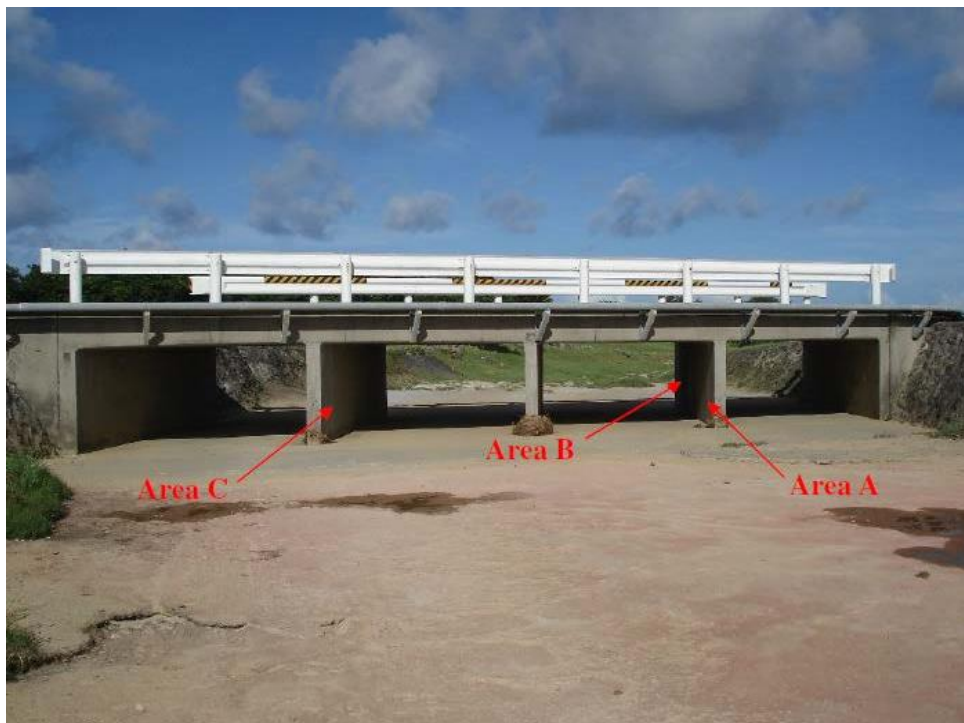
Bridge 2 that received the full Surtreat system was evaluated for effectiveness of the system. The same three specific areas chosen for the 2007 inspection were previously tested in 2010 as shown in Figure 2 were evaluated. These areas were designated as areas A, B, and C. All three areas were on vertical surfaces. No cracking or spalling of the treated area was visually apparent. A few small square patches were observed that were not originally present at the time of treatment, and the circumstances of their installation are unknown. Figures 3, and 4 show the condition of Bridge 2 as found in 2016.

Figure 2 – View from upstream of Bridge 2 at the Kuwae Tank Farm, Kadena AFB, 2010

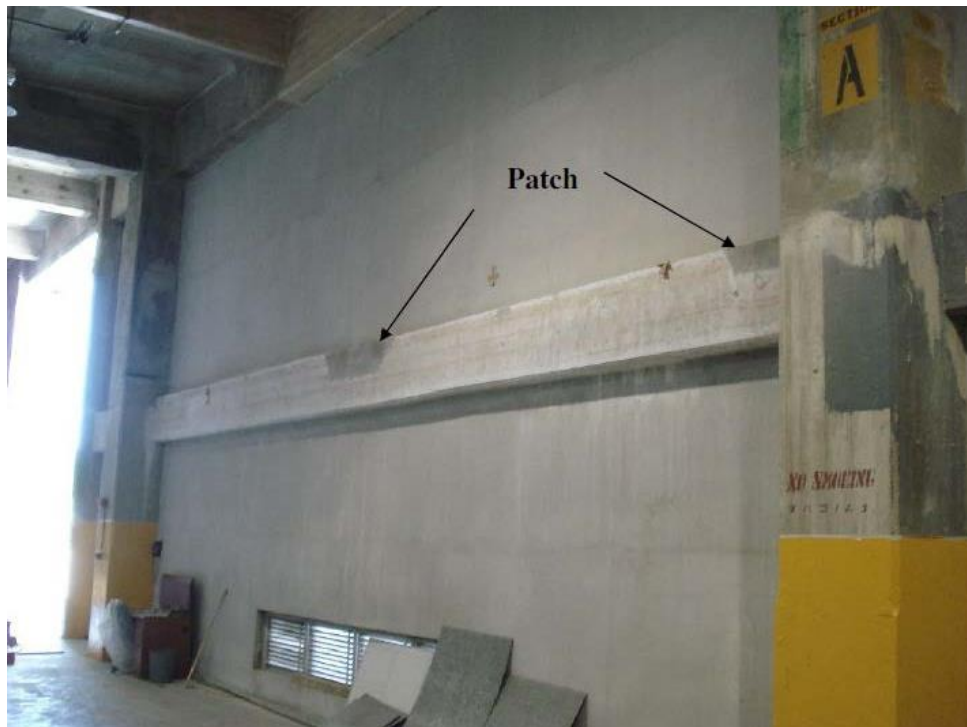
The Surtreat system was previously applied at the warehouse building no. 306 in Naha Military Port. Section 1 where the system was applied is a section of ring girder adjacent to the exit door in section A of the building. Visually, the ring girder identified as Section 1 with the Surtreat system had no apparent changes since the last testing performed in 2010 as shown in Figures 8 and 9. Section 1 appeared in good shape without signs of deterioration. However, the other ring girder identified as Section 2 with the NASA coating had a clear visual indication of the coating delaminating from the concrete surface. This deterioration can be seen in Figure 10 below.

Figure 8 - Section 1 of the ring girder at Building 306 in the Naha Military Port, 2010
