## Introduction

Construction Defect Litigation has been a scourge to many aspects of the building business in the past 15 years. We are going to present a high-level overview of the events that have lead, and continue to lead us to the courthouse steps, and what can be learned from this big-picture survey of the landscape, so that our navigational skills improve with experience.

A guided tour through some of the most common errors and omissions fueling the litigation frenzy in the California building industry

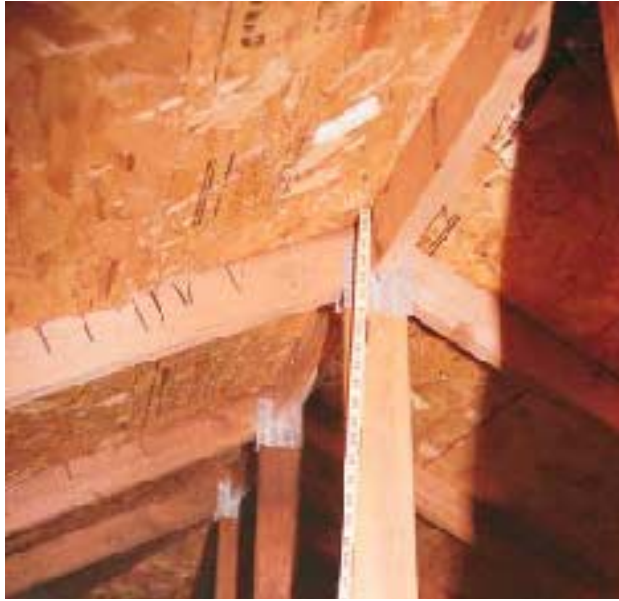
**Figure 1.** Nails that miss the truss — a result of sloppy work with a pneumatic nailer — void the strength of the roof diaphragm.

Failure to follow the nailing requirements for shear walls and diaphragms is a common defect. Many builders temporarily set the plywood in place with a few hand-driven nails, then return later to finish the nailing with a gun. Unfortunately, we sometimes find that the second step in the process has been forgotten and the finish materials are installed over inadequately attached plywood. Another typical mistake is the substitution of box nails or sinkers for the specified common nails, or use of a smaller size nail. Figure 1 shows an example of just plain sloppy nailing.

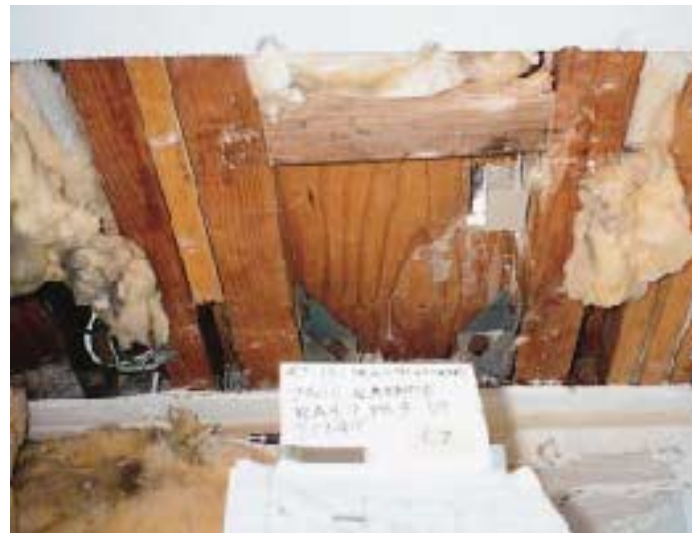
**Figure 4.** This shear plywood should have extended to the top of the double top plate — a mistake that can be remedied with the addition of metal connectors across the two plates.

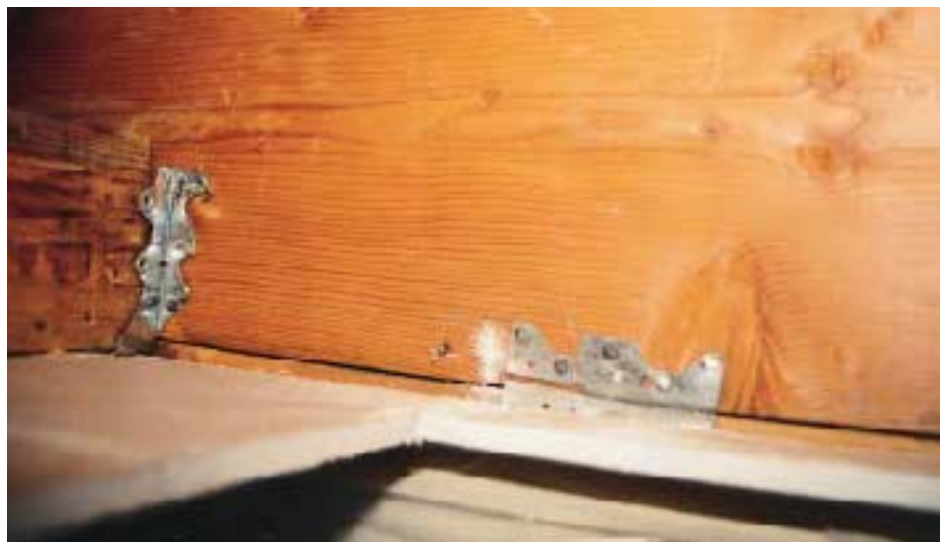
**Figure 5.** These shear wall hold-downs are too close together, making the shear wall practically useless in resisting overturning forces.

Another common mistake occurs when the hold-downs are attached to the wrong members, creating a shorter shear wall than the plans called for. This is important because the uplift load on the hold-downs increases exponentially as the hold-downs get closer together. When hold-downs are placed too close together, the uplift loads will exceed the hold-down's capacity, creating the potential for catastrophic failure in an earthquake or hurricane (Figure 5).

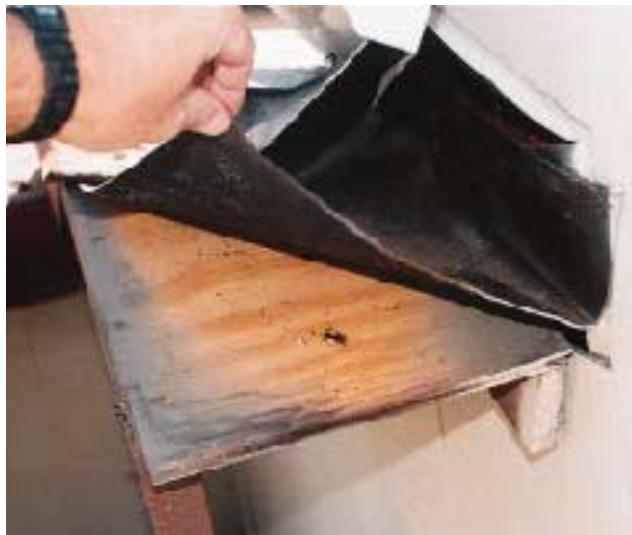
**Figure 7.** Instead of folding down over the edge, the felt paper on this rake overhang was cut flush with the top of the sheathing, allowing rain water to wet the surface of the roof deck.

One of the most common mistakes I see is the failure of the roofer to turn down the 30-lb. felt underlayment to cover the edge of the decking at the rake. Instead, the felt is cut flush with the top edge of the roof sheathing or barge rafter. Any water that makes its way past the rake tiles has an easy path onto the wood deck (Figure 7). Unfortunately, like most roofing defects, this cannot be readily inspected on a completed roof because the rake tiles cover the edge of the roof.

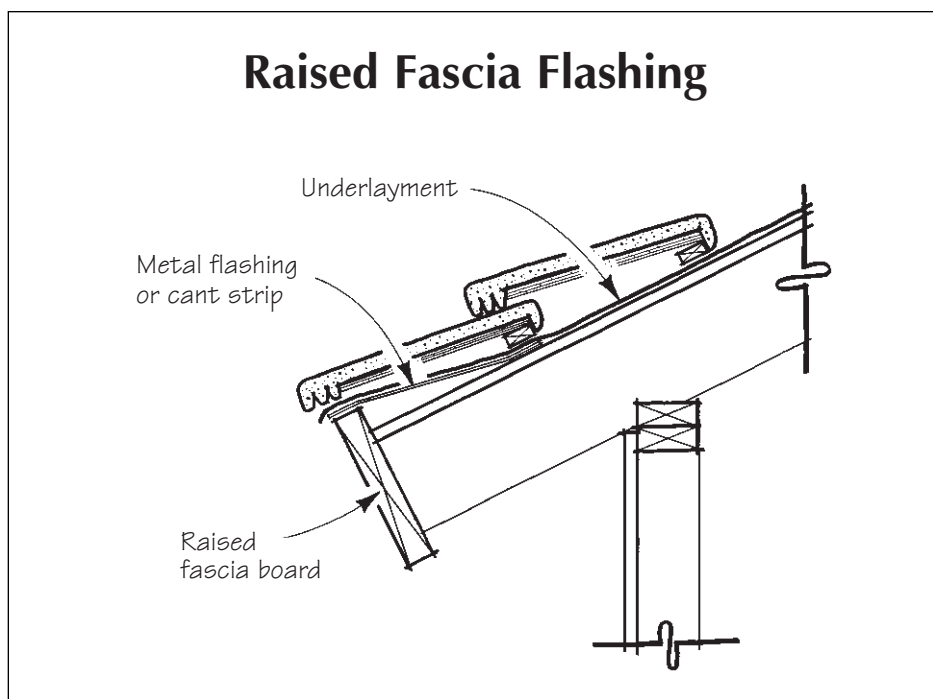
**Figure 8.** A raised fascia board (illustration) requires a heavy metal flashing or cant strip to ensure that runoff passes over the edge. Otherwise, water will pond, as in the photo, resulting in leaks and rot in the eaves.

Another common mistake involves a standard tile roof detail: the raised fascia board. The detail is acceptable, but accommodation must be made for the void that is created behind the fascia board by installing a sheet metal flashing or other anti-ponding device. Many roofing contractors omit this flashing, and the underlayment soon begins to sag and pond water, which makes its way behind the fascia and into the eaves (Figure 8).

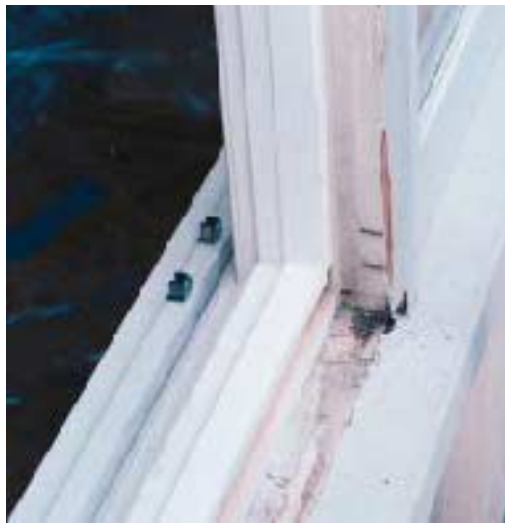
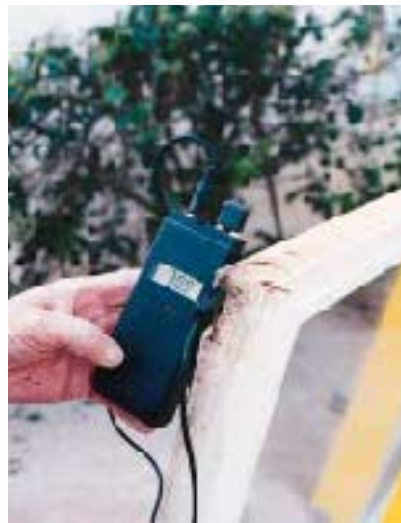
**Figure 11.** Wood windows should be painted on all raw wood surfaces. Otherwise, they will pick up excessive moisture (as the moisture meter reading in the photo at right shows), causing them to swell or even rot.

Wood windows are the exception in Southern California construction (most are aluminum), which may be the reason they are often not protected adequately from the harmful effects of moisture and temperature extremes. Although most wood windows come with an exterior primer from the factory, all components and all edges should be painted as soon as possible. When wood windows are not properly painted on all surfaces, the unfinished surfaces will take on moisture at a higher rate than the painted areas, creating uneven expansion and contraction and the possibility of rot (Figure 11). A common manifestation of damage is when the windows fail to operate properly, especially after swift changes in the weather.

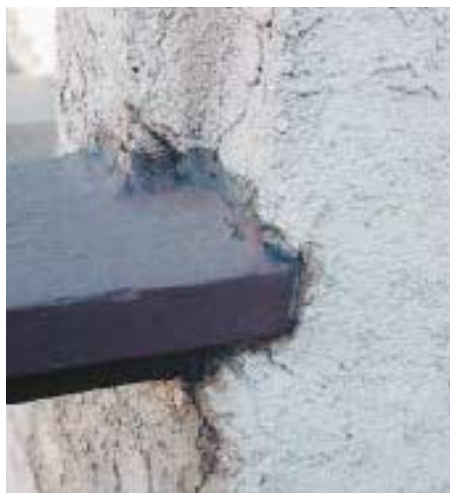
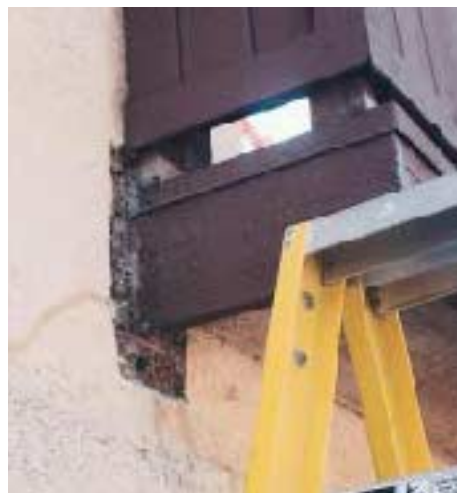
**Figure 12.** Framing protrusions, such as handrails (left) and cantilevered joists (right), are difficult to flash properly, inevitably leading to moisture intrusion, cracked stucco, and decay in the structure below.

A condition that frequently results in failure is where a deck handrail or cantilevered joist passes through the stucco skin to the framing below (Figure 12). These intersections are difficult to flash and the necessary coordination between the trades is usually lacking. The best idea is to avoid these protrusions altogether. Instead, frame the deck with four posts from the ground and stop the handrail shy of the building.

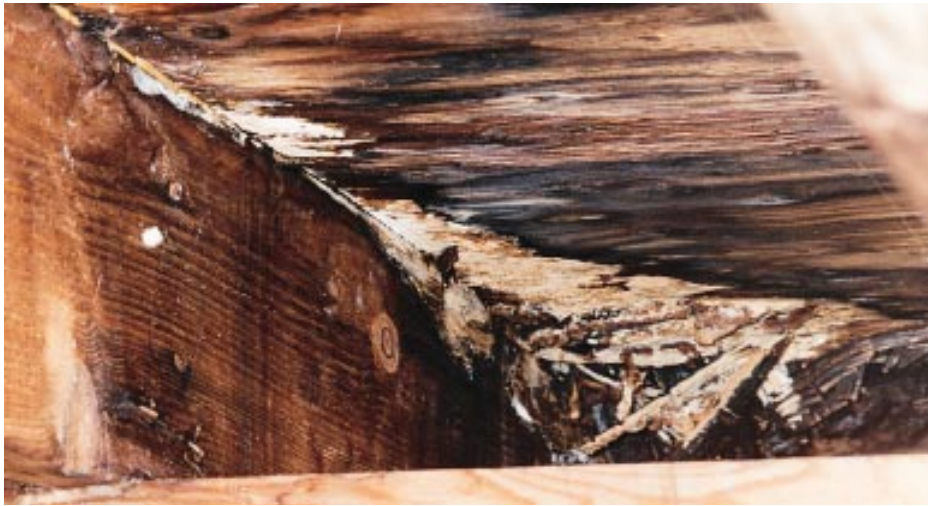
**Figure 15.** Because waterproof decks are difficult to detail properly, rotting substructure is a common defect.

The photo on shows a poorly flashed post penetration. The unsealed flashing acted more like a funnel, sending the water right into the framing and keeping it there, where it could do the kind of damage evident in Figure 15. Ponding of water on waterproof decks is another common problem (Figure 16), which can also lead to rot in the structure below.

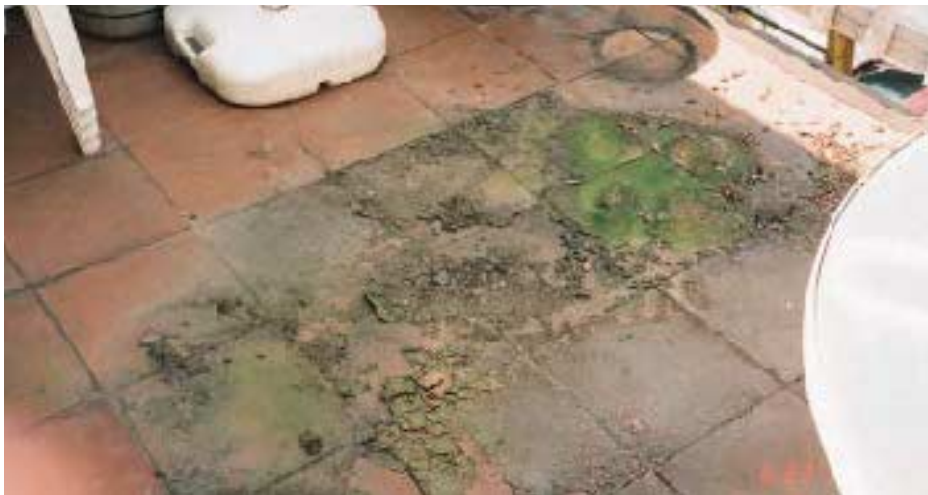
**Figure 16.** Besides ruining the finish surface, ponding on waterproof decks also leads to deterioration of the framing below.

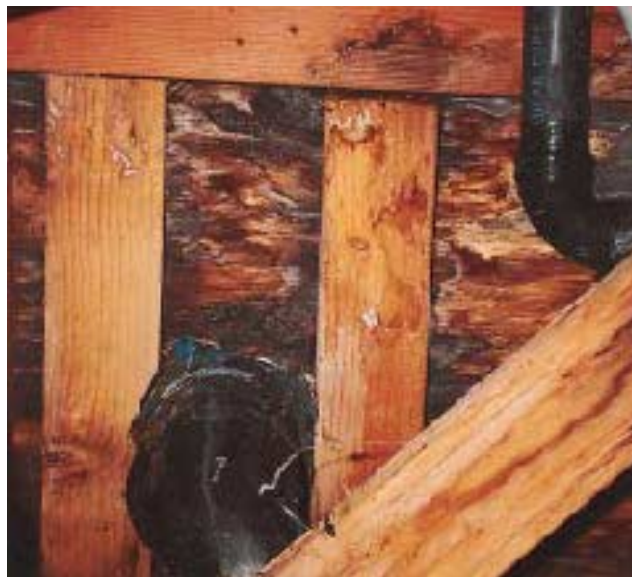
**Figure 17.** If hidden by finish surfaces, a leaky toilet connection can go undetected until structural decay sets in.

A common source for a plumbing leak is a poorly installed toilet (Figure 17). The connection to the closet flange is important because the toilet receives so much use, which includes supporting the entire body weight of the user. If the toilet has not been set level, or if the flange is too high or low in relation to the finish floor, it's only a matter of time before a leak develops. A leaky toilet often goes unnoticed for some time, since the water may leak under the finish flooring directly into the framing.

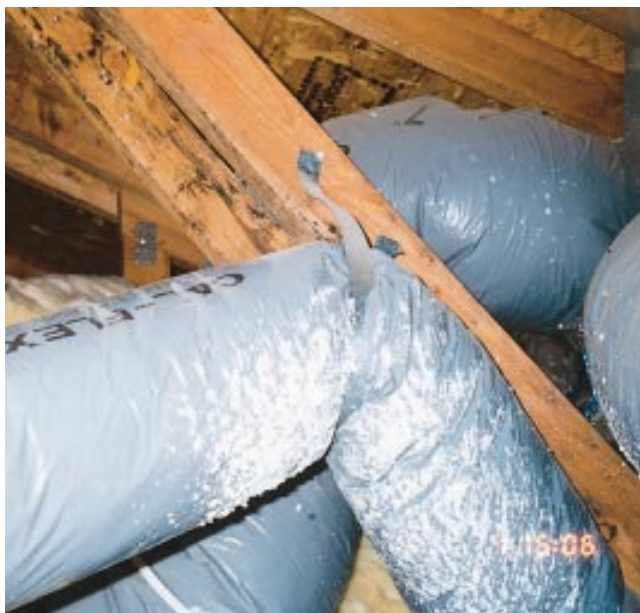
**Figure 20.** A pinched duct can result in uneven temperatures. It's easy to fix if it's accessible, but easier still to avoid.

As with plumbing, many of the hvac defects cited in a typical defect case are nuisance and code issues that are easy to correct, like construction debris in the return air plenum, unsecured units, and no trap vent on the condensate drain. These issues rarely cause serious owner dissatisfaction. Pinched or crushed ducts are another common problem (Figure 20), which can cause uneven heating or cooling and result in owner discomfort. The cause may be sloppy installation or damage by a subsequent trade. The repair is as simple as unpinching the duct or replacing any short sections that have been permanently damaged.

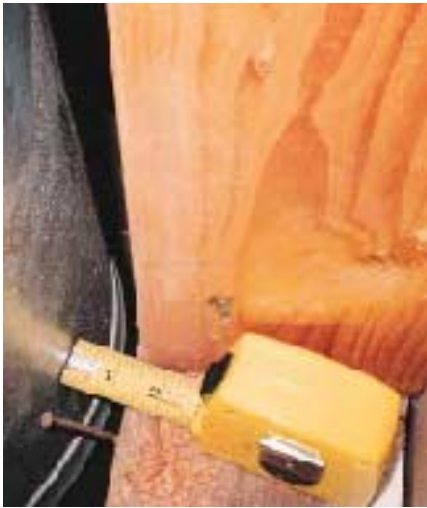
**Figure 21.** As a matter of life safety, combustion appliance vent pipes must have proper clearance to combustibles. The guidelines are usually stamped right on the appliance itself.

This is a real life safety issue that can cause fires (Figure 21, page 66). It's something the municipal inspector should catch, but it often seems to be missed. Different types of flue vents have different distance requirements from combustibles. Generally, a single-wall vent must maintain 6 to 18 inches or more clearance, while a double-wall (B, BW, or L type) needs anywhere from 1 to 9 inches, depending on the rating of the appliance it is venting. Many vents have clearance guidelines printed directly on the pipe. The stick in the spokes for builders is that many materials we normally think of as not being combustible are considered so by the fire safety section of the code. For example, drywall is considered a combustible material by this code definition.
