FPB Reservoir Discussion

Frankfort Electric and Water Plant Board
Frankfort, Kentucky
David Billings, Chief Water Engineer

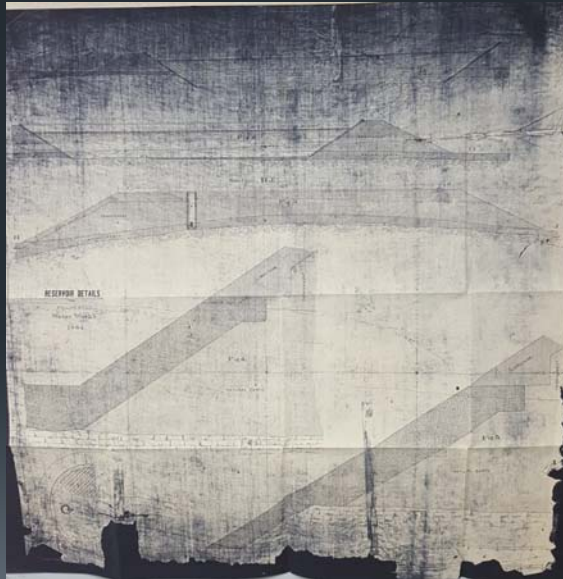
Reservoir History

- Circa 1885, the Kentucky River becomes our water source with the construction of a new pumping plant and the Reservoir. Original capacity was approximately 6.5 MG.

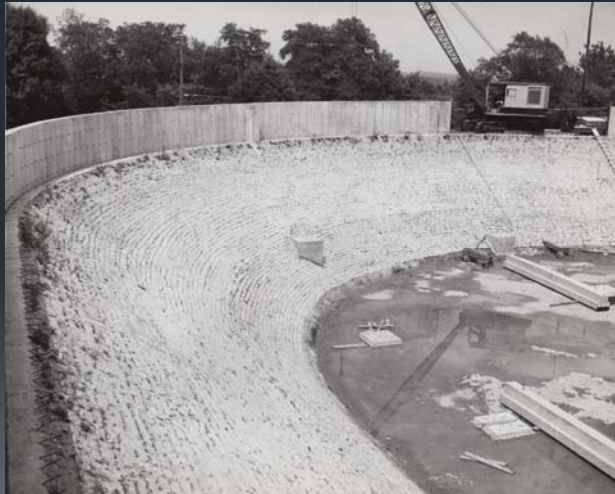
Reservoir History (cont.)

1962 - Vertical wall section (ring wall) being added to increase overall capacity to 9.2 MG

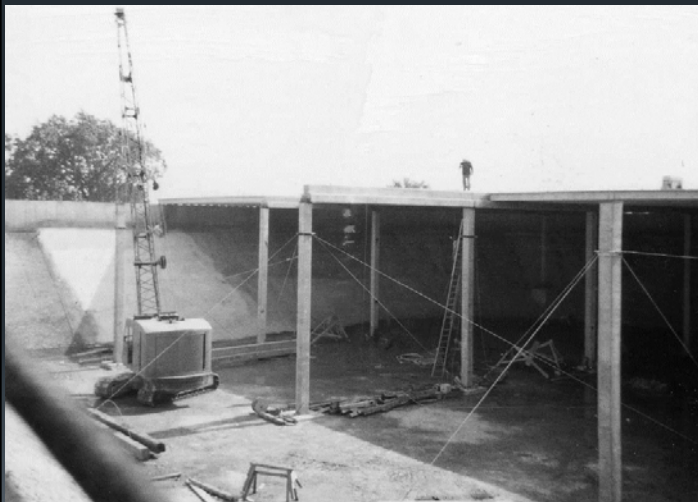
Reservoir History (cont.)

1962 -Roof system consisting of columns, support beams, and roof system added for health concerns and to provide limited nuclear fallout protection.

Gunite (thin layer of concrete) applied over limestone pavers.

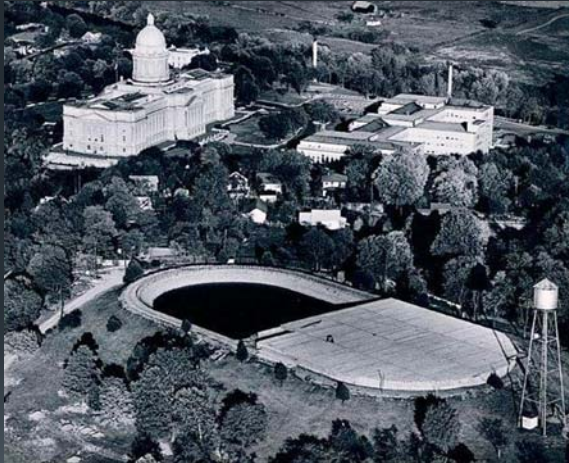
Reservoir History (cont.)

1961 – During construction photo showing ½ work complete.

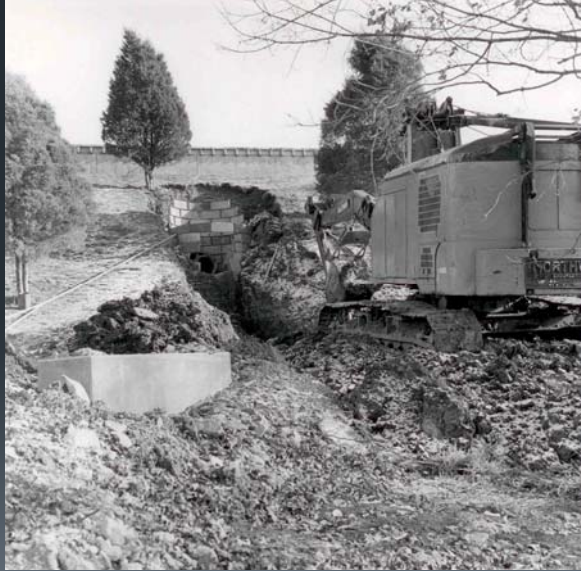
Reservoir History (cont.)

1974, New treatment plant and 36" water line constructed to the Reservoir. In total, there are 36", 20", 14", and 12" water lines on the existing Reservoir site.

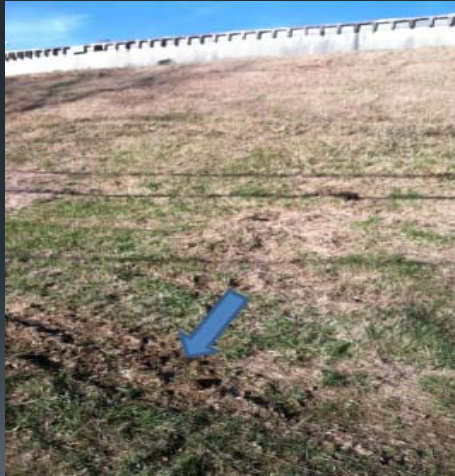
Seepage 2015

Exterior embankment leakage event

- The situation was effectively mitigated but could have developed into a potentially serious situation had it continued unnoticed (piping)
- Event occurred on the South Basin on the Reservoir Rd side

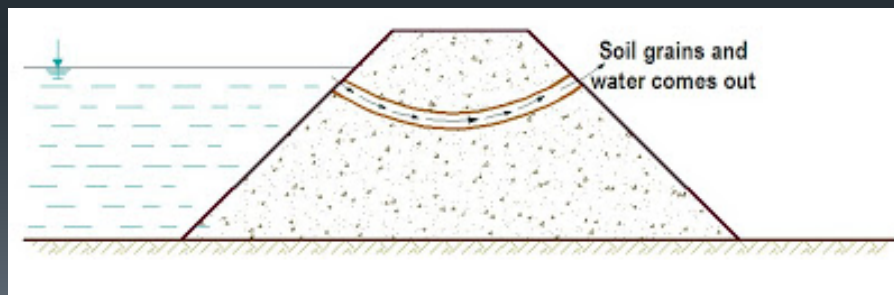
What is Piping?

- Piping is internal erosion of the embankment or foundation material caused by seepage

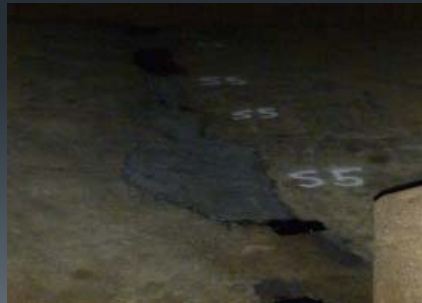
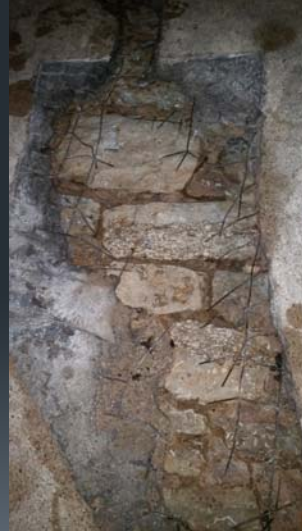
Mitigating the seepage required internal repairs to stop leakage

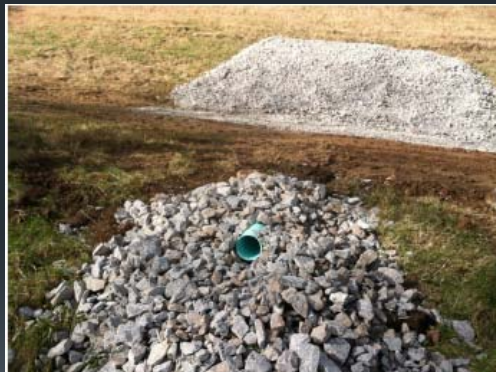
Mitigating required external repairs to control leakage

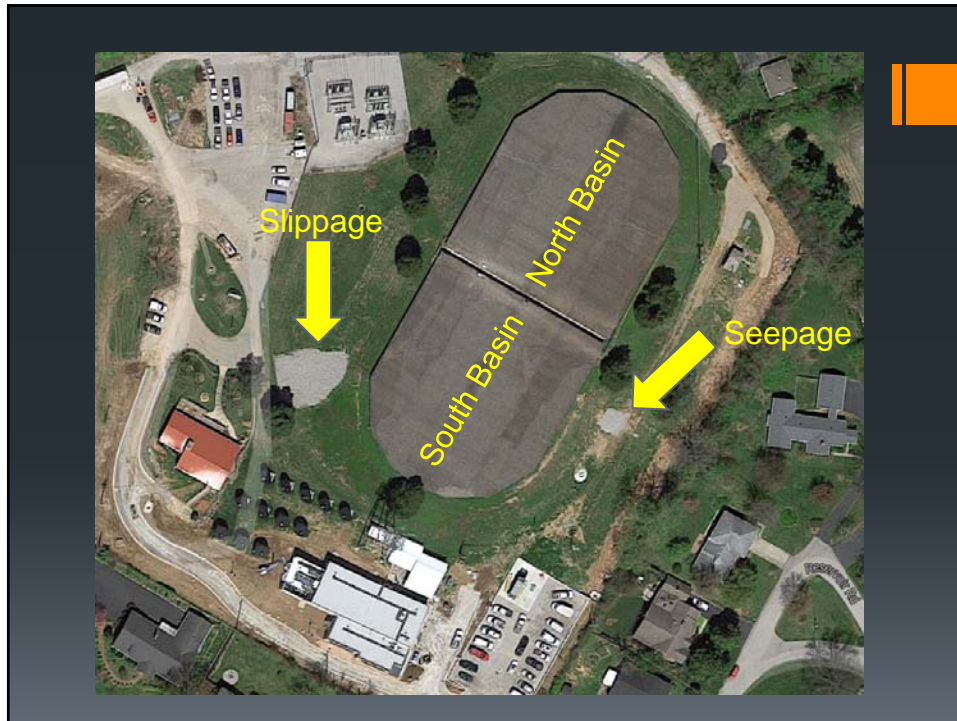
Seepage Mat

A seepage mat was installed in the affected area to control seepage that might continue. The seepage mat allows any remaining leakage to be released at a controlled manner such that piping doesn't occur. Piezometric monitoring wells were also installed near the seepage area to gauge water levels in the earthen embankment.

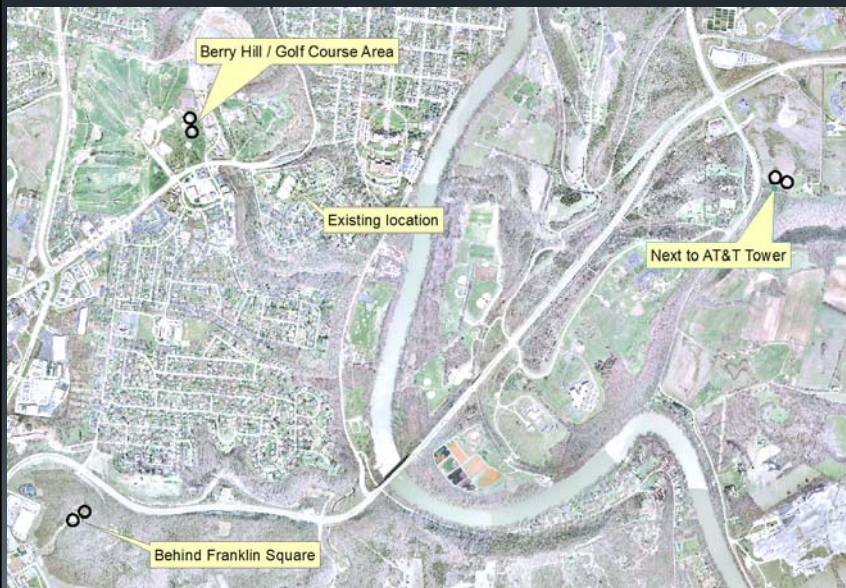
Move? – Limited Choices

Potential undeveloped areas with necessary ground elevation of approximately 780 ft.

- Existing location
- Berry Hill / Golf course area
- Behind Franklin Square area
- Next to AT&T tower site off Sower BLVD

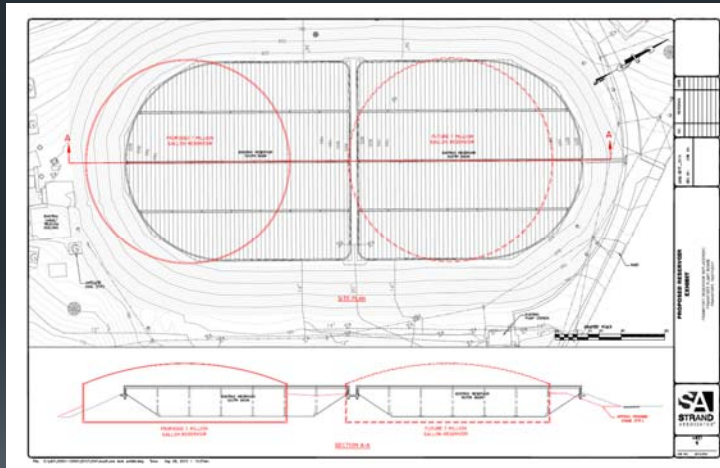
Conceptual Plan View

- Currently in design phase (as of Aug 2016)
- Design Guidelines
 - Existing Site
 - Ground Storage
 - One 7 MG tank (Second 7 MG tank at some point in the future)
 - Smaller footprint (approx. 22% less)
 - Less runoff
 - More efficient cross section
 - Improved drainage

- Design is not complete
- Open to suggestions
- Available options
