SOUTHERN PLAINS
TRANSPORTATION CENTER

Rehabilitation of Deteriorated Timber Piles Using FRP Composites

SPTC15.1-43-F

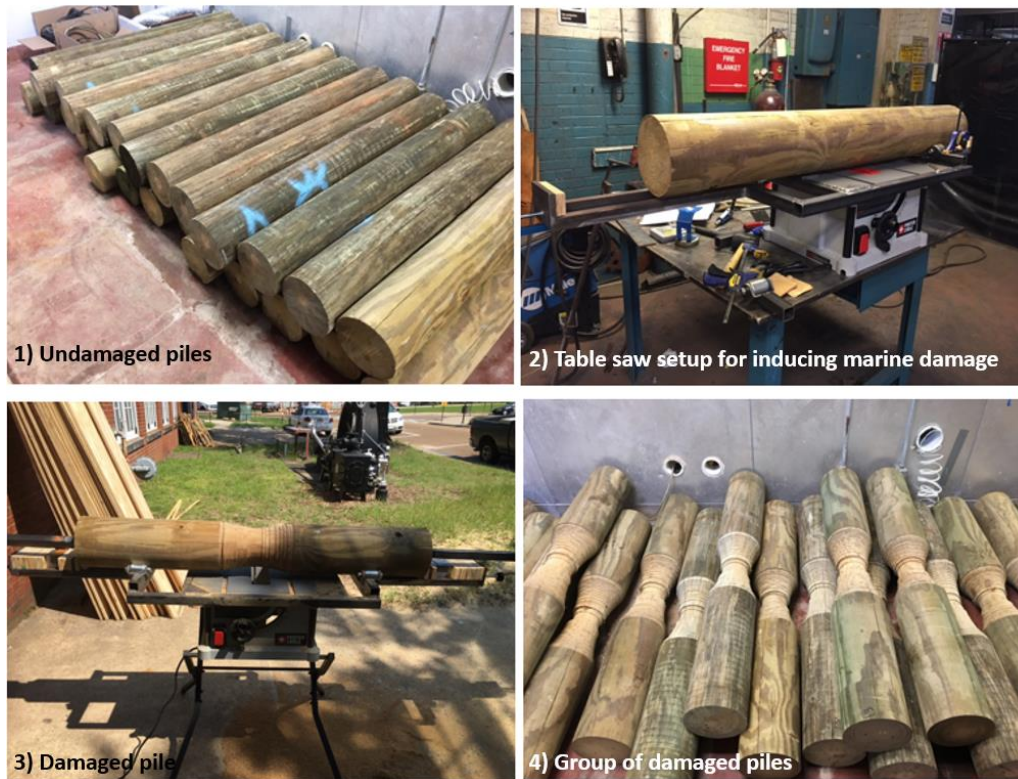
Figure 4. a) Undamaged piles, b) setup for inducing marine damage, c) damaged single pile, d) damaged group of piles

given location in the damaged region. Two adjacent blades were used to induce damage incrementally as shown in Figure 4.

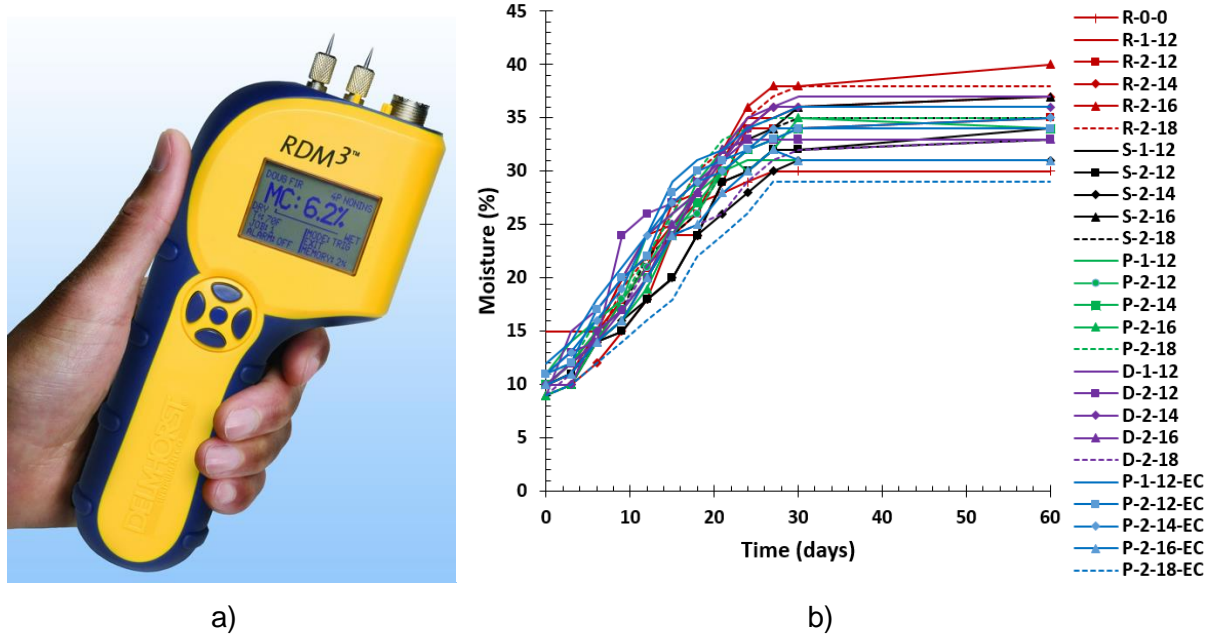
Figure 5. a) Delmhorst Moisture Meter used to measure moisture content, b) moisture content versus time (source for (a): <http://www.bestharveststore.com/Delmhorst-RDM3-Wood-Moisture-Meter-Plus-with-21E-Contact-Pins-and-Case-p229.html>)

All piles were fully saturated by immersing them in a water container. Table 1 illustrates the moisture content before and after saturation. After the initial moisture content of the piles was recorded, all piles were immersed in a water container and the moisture content was measured every three days using a moisture meter (Figure 5a). When moisture content readings reached the point where there was no appreciable increase between subsequent readings the piles were taken out of the water container and were prepared for repair. The amount of time that it took for the piles to be fully saturated was approximately 30 days. Figure 5b shows the moisture content as a function of time for 26 out of the 42 tested piles. After the piles were repaired they were immersed in the water container again for 30 days to allow the infill grout and epoxy to gain their design strength. The moisture content was measured only

after 30 days when the repaired piles were taken out of the water container and were prepared for testing. No intermediate moisture readings were taken between the time the piles were repaired and the time that they were tested due to the weight of the piles (approximately 300 lbs). However the moisture readings taken before the piles were tested are similar with those taken prior to the repair, which suggests that the piles were fully saturated during that time. The reference undamaged and damaged unrepaired piles were left in the water container until the day they were tested.

The average moisture content before the piles were immersed in water was 10% and 11% for concentrically loaded and eccentrically loaded piles, respectively, and the average coefficient of variation for each case was 12% and 14%, respectively. The average moisture content of the piles after they were immersed in water was 35% and 33% for concentrically loaded and eccentrically loaded piles, respectively, and the average coefficient of variation for each case was 7% and 11%, respectively. The coefficient of variation in the fully saturated piles was less than that calculated based on initial moisture content.

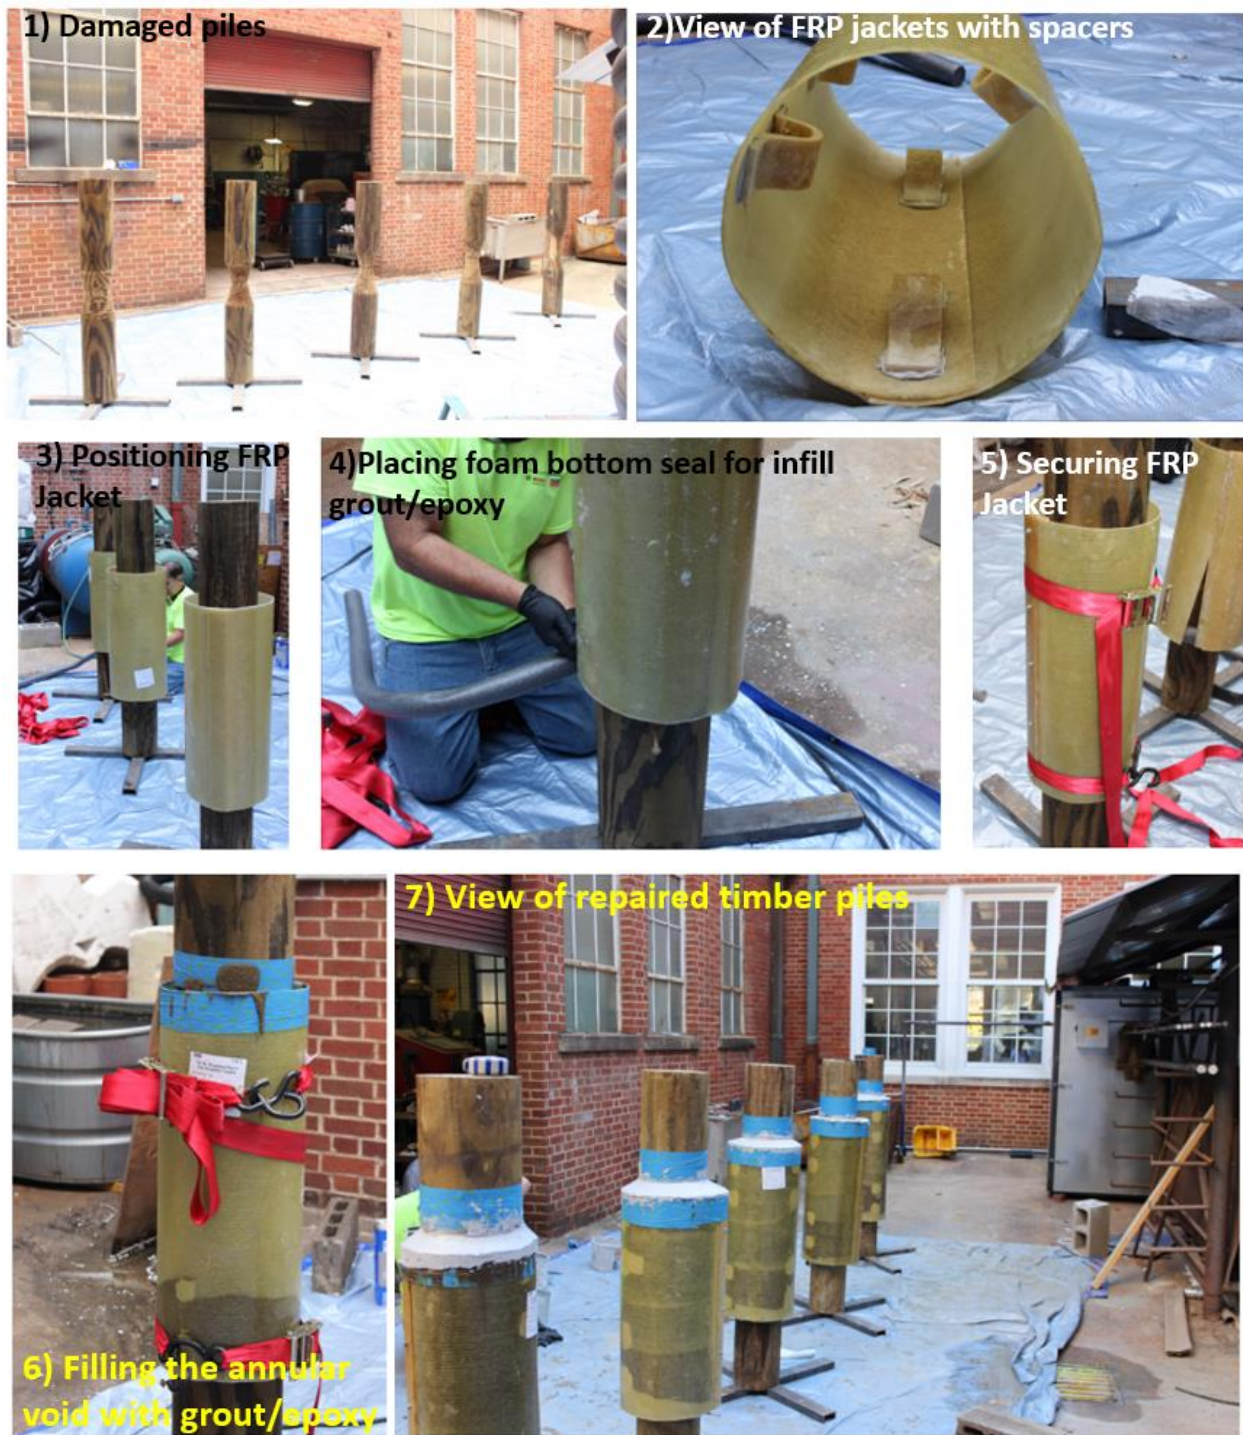
Figure 9. Repair of damaged timber piles – Simpson

Figure 9 shows the repair of the damaged timber piles with Simpson Strong Tie products. The damaged piles were positioned vertically using the steel cross strands described earlier and the prefabricated FRP jackets were installed by opening the tongue and groove joint to receive the pile. The prefabricated FRP shell featured spacers on the inside to create the desired annular space. A foam seal was installed at the bottom to serve as a pour stop for the infill grout or epoxy. Nylon ratchets were used to additionally secure the FRP jacket in the desired position. For the piles that featured a 1 in. annular void, a multi-purpose marine epoxy grout was used as the fill material for the entire length of the repair. Whereas for the piles that featured a 2 in annular void, the multipurpose marine epoxy grout was used only for the bottom 6 in. and the top 4 in. of the repair. The rest of the annular space was filled with non-metallic grout. Finally, a low modulus trowel grade epoxy was used to bevel the top of the repair as shown in Figure 6 and Figure 9. This method also relies on the prefabrication of the FRP jackets to match the size of the decayed pile and the desired annular void.

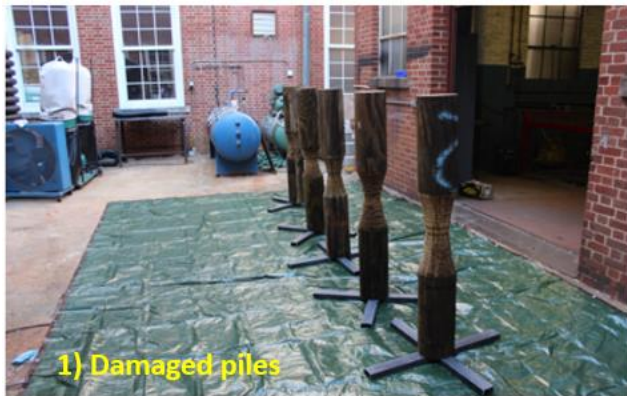
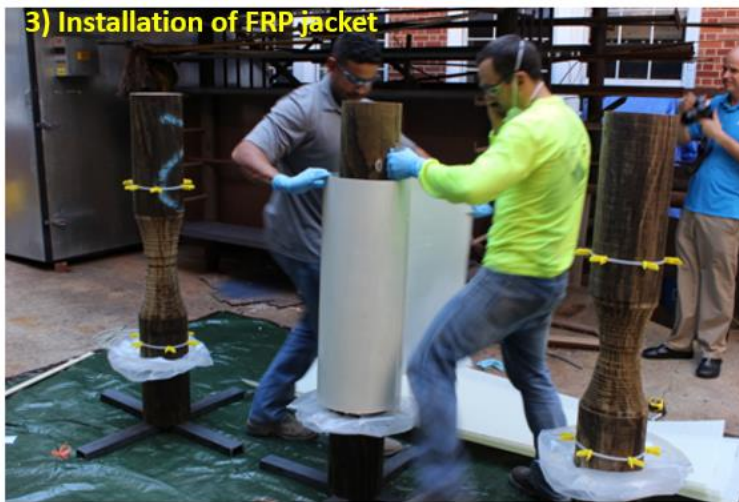
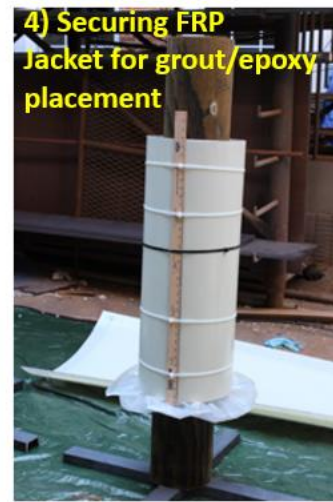
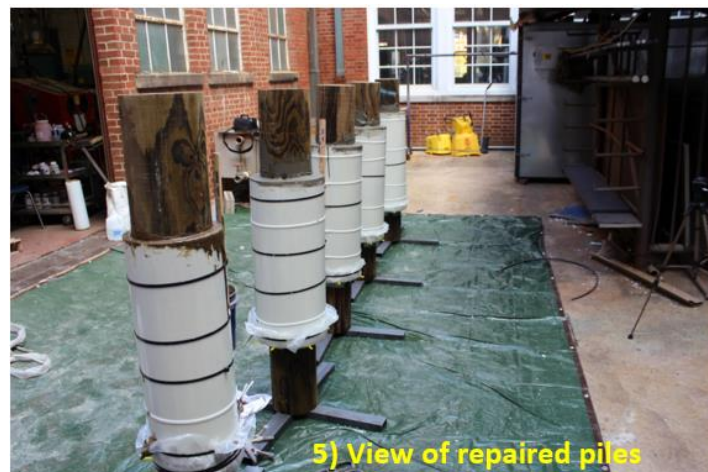
Figure 10. Repair of damaged timber piles – Pilemedic

Figure 10 shows the repair of the damaged timber piles with Pilemedic products. The damaged piles were secured vertically on the steel cross stands and spacers were installed above and below the damaged region to create the desired annular space. Plastic pour stops were installed at the bottom prior to the installation of the FRP laminates. The FRP laminates in this case came in flat sheets and were custom cut to match the diameter of the pile and the desired annular space. Two layers of bidirectional FRP laminates were wrapped around the damaged piles to create an 8 in. minimum overlap. After the spacers were installed, a coat of underwater epoxy was applied to the outside of the first FRP layer and the laminate was wound around the damaged pile to create an 8 in. minimum overlap (Figure 7c). Similarly, a coat of underwater epoxy was applied to the inside of the second FRP layer and the laminate was

wrapped around the first layer to create an 8 in. minimum overlap. Zip ties were used to additionally secure the laminates in the desired position and tie the plastic pour stops to the FRP laminates to seal any voids. Finally, the annular void was filled with either underwater epoxy or grout.

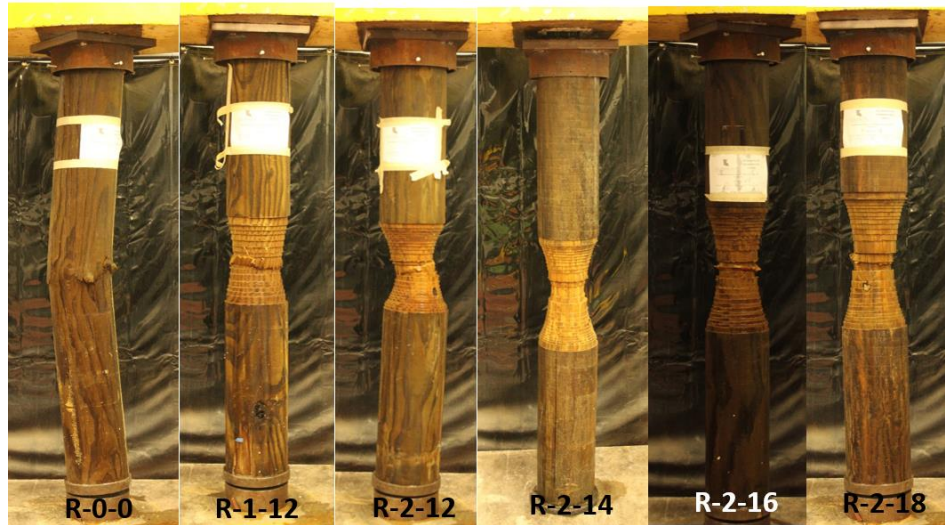
Figure 12: Testing of undamaged and damaged-unrepaired timber piles loaded concentrically

Table 2 provides a summary of the maximum loads measured for all reference piles. The maximum load was divided by the net cross-sectional area to calculate the failure stress in the reference piles. The average failure stress was 2.5 ksi and the coefficient of variation was 15.2%. The differences in the peak stress are attributed to the variability of the wood material despite the fact that all samples were obtained from the same jungle. This variability stems from the presence of knots, orientation of grains, etc. All failure modes featured a material failure due to the short length of the piles. Figure 12 illustrates the failure mode in the undamaged pile and the damaged unrepaired piles. In both cases the failure occurred at mid-height of the pile. For the damaged unrepaired pile this was expected because the smallest cross section of the pile was at mid-height. For the undamaged pile the failure was expected to occur in the weakest cross section.

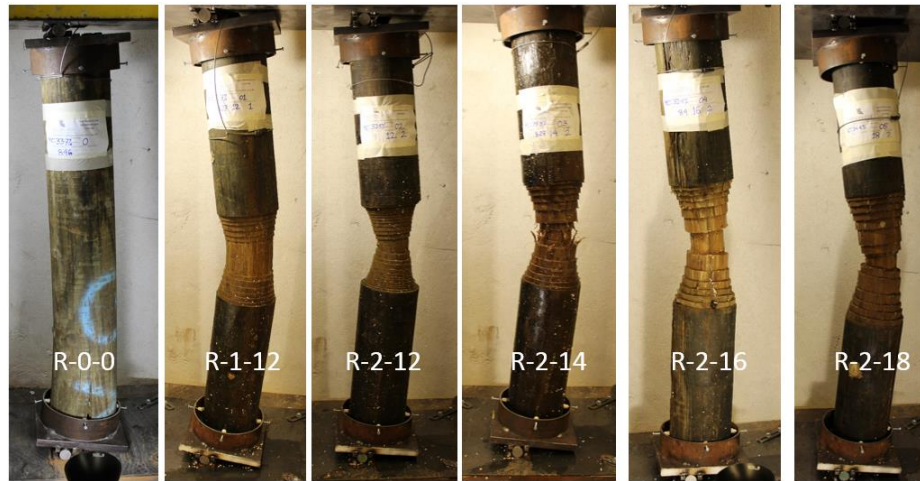
Figure 29 illustrates the failure mode in the undamaged pile as well as damaged unrepaired piles. The failure in the undamaged pile occurred at the ends and featured wood crushing and longitudinal cracking. The failure in all damaged unrepaired piles occurred at mid-height in the region that featured the smallest cross-section of the pile. The mode of failure was wood crushing. Figure 30 illustrates the typical failure mode for the repaired piles. For each repair technique the failure of the pile with a 1 in. damage depth and a typical failure for the piles with a 2 in. damage depth is shown. In general the failure mode featured a compression failure in the form of wood crushing. Two out of the 15 repaired piles featured screw pullouts, which was observed during the removal of the steel cap after the completion of the test. The repaired piles that featured screw pullouts were P-1-12 and D-2-18. While it is not clear at which loading stage the screws pulled out from the two piles, an examination of the peak load for P-1-12 and D-2-18 suggests that screw pullout must have occurred after the peak load was achieved sometime during the descending branch in the load displacement curve. The peak loads for P-1-12 and D-2-18 were 73 kips and 70 kips, respectively, which is between the range observed for the other piles (64 kips to 81 kips). The two screw pullout events are attributed to local defects in the wood at the connection region as well as damage in the tension zone after the peak load was achieved.

Figure 29. Testing of undamaged and damaged-unrepaired piles loaded eccentrically

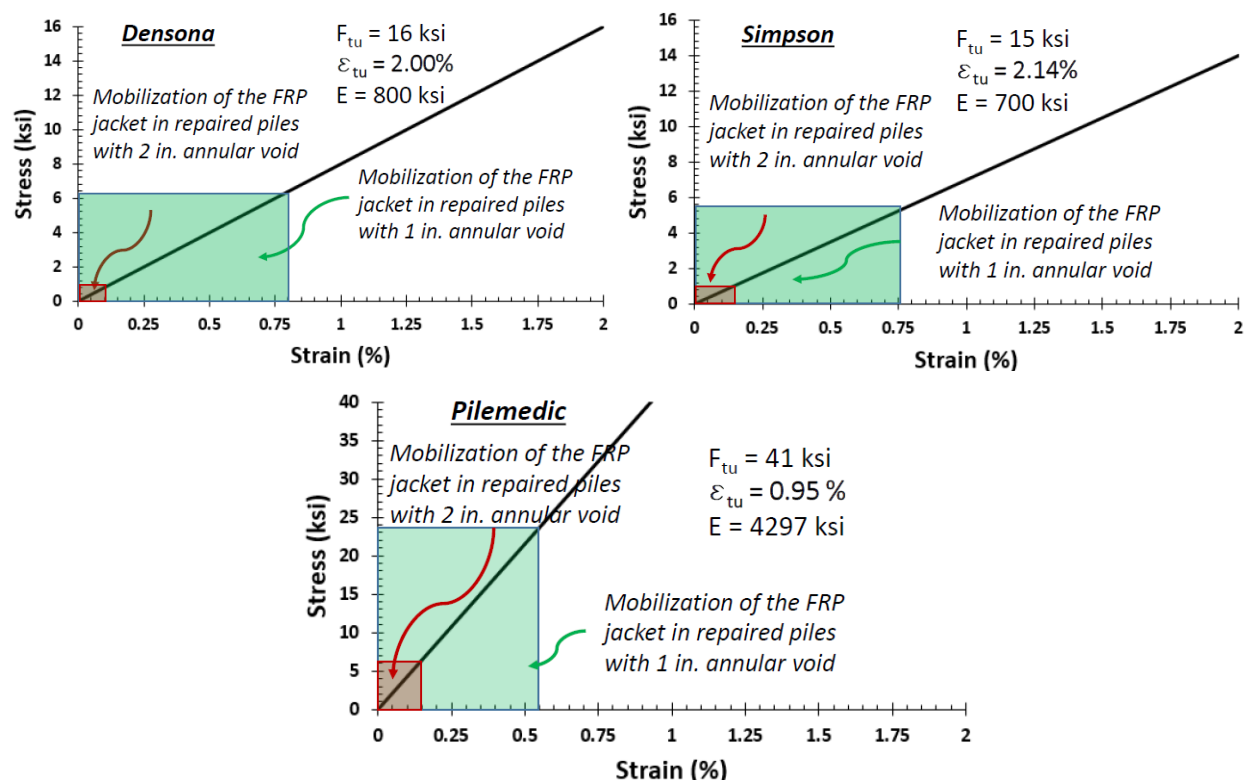
Figure 33 illustrates the mobilization of the FRP jacket in both cases. The maximum measured strains in the piles with 1 in. annular void repaired with Densona and Simpson products vary from 0.75% to 0.80%. The ultimate strain capacity of the FRP shells in both cases is 2%. As a result, less than or equal to 40% of the capacity of the FRP shell is being utilized. The maximum measured strains in the piles with 1 in. annular void repaired with Pilemedic products are approximately 0.55%, which is less than the 0.95% ultimate strain capacity of the shell. Also, in this case only less than 60% of the capacity of the FRP shell is being utilized. The mobilization of the FRP shell for piles with a 2 in. annular void reduces significantly. In this case the measured strains for piles repaired with Densona and Simpson products vary from 0.10% to 0.15%, which is less than or equal to 7.5% of the capacity of the FRP shell. The measured strains in piles repaired with Pilemedic products were approximately 0.15%, which is equal to 16% of the capacity of the FRP shell. This suggests that as the annular void gets larger the primary function of the FRP shell is to serve as a stay in place form rather than provide circumferential confinement or any additional structural capacity.

Figure 33. Stress-strain curve for FRP jacket and its mobilization based on the thickness of annular void for eccentrically loaded piles
