A Freshwater Controversy – Repairing the Estabrook Dam is not the best alternative for the Milwaukee River or the Community

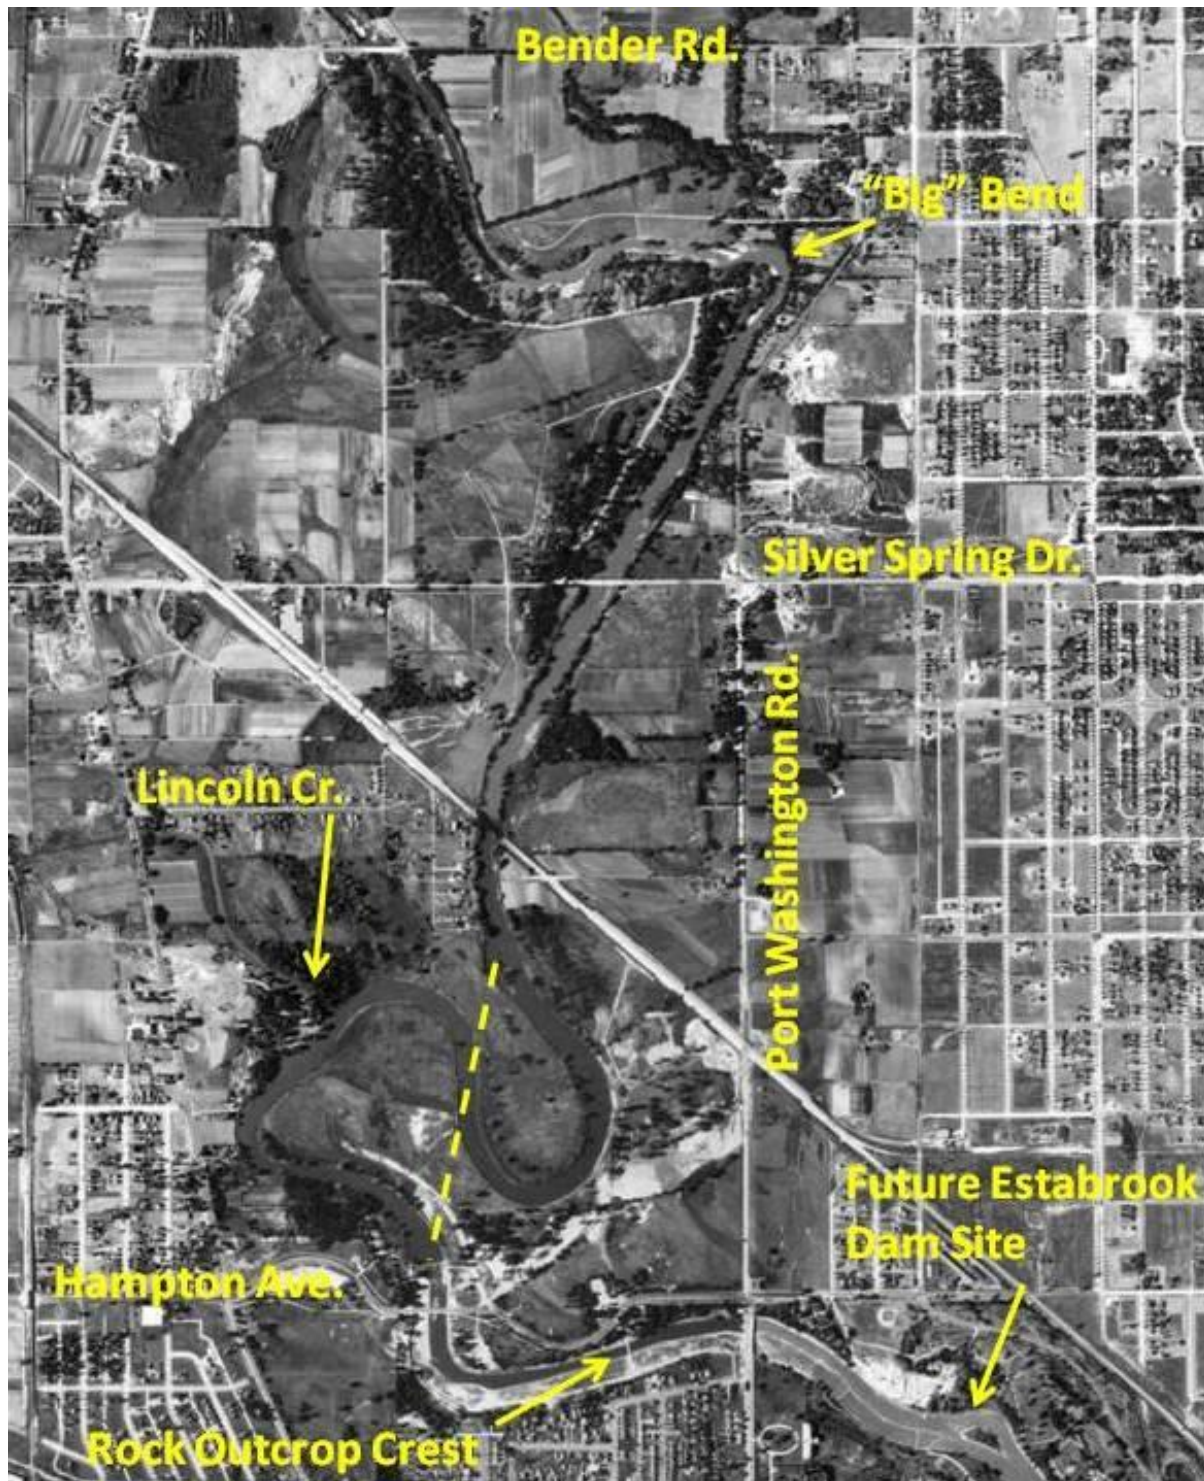
Figure 1. 1937 aerial photograph showing historic meander of the Milwaukee River in Lincoln Park prior to construction of the Estabrook Dam and 3,000-ft long by 200-ft wide “center-cut” (yellow dashed line). Widening and deepening of the river channel and rock outcrop is completed upstream of future dam site to the temporary cofferdam just upstream of Hampton Ave. bridge. Planning documents stated the rock outcrop backwater effect extended 3 miles upstream which coincides with the “big bend”. Source: Milwaukee County Interactive GIS Mapping website.

Prior to the 1930's lowering of the rock outcrop and construction of the 0.4 mile long "center cut" between Hampton Avenue and the upper confluence of the present day "east and west Oxbows", the Milwaukee River was a low-gradient, meandering alluvial river channel dominated by pool and run features. Its immediate corridor and broad floodplain included wetlands that supported habitat for a diverse plant and animal community sustained by seasonal flood waters that deposited nutrient-laden sediment. The top of the bank was reported to be only 2-feet from the normal (base-flow) water surface suggesting the entire river valley was inundated during floods. The flood waters likely extended upstream into additional wetlands along "Mud Creek" (present day Lincoln Creek).

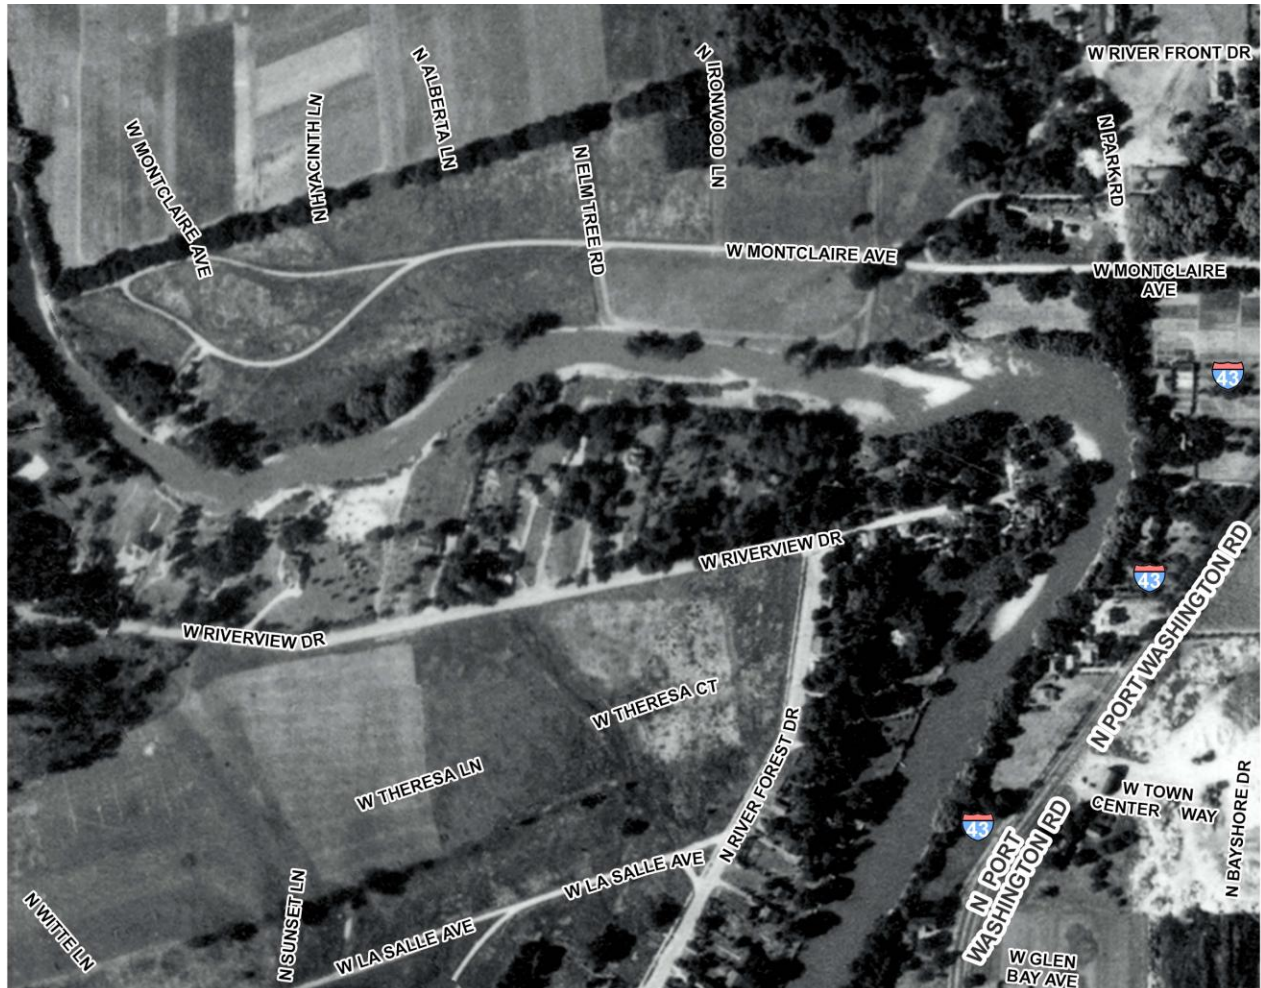
Figure 2. 1937 aerial photograph of Milwaukee R. between the “big bend” and Bender Rd. showing extent of lateral bar development consistent with free-flowing alluvial river channel. Note the lack of residential development along both left and right banks that pre-dates the construction of the Estabrook Dam in 1940. Currently there are an estimated 72 waterfront residential structures in this reach. Source: Milwaukee County Interactive GIS Mapping website.

The 1937 river width between the “big bend” and Bender Road was narrower at 80-feet, which is consistent with historic survey accounts by the City of Milwaukee Engineer that reported channel widths ranging between 70-feet and 130-feet. The 1937 aerial photographs and City of Milwaukee engineer drawings shows alternating lateral sand and gravel bars that are consistent with the morphology of a free-flowing, moderate-gradient alluvial river channel dominated by shallower riffles/runs unaffected by the rock outcrop (Figure 2 and 3).

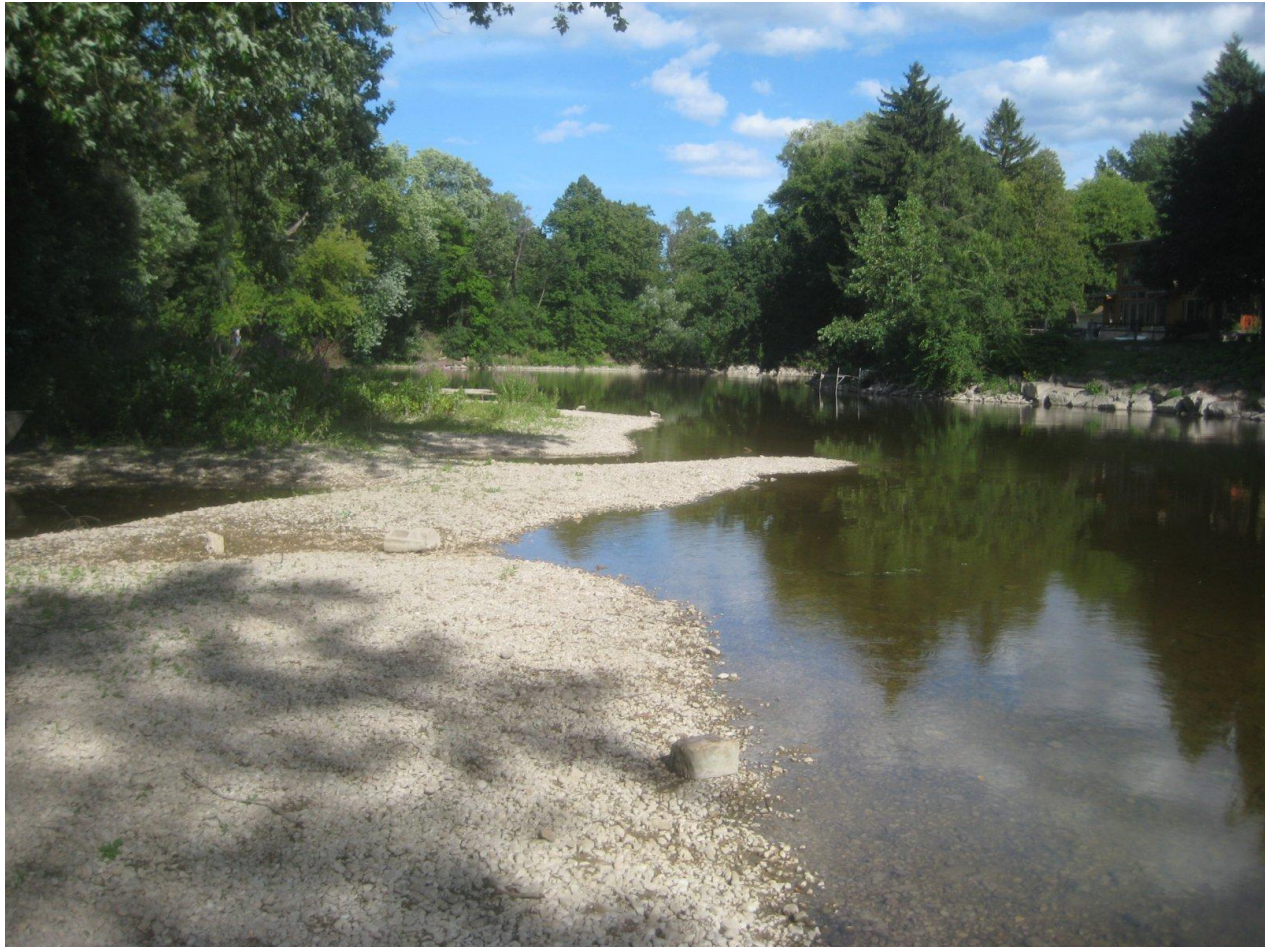
Figure 3. Photo of Milwaukee River between Bender Road and Silver Spring Drive approximately 2.6 miles upstream of the Estabrook Dam showing lateral bars formed by the river during the extended drawdown of the Estabrook Dam since 2008. A good example of sediment transport and river channel adjustment from an impounded condition to a free-flowing river. The large gravel to small cobble sized material is typical of the river's forces to transport sediment as "bed-load", maintain a stable river channel dimension and water depth, and create floodplain along this narrower reach of the river. These lateral bar features can be observed from 1937 aerial photographs prior to excavation of the center cut and construction of the Estabrook Dam. Pre-construction and existing channel widths are relatively unchanged. The daytime flow at the time of the photo was approximately 180 cubic feet per second which is 60 cubic feet per second lower than the 100 year median flow of 240 cubic feet per second. These water depths may be challenging to navigate by larger deep drafting power boats but are sufficient for small water craft such as kayaks and canoes. Photo taken August 4th, 2015 by Michael Horne, UrbanMilwaukee.com

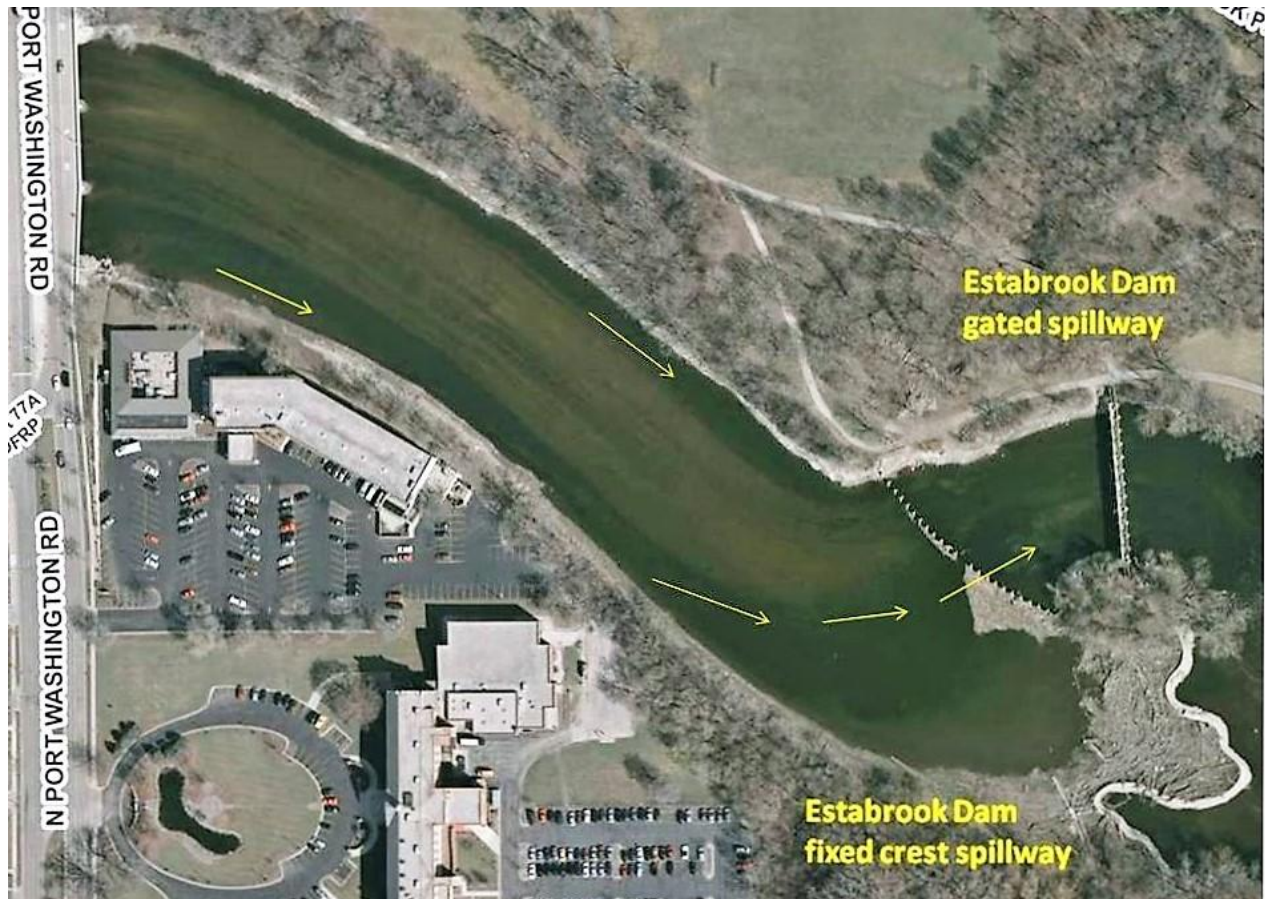
Figure 4. 2010 aerial photo of the Milwaukee R. between Port Washington Rd. and the Estabrook Dam. Scoured sediment plume is visible as light brown hue exiting through the dam's gated spillway. Sediment and comingled debris visible behind the fixed crest spillway was removed along with sediment that extended up the shoreline in 2015. Source: Milwaukee County Interactive GIS Mapping website.

The exception was the reach in the vicinity of the I-43 Bridge where depths were approximately 0.5-feet. Mr. Holmes states *“The lower portion of the impoundment was largely clear of sediment when surveyed in 2010 as part of planning for the second phase of contaminated sediment removal project, with only 6-inches of sediment present above the bedrock beneath the I-43 Bridge.” “All this suggests the flow dynamics within both the natural and man-made impoundment are sufficient to keep significant portions of the impoundment largely free of sediment.”* I would agree that the limited amount of sediment accumulation in this river reach is related to *“flow dynamics”*. However, the process is far from being just *“natural”*. The County has routinely contributed to this process by routinely opening the dam gates and flushing accumulated sediment to river reaches downstream of the dam (Figure 4). The accumulation of large volumes of contaminated sediment behind the fixed crest spillway but not behind the adjoining gated spillway where the drawdown occurs provides some evidence to this man-made process. Pre-remediation deposits of contaminated sediment were identified along the I-43 reach but were eroded away prior to mobilizing for removal.

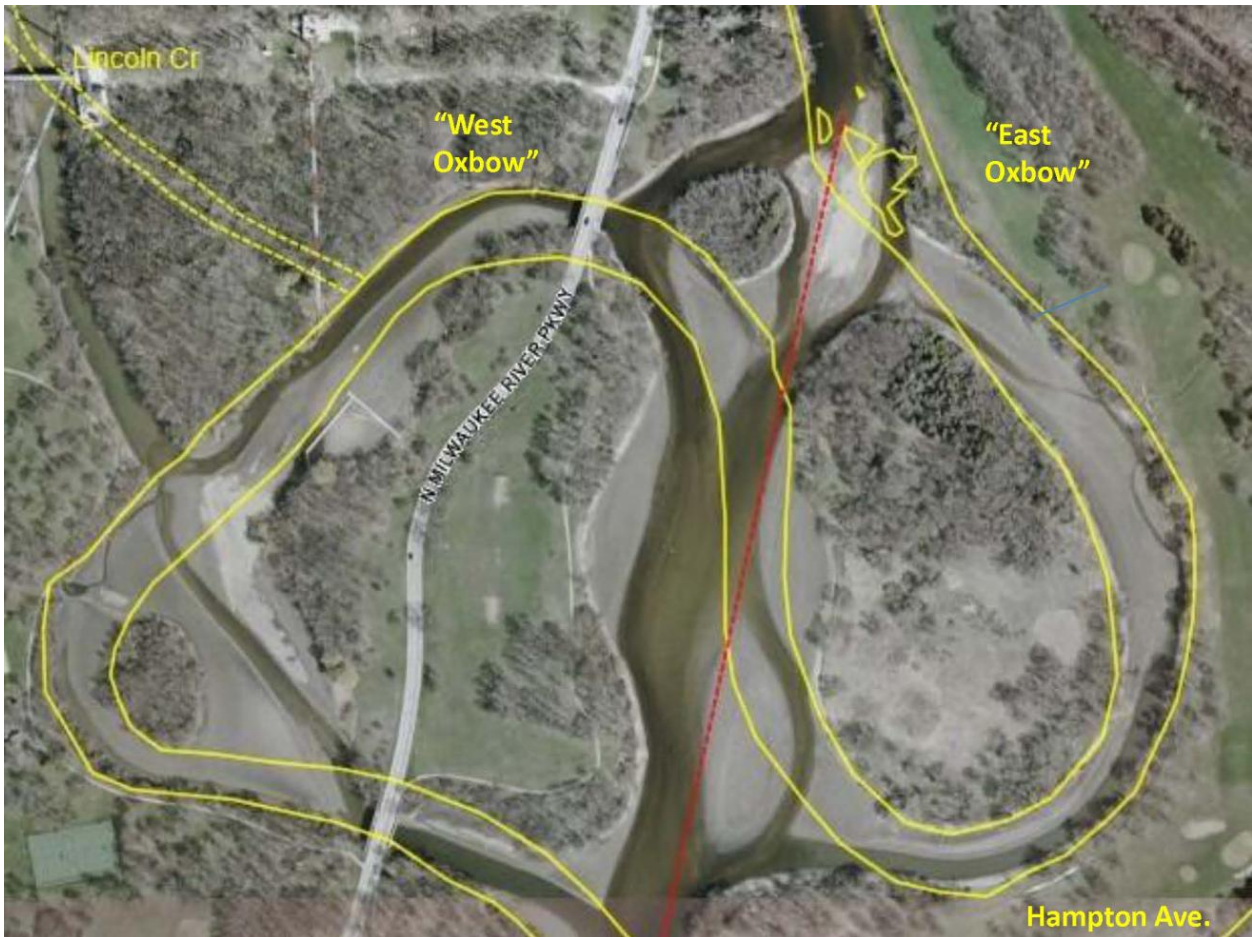
Figure 5. A 2005 aerial photograph of the Milwaukee River in Lincoln Park between Hampton Ave. and the upper confluence of the present day “east and west oxbows”. The spring 2005 photograph was made during the annual drawdown of the Estabrook Impoundment and pre-dates the WDNR’s 2008 ordered drawdown and removal of contaminated sediment between 2011 and 2015. The yellow lines are the 1937 natural river shorelines and meander that pre-dates excavation of the 0.6-mile long by 200-ft wide center-cut for mitigating the impact of flood flows and ice dams, and construction of the Estabrook Dam in 1940. The dashed red line is the approximate centerline of the excavated center-cut. Exposed and shallow water fine grained sediment deposited in the impoundment is evident as light gray shaded areas. Shoreline vegetation depicts the extent of the impoundment when the dam gates are closed and the impoundment is filled. Source: Milwaukee County Interactive GIS Mapping.

While the final estimated volumes of accumulated sediment and contaminants removed during the three remediation projects are not published, based on my conversations with a DNR engineer the final volume of contaminated sediment removed from the Estabrook Impoundment will be close to 176,200 cubic yards, 7,630 pounds of [PCB](#) and 16,718 pounds of [PAH](#) at a cost of \$49 million (Table 2). **The volume of removed sediment is equivalent to over 12,580 dump trucks.** I'm confident that if sediment surveys were extended throughout the 103-acre impoundment so to provide estimates of all accumulated sediment in the Estabrook Impoundment, and if the County had not been opening the dam gates and eroding a portion of accumulated sediment downstream of the dam on an annual basis, the amount of accumulated sediment since construction of the dam in 1940 would well exceed the 176,200 cubic yards of just the contaminated sediment removed from the impoundment (Figure 5).

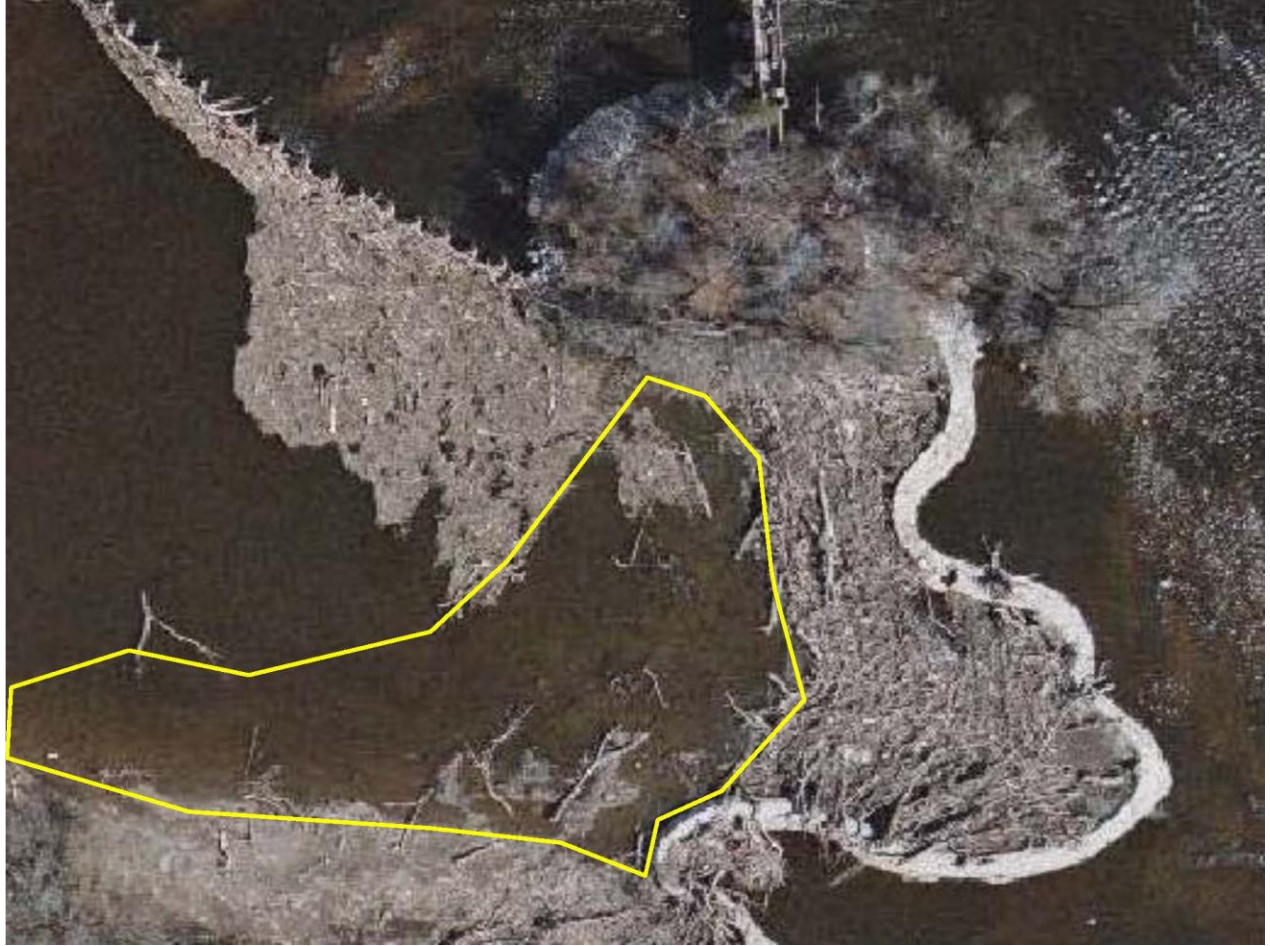
Figure 6. 2005 aerial photograph showing debris field accumulated behind the Estabrook Dam “serpentine” fixed crest spillway (lower) and the “dragons teeth” array installed to protect the gated section of the spillway (upper) from ice and debris. Comingled debris and contaminated sediment up to 5-feet thick is evident as light brown material inside the yellow boundary. Debris continued to accumulate behind the spillway until a 2010 flood eroded the debris and a portion of the comingled contaminated sediment downstream. Source: Milwaukee County Interactive GIS Mapping website.

The County has been delinquent in removing large debris, especially from the fixed crest spillway. Debris stored behind the spillways and dragon’s teeth can reduce flood flow capacity, and prevent the operation of the gates. Lack of funding has been a problem. The County has never responded to directives to remove debris from behind the fixed crest spillway, and instead relied on flood events to pass the debris downstream, like the 2010 flood. Removal can be difficult and expensive, and only recently was the County able to obtain an access agreement to the spillway via private property (Figures 6 and 7).

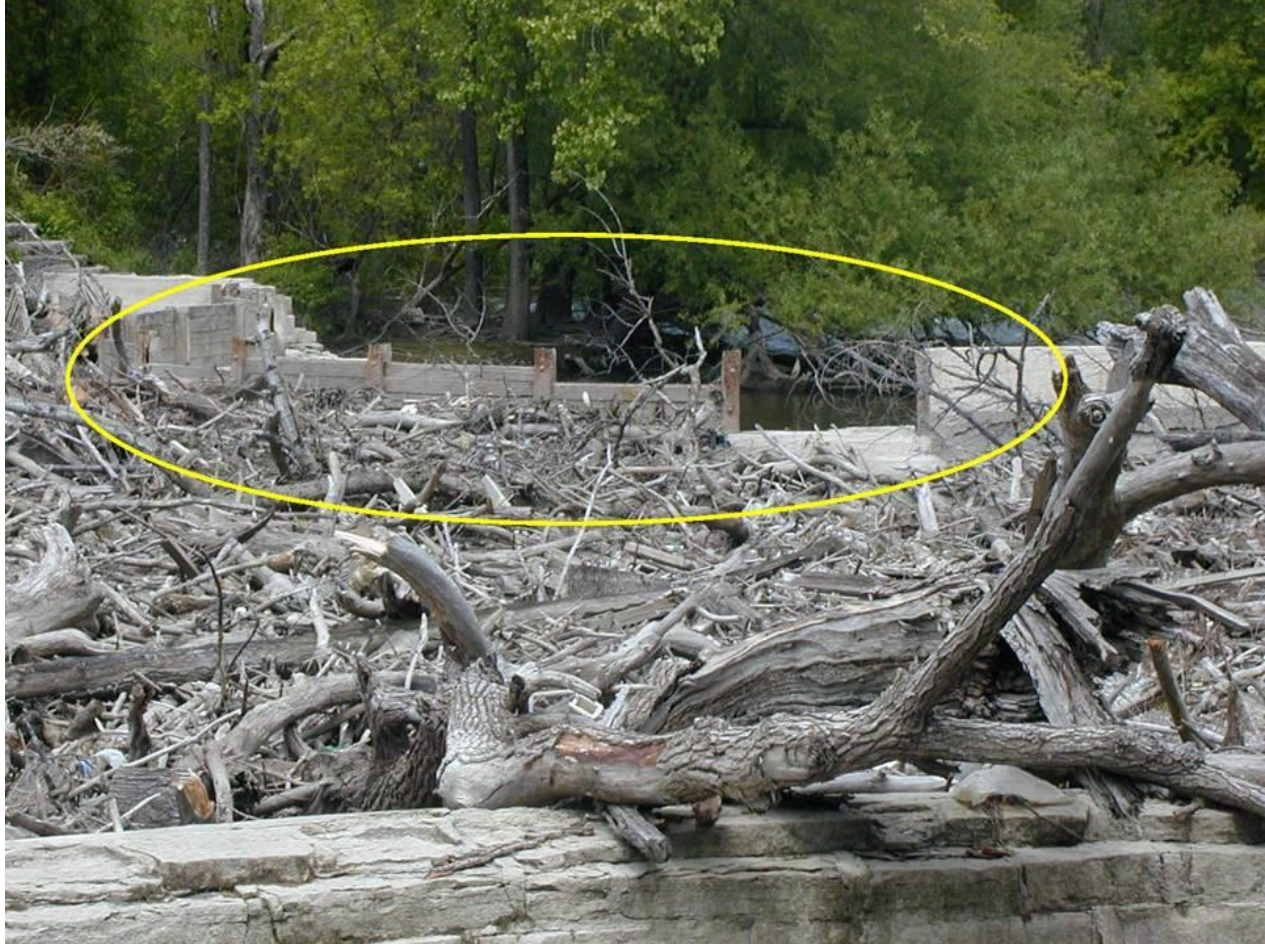
Figure 7. May 26, 2009 photo looking downstream along debris field deposited behind the Estabrook Dam's fixed crest spillway. The debris can impact the flood flow capacity and structural integrity of the spillways Flashboards and supports bounded by the yellow line were damaged by the debris and had to be replaced. Debris continued to accumulate behind the spillway until a 2010 flood eroded the debris and a portion of the comingled contaminated sediment downstream. Source: Will Wawrzyn

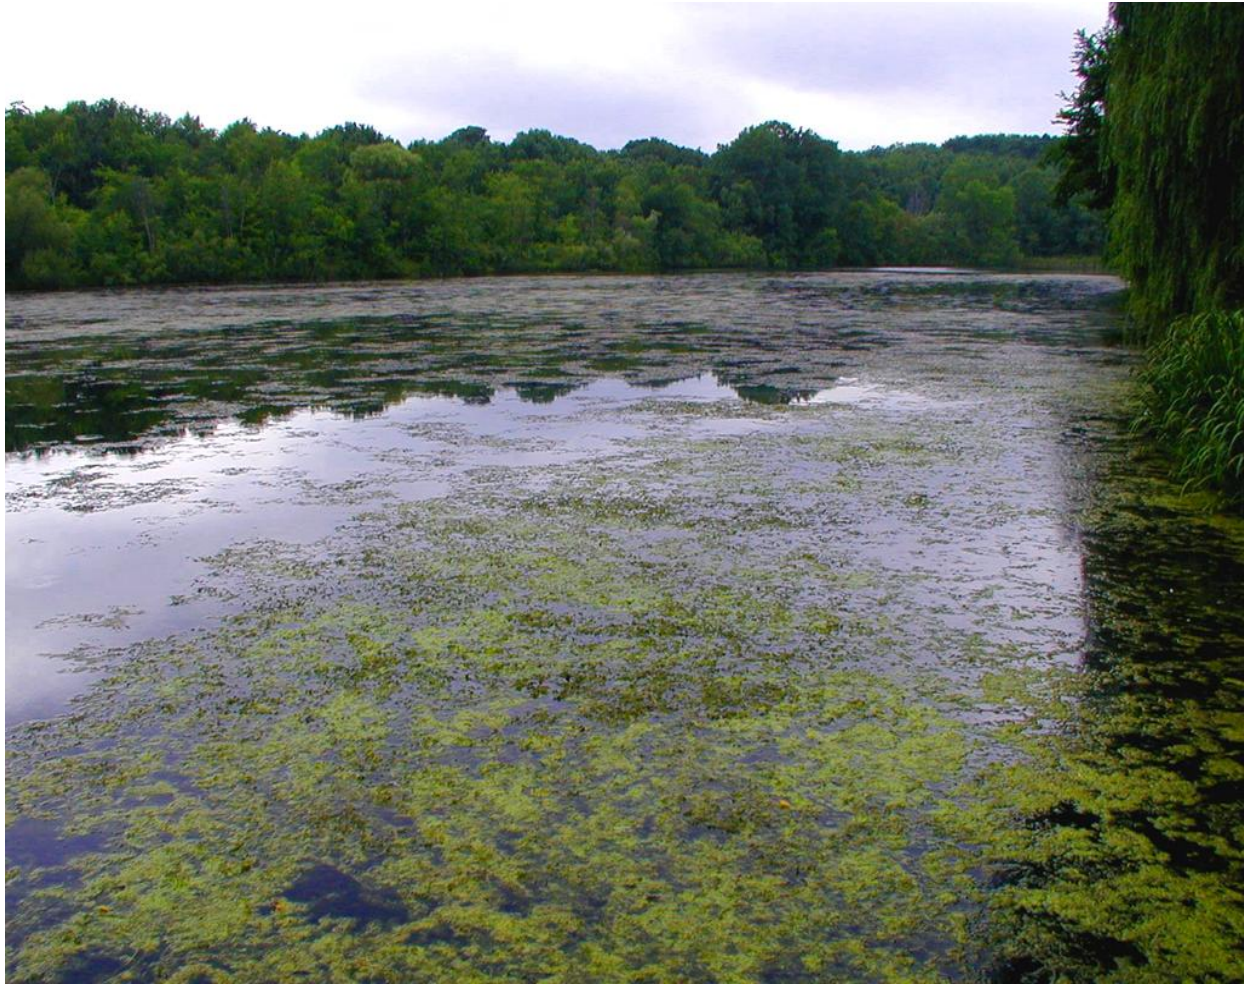
Figure 8. Photo of the Cedar Creek, Schweitzer impoundment in Washington County, WI, September, 2001 showing nuisance growth of non-native Eurasian watermilfoil and blue-green algae (green surface “scum”) prior to removing the dam in 2003. Source: Will Wawrzyn

Residence time will not be the deciding factor that contributes to nuisance rooted aquatic plant growth. The Estabrook Impoundment will continue to accumulate nutrient and organically rich sediment, and with sufficient sunlight penetrating all water depths throughout the impoundment, conditions will be ideal habitat for benthic algae and rooted aquatic plant production. These conditions were present in the former North Avenue impoundment and other impoundments in the Milwaukee River watershed and were responsible for nuisance biomass of rooted aquatic plants, in particular non-native [Eurasian watermilfoil](#) and [Curly-leaf pondweed](#) which unlike many native plant species, are tolerant of degraded habitat. The Estabrook Impoundment will not be immune to developing similar nuisance conditions (Figure 8 and 9).

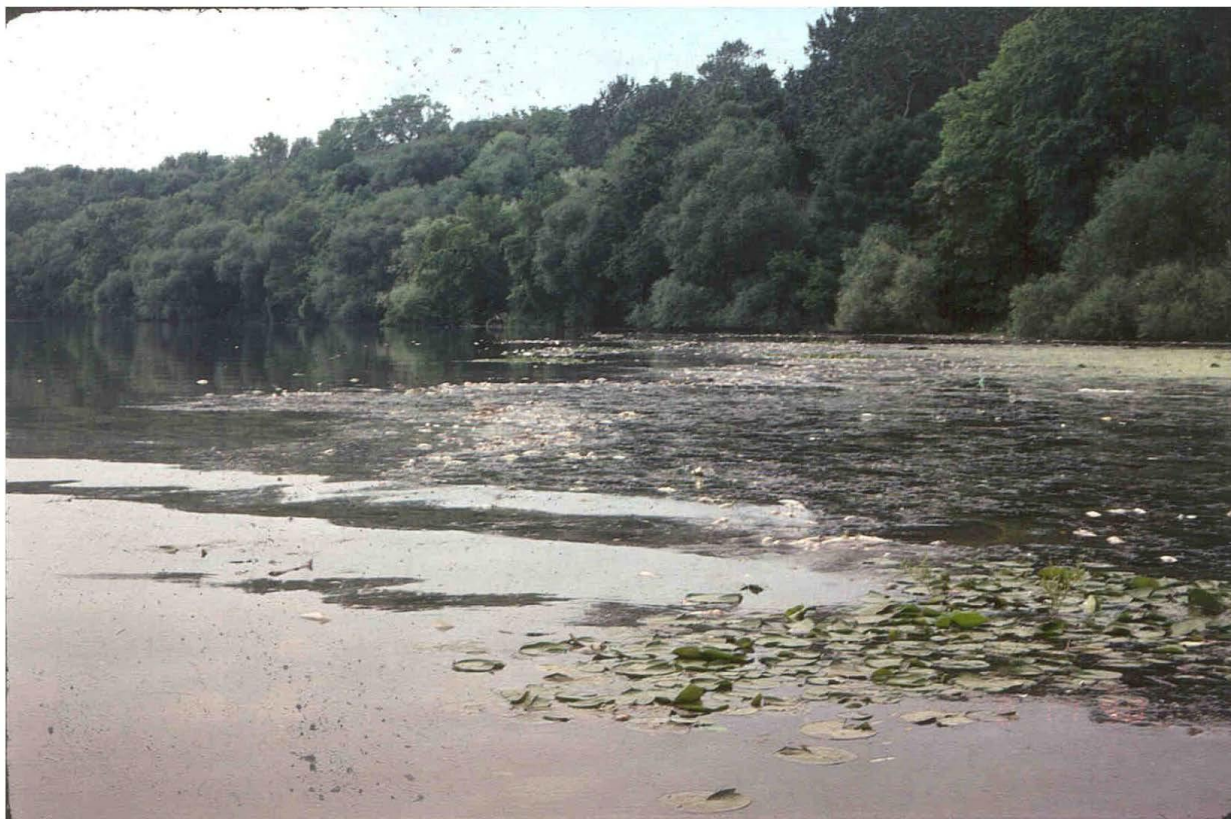
Figure 9. Photo from August 1990 fish kill investigation on the Milwaukee River North Avenue impoundment near Locust Street. Source: Will Wawrzyn

Both the Estabrook and former North Avenue impoundments have similar morphology and respond to the same sources and quality sediment, and flow regimes. Both experienced the legacy of polluted sediment from point and non-point sources of pollution, and while the sources of PCBs no longer exist, the Estabrook Impoundment will continue to accumulate polluted sediment from stormwater runoff including nutrients (nitrogen and phosphorus) from rural and urban sources, and potentially toxic heavy metals and [polynuclear aromatic hydrocarbons \(PAHs\)](#) from urban runoff. Sediment accumulation in the 150-year old North Avenue impoundment was estimated at 710,000 cubic yards with a maximum sediment thickness of 12-feet. Without accounting for the compaction of cohesive clay and fine silt particles, that amounts to a sedimentation rate of 1-inch per year over the 150-year life of the North Avenue Dam and impoundment. This rate and thickness of accumulated sediment may not impact some uses in the short term (e.g., navigation), but the rate and thickness of accumulated sediment will begin to impact water quality, fish and aquatic life habitat and their populations in just a few years. I am not aware of any records that account for drawdowns but personally observed partial drawdowns in 1971 and 1985. Water depths varied from less than 1-foot over half of the 90-acre impoundment, to a maximum of 9-feet along a narrow [thalweg](#) that meandered through the impoundment. Shallow areas were overgrown with nuisance amounts of submerged aquatic plants and filamentous algae. An investigation of a massive fish kill on August 1990 found 1,000's of dead fish. Eight species were identified, six of which are classified as tolerant to environmental degradation. Greater than 90% of the fish and biomass were non-native common carp and tolerant native white sucker. Common carp, white sucker and goldfish were represented by a wide range of year classes indicating ideal conditions for reproduction and survival, and top predators were absent (e.g., northern pike). Dissolved oxygen levels in the shallow and extensive respiring Eurasian watermilfoil plant beds were less than 0.5 part per million, well below the state water quality standard of 5 parts per million for protection of fish and aquatic life. Sediment was described as "effervescent" from methane gas released from the sediment, which also contributes to oxygen depletion. Physical habitat, sediment and water quality was very degraded. Over the years leading up to the removal of the North Avenue Dam in 1997, recreational fishing was non-existent. Similarly, recreational boating was almost non-existent except for the [Milwaukee Rowing Club](#) which had operated out of the Village of Shorewood's Hubbard Park for years until they relocated to the Milwaukee River in downtown Milwaukee just prior to removing the dam (Figure 9).

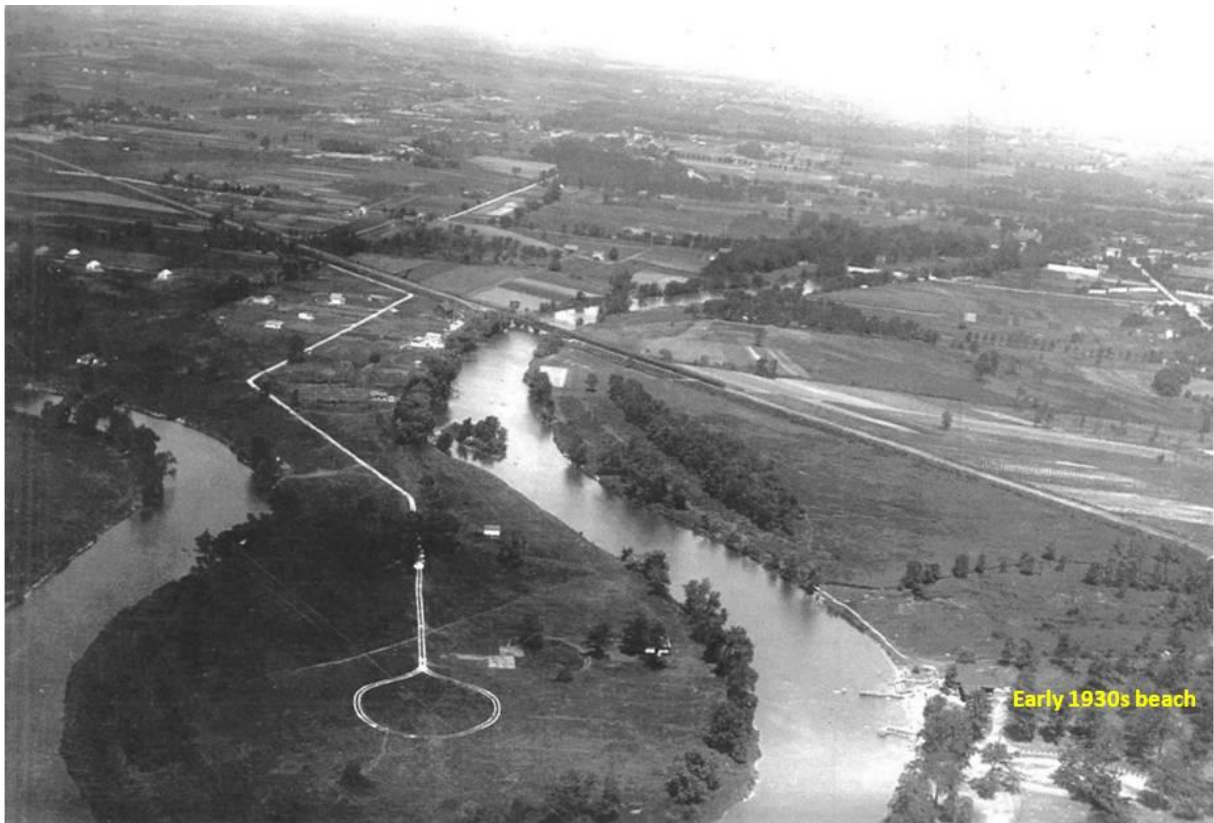
Figure 10. Looking northwest along the free-flowing Milwaukee River meander prior to excavating the center cut and construction of the Estabrook Dam. 1930's beach is located along lower right corner of frame and was eventually abandoned due to degraded water quality. As a result of the center cut, the beach would have been located in the present day "east oxbow" which has filled in with sediment. Photo and text modified from UrbanMilwaukee.com, February 16, 2016.

along the Milwaukee River at Lincoln and Estabrook Parks were present when the river was free-flowing and prior to construction of the Estabrook Dam and impoundment (Figure 10).

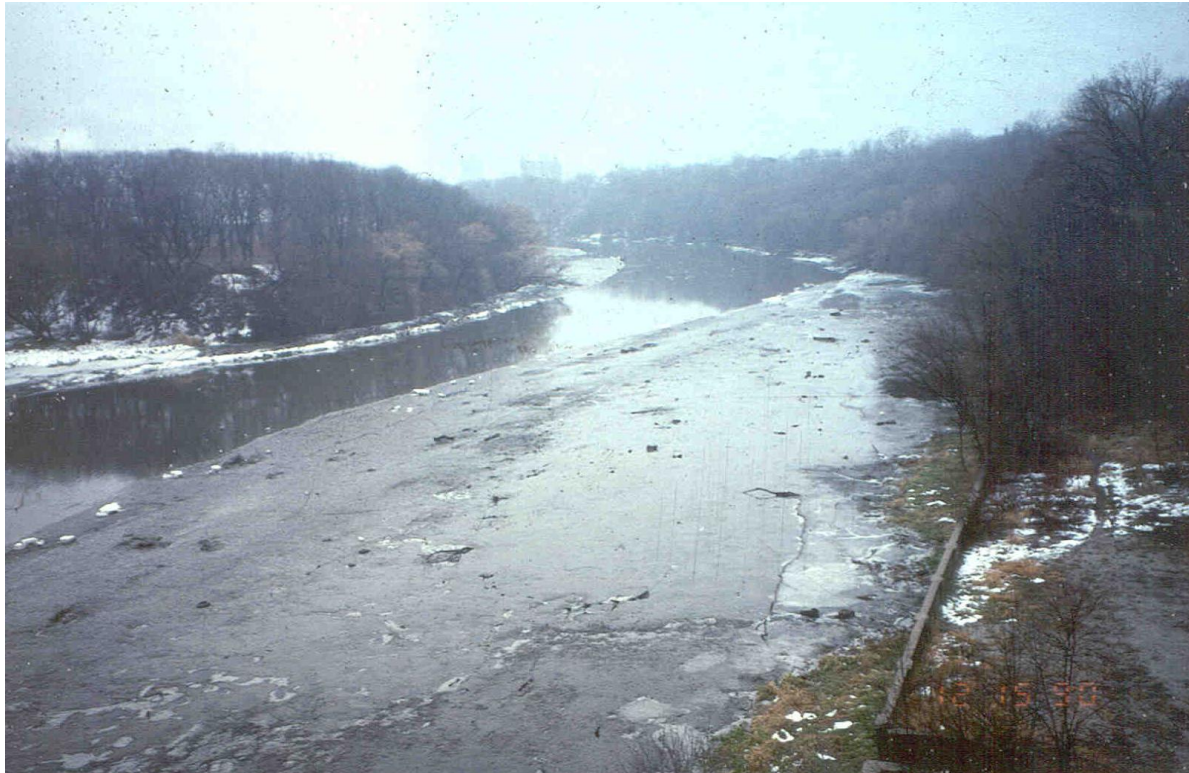
Figure 11. Looking downstream along the Milwaukee River from the Locust Street Bridge following drawdown of the former North Avenue impoundment in December 1990. Lower right area of exposed sediment and emergent vegetation was the site of the former swimming beach and school at Gordon Park in Milwaukee's Riverwest neighborhood that featured water depths of 5-ft prior to filling in with sediment (see Figure 6). Over 700,000 cubic yards of sediment up to 12-feet deep were deposited in the 90-acre impoundment over its 150-year existence. Partial impoundment drawdowns occurred in 1970 and 1985. Source: Will Wawrzyn

Public beaches and private swimming schools were operated along the former North Avenue Dam and its impoundment and eventually abandoned because of poor water quality and, I might add, filling in by deep "mucky" sediment (Figure 11).

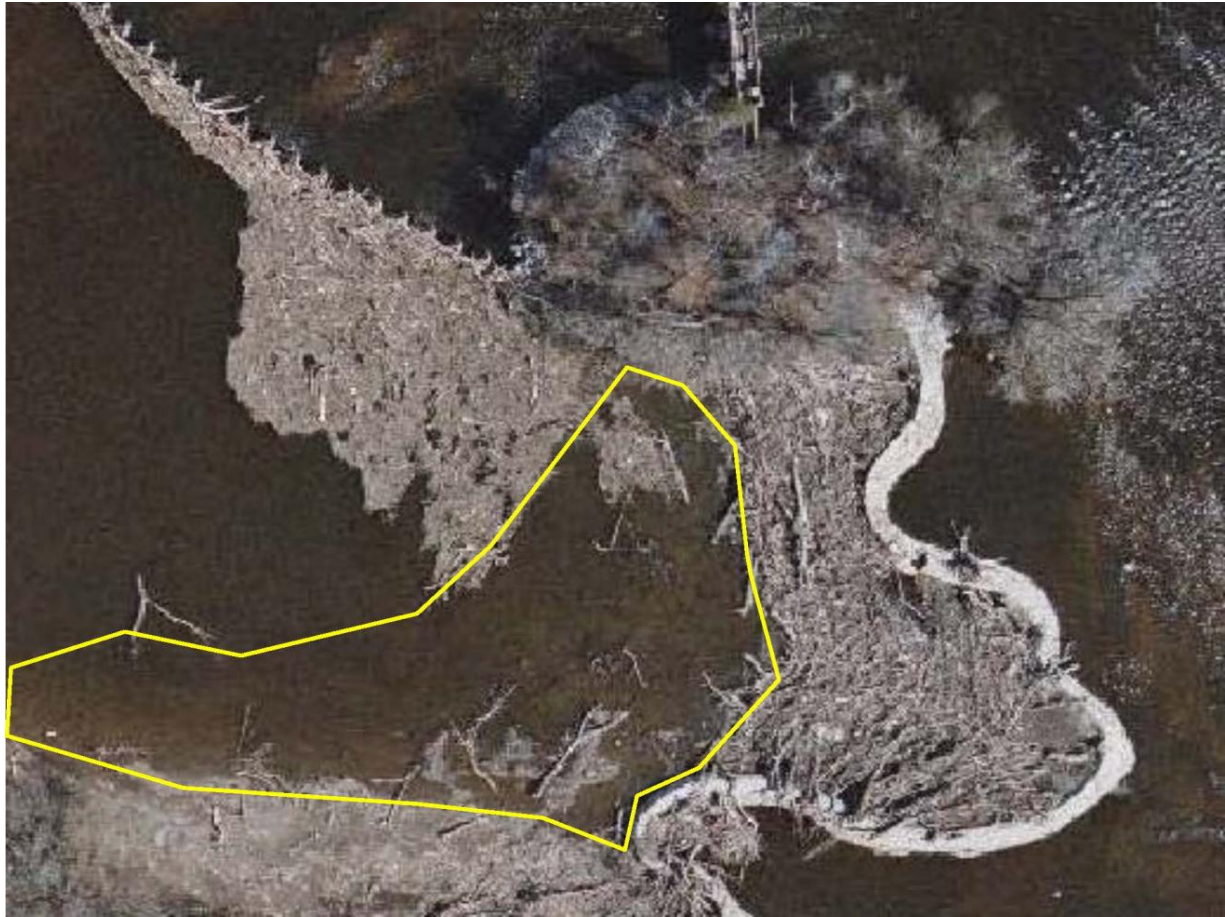
Figure 17. 2005 aerial photograph showing debris field accumulated behind the Estabrook Dam “serpentine” fixed crest spillway (lower) and the “dragons teeth” array installed to protect the gated section of the spillway (upper) from ice and debris. Comingled debris and contaminated sediment up to 5-feet thick is evident as light brown material inside the yellow boundary. Debris continued to accumulate behind the spillway until a 2010 flood eroded the debris and a portion of the comingled contaminated sediment downstream. Source: Milwaukee County Interactive GIS Mapping website.

- Debris removal costs could include a greater level of review, but not because the current estimate of \$50,000 per year is too high. I believe the estimate could be underestimated once the County is required to remove debris on a regular basis at the fixed crest spillway (Figure 17 and 18). When the County contracted for debris removal, it was done so only for the gated section of the spillway and “dragon’s teeth”. Typical costs for debris removal at the gated spillway and dragon’s teeth were up to \$40,000. There are no records of the County ever conducting debris removal at the fixed crest spillway despite orders to do so. Compared to the gated section of the spillway, the fixed crest spillway accumulates much larger volumes and mass of debris and comingled sediment. This section of the spillway is longer and irregular and may require a boom to remove instead of an excavator. Access is private, narrow and confined, and will require protection and cleanup from heavy equipment.

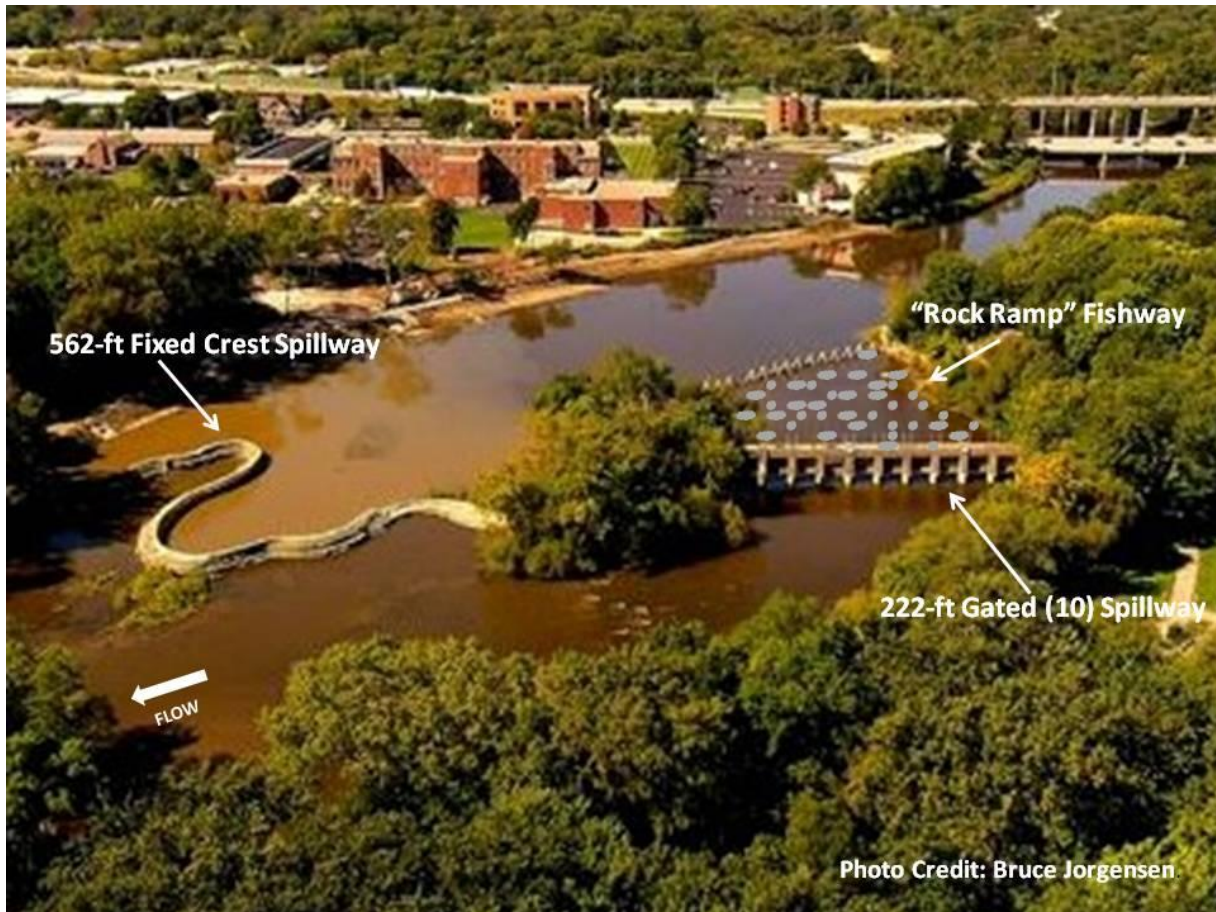
Figure 21. 2015 drone photograph of the Estabrook Dam including 562-ft fixed crest spillway and 222-ft 10-gated spillway sections. When the gates are closed, river flow is over the fixed crest spillway. Gates have remained open and the impoundment drained since the 2008 drawdown order by the DNR. Under dam management Alternative 4 developed by AECOM and described in the environmental assessment, the fixed crest spillway would be lowered and the gated spillway would be removed and replaced with a “rock ramp” to enable fish passage while maintaining most of the impoundment depths. Source: Bruce Jorgensen

Alternative 4 may be considered a hybrid between the dam repair with a fishway Alternative 1A, and the dam removal Alternative 2. Alternative 4 includes the removal of the 222-ft long 10-gated spillway section of the dam and lowering the 562-ft long serpentine fixed crest spillway by 6-inches. The gated spillway would be replaced with a “rock ramp” fishway that mimics a natural stream's riffle run features (Figure 21). It is a “passive” fishway design in that it operates using “run-of-the-river” flows and does not require managing structures to adjust fishway flows. Because large volumes of river flow can pass through the fishway, it is very effective and efficient at attracting fish to the fishway entrance and passing all native fish species regardless of river flow conditions and a fishes swimming behavior. This alternative would not cause any increase in the 100-year flood elevation, and under median river flow conditions, water levels along the impoundment would decrease between 0.4 and 1.2-feet. Water depths would range from 1.9 and 7.9-feet and would be adequate for power boats except near Bender Rd. The “rock ramp” crest elevation would be 615.4-feet or 6-inches lower than the historic rock outcrop’s minimum reported elevation. The “rock ramp” alternative has a 20-year present worth cost of \$3.3 million or \$2.9 million less than the County Board’s policy of dam repair with a fishway, but was never seriously considered despite the \$2.9 million savings. Dam repair proponents presumably were unwilling to compromise and accept any reduction in impoundment depth. This alternative would not prevent the accumulation of sediment in the impoundment without an approved operational order that allows for an extended seasonal drawdown and flushing of sediment. As a result, sediment would accumulate in the impoundment over time and environmental degradation would follow similar to those described for the dam repair alternative.

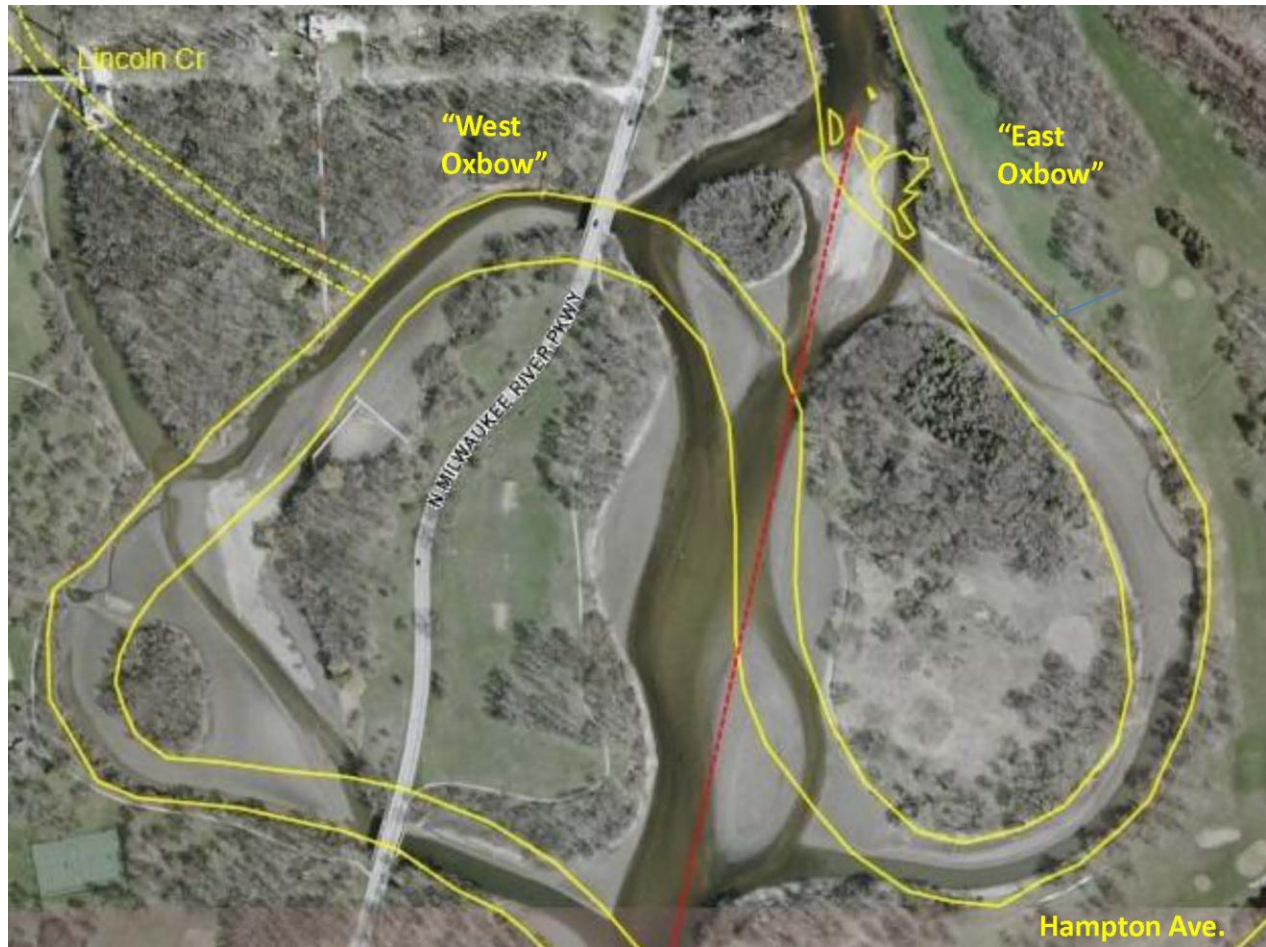
Figure 22. A 2005 aerial photograph of the Milwaukee River in Lincoln Park between Hampton Ave. and the upper confluence of the present day “east and west oxbows”. The yellow lines are the 1937 natural river shorelines and meander that pre-dates excavation of the 0.6-mile long by 200-ft wide center-cut for reducing but not eliminating the impact of flood flows and ice dams, and construction of the Estabrook Dam in 1940. The dashed red line is the approximate centerline of the excavated center-cut. Source: Milwaukee County Interactive GIS Mapping website.

Historically, the river was located along a single meandered channel. It flowed south through the present day “east oxbow”. From the east oxbow outlet, it flowed north to the present day confluence of the river and east-west oxbows. It then flowed west and then south through the present day “west oxbow”, past the confluence with Lincoln Creek, and then flowed through the bridge at Hampton Avenue (Figure 22).
